Vehicle Owner's Questionnaire To Report Vehicle Safety Defects

17 digit Vehicle Identification Number 4JGBB86E26, Make MERCEDES BENZ, Model ML350, Model Year 2006, Date Purchased, Dealer's Name and Telephone Number, Engine: No: Cylinders, Fuel Type, Original Owner, Dealer's City, State, Zip Code, Transmission Type, Antilock Brakes, Cruise Control, Powertrain, Vehicle Component Code 010000 STEERING, Multiple Failure: ABS INVOLUNTARILY ENGAGED / STEERING FAILED

Incident Date(s) 14-SEP-2008, Failure Mileage 34695, Failure Speed 40

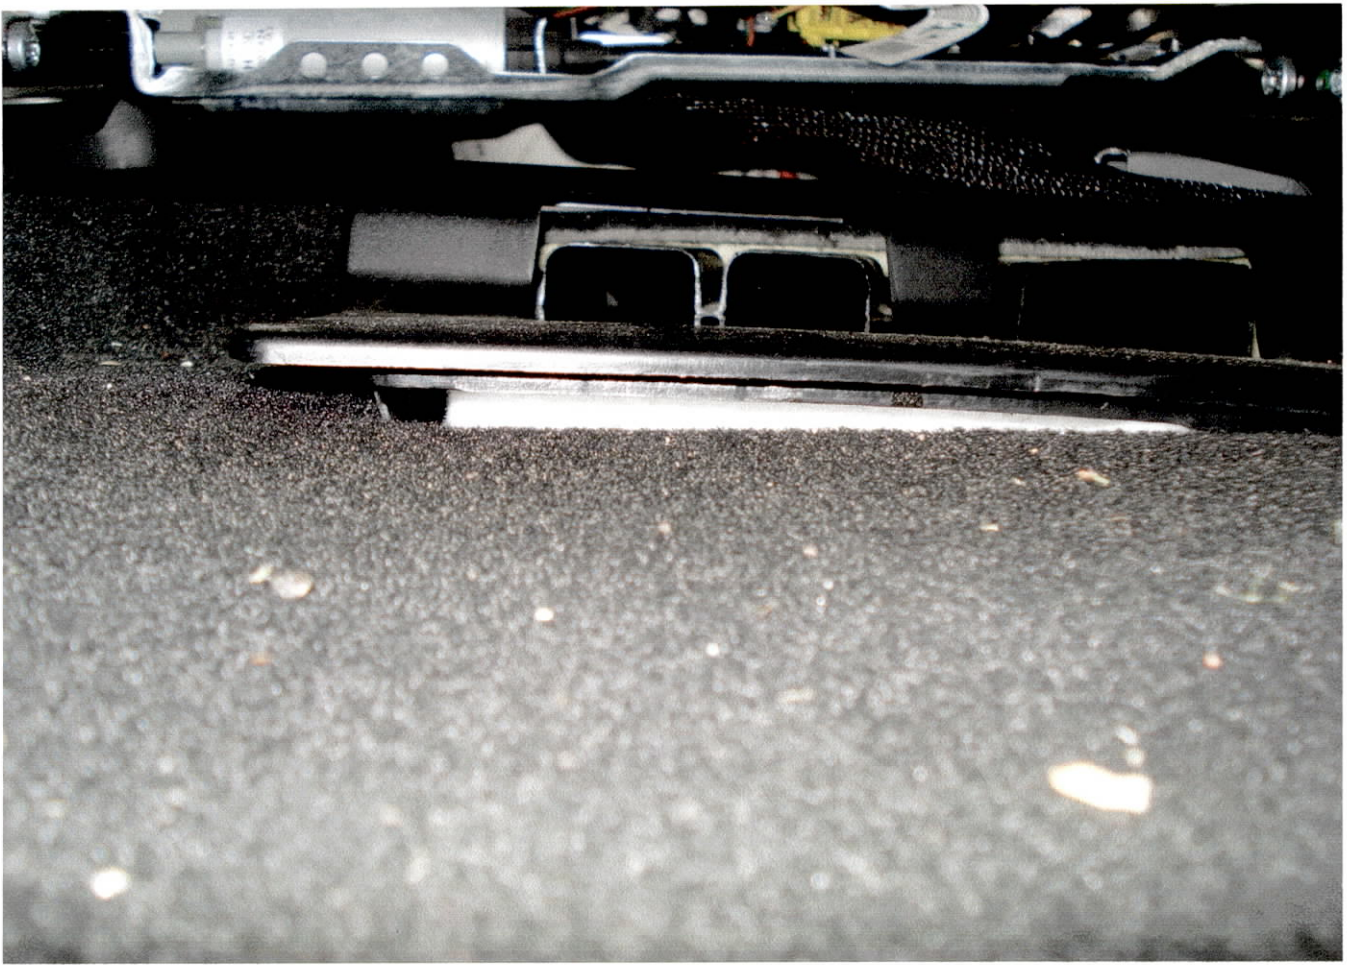
THE VEHICLE WAS TAKEN TO DEALER, BUT THEY DID NOT ADMIT COVER DEFECT. UPON RETURN OF THE VEHICLE FROM REPAIR, I PERSONALLY EXAMINED COVER. THE COVER WAS NOT REPLACED FLUSH TO FLOOR AND THERE WAS NO LATCH OR OTHER

MECHANISM TO ENSURE COVER WAS SECURELY PROTECTING COMPONENTS BELOW (INCLUDING BATTERY AND COMPUTER). WHEN I TRIED TO REMOVE COVER MYSELF IT POPPED UP ON THE OTHER SIDE. AFTER REPAIR ATTEMPTS I WAS ABLE TO CLOSE THE COVER, BUT STILL DO NOT BELIEVE IT IS SEALED OR EVEN PROVIDES AN EFFECTIVE BARRIER TO CRITICAL COMPONENTS. I BELIEVE THIS DESIGN FLAW IS DIRECTLY RESPONSIBLE FOR CRITICAL FAILURE SECONDARY TO A COMMON EVENT (A SPILLED DRINK IN THE BACK OF A FAMILY CAR). EVENTS SUCH AS THESE SHOULD BE EXPECTED AND THEREFORE STEPS SHOULD BE TAKEN TO PREVENT INFILTRATION OF VITAL COMPONENTS.

VIEW OF COVER AS IT WAS WHEN RETURNED FROM REPAIR WITH LARGE GAP/BREACH OF LEFT FRONT COVER. IT WAS DIFFICULT TO GET FLUSH WITH CARPET AND NO MECHANISM OR LATCH TO ENSURE IT STAYS FLUSH. A SIMPLE KICK WITH YOUR FOOT POPS UP THE COVER AGAIN.

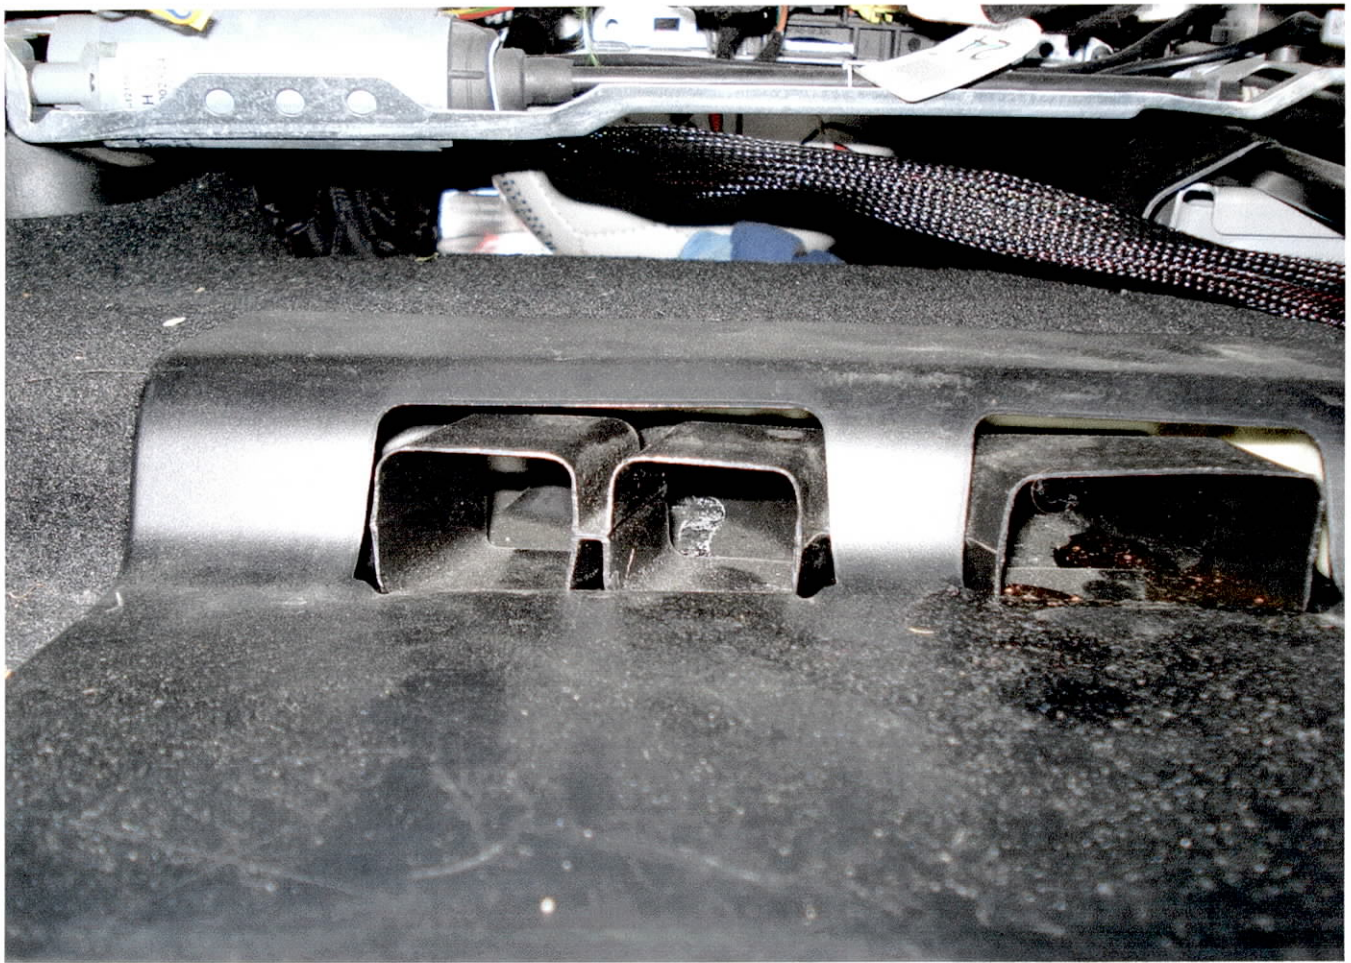
VIEW OF AIR VENTS AND GAPS BTW
AIR VENTS AND COVER LEADING TO OPEN
ACCESS TO BATTERY AND COMPUTER COMPARTMENT

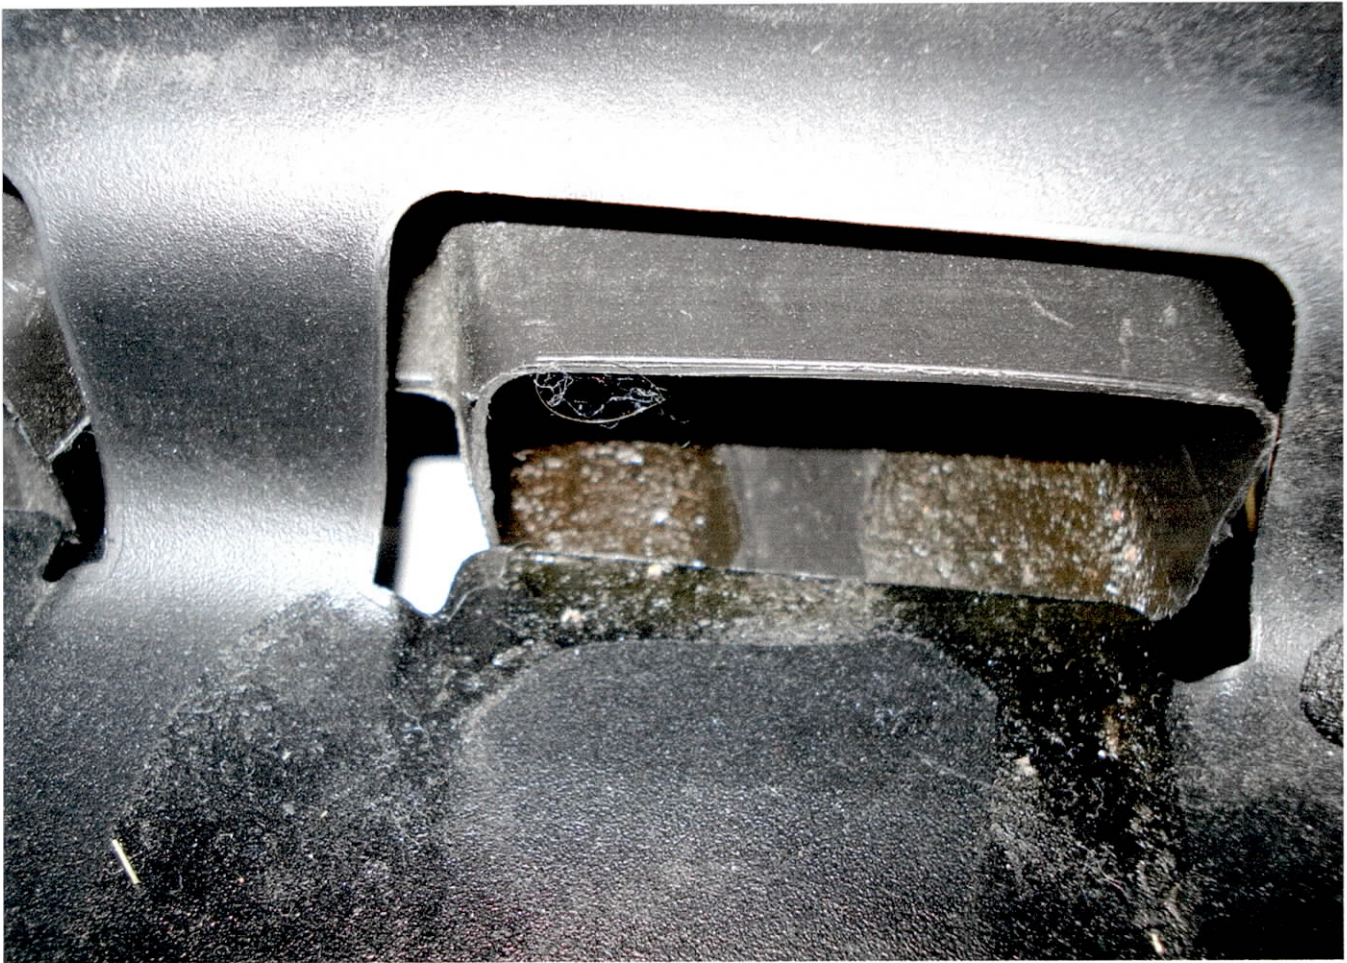
TL*THE CONTACT OWNS A 2006 MERCEDES BENZ ML350. WHILE DRIVING APPROXIMATELY 40 MPH, THE CONTACT'S DAUGHTER ACCIDENTALLY SPILLED A SMOOTHIE ON THE ELECTRICAL COMPONENT COVER LOCATED ON THE MIDDLE ROW FLOOR. THE LIQUID PENETRATED THE ELECTRICAL SYSTEM AND THE INSTRUMENTAL PANEL. AS A RESULT, THE STEERING AND THE ABS FAILED. THE CONTACT LOST CONTROL OF THE VEHICLE, BUT WAS ABLE TO PULL OVER TO THE SIDE OF THE ROAD. THE VEHICLE WAS TAKEN TO THE DEALER AND THEY CONCLUDED THAT THE ELECTRICAL COVER WAS DEFECTIVE. THE DEALER REPLACED THE WINDOW MOTOR AND THE COMPUTER AT THE COST OF \$1,384. THE MANUFACTURER FILED A REPORT AND STATED THAT THE COVER WAS DESIGNED IN THAT MANNER. THEY WOULD NOT ASSIST. THE CURRENT AND FAILURE MILEAGES WERE 34,695.

SMOOTHIE STAIN ON COVER AND VENTS.
GAPS VISIBLE WHERE FLUID COULD ENTER
BATTERY AND COMPUTER COMPARTMENT

LABOR
1 15MBZ04
CHECK STARTING SYS TECH(S):889 540.95
CLIENT STATES VEHICLE LOST ALL POWER AND WILL NOT RESTART
FOUND STRAWBERRY SMOOTHIE SPILLED IN FRONT SAM.
REPLACED FRONT SAM AND PROGRAMMED CONTROL UNIT.
REMOVED, RECHARGED AND TESTED BATTERY. CLEANED
DEBRIS FROM BATTERY WELL AND RIGHT FRONT FOOTWELL
AREAS.

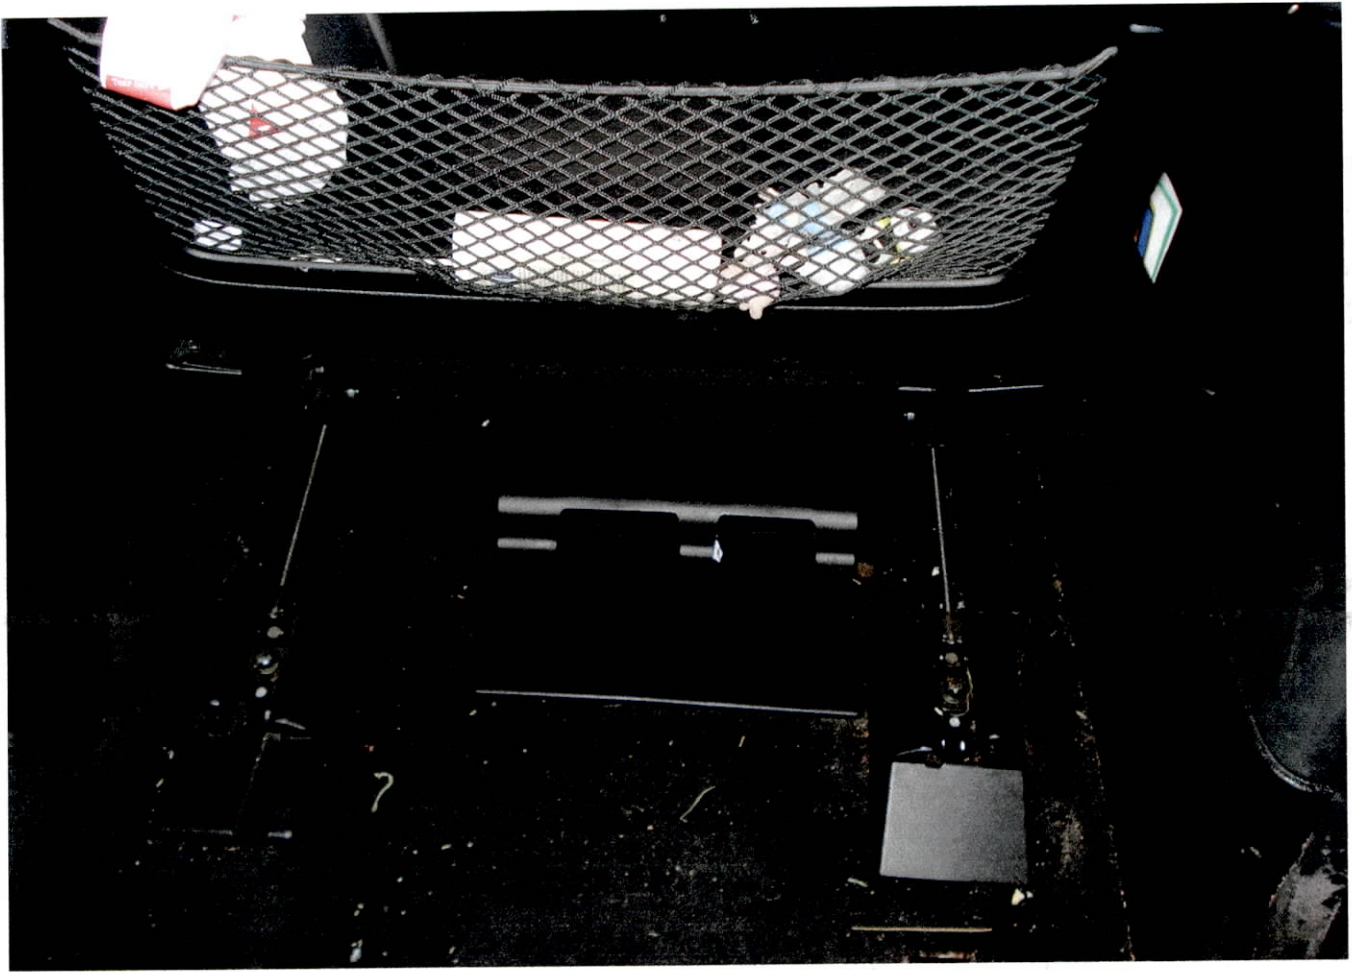
VIEW OF COVER UNDER PASSENGER SEAT
FROM REAR ROW

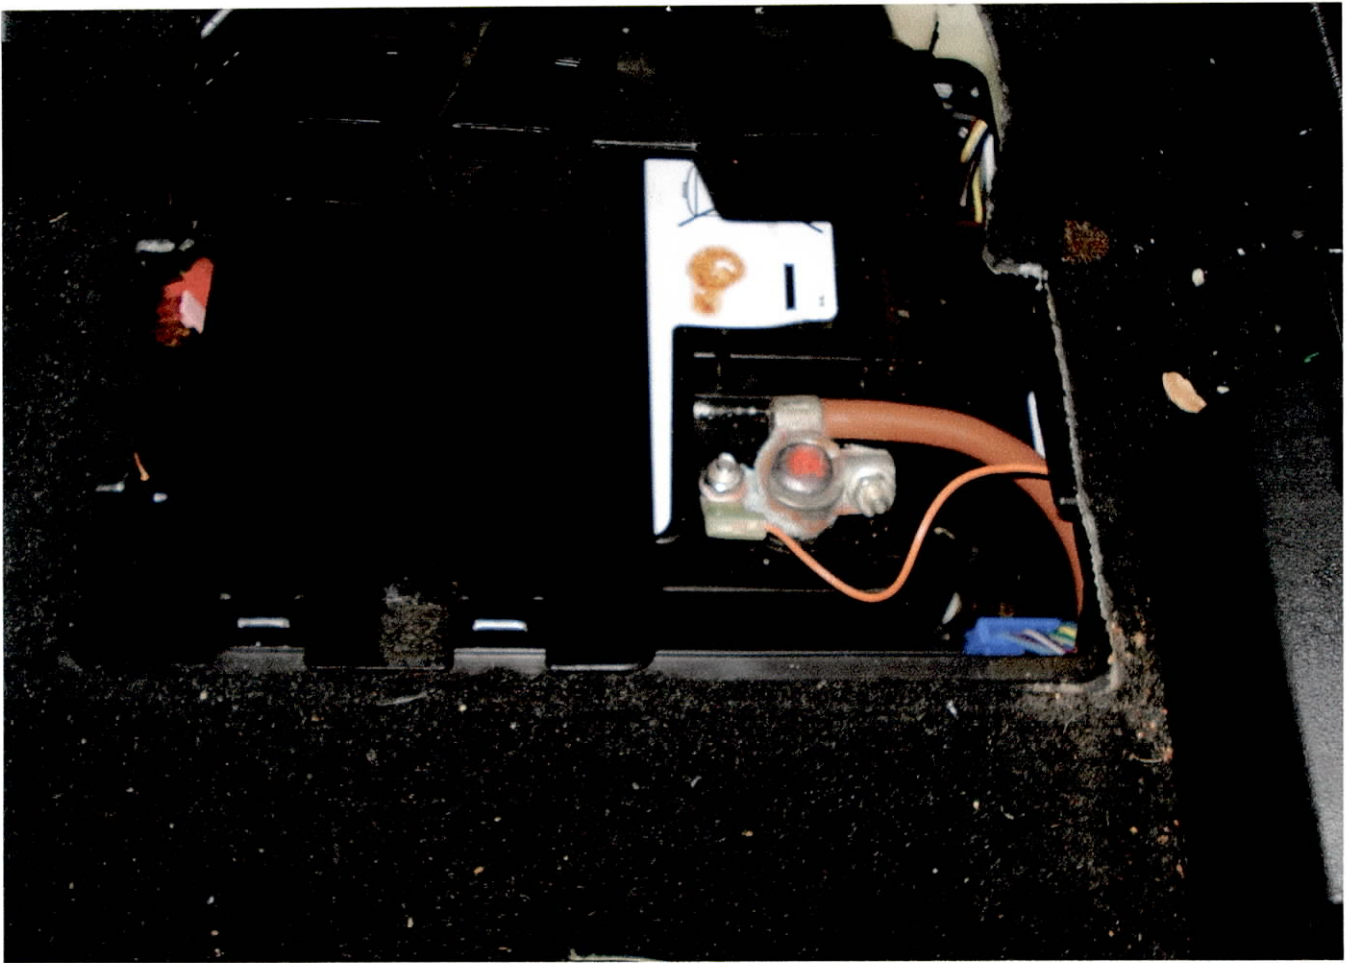
VIEW WITH COVER OFF. BATTERY AND
COMPUTER PARTS IN VIEW

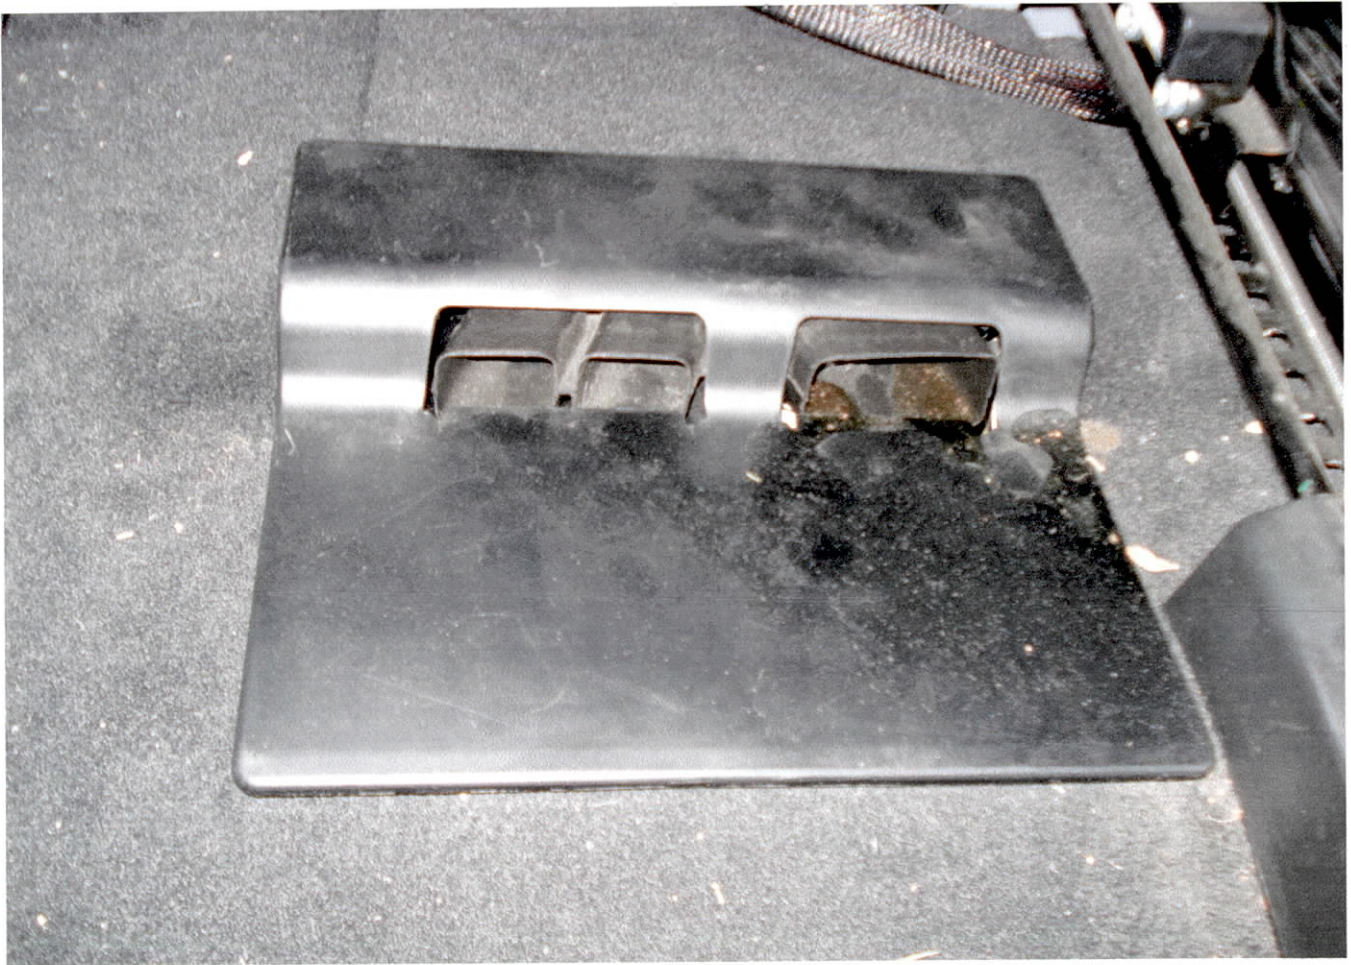
Full view of cover / vents and smoothie
stain.
