**DOT Auto Safety Hotline**  
**Vehicle Owner's Questionnaire**  
**To Report Vehicle Safety Defects**  
2008 NOV -7 PM 4:38  
1-888-DASH-2-DOT  
(1-888-327-4236)  
INTERNET: www.nhtsa.dot.gov/hotline

**DENNIS INVESTIGATIONS**

**DENNIS INVESTIGATIONS**  
NARRATIVE  
**CONFIDENTIAL**

**ORIGIN AND CAUSE SUMMARY**

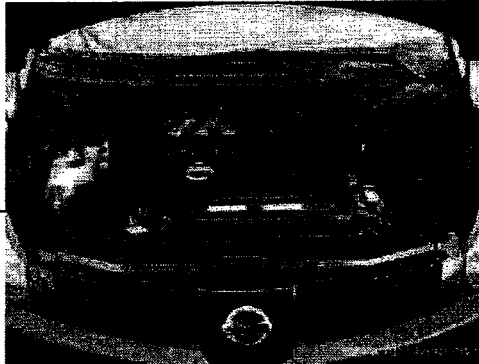
23. The power distribution box was located on this side of the vehicle and is positioned on its side to the right of what appeared to be the windshield washer fluid reservoir and radiator reservoir.

*Power Distribution Box*

*Exemplar photograph of engine*
