U.S. Department  
of Transportation  
National Highway  
Traffic Safety  
Administration

Vehicle Owner's Questionnaire

To Report Vehicle Safety Defects

Reference No.  
10256500

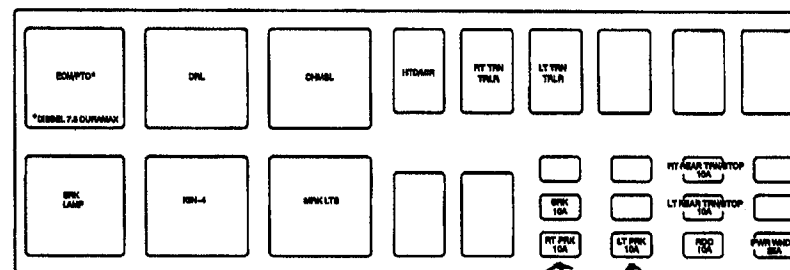
We left Pahrump on October 24, 2008, pulling our 20' Wells Cargo box trailer, (I also pulled a 24' Komfort travel trailer prior to the first incidence). We traveled to Las Vegas then to Mesquite NV., stopped for something to eat at 6:30 P.M. and then proceeded to Salt Lake City UT. As we were entering the Virgin River Gorge Canyon between Mesquite and St George UT, we heard a click and realized not only were all the tail lights and marker lights out but also the dash lights (control panel – speedometer). We stopped safely and replaced the same fuse that had blown earlier to no avail. We had no choice at that point but to proceed. The emergency flashers did work, so we continued one step at a time. We drove slowly and made it safely to St George. It was now after 10:00 P.M. on Friday night. Nothing was open for repair so we decided to continue one city at a time toward SLC. We used cruise control and a flash light often to check our speed and reset when we had to change speeds; we arrived in SLC after 4:00 A.M. Saturday the 25<sup>th</sup> and parked. On Monday the 27<sup>th</sup>, we contacted Jerry Seiner GMC at 106<sup>th</sup> S. & I-15 and arranged to take the truck in on the 28<sup>th</sup>. They checked out the problem and replaced a fuse blown further up the line. It was stated that the upfitter (Regency Vans) who had placed the truck bed on the chassis had not followed the correct procedure by not using the 25 amp fused connector provided by GMC to wire the lights on the truck bed. Regency mechanics had indiscriminately clipped one of the wires leading to the left front marker light which is fused by itself with a 10 amp fuse and spliced all the marker and tail lights on the truck bed to that point.

As Jerry Seiner  
truck wired

As my truck  
wired

118 IPA (N/C)  
 1 88909756 FUSE KIT (N/C)  
 5367 2.50 REWIRE ALL BED AND TAIL LIGHTS TO THE PROPER UPFITTER  
 CONECTION PER GM UPFITTER GUIDELINES. RECHECK FOR PROPER OP=OK.
