Secretary of Transportation  
Raymond LaHood  
U.S. Department of Transportation  
1200 New Jersey Ave, SE  
Washington, DC 20590

November 6, 2010

It wasn't until later that we found out about the defect known to Chrysler and the National Highway Traffic Safety Administration (NHTSA) as "park-to reverse, false park or inadvertent rearward movement." In a vehicle with the park-to-reverse defect, an operator of the vehicle in normal use can inadvertently place the shift selector (also referred to as the "Rooster Comb") between the intended park and reverse gear positions. The shift selector will remain for a period of time between the intended gear position and from this position it may (or may not) have a delayed engagement of powered reverse. Upon having an engineer inspect and test our mother's Chrysler Town & Country Mini-Van, he indicated the van did in fact have the defect. The vehicle would go into false park (the cues indicate that the van is in park but seconds later it will self-shift into reverse,) four out of ten times when tested.

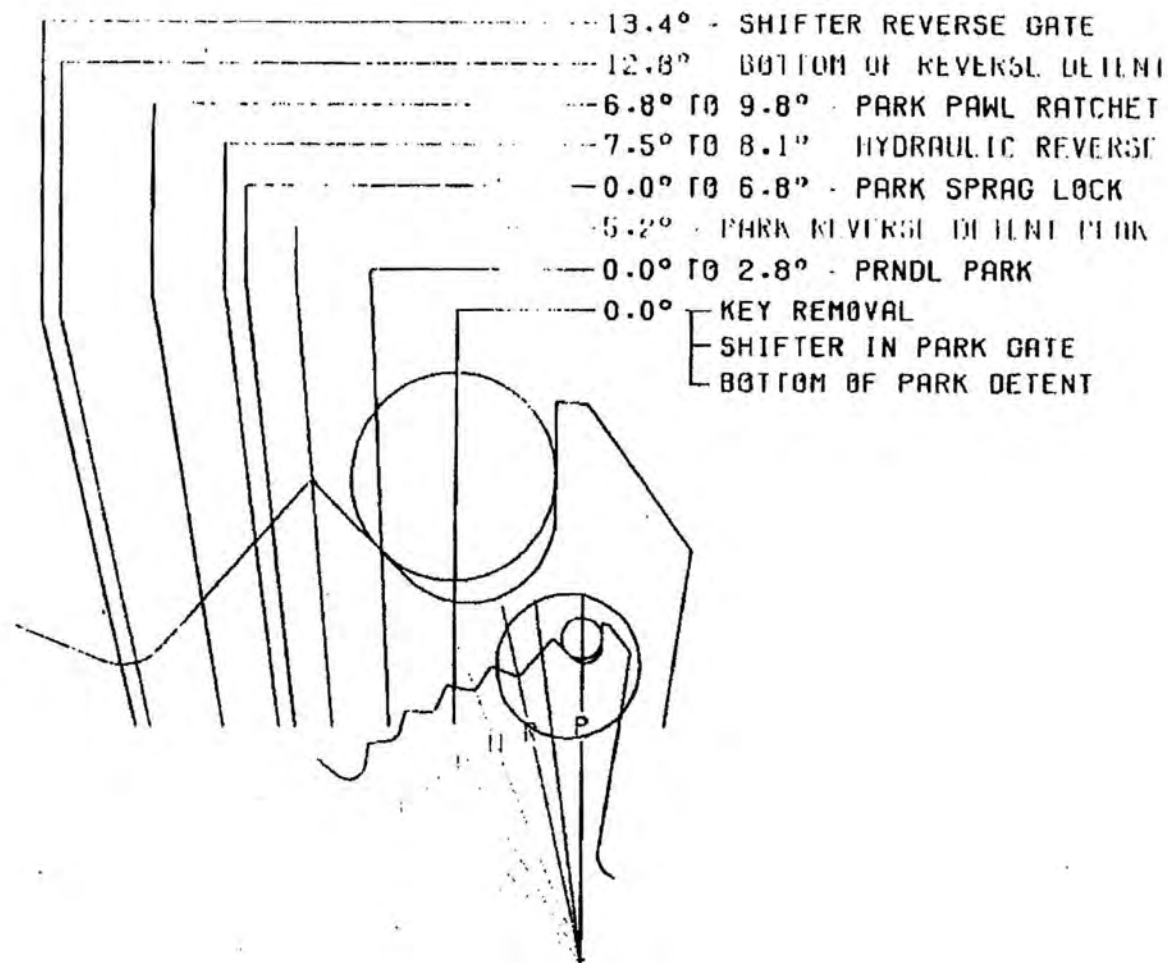
Figure 6. Angular displacement between reverse and park in rooster comb. Detent roller at reverse gear, manual valve fully open at R, vent fully closed.

Figure 7. Reverse to Park shift events corresponding to angular position of detent roller in rooster comb.
