**Subject: S10 APPROPRIATE HANDLING - LETTER FROM [REDACTED] REGARDING A CHRYSLER TOWN AND COUNTRY TRANSMISSION DEFECT**

**Control number:** S10-101110-004      **Action office:** NHTSA  
**Document date:** 11/6/2010      **Due date:**  
**Author(s):** [REDACTED]  
**Subject:** Chrysler Town and Country Transmission Defect  
**Action:** Appropriate Handling

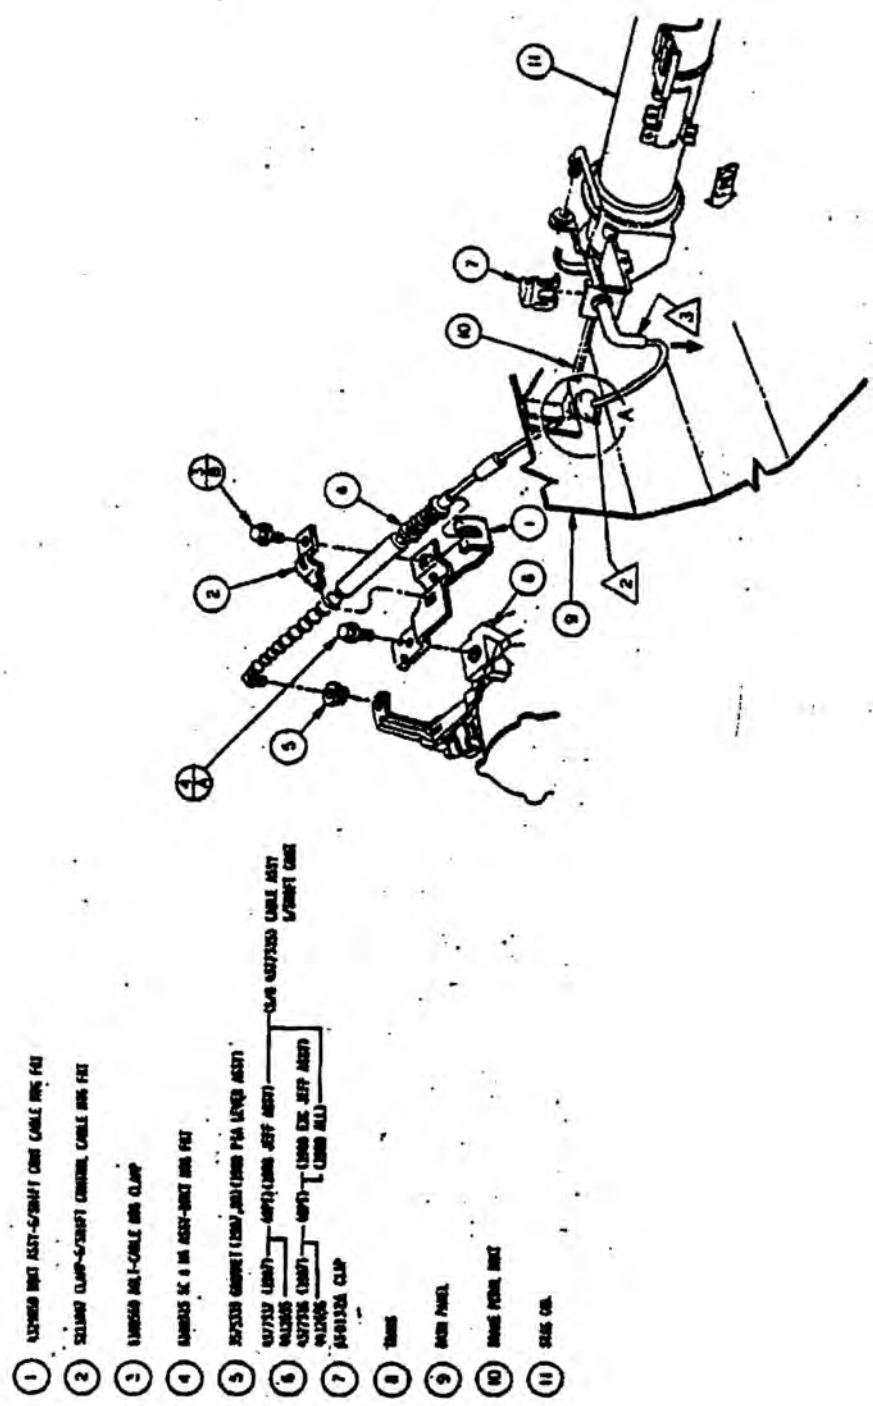
Figure 1. Components of Gear Selector Mechanism

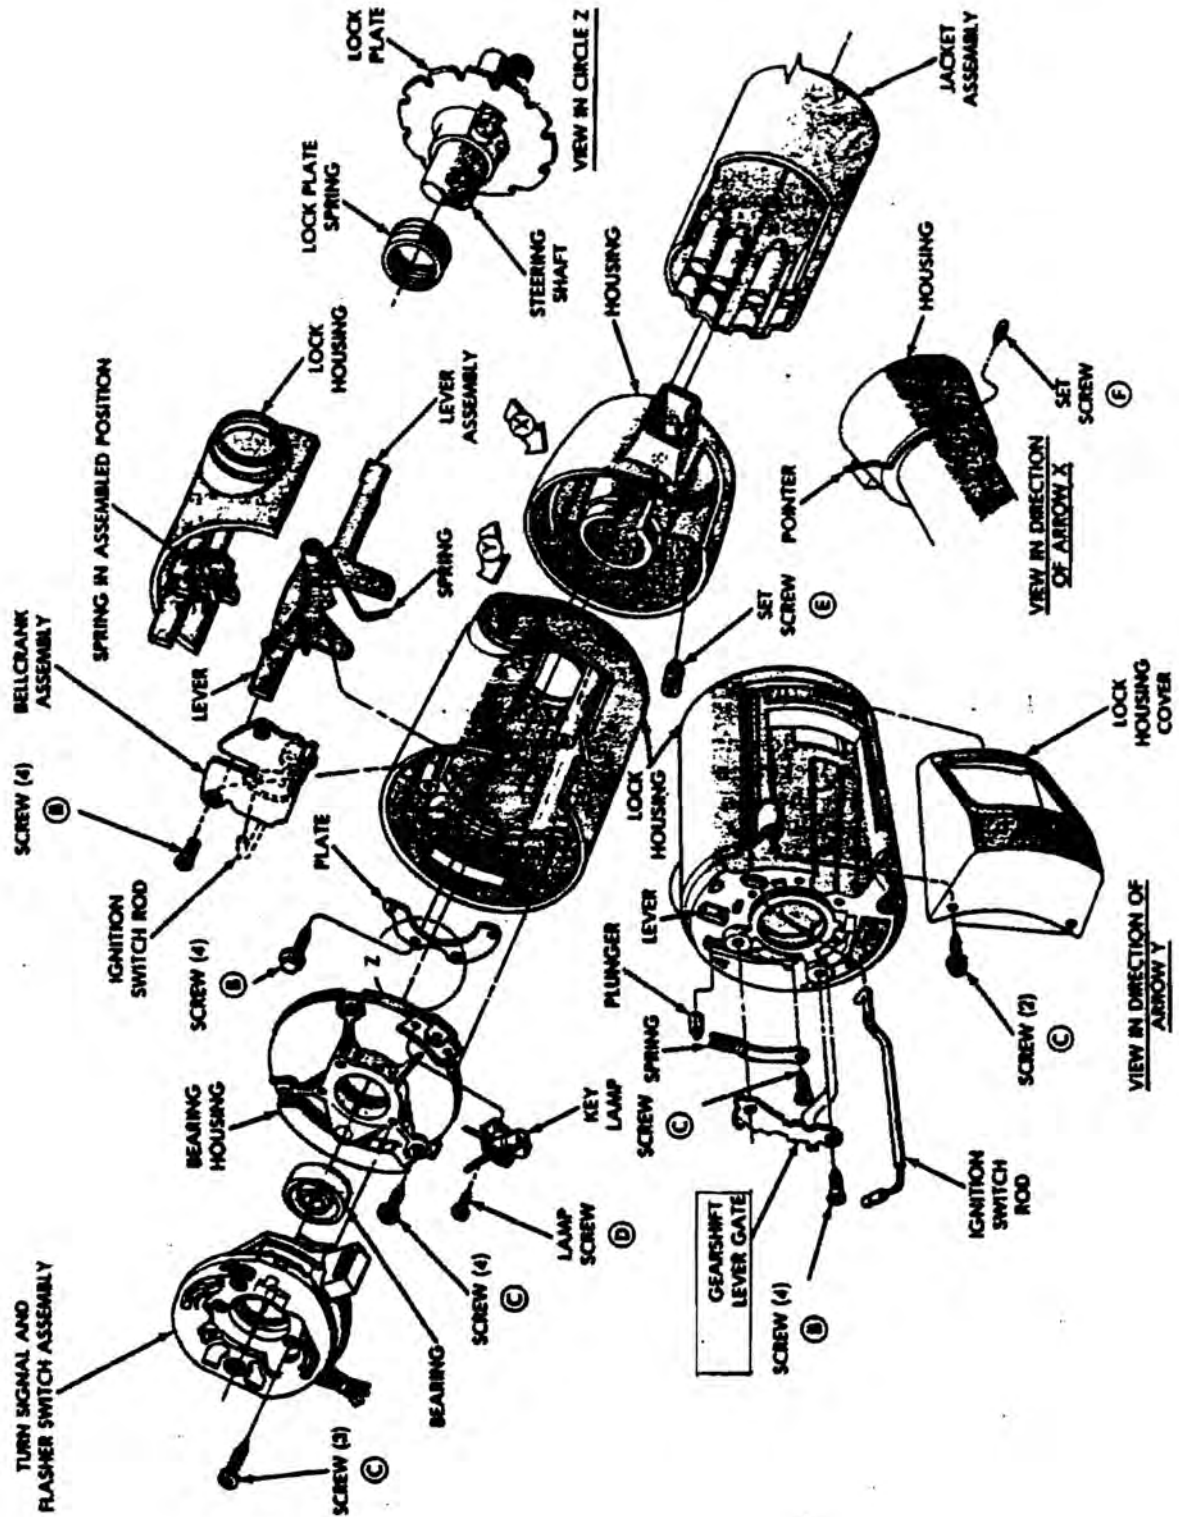
Figure 2. Steering column upper end showing installation of shift lever gate

Figure 3. Shift lever installation and lock housing with gate

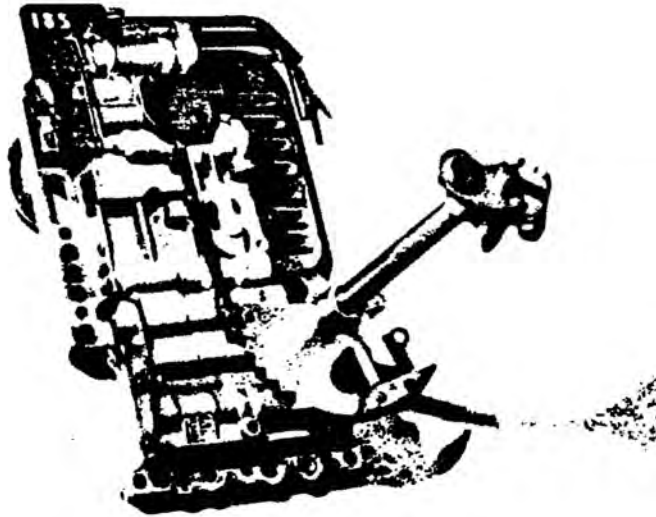
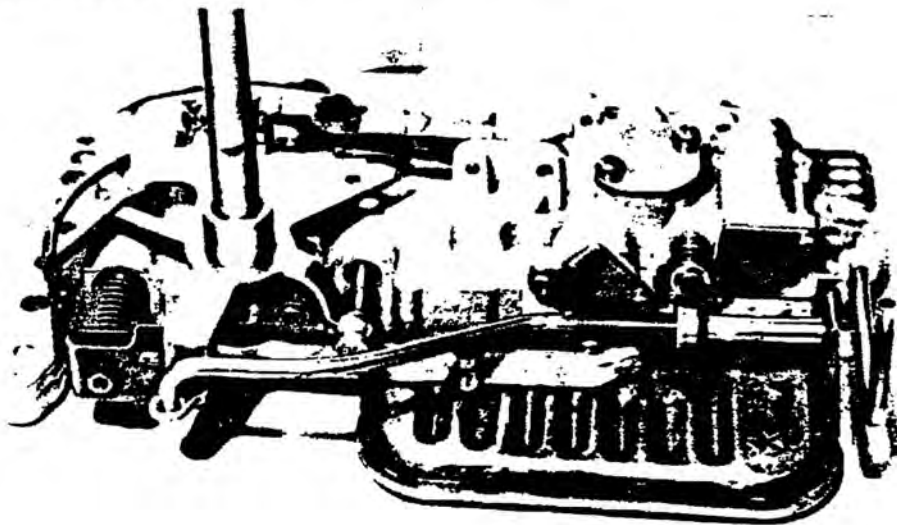
Figure 5.

- A. Location of park rod installed. Park pawl located under cone of park rod at left.

- B. Park Not Applied. Relative positions of park rod (with cone), park pawl, and park gear.

- C. Park Applied. Park pawl engages park gear. Transmission output shaft locked.

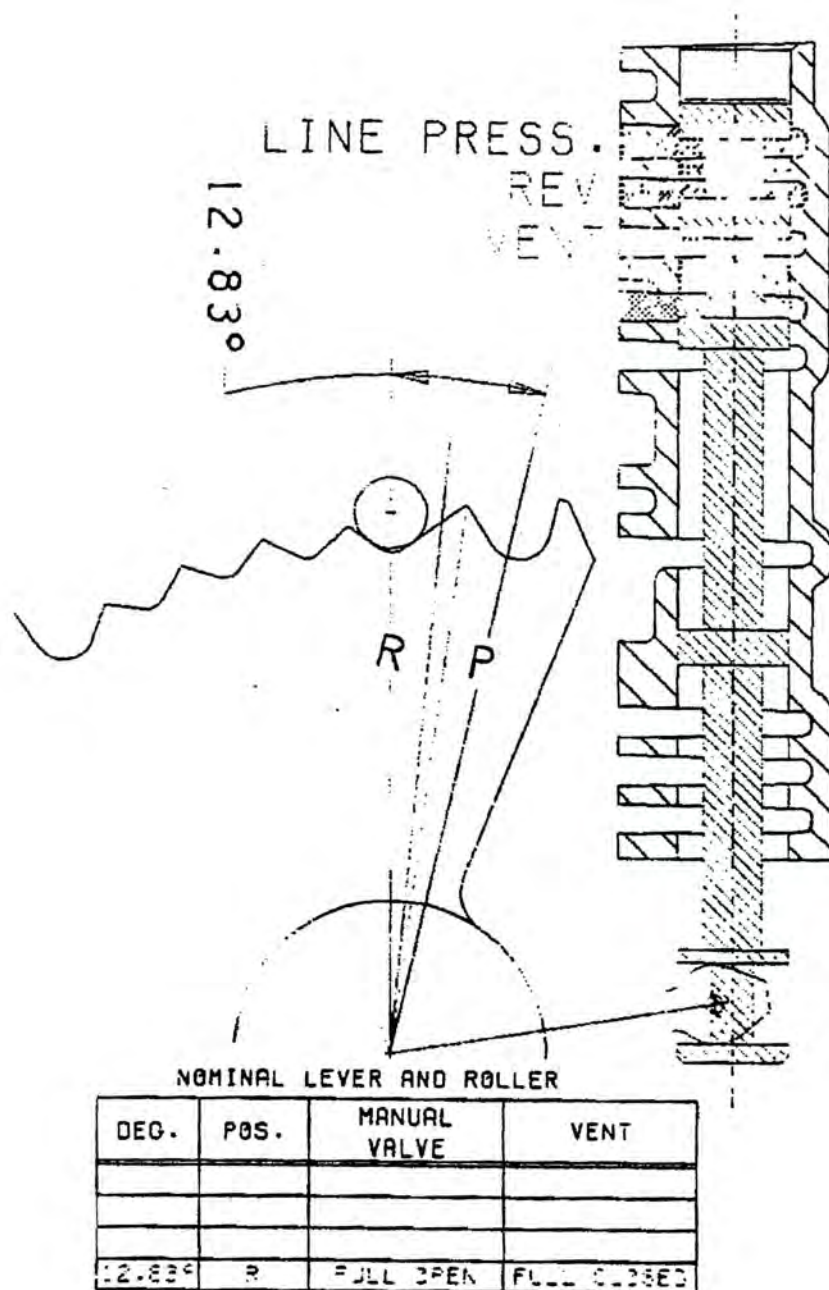
Figure 6. Angular displacement between reverse and park in rooster comb. Detent roller at reverse gear, manual valve fully open at R, vent fully closed.

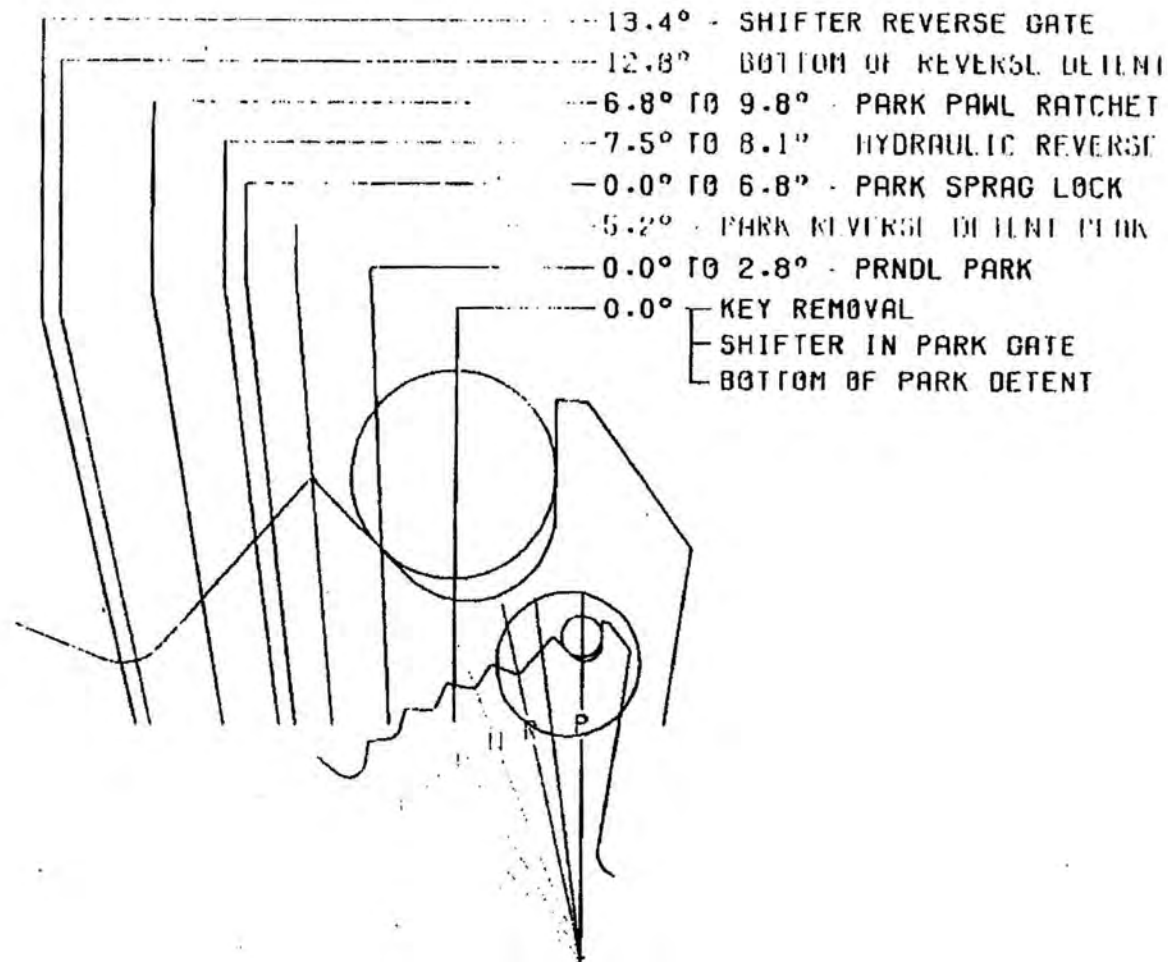
Figure 7. Reverse to Park shift events corresponding to angular position of detent roller in rooster comb.

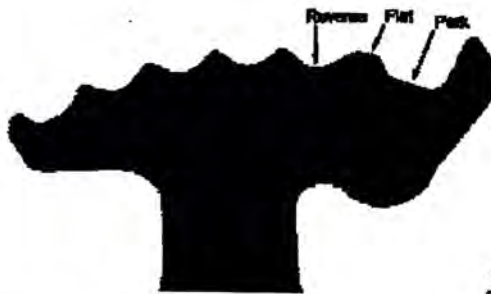
Figure 1

One important characteristic of the transmission design is the use of a manual detent lever with a "flat" area between the "Reverse" and "Park" detents (Figure 1).

This manual detent lever is on all ZJ model transmissions and all 6 cyl. WJ model transmissions.

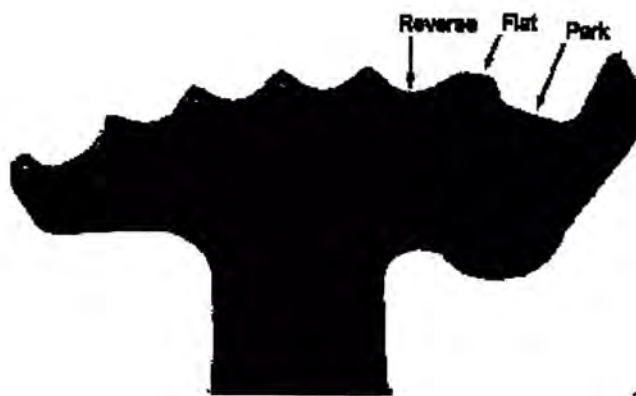
**Figure 4.1 – Transmission Manual  
Detent Lever Models 42RE, 44RE & 46RE**

A major factor for UPR appeared to be the significant differences in the shape of the manual detent levers between the subject Grand Cherokees and the peer vehicles. The Grand Cherokee manual detent lever had very shallow detent notches and a flat area between Reverse and Park whereas peer vehicles had deeper detent notches and no flat spot. This flat area allowed the Grand Cherokee transmission to be inadvertently mis-shifted, leaving it between Reverse and Park. UPR appeared to occur only when mis-shifted in this manner. Figure 4.1 shows the Grand Cherokee manual detent lever. Figure 4.2 shows a GM manual detent lever that was typical of the peer vehicles.

detent lever, P/N 4617439, depicted previously in Figure 4.1. Starting with the 1999 models, the subject vehicles with V8 engines were equipped with a Model 45RFE transmission that utilizes a Manual Valve Cam Plate (Fig. 7.1) in place of a Manual Detent Lever. This design change would appear to help prevent UPR.

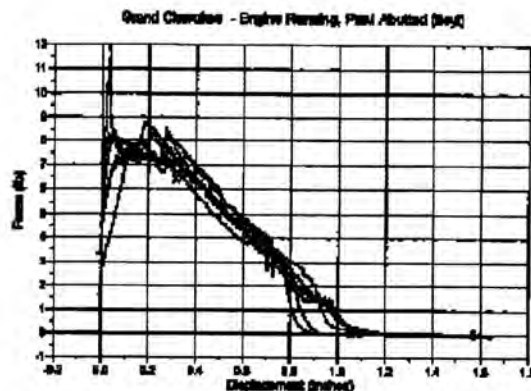
**Figure 7.2 – Force/Displacement Curves for Model 45RFE Transmissions**

Force vs. displacement tests were performed on six 1999 Grand Cherokees equipped with V8 engines and Model 45RFE transmissions, six 1999 Grand Cherokees equipped with I6 engines and Model 42RE transmissions, and one 2002 Grand Cherokee equipped with an I6 engine and a Model 42RE transmission. The force vs. displacement profiles were significantly different between the Model 45RFE and Model 42RE transmissions. Figure 7.2 shows that after an initial spike, the forces required to shift the Model 45RFE transmission decreased as lever travel progressed from Reverse to Park. The flat line with zero force at the end of the plots demonstrates that the movement to Park was completed without any additional force input.

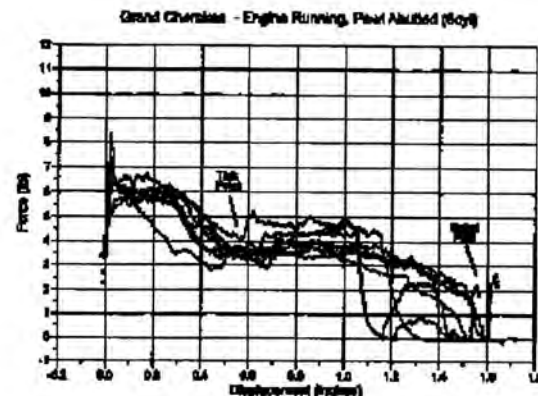
**Figure 7.3 – Force/Displacement Curves for Model 42RE Transmissions**

Conversely, Figure 7.3 shows that the forces required to shift the Model 42RE transmission remained relatively constant as lever travel progressed from Reverse to Park. Forces on two Model 42RE transmissions dropped to zero near the end of the shifts but then required additional force input of 1 to 2 lb to reach gated park, similar to the pre-1999 vehicles tested during Phase I. Individual data plots for tests of the Model 45RFE transmission are provided in Appendix III. Individual data plots for tests of the Model 42RE transmissions are provided in Appendix IV.

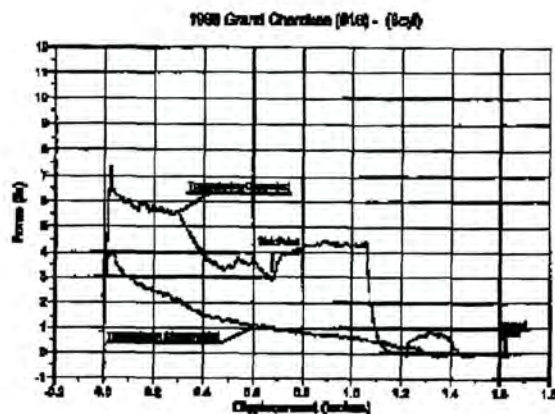
**Figure 7.4 – Force/Displacement  
1999 Model 42RE Transmission**

Force vs. displacement characteristics were determined and compared between a 1998 and a 1999 subject vehicle, each equipped with a Model 42RE transmission. The primary difference between the two vehicles was the newly designed shift lever detent and spring that became standard beginning with the 1999 model. Testing was performed with the shift cable both connected and disconnected from the transmission. The lower of the two force plots in Figures 7.4 and 7.5 show the force vs. displacement with the transmission disconnected while the upper force plots show the force vs. displacement with the transmission connected. The "disconnected" curve for the 1999 Model 42RE transmission (Fig. 7.4) shows a significantly higher peak force at the beginning of lever travel than the 1998 Model 42RE "disconnected" curve (Fig. 7.5) because of the additional force generated by the new detent and spring in the shift lever. While the magnitude of the forces in the "connected" curves was higher for the 1999

model, the overall profiles of both curves were somewhat similar. Both models exhibited a decrease in force midway through the shift, just before the tick point. It was possible to perch the transmission between Reverse and Park in both vehicles. Although the force vs. displacement curve profiles were somewhat similar between the two vehicles, the 1999 model did require higher shift forces which may be a factor in reducing mis-shifting from a human factors standpoint. However, the redesigned shift lever did not prevent the possibility of mis-shifting. Full size data plots are provided in Appendix V.

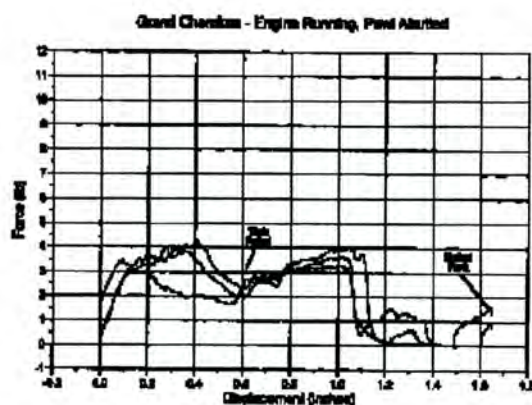
Figure 7.15 – Force vs. Deflection Curves for 1995 and 1998 Model 42RE Transmissions

Test results of the three pre-1999 subject vehicles tested in Phase I, all of which were equipped with Model 42RE transmissions, were compared to the test results for six 1999 subject vehicles equipped with Model 42RE transmissions tested in Phase II. As illustrated in Figures 7.15 and 7.16, with the exception of the higher initial peak force in the 1999 and later model vehicle data, the plot profiles of the two sets of vehicles were similar. Both sets of plots show a decreased force near the tick point and the need for the shift lever to be pushed completely into gated Park for two vehicles from each group.
