U.S. Department
of Transportation
National Highway
Traffic Safety
Administration

DOT Auto Safety Hotline
Vehicle Owner's Questionnaire
To Report Vehicle Safety Defects
1-888-DASH-2-DOT
(1-888-327-4236)
INTERNET:www.nhtsa.dot.gov/hotline

**Transmission Shift Linkage Failure
Resulting in Vehicle Movement After Shift to Park.**

2002 Chevrolet Trailblazer 4WD
VIN: 1GNDT13S622 [REDACTED]
Vehicle mileage: 75,100.

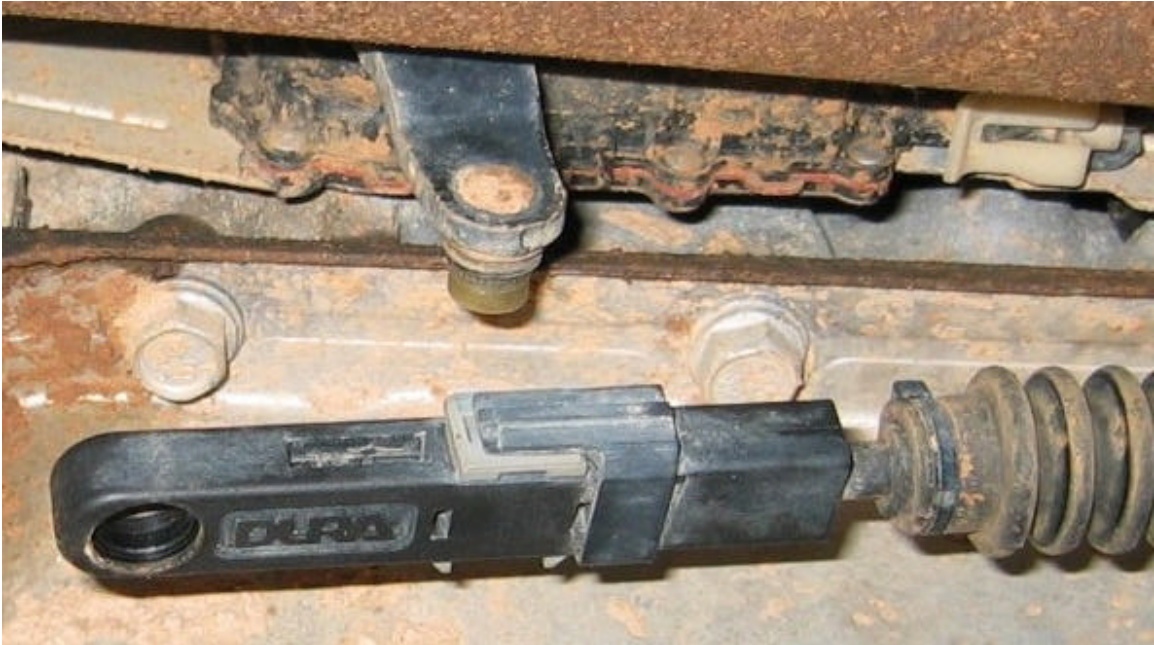
When I looked under the car and checked the linkage, I saw that the shifter cable, part # 15785087 was no longer attached to the Transmission Range Selector Lever, part # 15082892. There is a white nylon bushing in the end of the shifter cable that holds the cable end on the selector lever. One side of the bushing had broken off. Photos are attached below that show the problem parts.

Photo 1 below shows the shifter cable (15785087, with "DURA" molded into cable end) and the Transmission Range Selector Lever (15082892) in the positions that they were in when the car lurched forward. Note the separation between the linkage cable end and the selector level. The cable is in the Park position while the Range Selector Lever is in the Drive position.

I was able to affect temporary repairs by manually moving the Transmission Range Selector Lever to the Park position and placing the linkage cable end back onto the end of the selector level. The stiffness of the cable held it in place long enough to move the vehicle. This also allowed the shifter to operate normally again.

As of today, November 24, 2009, only temporary repairs have been made. The cable is secured in place with a wire wrap, pending further action.

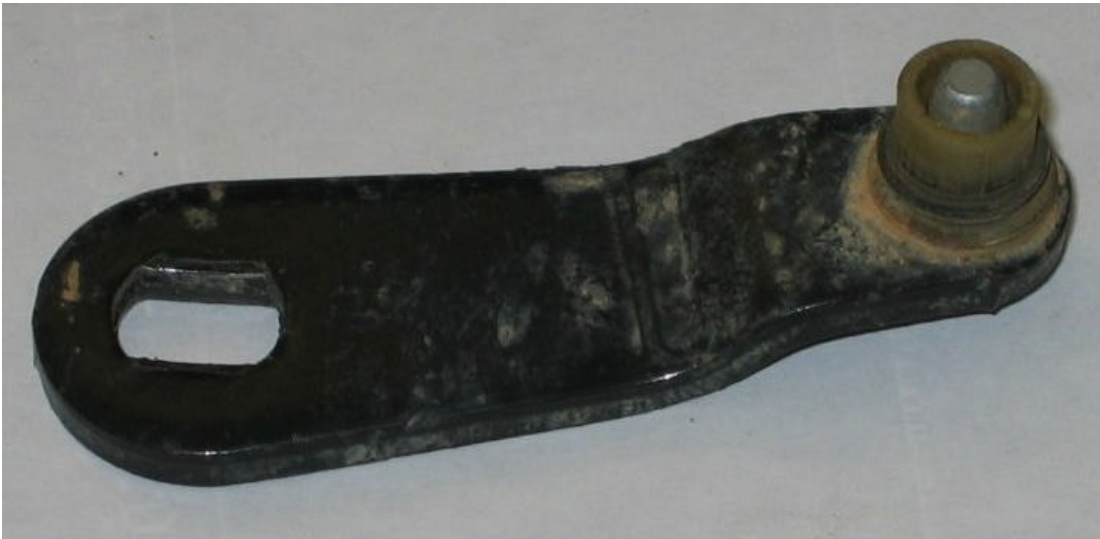
Photo 2

Photos 2 and 3 show the nylon bushing still attached to the Range Selector Lever. Observe the jagged edge where the bushing failed. The other half of the bushing actually holds the shifter cable on this arm. (The nylon bushing is NOT part of the Range Selector Lever, it is part of the shifter cable.) That part of the bushing was lost somewhere.

I intend to repair this by obtaining a replacement selector arm, removing the post and replacing it with a shoulder bolt that will secure the cable in place.

The failed part will be available as shown in Photo 2, after I replace the selector arm.

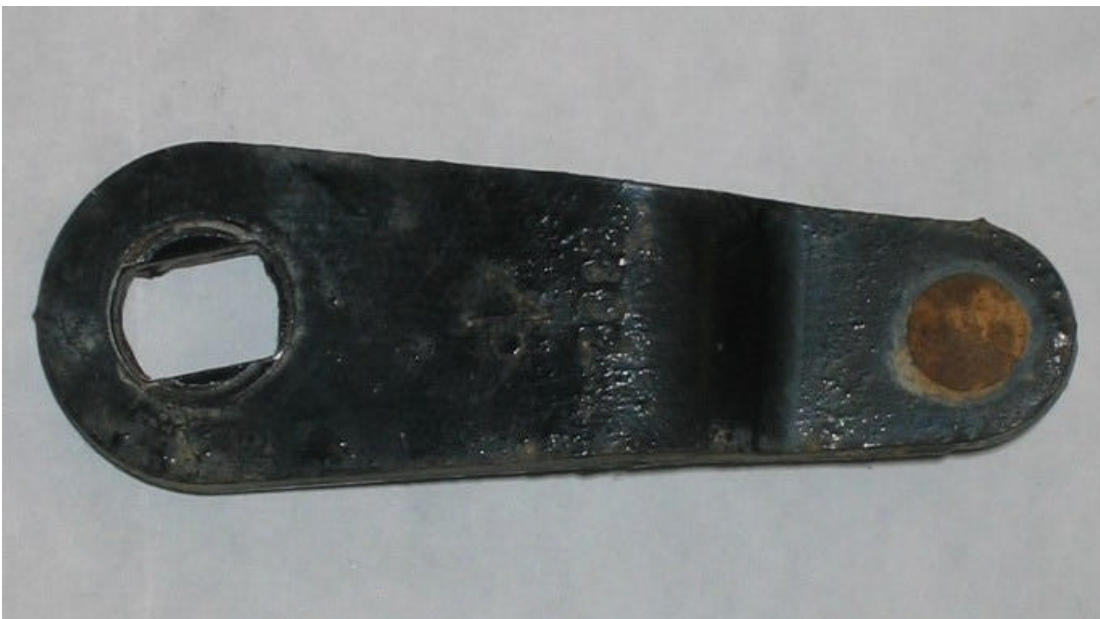
Photo 4 is a reference photo of the back of the range selector arm.
