**DOT Auto Safety Hotline**  
**Vehicle Owner's Questionnaire**  
**To Report Vehicle Safety Defects**  
**1-888-DASH-2-DOT**  
**(1-888-327-4236)**  
**INTERNET:www.nhtsa.dot.gov/hotline**

Reference No.  
10298171

SETRA

S417

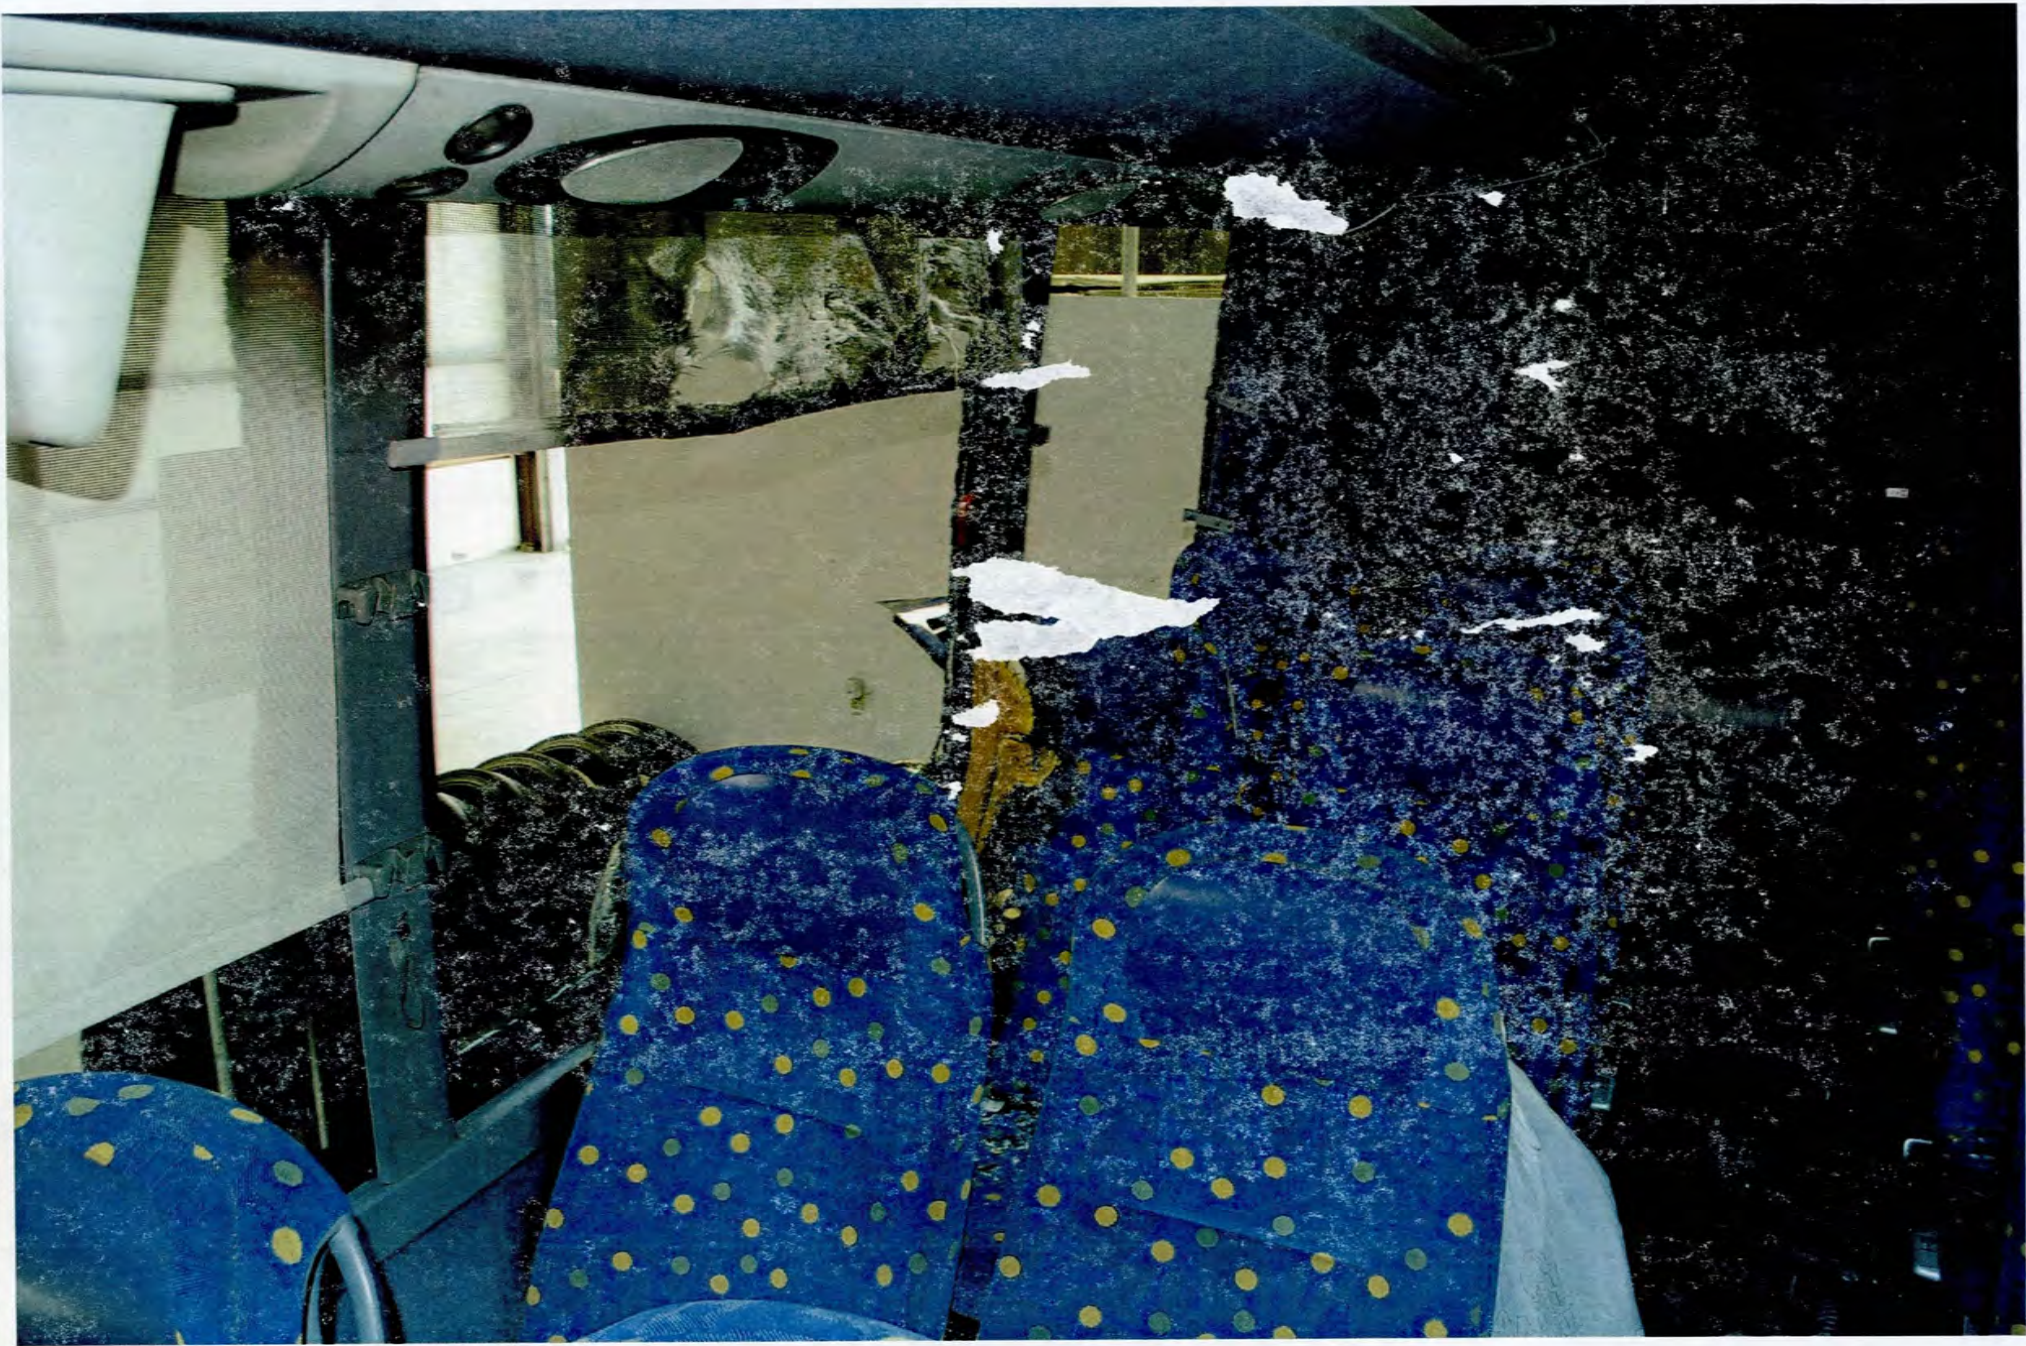
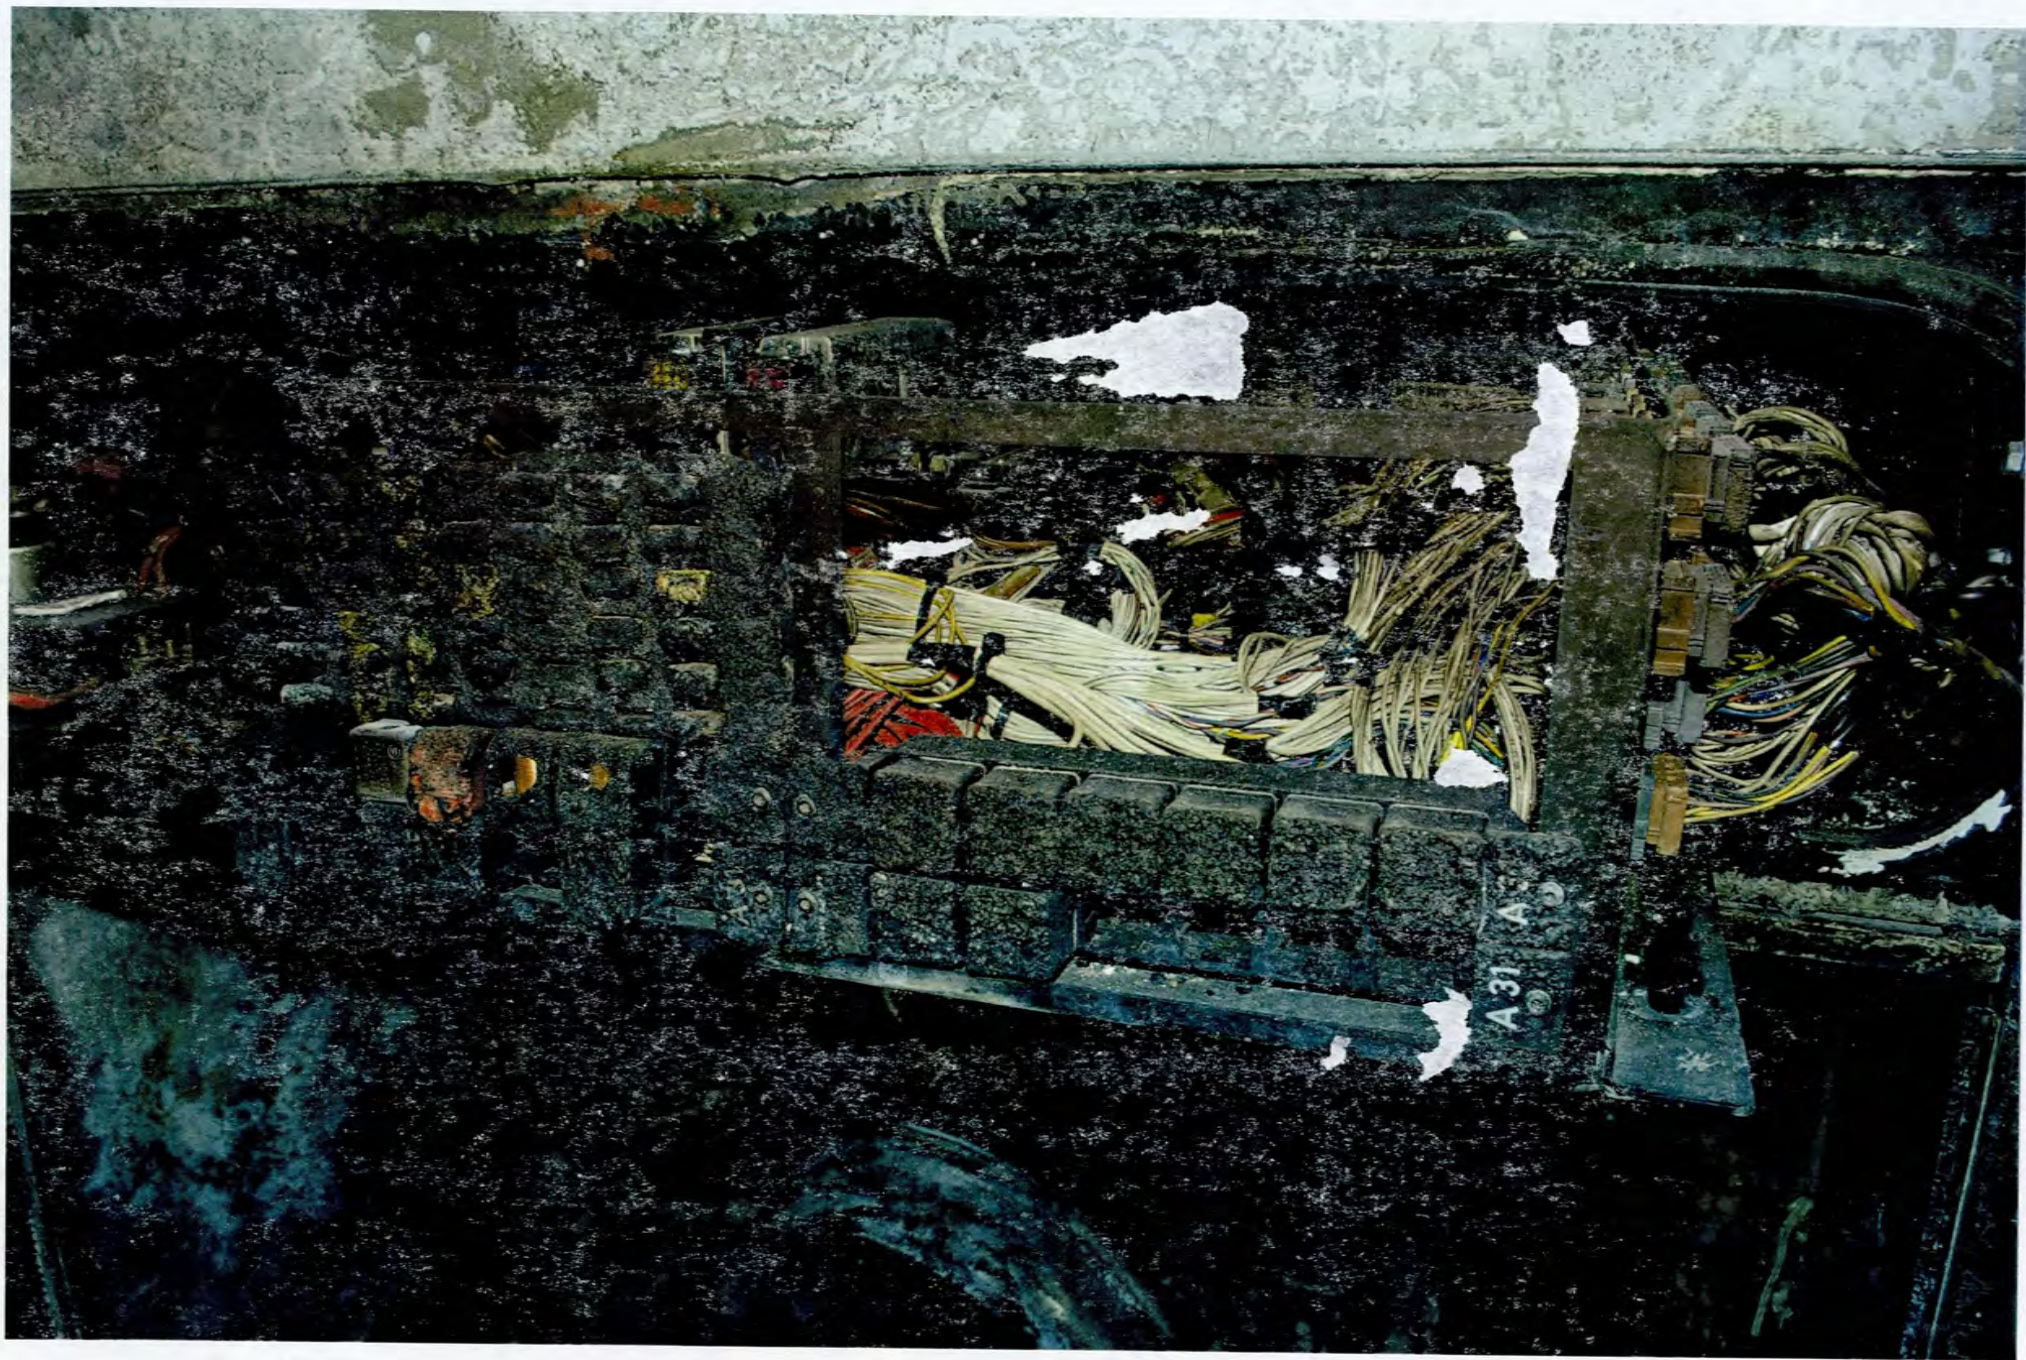
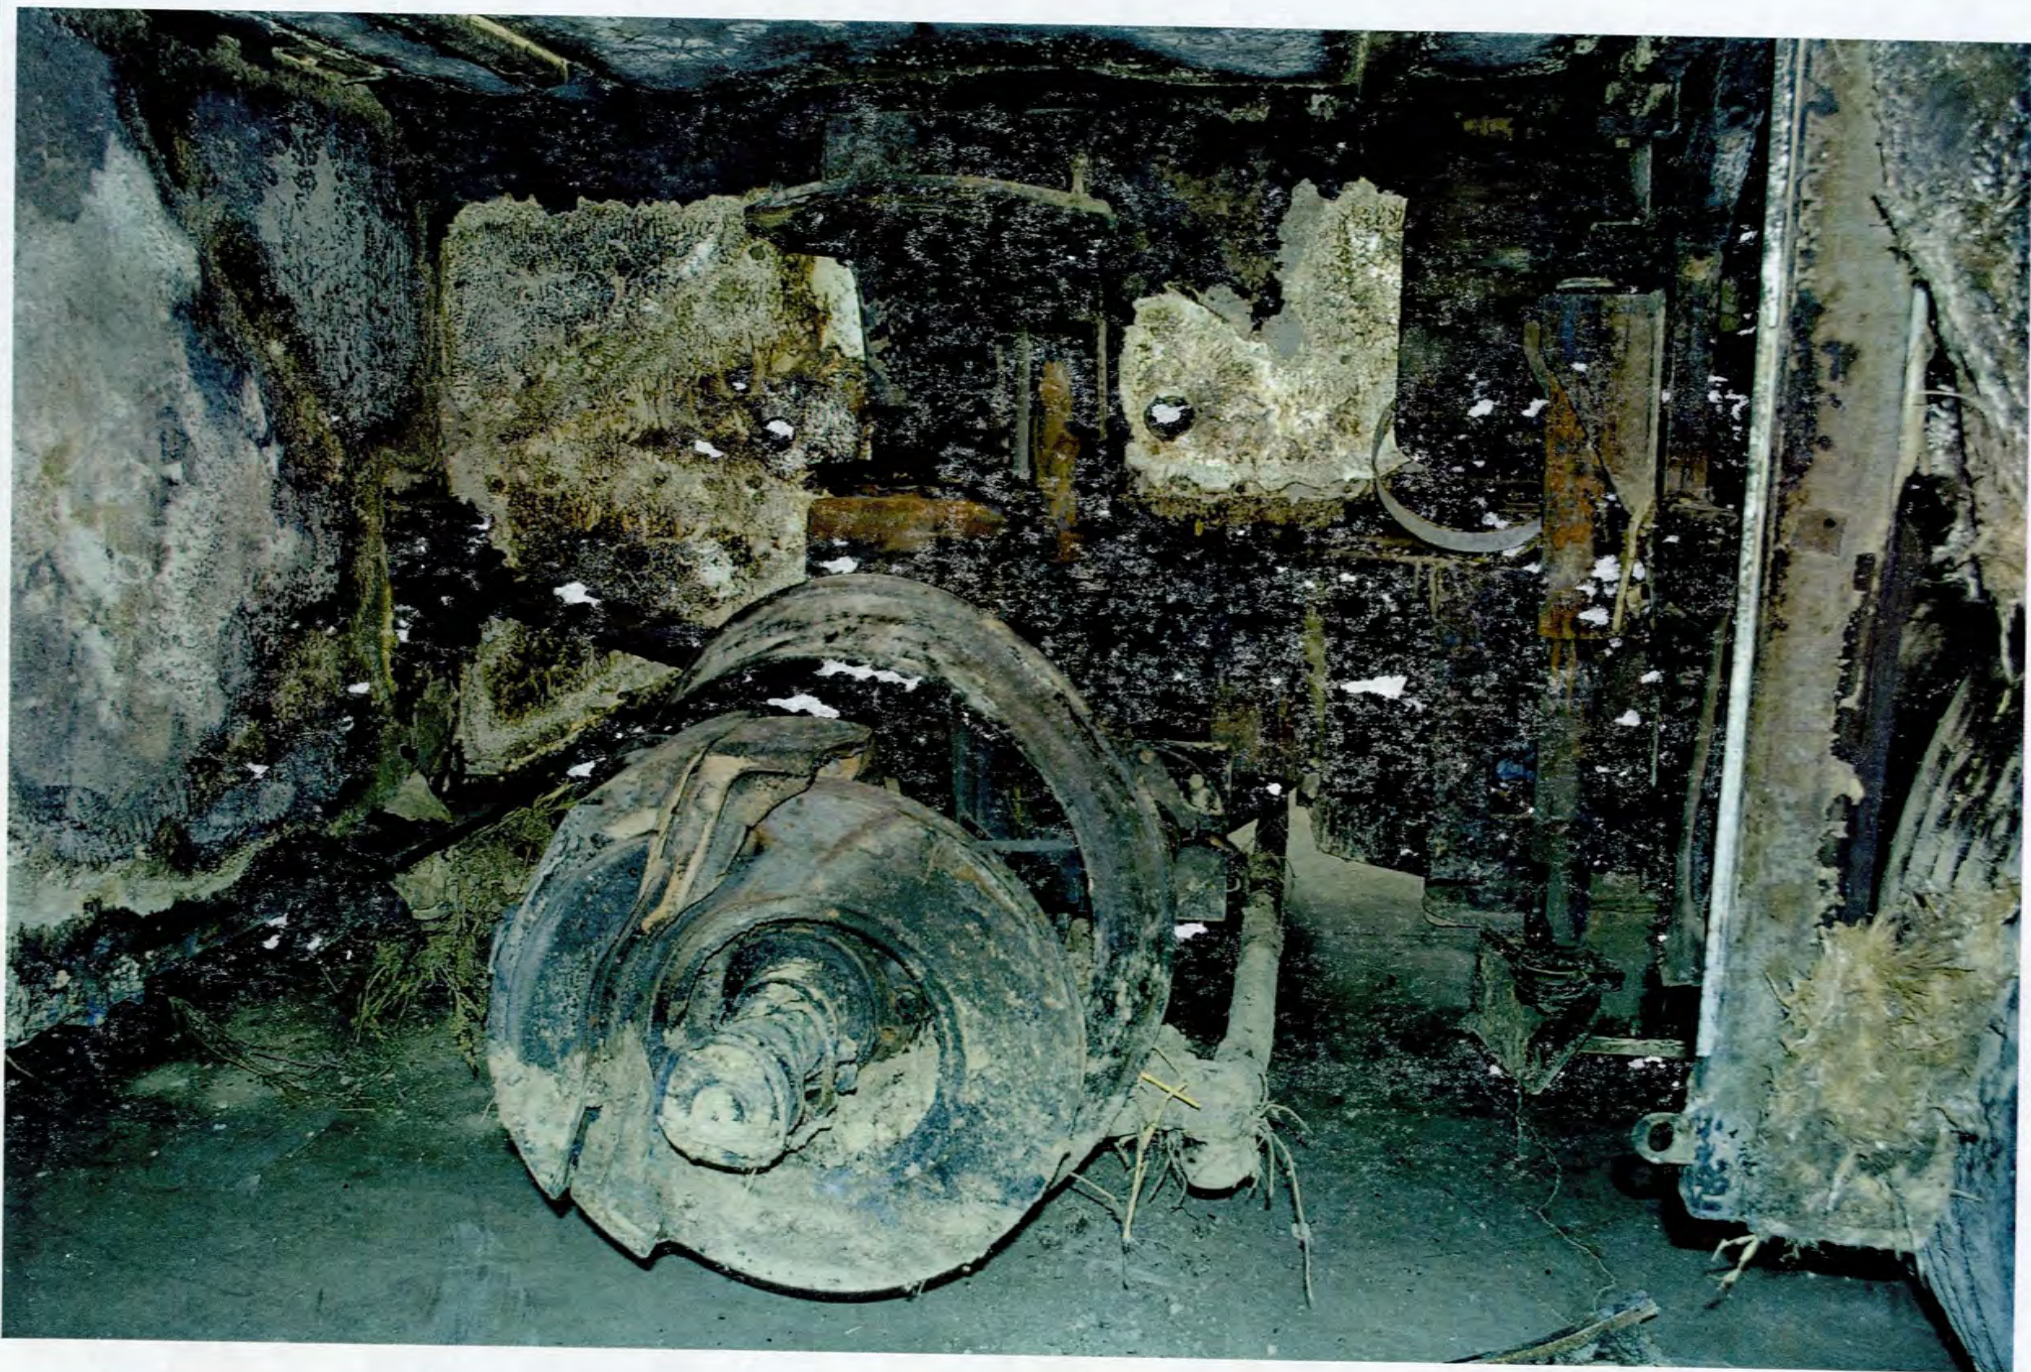
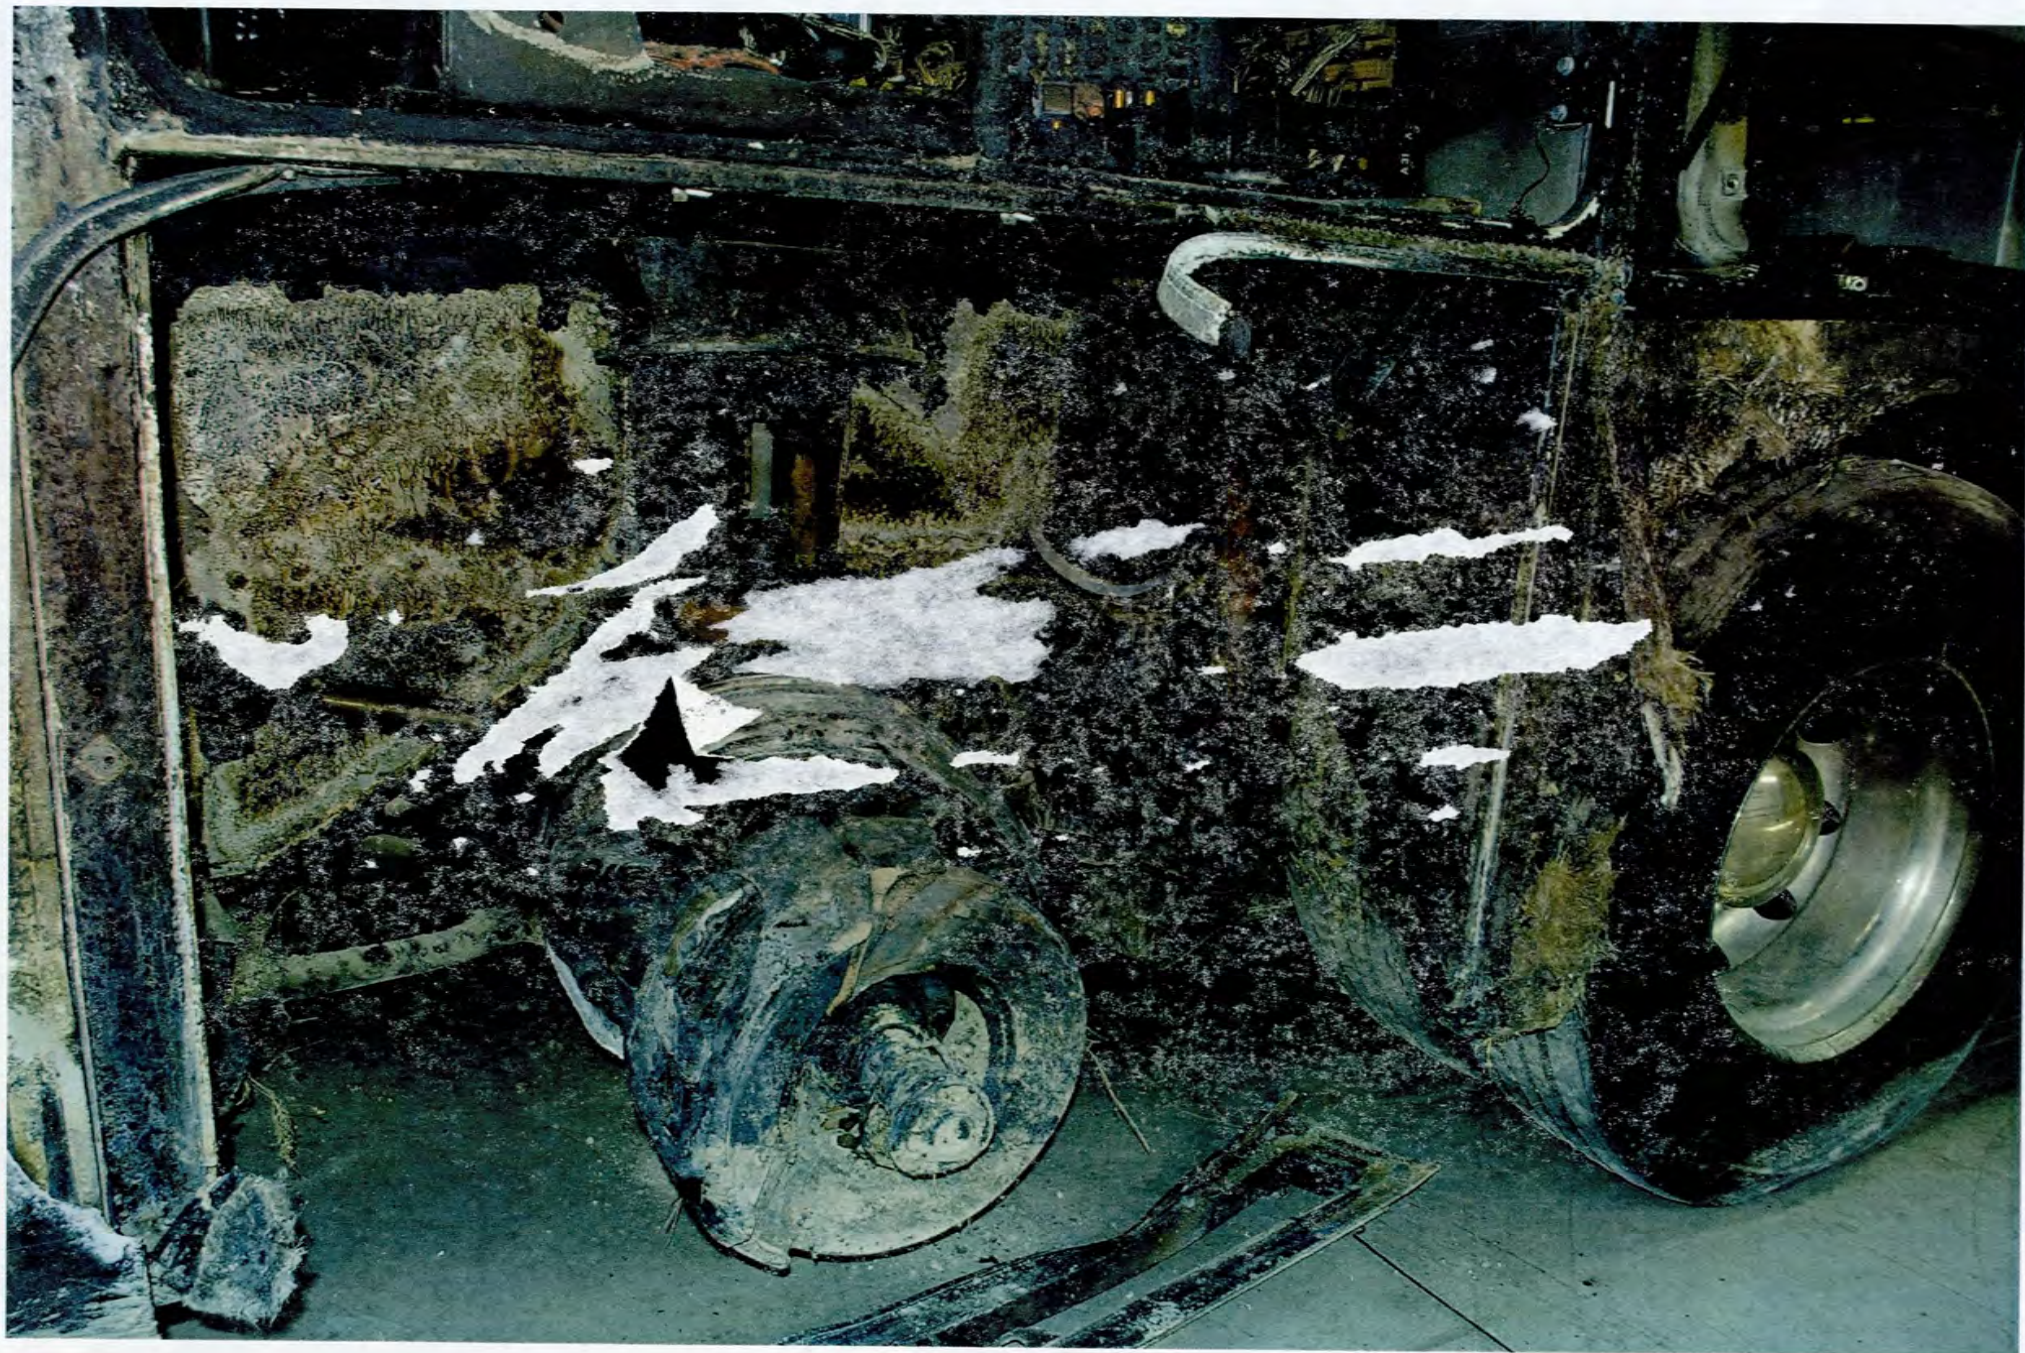
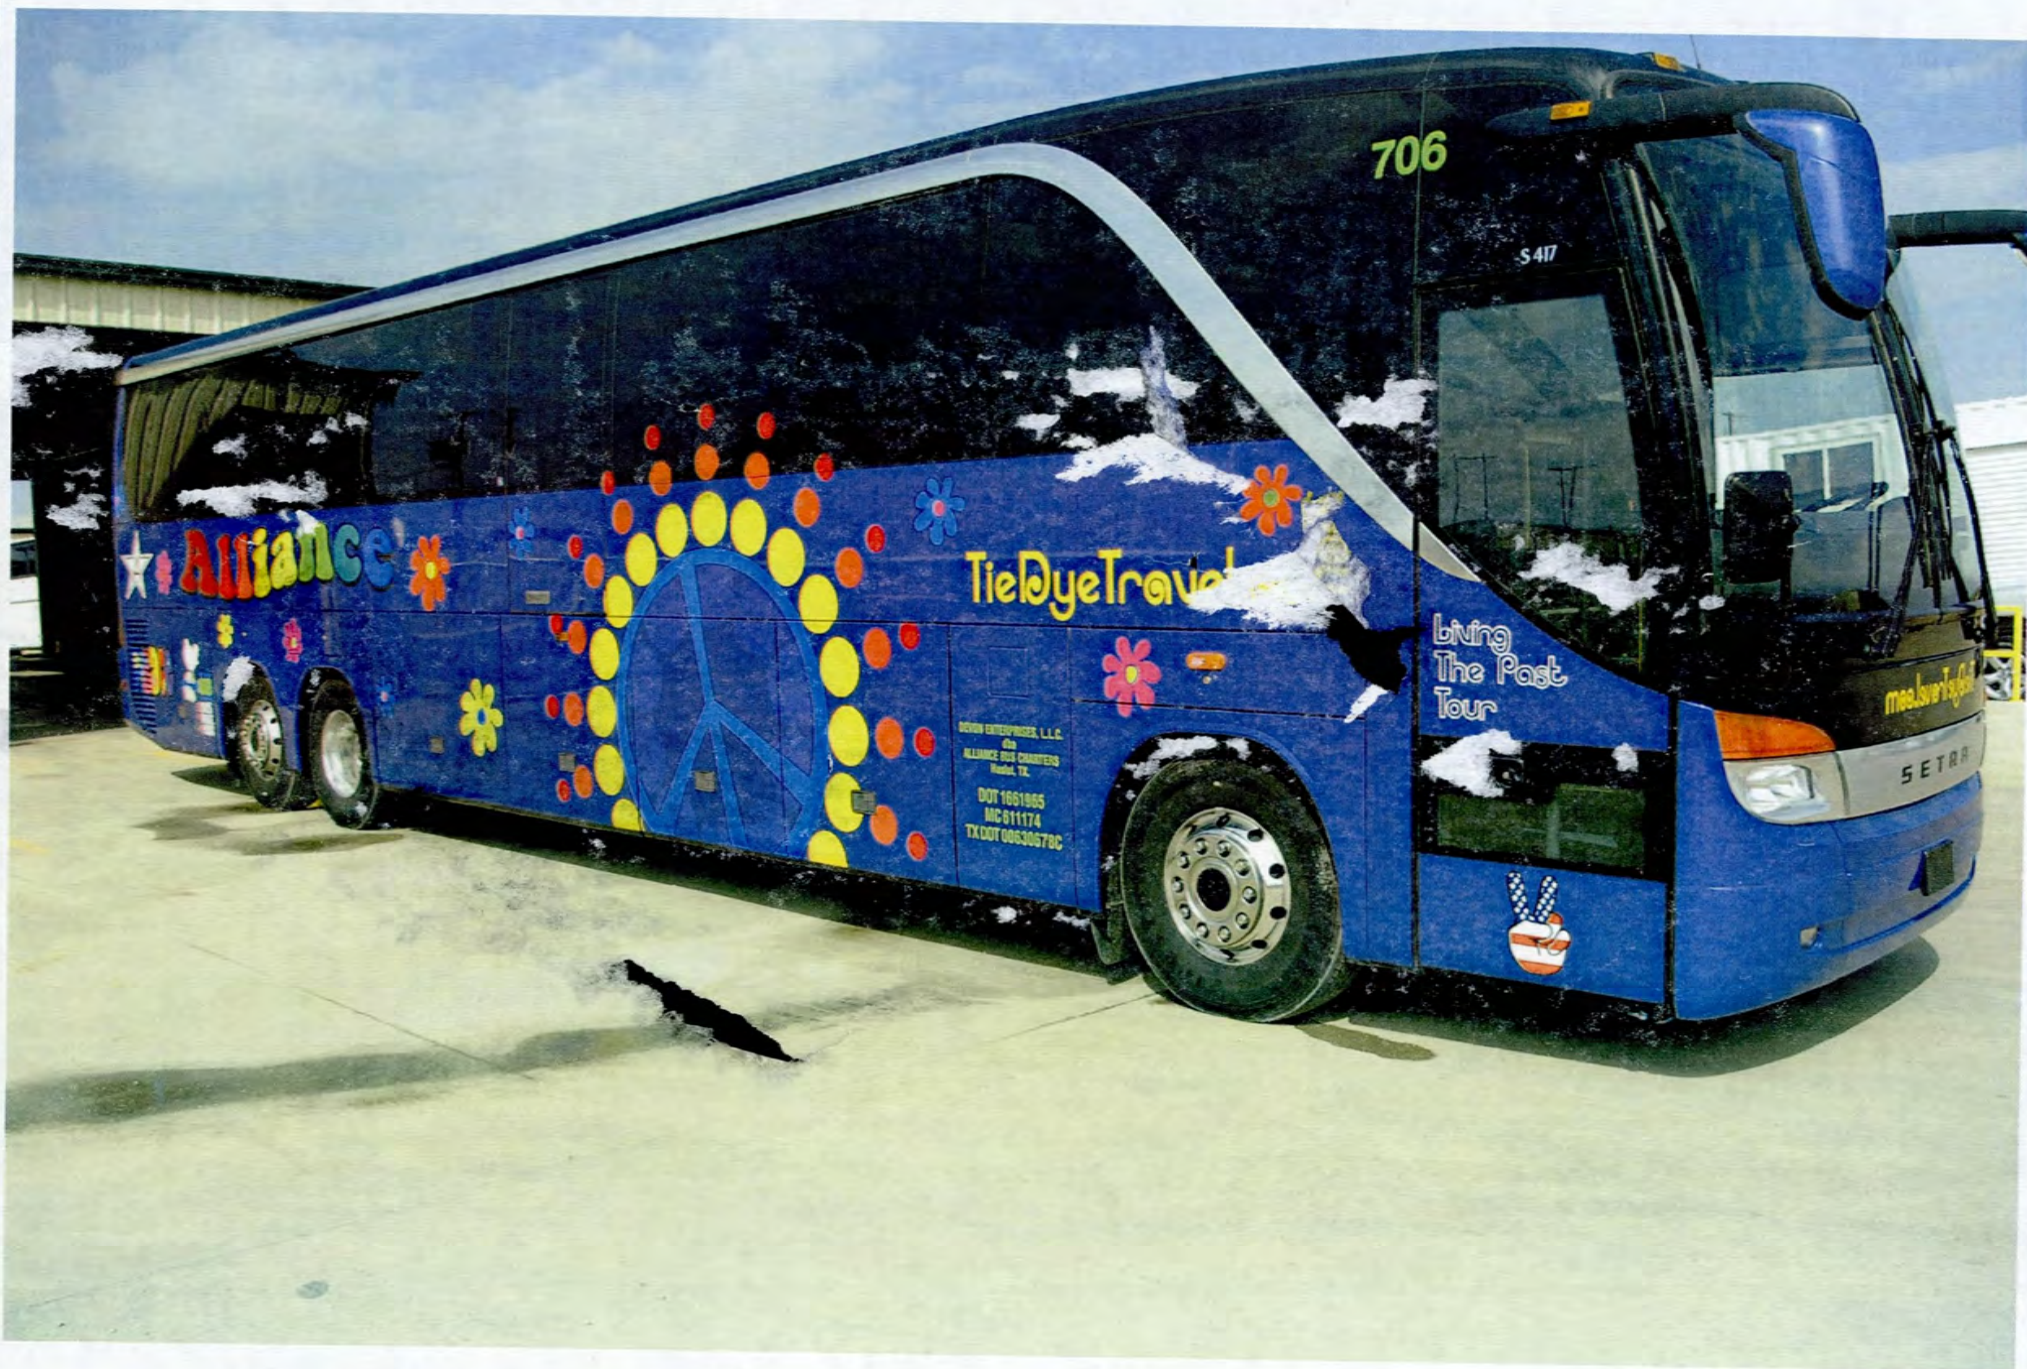
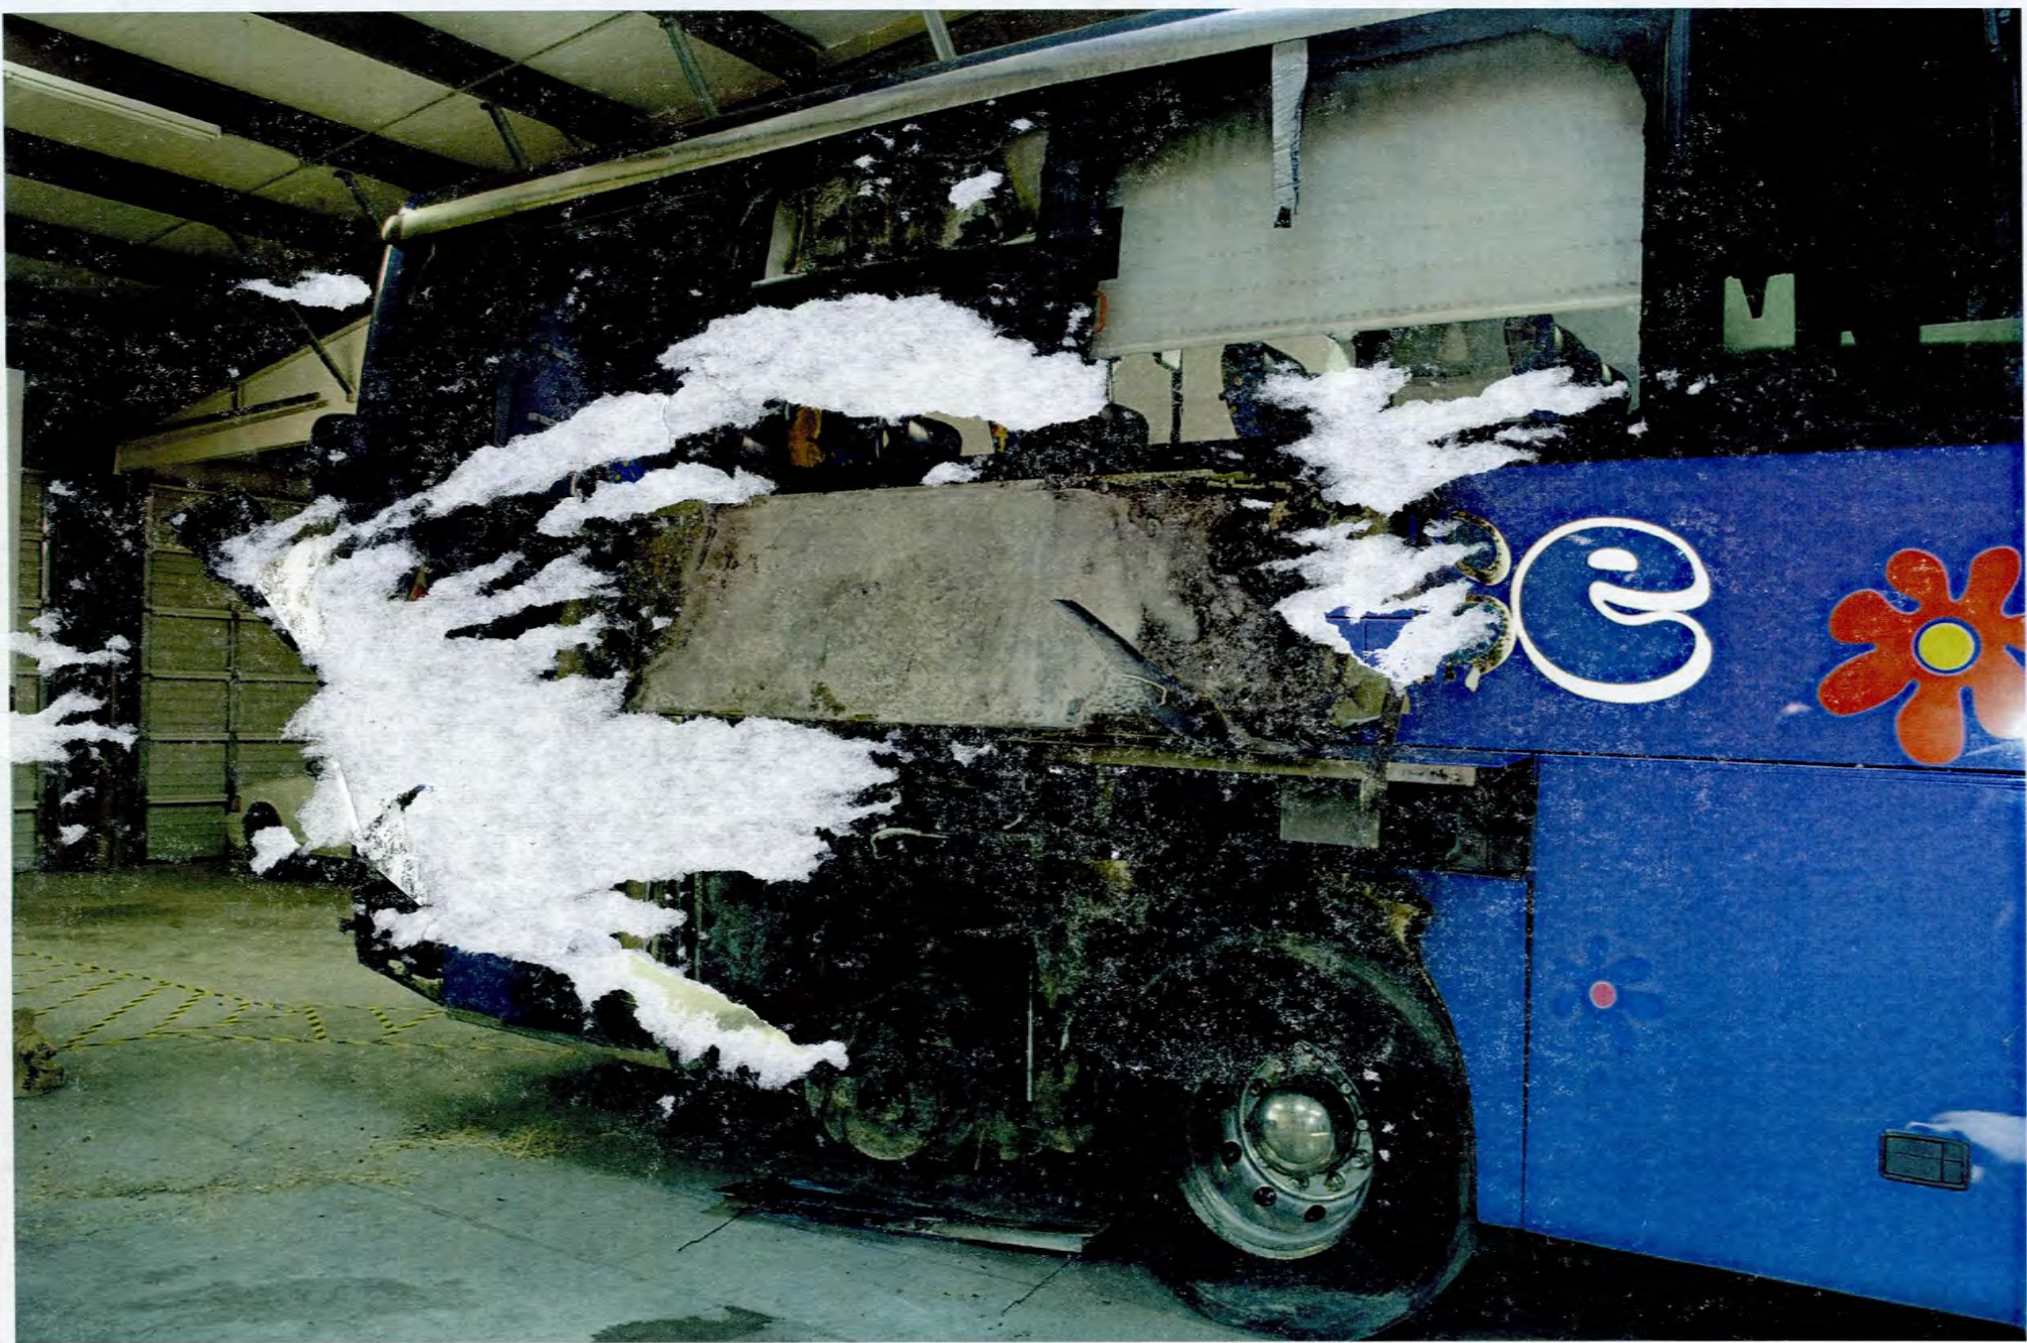
This bearing fire was on a steering light, rear tag tire. The maintenance requirements for these wheel bearings are to be repacked once every 2 years or 100,000 miles. When we purchased the bus in question, it had 249,000 miles on it. The purchase date was November '07. When the fire occurred, the vehicle had been in our possession for less than 2 yrs and it had less than 100,000 miles put on it. To date, most manufactures use sealed bearings vs. the ones that need to be greased. Setra is still using greased bearings. These bearings take a lot of wear due to being steering axles. In our opinion, this was a bearing failure, not negligence on our part to perform the proper maintenance. There was no warning of any kind before this fire. The damage seen in the pictures happened in less than twelve minutes from the time of the start of the fire till the time the fire department responded. The bus in question is housed at our location and at this time the repairs have not been made. We ask that you please investigate this issue. This is very important to us as we have three more identical buses in our fleet. We feel that these bearings should no longer be open bearings, but changed to sealed bearings before someone is seriously hurt or worse yet, killed.
