Subject: FW: Material scan into repository 10304297
Date: Wednesday, March 10, 2010 9:42:33 AM
Attachments: [10304297PAR.pdf](#)

Can the attached pdf file (police accident report) be added to the private repository associated with VOQ 10304297?

Iowa Department of Transportation INVESTIGATING OFFICERS REPORT OF MOTOR VEHICLE ACCIDENT

Report #2008120189
I-10 WB to Overland Avenue

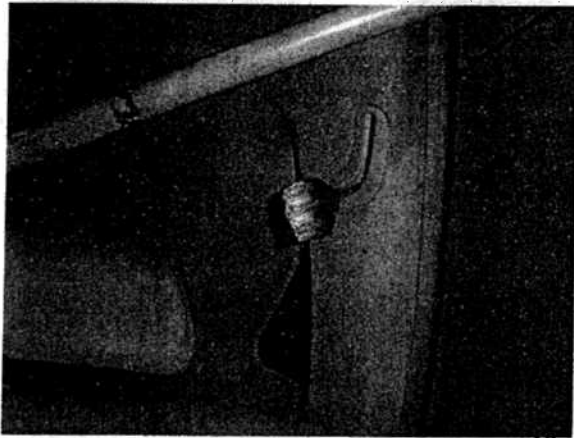
driver's seating position had an additional airbag at the driver's knee level that also deployed. The left front and right front shoulder/lap restraint were stretched/ wavy and would not retract. When the buckles were placed in their respective latches they both clicked and held under load.

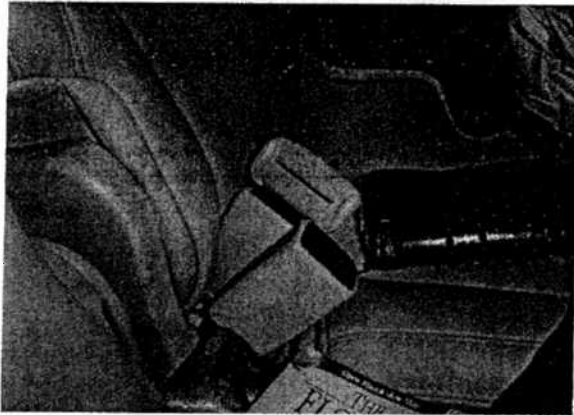
The left rear lap/shoulder restraint was cut across its width and the buckle was found secured in the latch. The right rear and middle rear shoulder/lap restraint was found fully retracted and did not show any unusual wear.

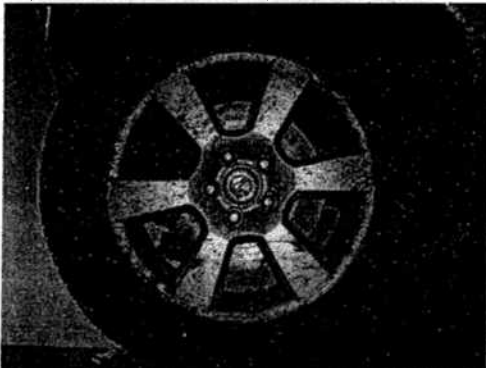
4
5 **LEFT FRONT:**

11
12 There was a 2-inch laceration to the outer sidewall at the 11 o'clock position. There were heavy
13 abrasions and gouging around the outer perimeter of the rim. The outer face of the sidewall was
14 covered with what appeared to be dried battery fluid, green in color.

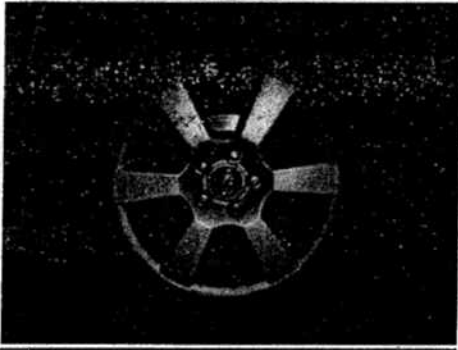
3 The left rear tire appeared to be in good condition with scuffs/dirt across the entire outer face of
4 the tire and wheel assembly.

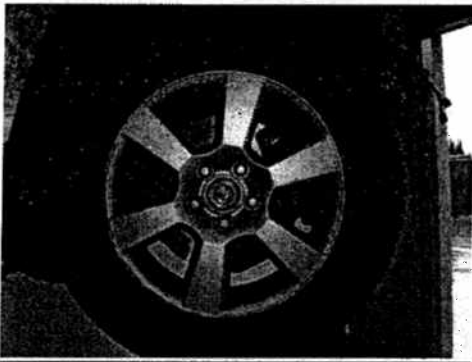
7 **RIGHT FRONT:**

14 The right front tire appeared to be in good condition with no remarkable collision damage.

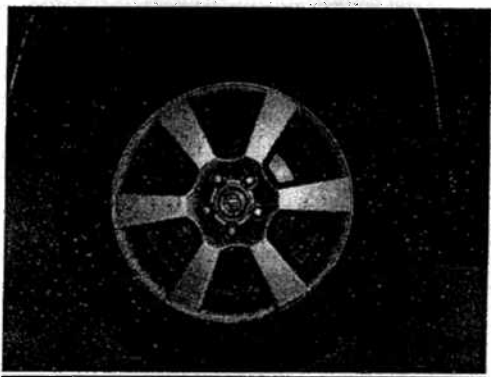
4 **RIGHT REAR:**

11 The right rear tire appeared to be in good condition with no remarkable collision damage.

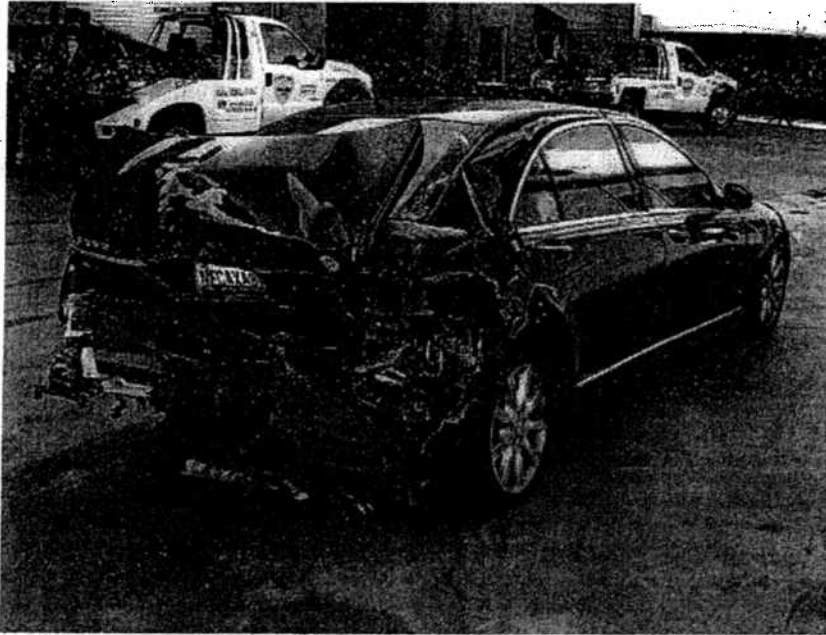
3 Vehicle #2 sustained major contact damage to its rear. The primary direction of force was from
4 back to front.

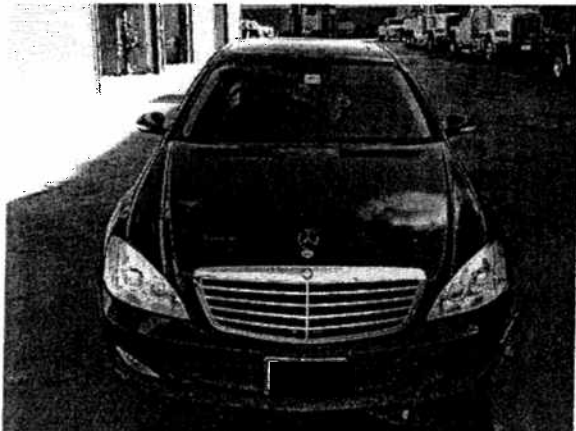
9 The left front fog light was displaced. The left side marker light was displaced. The left edge of
10 the front bumper was cracked and displaced outwards. Debris and dirt were found covering the
11 lower half of the entire width of the front bumper.

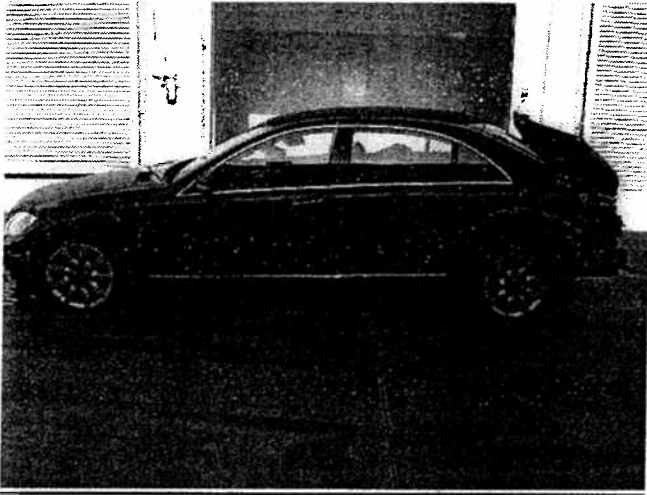
1 **LEFT SIDE:**

3 The plastic skin on the trailing edge of the side member was cracked and displaced. The plastic
4 inner lining in front of the left rear wheel well had a 12-inch tear. The left rear door's upper trailing
5 edge was displaced outwards. The left rear quarter panel sustained an 18-inch vertical crease at
6 a point 8 inches below the left outer trailing edge of the rear window.

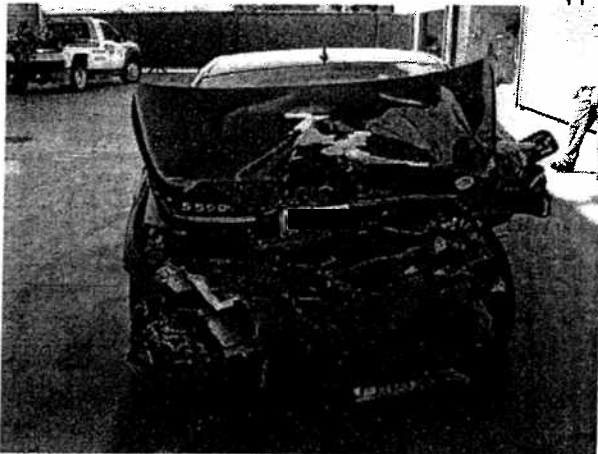
9 **REAR:**

The rear end of Vehicle #2 sustained substantial rear end damage, with the majority of damage being to the right rear. The rear bumper was pushed inwards and to the right, with the rear end inducing damage to the right rear axle by displacing it forward. The trailing edge of the trunk lid was pushed downwards and the leading portion was displaced vertically. The rear window was shattered, predominantly concentrated on the lower passenger side. The

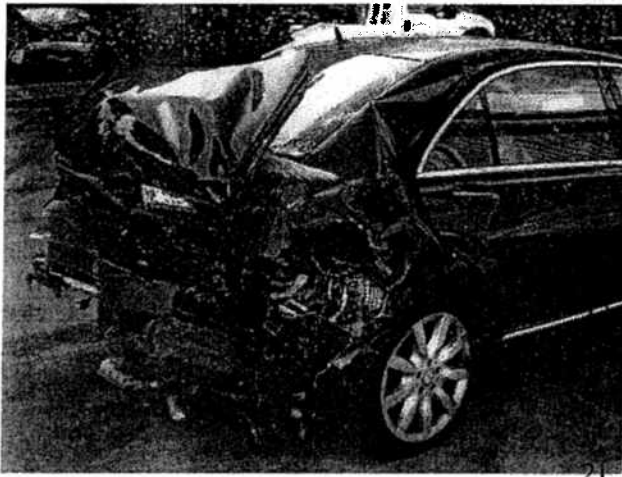
casings for the spare tire was torn and the spare tire was displaced from the vehicle. The right exhaust tip was pushed forward and was found adjacent to the rear of the lower portion of the right rear tire. The deepest point of intrusion to the rear was to a point in line with the rear of the right rear seat.

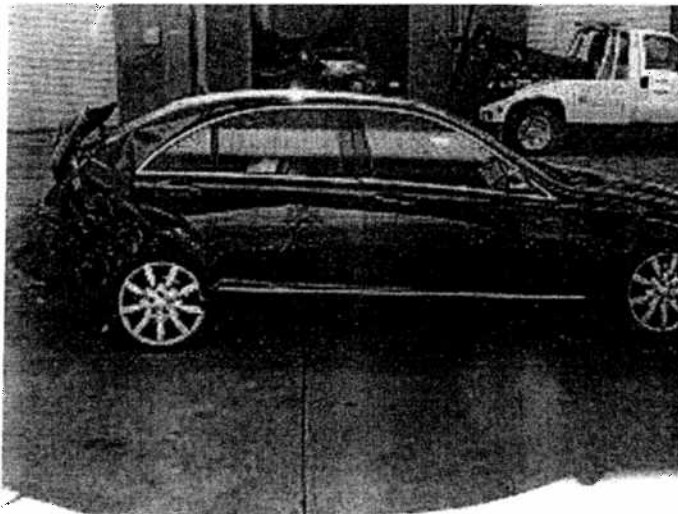
23 **RIGHT SIDE:**

25 The "C"-pillar sustained two areas of induced damage. The lower portion of the "C"-pillar sustained a vertical crease at a point above the trailing edge of the right rear door. The second damaged area of the "C"-pillar was an outwards buckling at a point approximately 8 inches above the rear window. The right rear door was displaced downwards and outwards. The frame above the right rear door was buckled slightly inwards. The right front door was
35 unable to be opened due to induced damage.

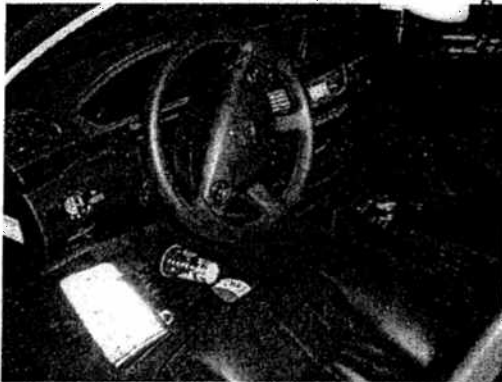
6 The Mercedes has five seating positions. All seating positions, including the middle rear, were equipped with lap/shoulder restraints. The front seating positions were also equipped with a Supplemental Restraint System (SRS) consisting of frontal airbags. Both airbags were not deployed. The driver's restraint was found cut across its width and was laying on the driver's seat. The buckle of the driver's restraint was found in the latch and would not eject.

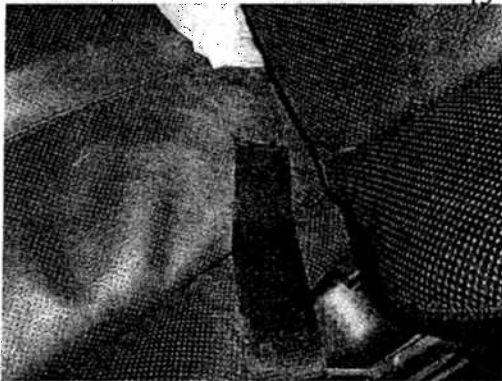
13 The latch housing was cracked open and displaced. The driver's seat backrest was displaced from the lower seat rest on the right side, reclining the driver's seat. All other safety restraints were found retracted in their housing with no signs of unusual wear. The right rear and left rear safety restraint were fully retracted and locked and would not extend. The left rear seat sustained induced damage and was displaced upwards and to the front of the vehicle.

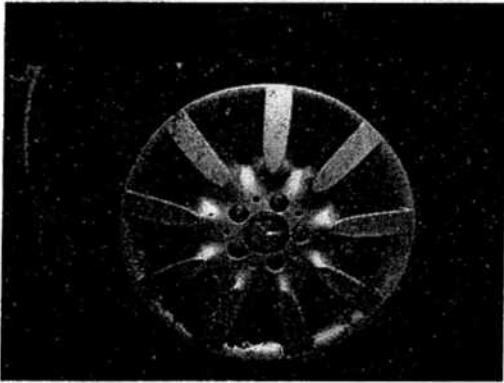
4
5 **LEFT FRONT:**

12 There was a 1/2-inch gouge on the outer sidewall of the tire at the 11 o'clock position. The outer
13 face of the tire and wheel was covered in dirt and debris.

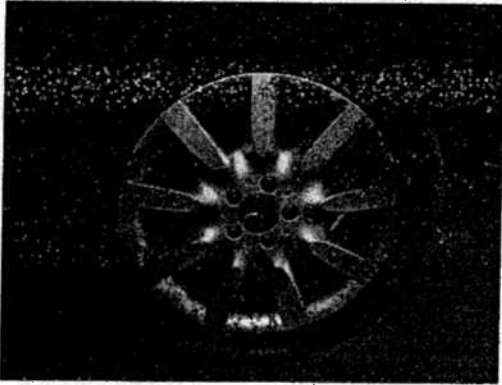
3 The left rear tire appeared to be in good condition and was covered in dried mud, dirt, and debris
 4 on its outer face.

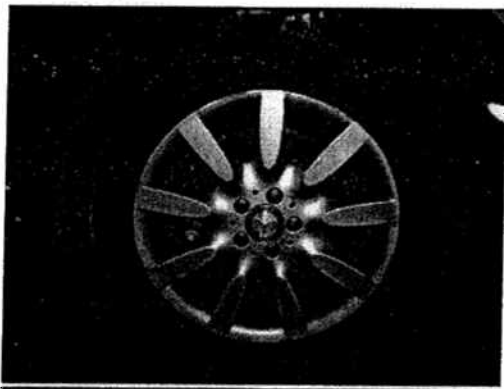
7 **RIGHT FRONT:**

14 There was an area of abrasions approximately 2 inches long at the 12 o'clock position of the
 15 outer rim's circumference that appeared old. There was a partial laceration to the sidewall of the
 16 tire at the 3 o'clock position, approximately 2 inches long.

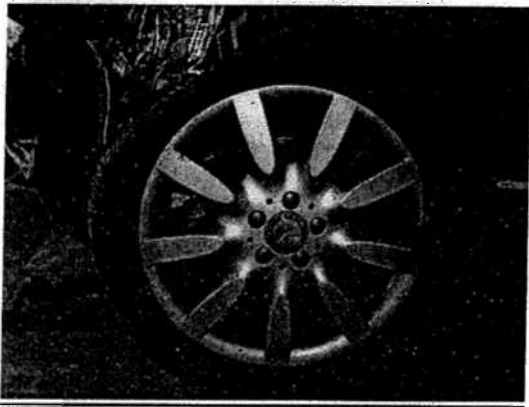
3 **RIGHT REAR:**

10 The right rear tire was deflated with the rear portion of the Mercedes pushed up against the width
 11 of the tread.

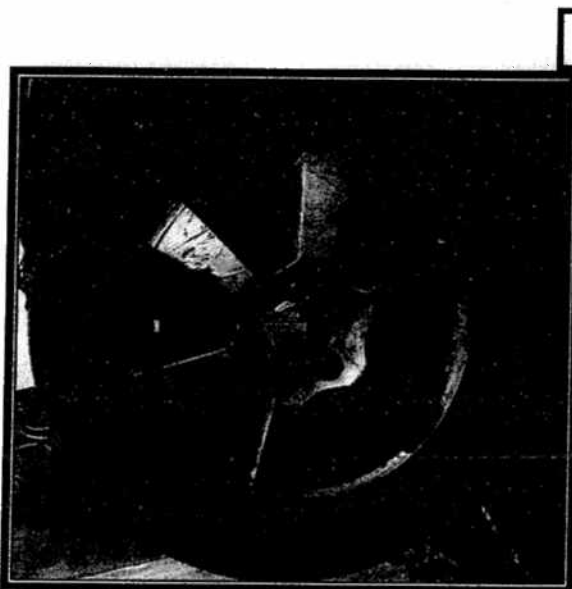
Figure 22 – Left front wheel and tire damage.

The left front tire appeared to have sustained collision related damage on the outboard side including superficial radial cuts on the sidewall at the 7, 8, 9, and 12 o'clock positions and a small tire cut at the 10 o'clock position (Figure 22, arrows marked in red). The right front tire did not appear to have sustained collision related damage, scratches, or scuff marks.

The left front wheel appeared to have sustained abrasions all around the flange and scratches all around the outboard side of the wheel. Abrasions and scratches were also found all around the inboard side of the wheel (Figure 23). The right front wheel sustained small abrasions around the outboard flange between the 4 and 6 o'clock positions.

- Examination of the tire and wheel assemblies did not disclose any pre-existing damage or impairment that might compromise their normal functional abilities or operating characteristics.
- Damage to the left front tire and wheel and right front wheel appeared to have been caused by the collision.
- The body molding rubbing against the right rear tire appeared to have been caused by the collision damage.
