CL-10316502-2079

**RE: Report of Unsafe 2005 Honda CR-V 4WD EX AT SE 4DR 2.4L - torque converter lockup and extensive vehicle shuddering.**

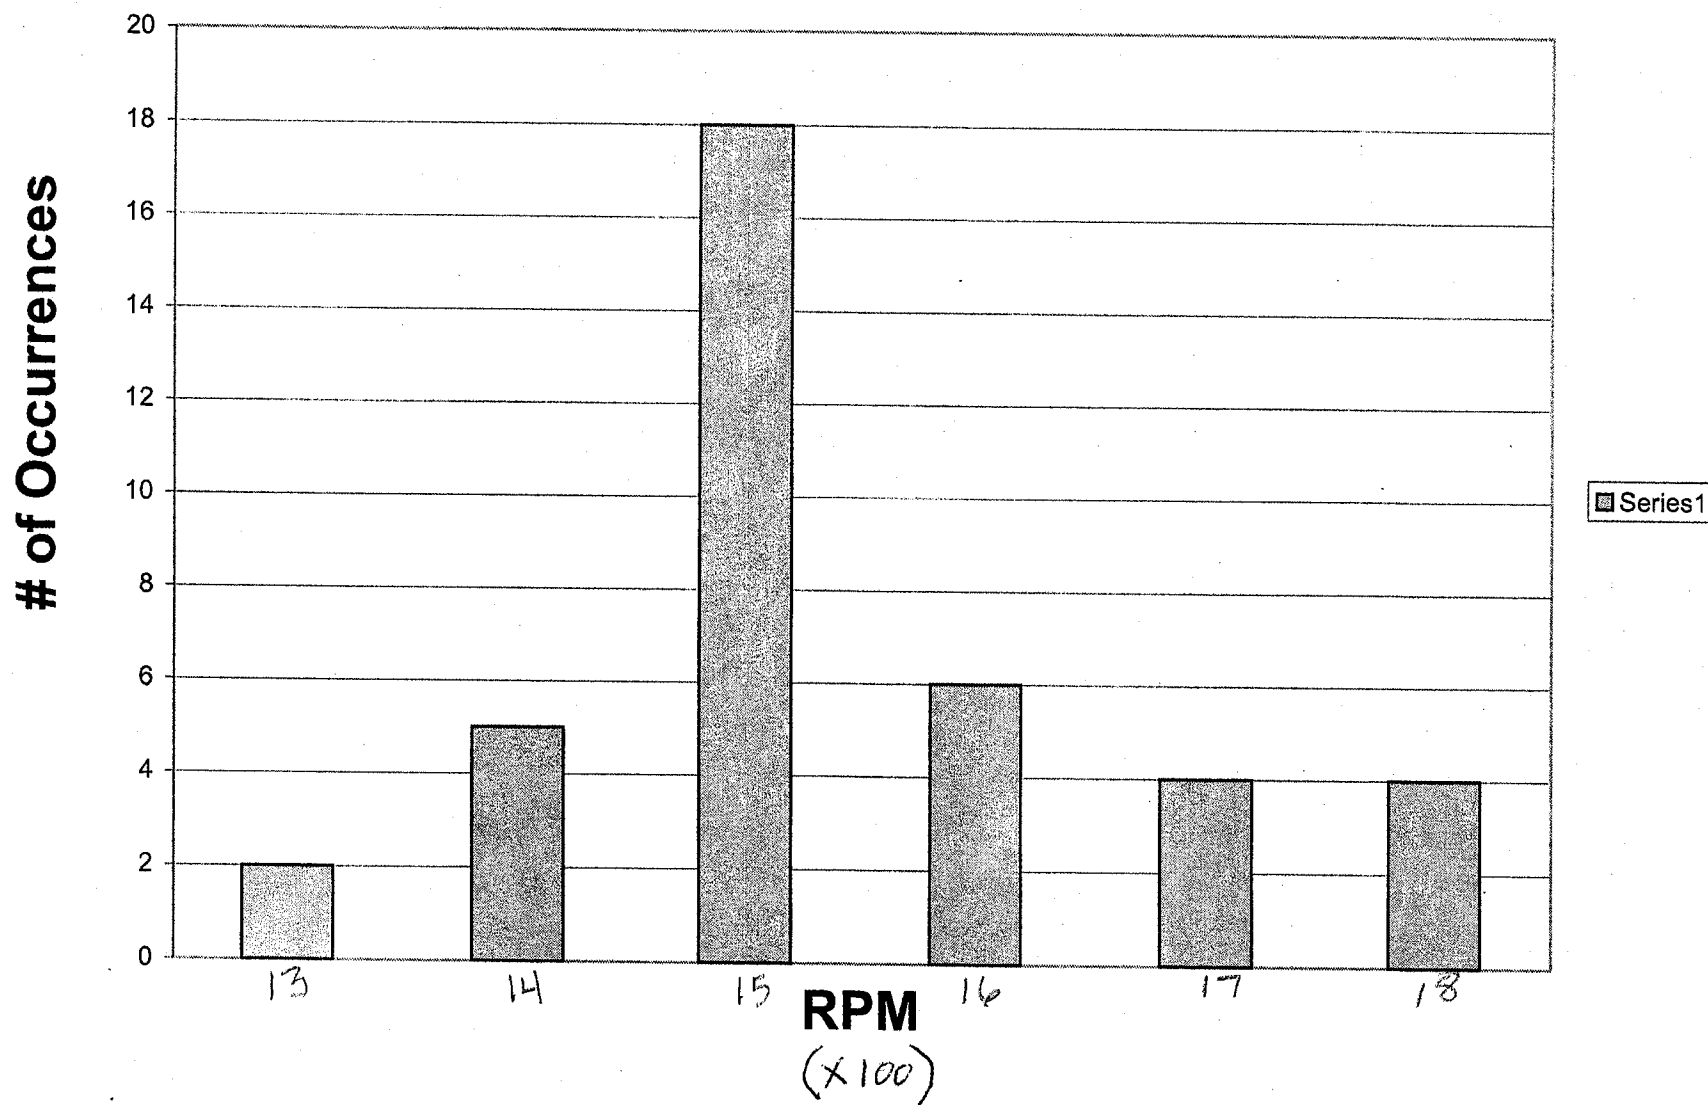
ATTACHMENT 2

This malfunction has been occurring since I purchased this Honda CR-V in 2006. A "Google" or "Yahoo" search of "CR-V Honda shaking" reveals this is a wide-spread defect. **Attachment 2** is data that I collected that identifies the RPM and frequency that shuddering occurs in this Honda CR-V.

## CR-V Shudder Events by RPM
