<p><b>VEHICLE INFORMATION</b></p>				
<p>17 digit Vehicle Identification Number Located at bottom of windshield on driver's side SAJDA23C5YL</p>		<p>Make JAGUAR</p>	<p>Model XJ</p>	<p>Model Year 2000</p>
<p>Date Purchased Nov 12, 2009</p>	<p>Dealer's Name and Telephone Number Sport Leasing aka: Ron Kardos 800-367-7678</p>		<p>Engine: No: Cylinders 8</p>	<p>Fuel Type: Premium 9250 Line</p>
<p>Original Owner <input type="checkbox"/></p>	<p>Dealer's City Foster City, CA</p>	<p>State CA</p>	<p>Zip Code 94404</p>	
<p>Transmission Type AUTOMATIC</p>	<p><input checked="" type="checkbox"/> Antilock Brakes <input checked="" type="checkbox"/> Cruise Control</p>	<p>Powertrain</p>	<p>Multiple Failure: YES - T.C GUIDES, T.CHAIN, ETC. - SEE RECORD</p>	<p>Incident Date(s) 16-JAN-2010</p>
<p><b>FAILED COMPONENT(S)/PART(S) INFORMATION</b></p>				
<p>Vehicle Component Code: 061000 ENGINE AND ENGINE COOLING: ENGINE TIMING CHAIN GUIDES/TENSIONERS THAT THEY CAUSED TIMING CHAIN TO BREAK AND JAM INTO A GEAR AND PISTONS TO SMASH INTO VALVES</p>			<p>Failure Mileage 93000</p>	<p>Failure Speed 0</p>

re: Additional information and documents to CORRECTED "Vehicle Owner's Questionnaire"  
Ref. No. 10317111; J

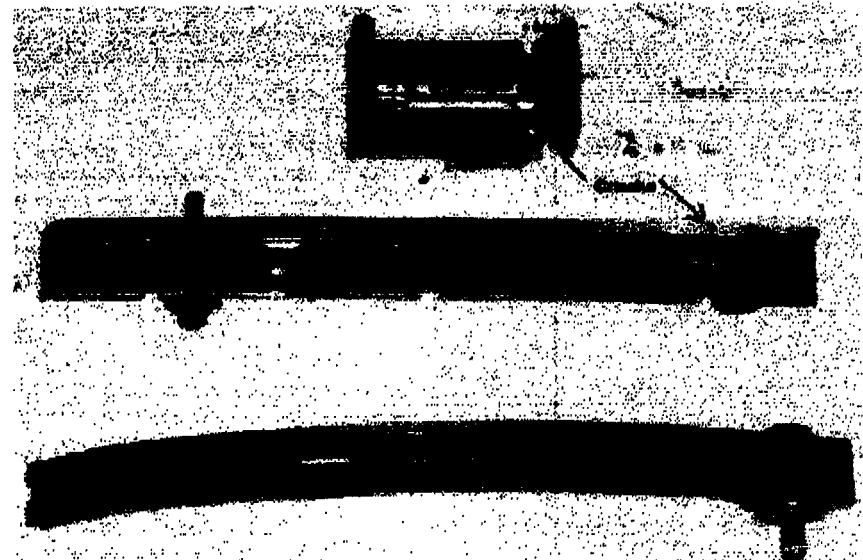
Right bank secondary tensioner and guides

Though the tensioners of this 1998 XJ8 engine with 56,000 miles appeared intact on visual inspection with the valve covers removed, upon disassembly both were discovered to be badly cracked, and so was one of the main tensioner guides. A cracked tensioner can break apart and cause cam chain failure, damaging the engine severely.

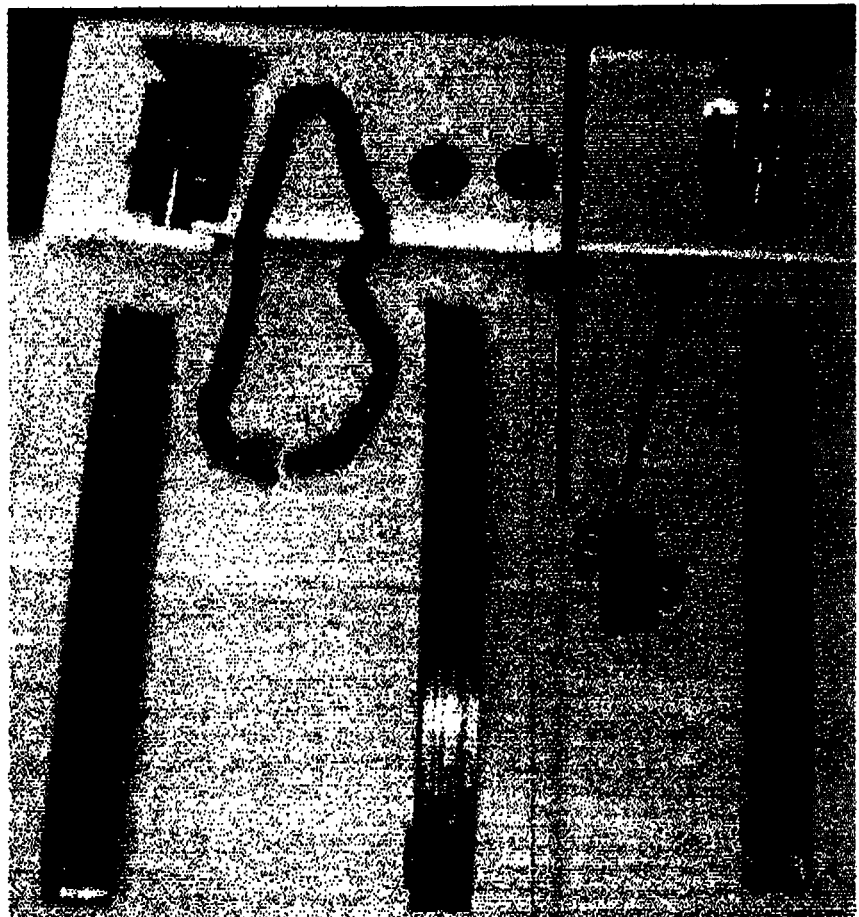
**When the worst happens:** This 1999 XJ6's tensioners both cracked. When the one at the top left broke, its timing chain (shown) snapped and the valves collided with the pistons. Two of the bent valves are shown in this photo. Though such damage requires significant shop time to repair, engine replacement is usually **NOT** indicated, and the parts required are reasonable in quantity and cost.

If you hear a rattle in the front of the engine, stop the car immediately and have it towed to a Jaguar service facility. Similarly, if the engine is running very roughly or refuses to start, have it towed. In either case, **DO NOT TRY TO**
