2003 Nissan-Datsun Maxima V6-3.5L (VQ35)

Vehicle Level → Technical Service Bulletins → Recalls → Recall - Engine Sensor Replacement → Owner Letter

Recall - Engine Sensor Replacement

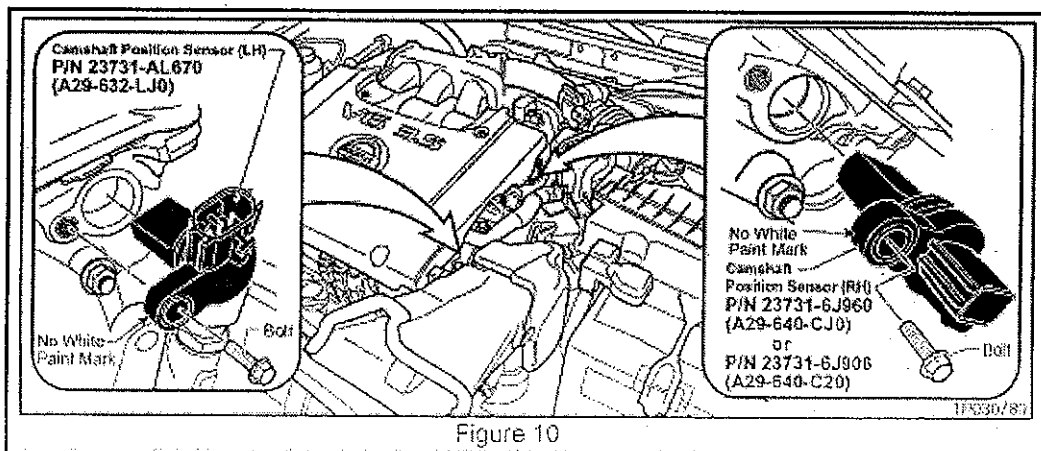
Figure 10

- ^ THE SENSORS IN THIS KIT ARE DIFFERENT. IT IS CRITICAL THAT EACH SENSOR BE INSTALLED IN THE CORRECT LOCATION. REFER TO "FIGURE A" AND THE ILLUSTRATIONS IN THIS REPAIR SECTION FOR SENSOR LOCATIONS.
- ^ Each new sensor (within each kit) is contained in a bag. The bag is labeled with the Nissan part number. Keep the sensor in the bag until just before it is installed. The supplier part number is on the face of the sensor. This number starts with "A29-".
- ^ The old and new sensors may appear identical, therefore KEEP THEM SEPARATE.

1. Record all radio station presets.
2. Disconnect the negative battery cable.
