| <b>DOT Auto Safety Hotline</b><br><b>Vehicle Owner's Questionnaire</b><br><b>To Report Vehicle Safety Defects</b><br><b>1-888-DASH-2-DOT</b><br><b>(1-888-327-4236)</b><br><b>INTERNET:www.nhtsa.dot.gov/hotline</b> | | | | FOR AGENCY USE ONLY 100148 | |
| 17 digit Vehicle Identification Number Located at bottom of windshield on driver's side<br>4S2CM58V4V <span style="background-color: black; color: black;">[REDACTED]</span> | | | Make<br>ISUZU | Model<br>RODEO | Model Year<br>1997 |
| Vehicle Component Code: 161000 STRUCTURE: FRAME AND MEMBERS | | | | Failure Mileage<br>139481 | Failure Speed<br>25 |

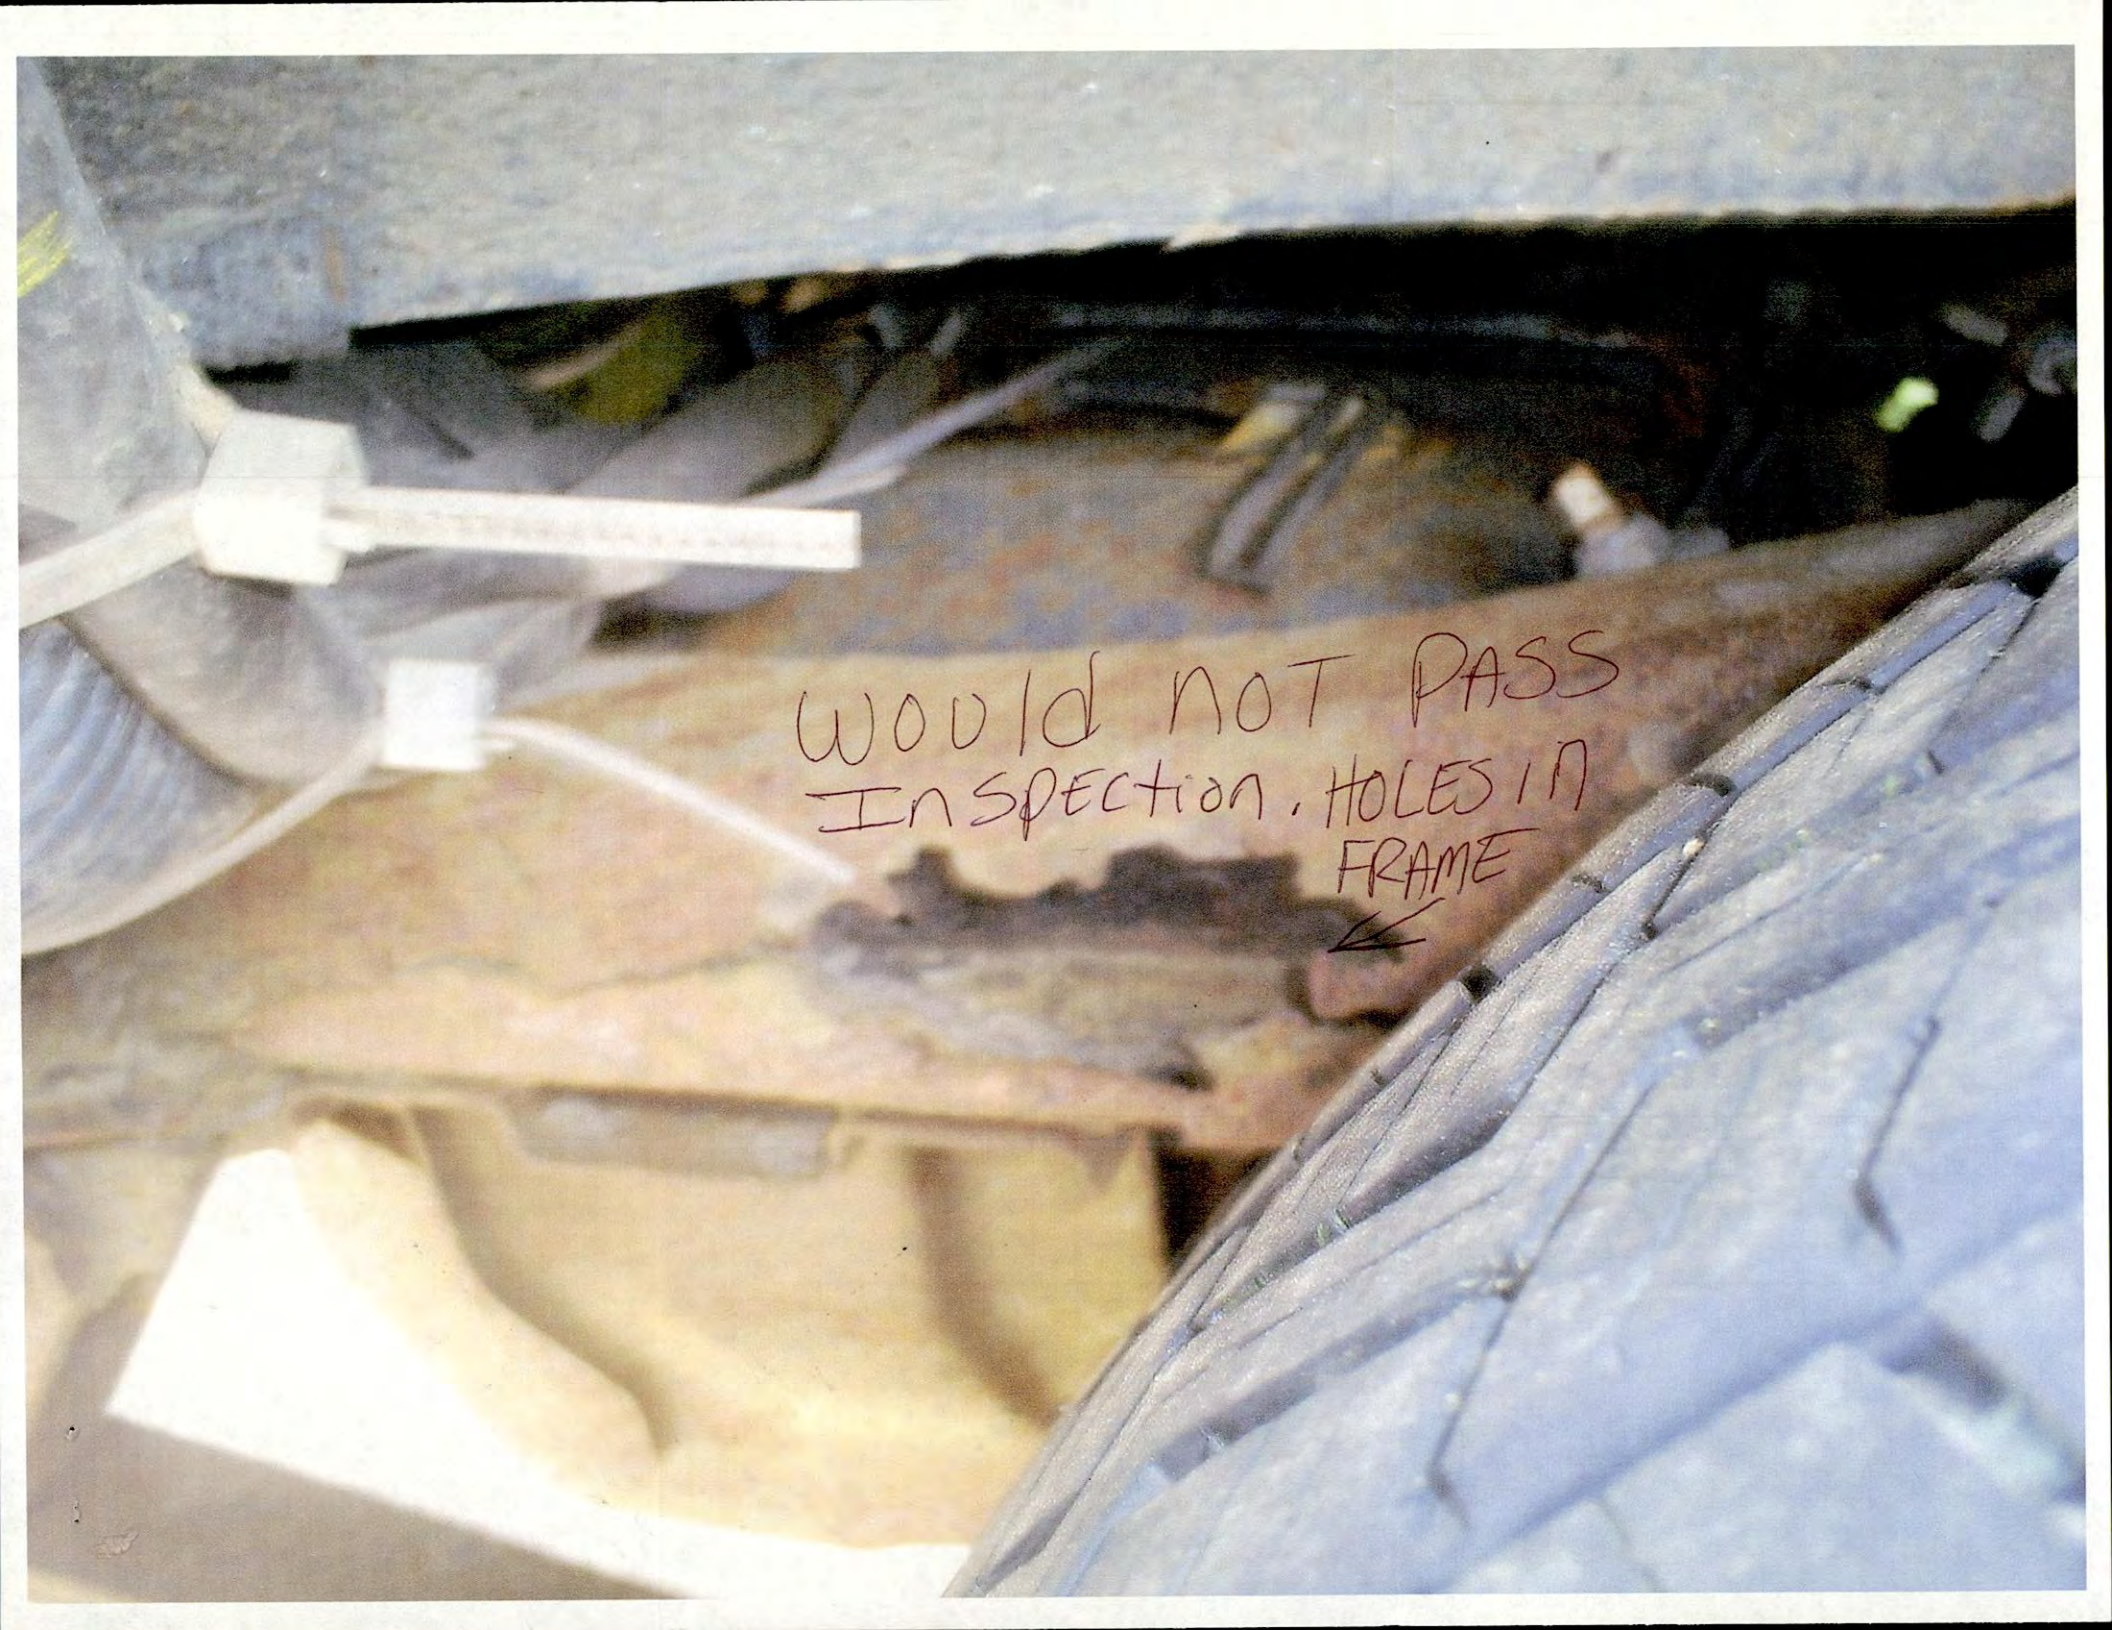
WOULD NOT PASS  
INSPECTION. HOLES IN  
FRAME  
↙

FRAME UNDERNEATH ALL  
ROTTED AWAY

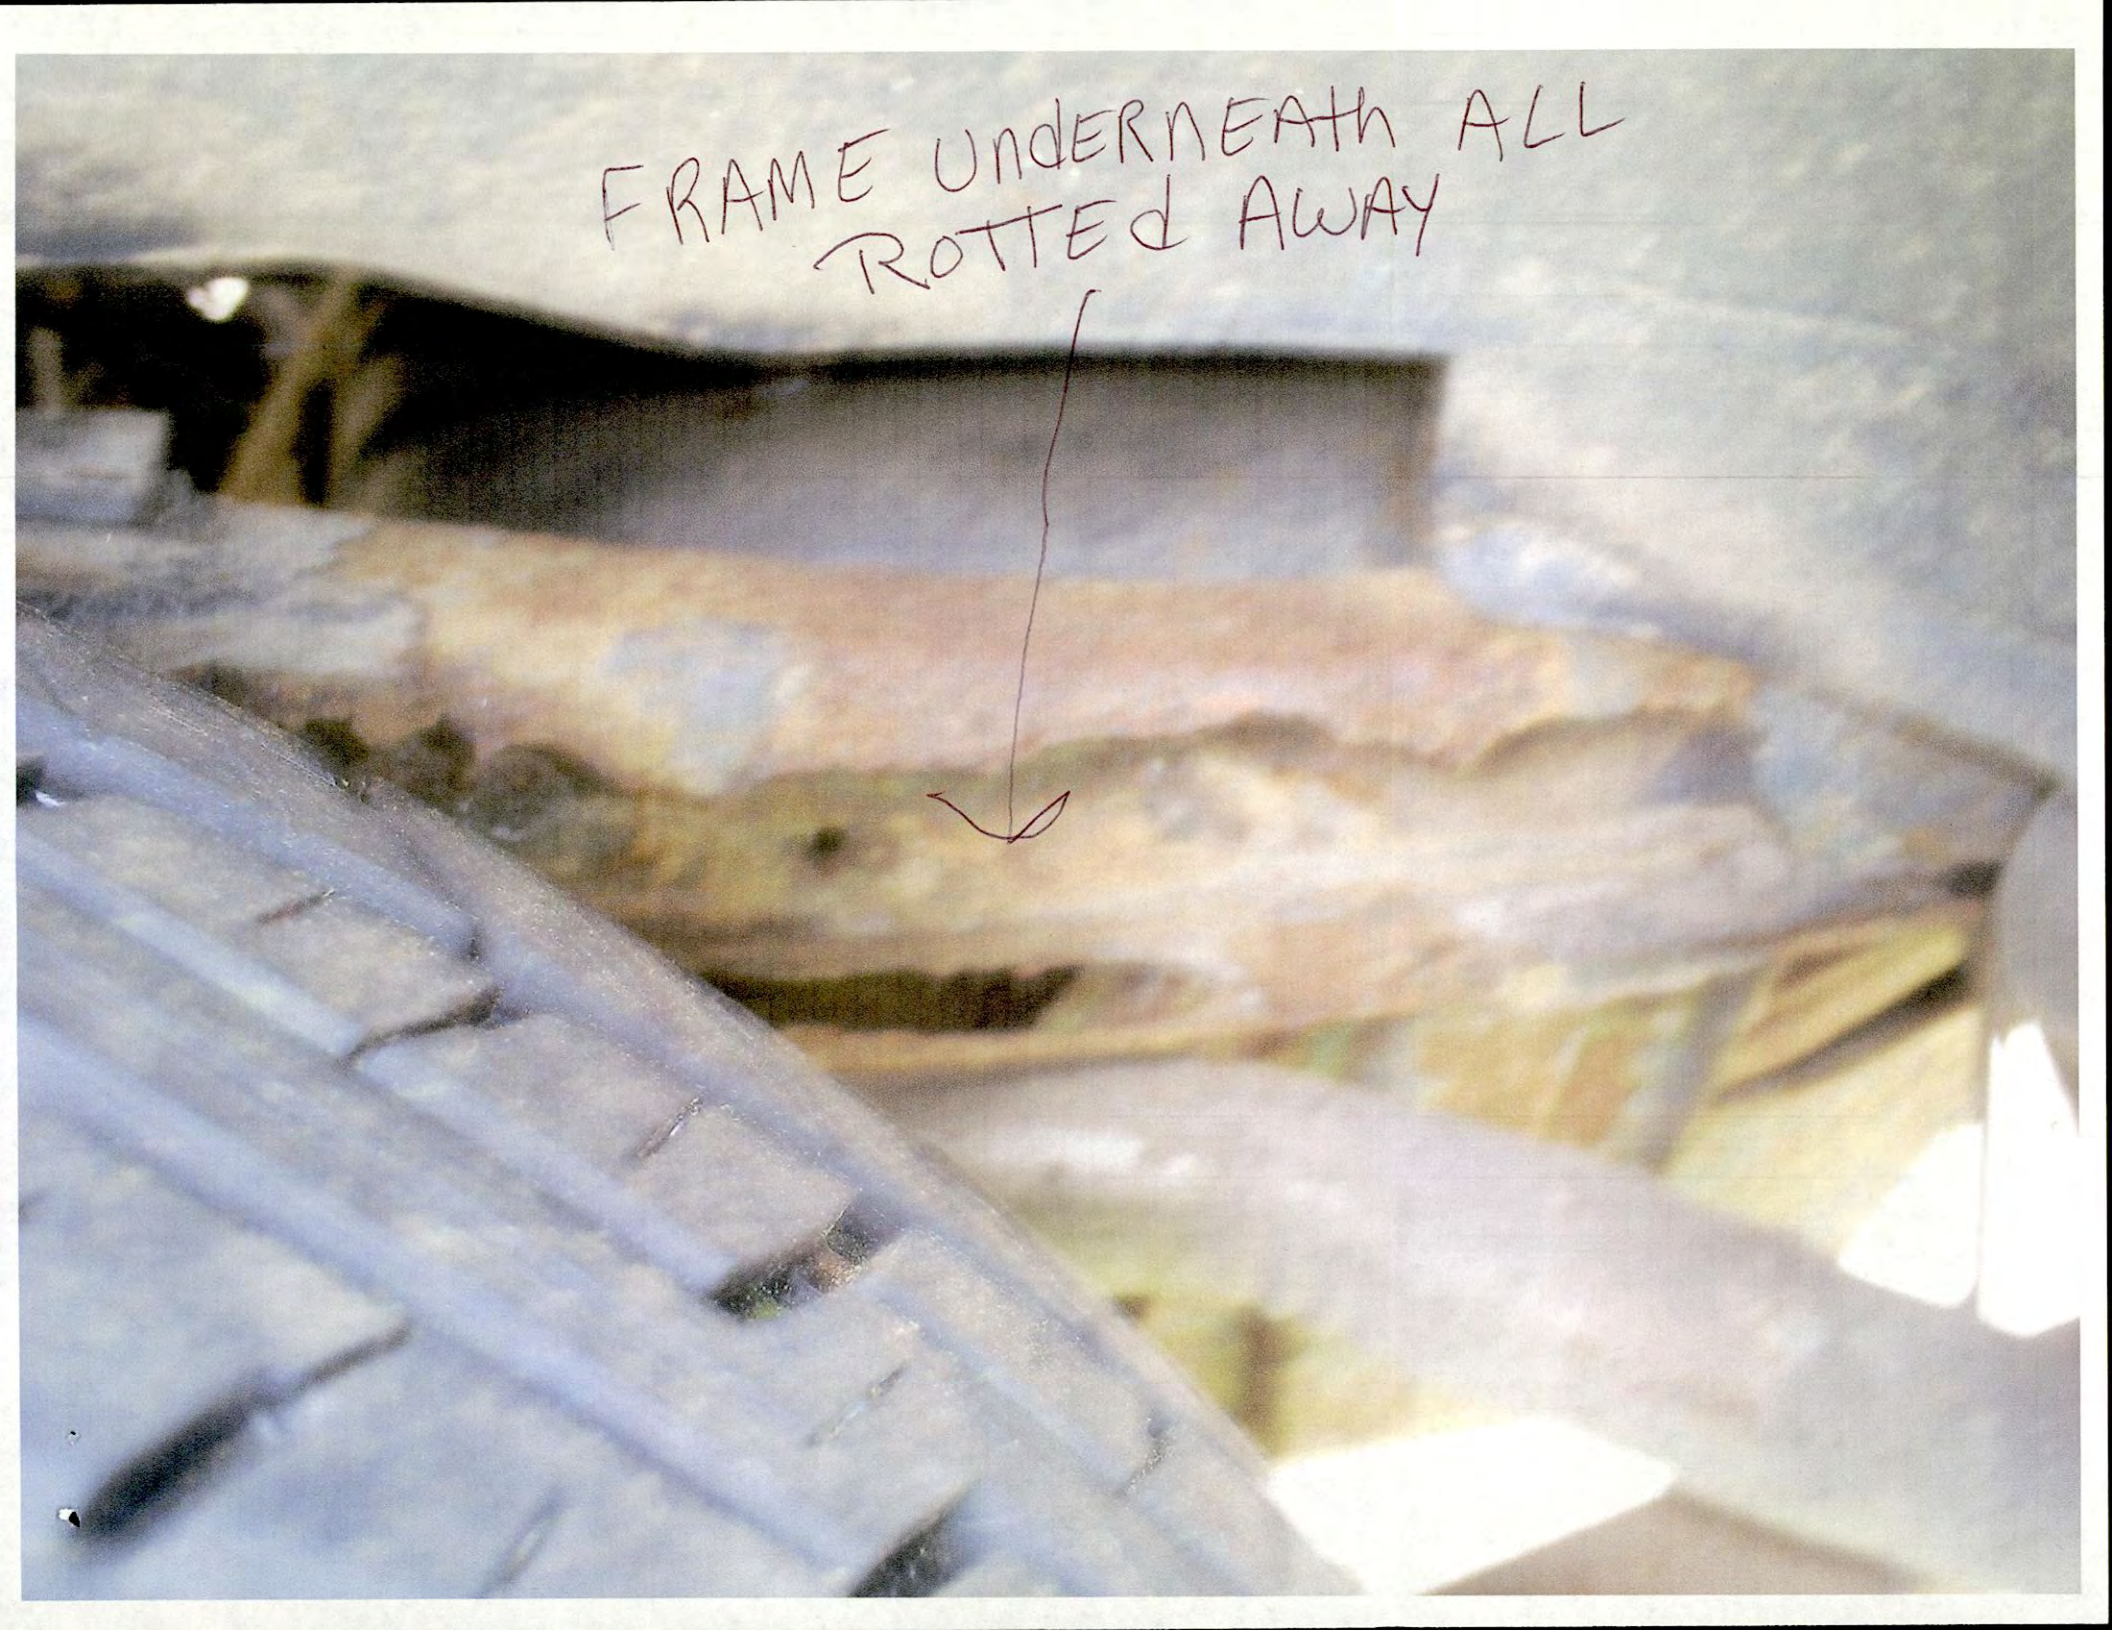
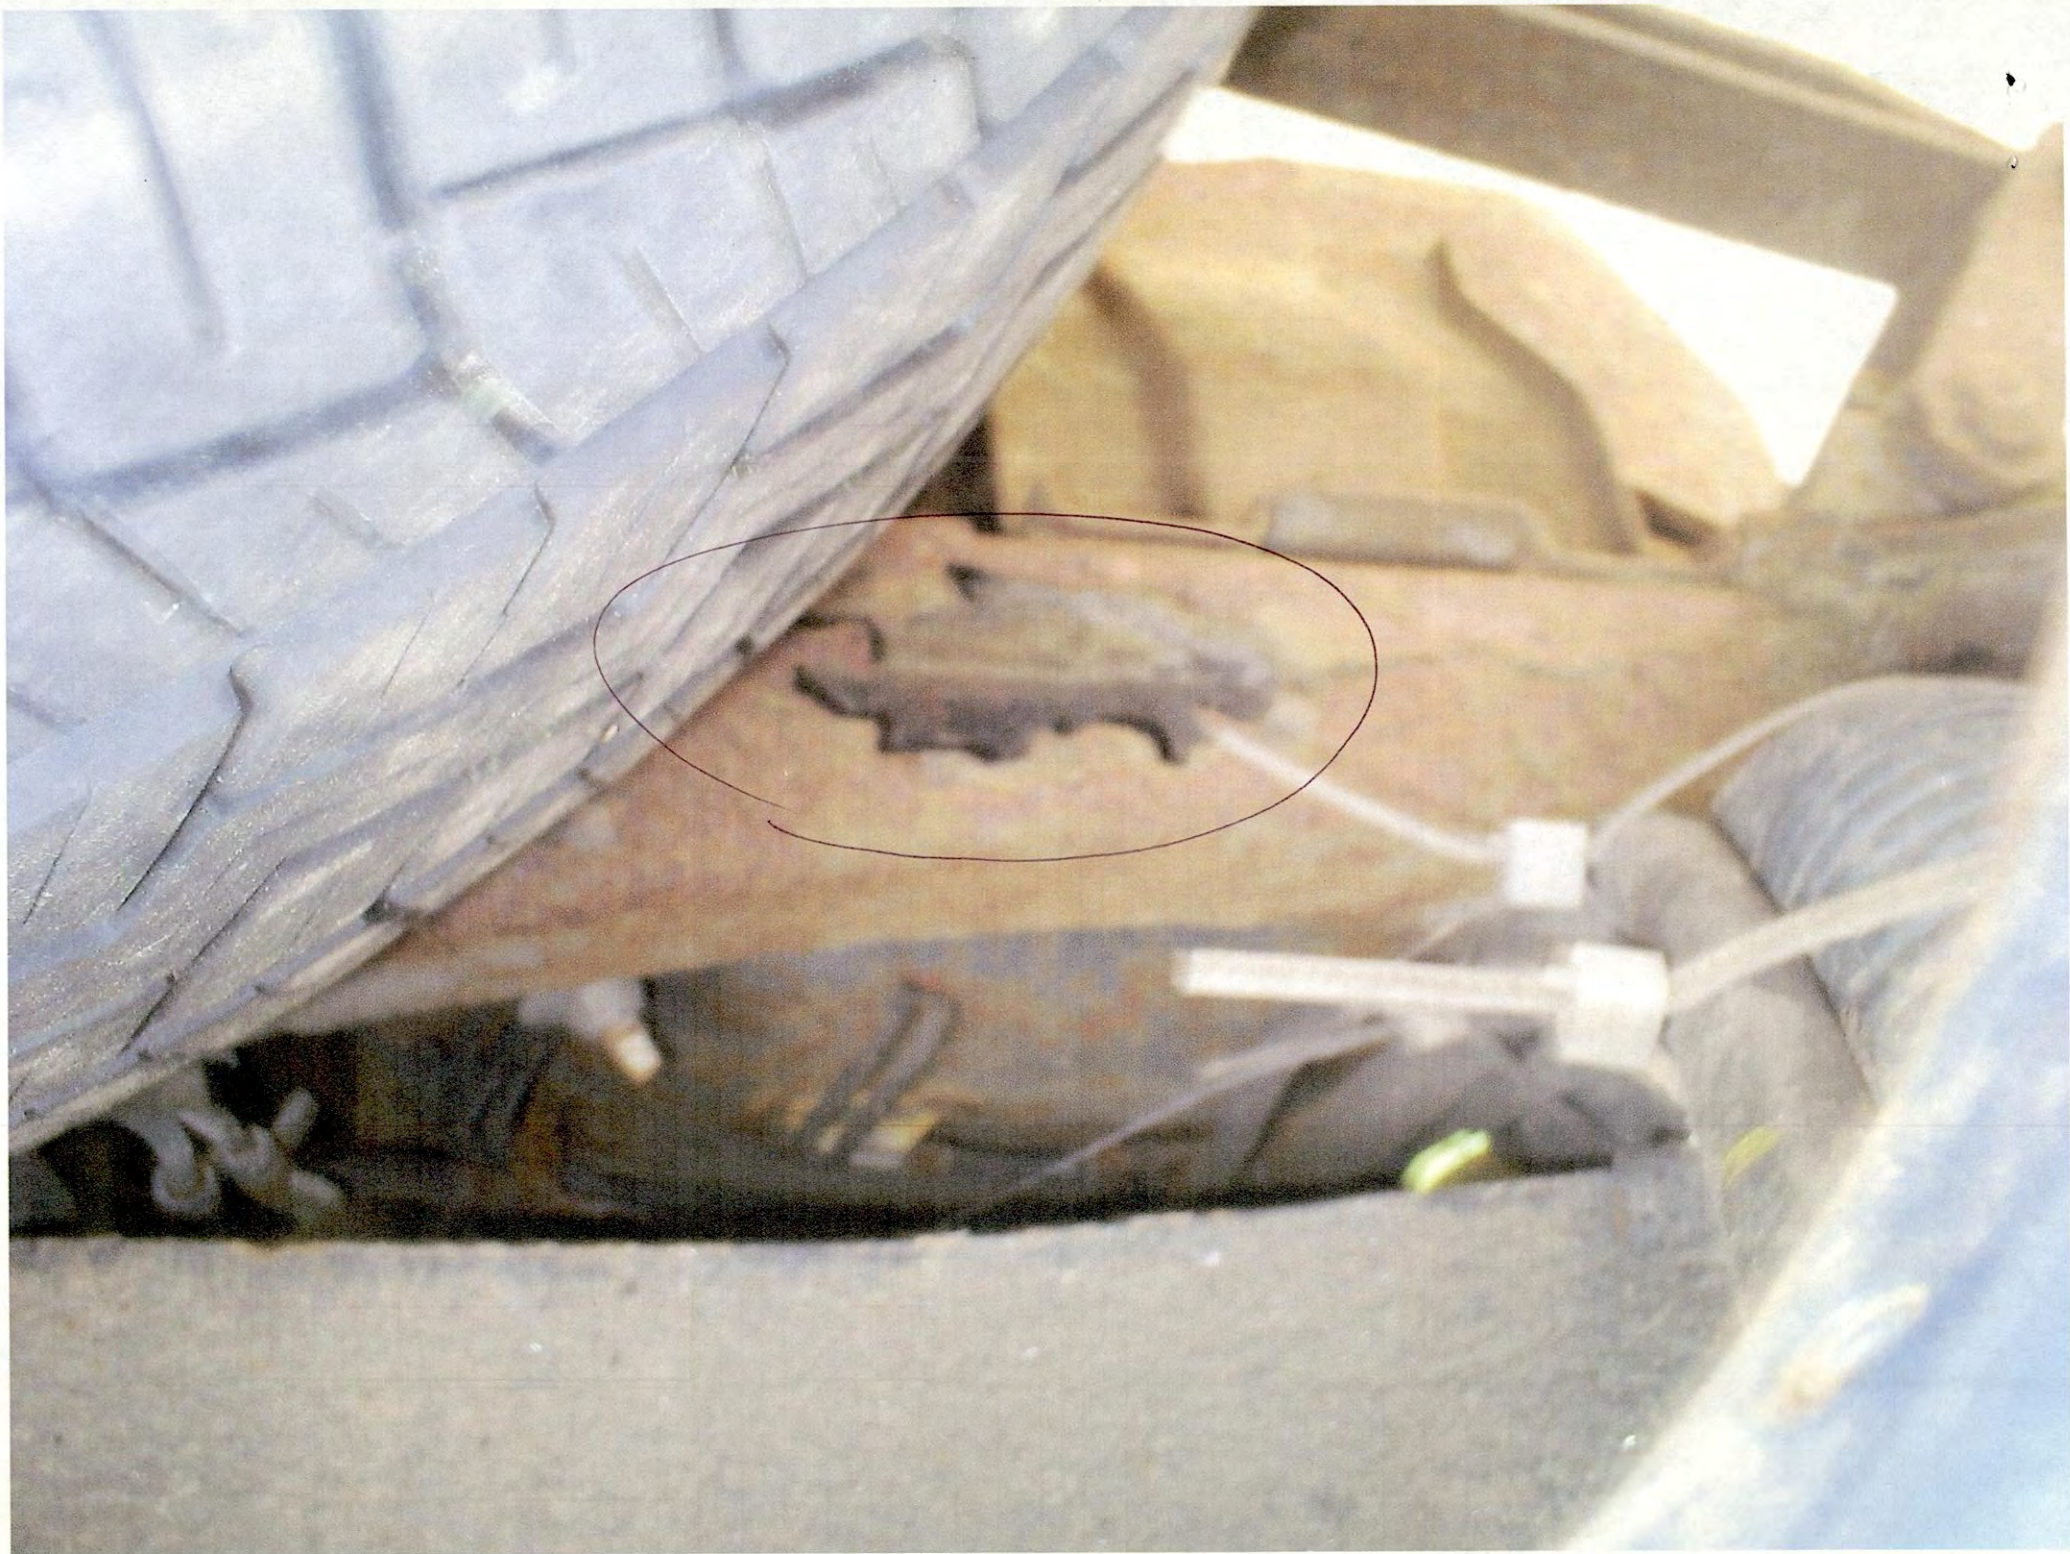
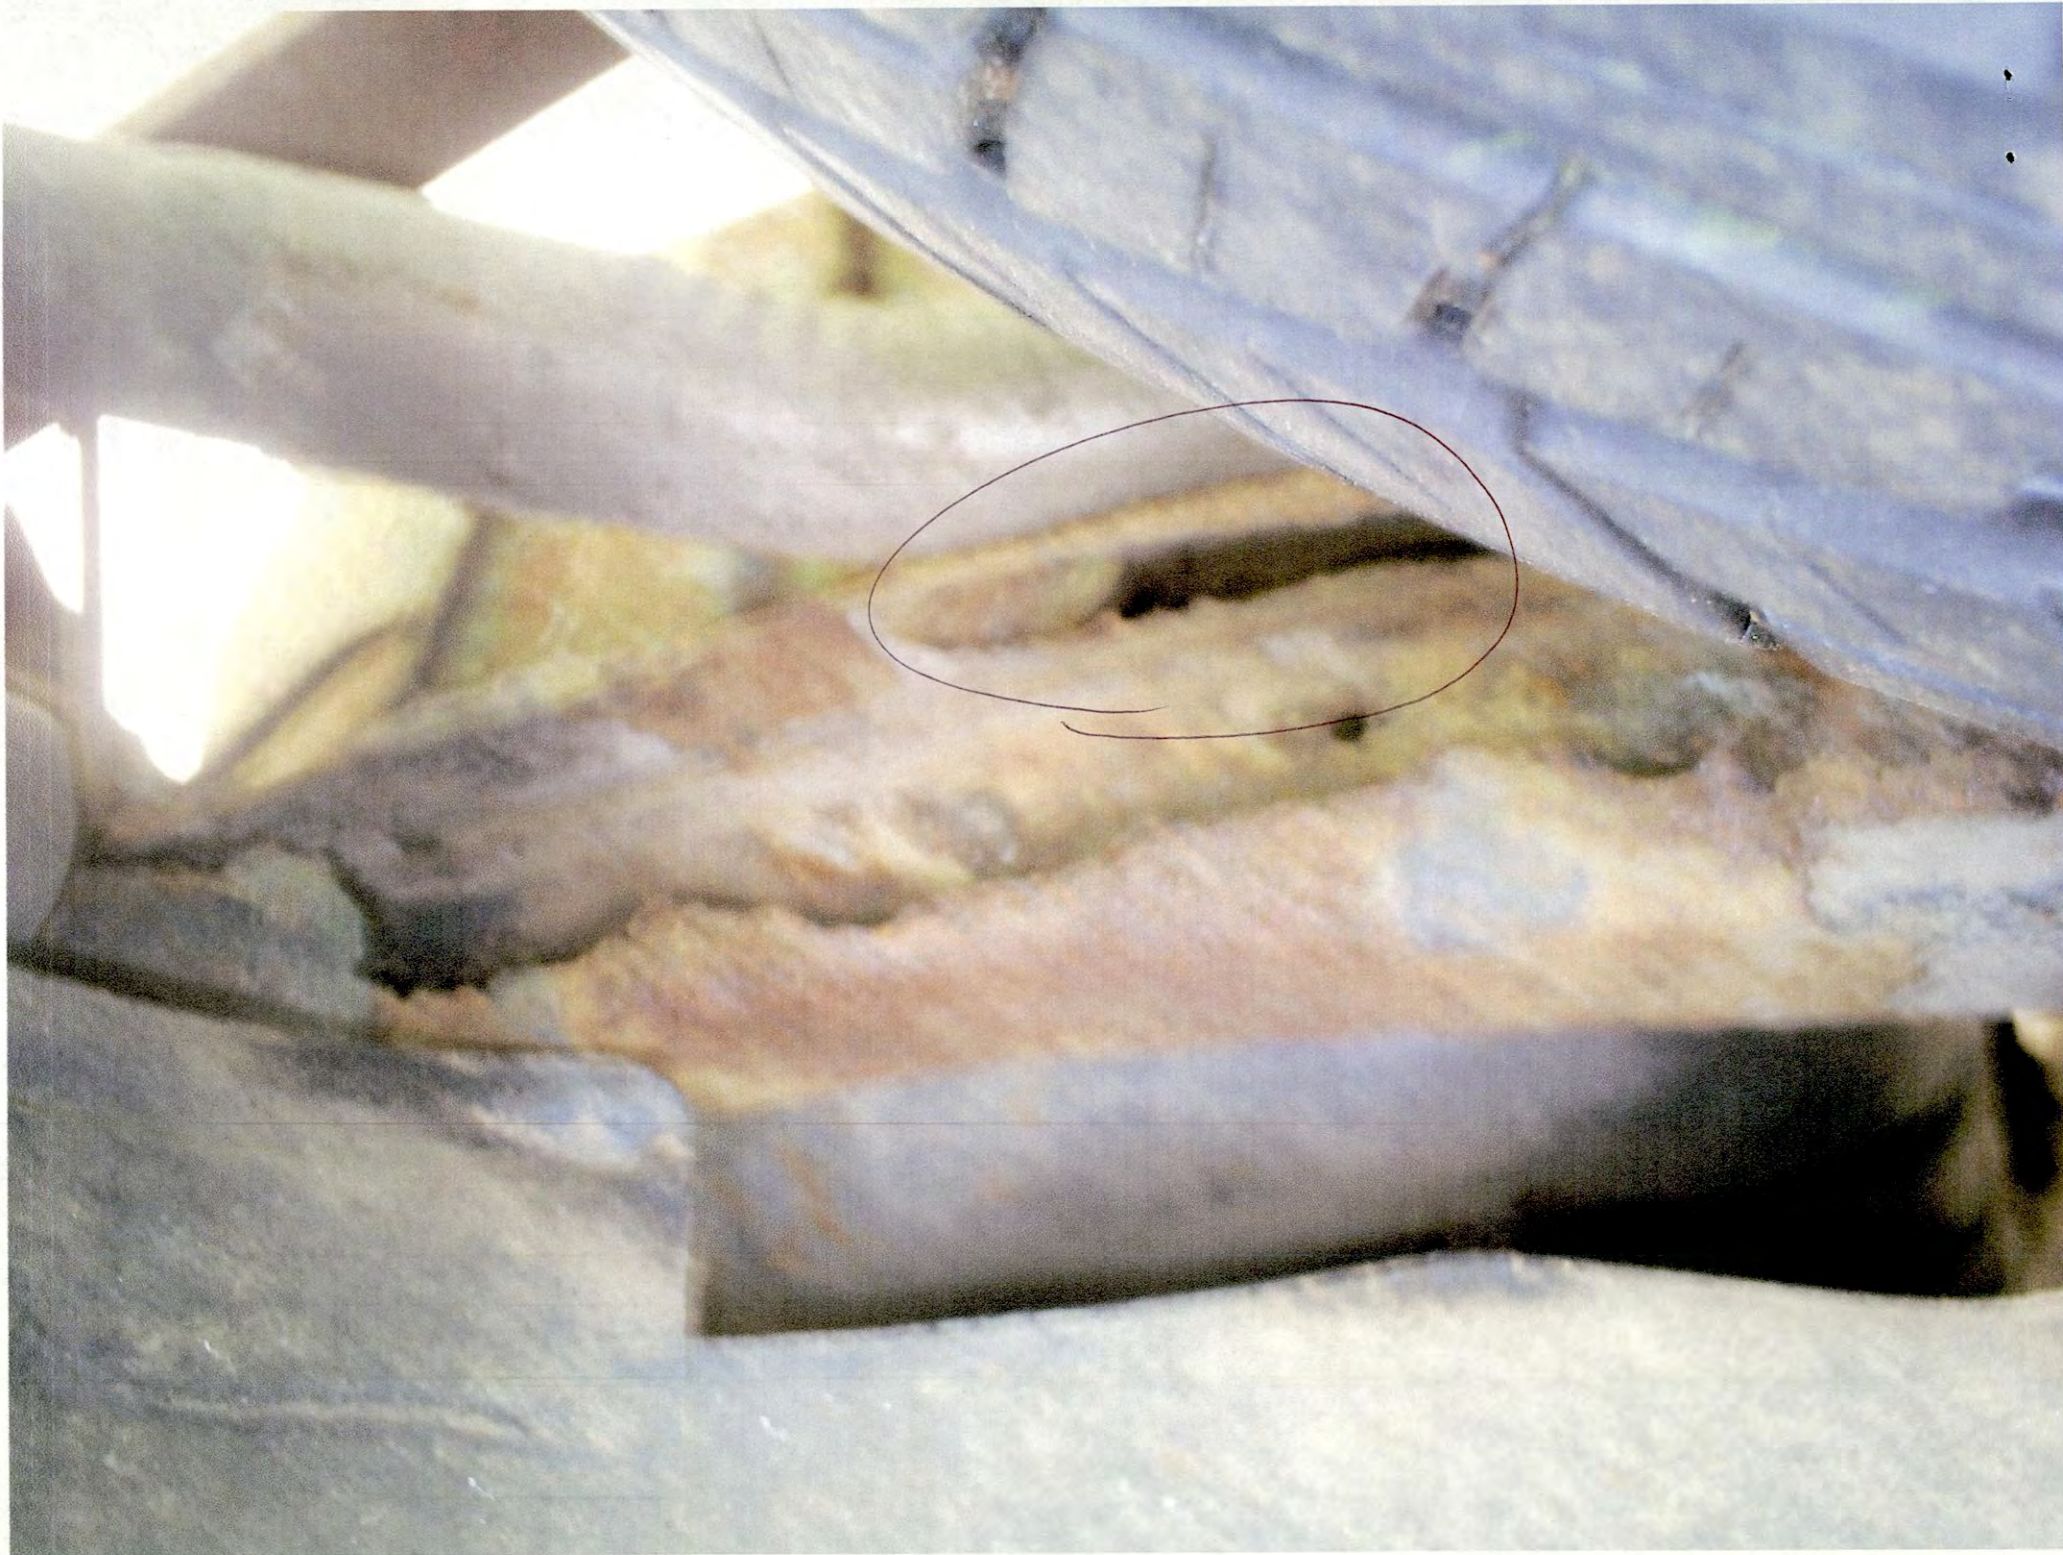
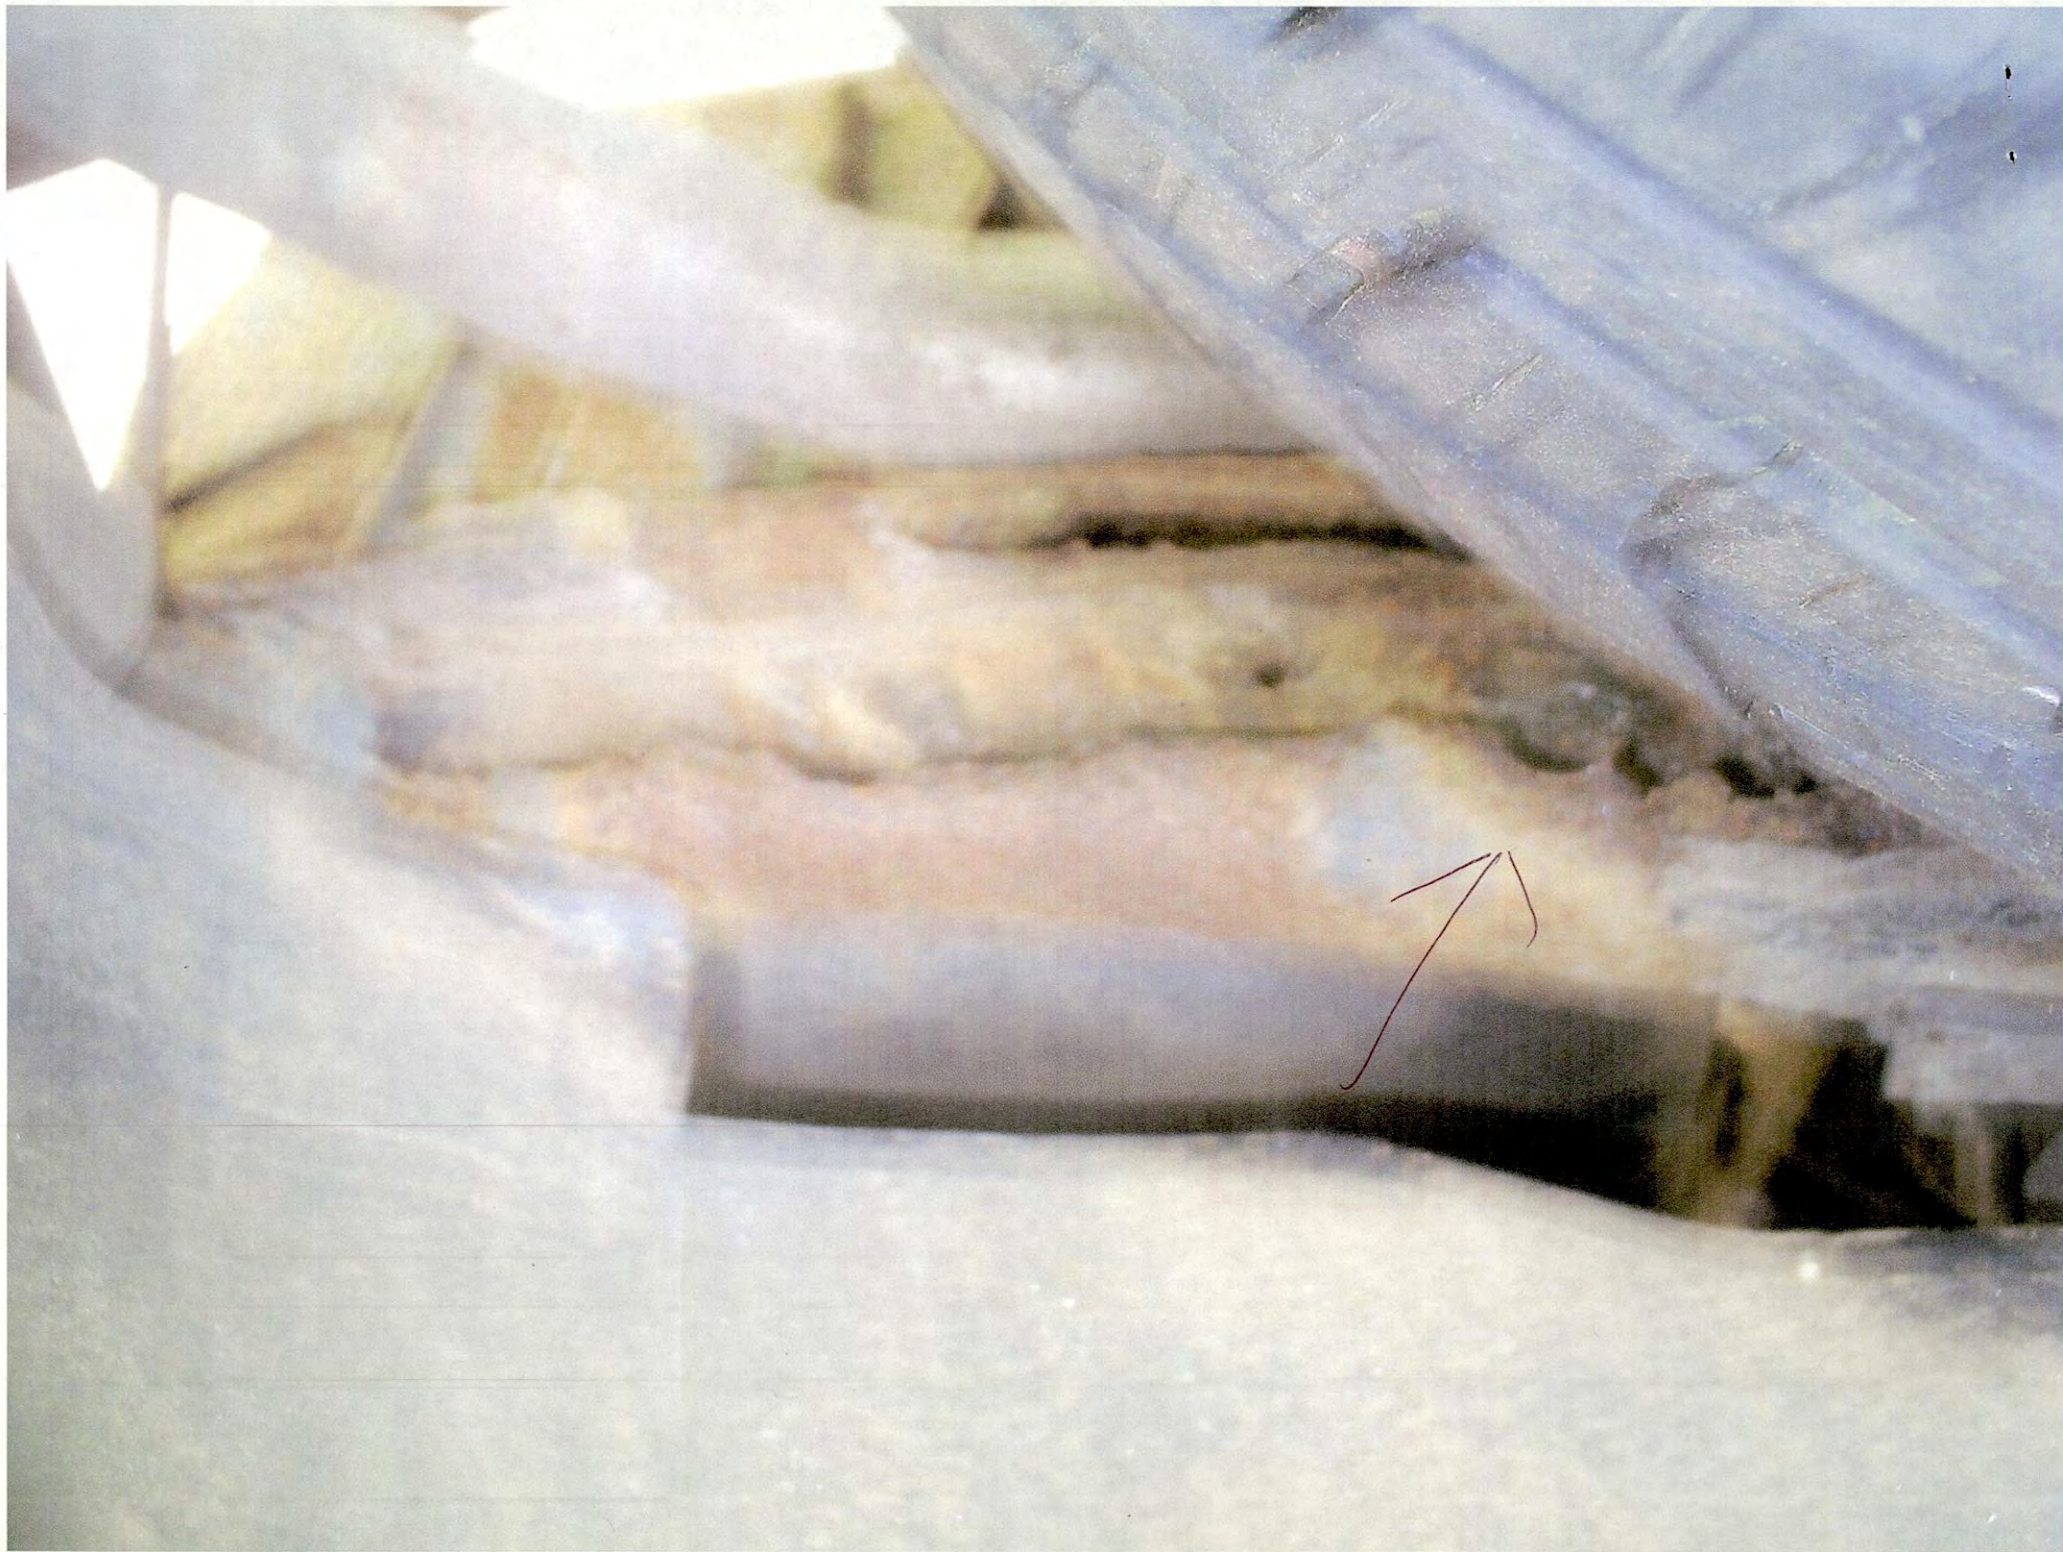
| TL*THE CONTACT OWNS A 1997 ISUZU RODEO. WHILE DRIVING AT 25 MPH, THE CONTACT NOTICED A THUMPING SOUND UNDER THE VEHICLE. THE CONTACT STATED THAT THE VEHICLE WOULD NOT PASS INSPECTION AS THE ENTIRE FRAME HAD RUSTED UNDERNEATH. THE VEHICLE HAD NOT BEEN INSPECTED AT THE TIME OF THE COMPLAINT. THE VEHICLE HAD BEEN PARKED AND THE CONTACT REFUSED TO DRIVE IT. THE CURRENT AND FAILURE MILEAGES WERE 139,481. | | | | | |

I'm enclosing pictures of what the underneath looks like. It is completely rotted away. If you touch it, it crumbles and breaks right off.
