**Inspection Report of Ford Scissor Jack**  
**RE: VOQ 10330290**  
**5/4/2011**

This inspection of a Ford scissors jack was performed in response to VOQ # 10330290 which was submitted on May 13, 2010 by [REDACTED] of Beavercreek, Ohio.

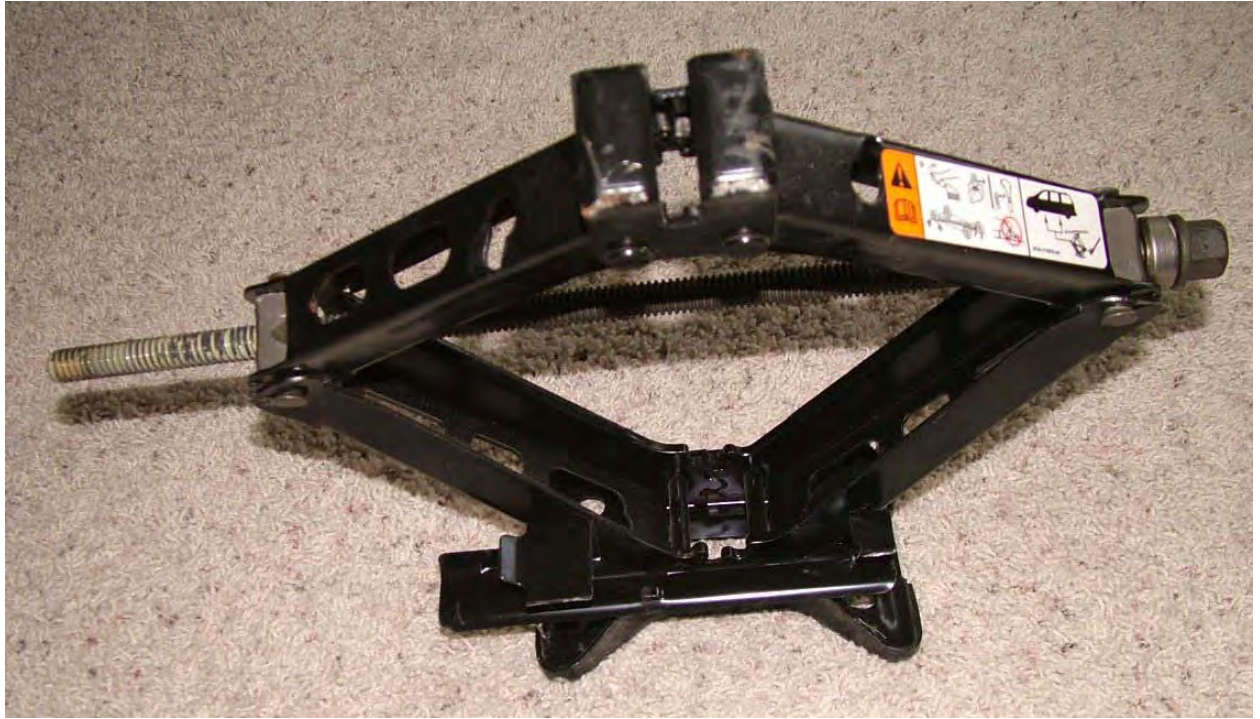
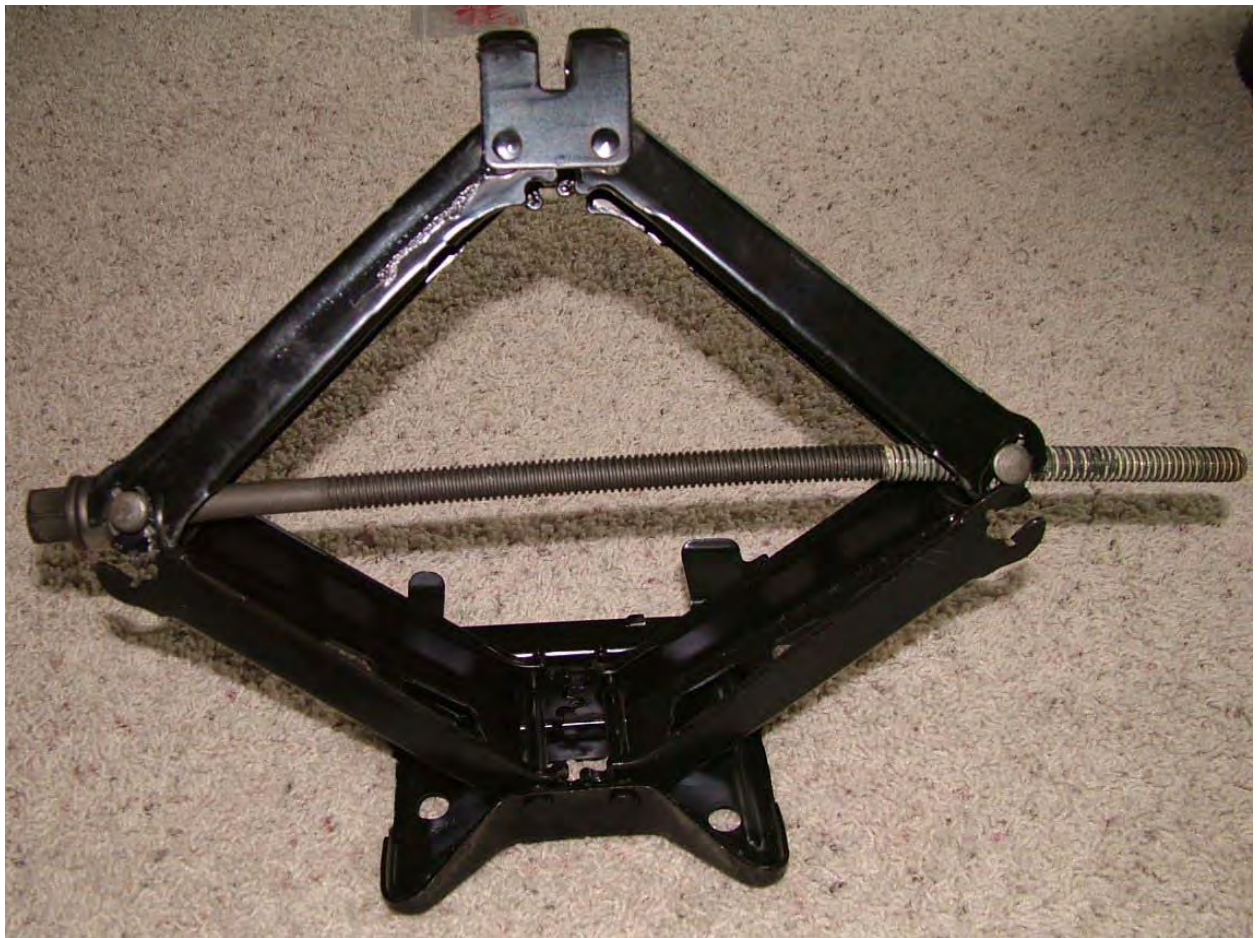
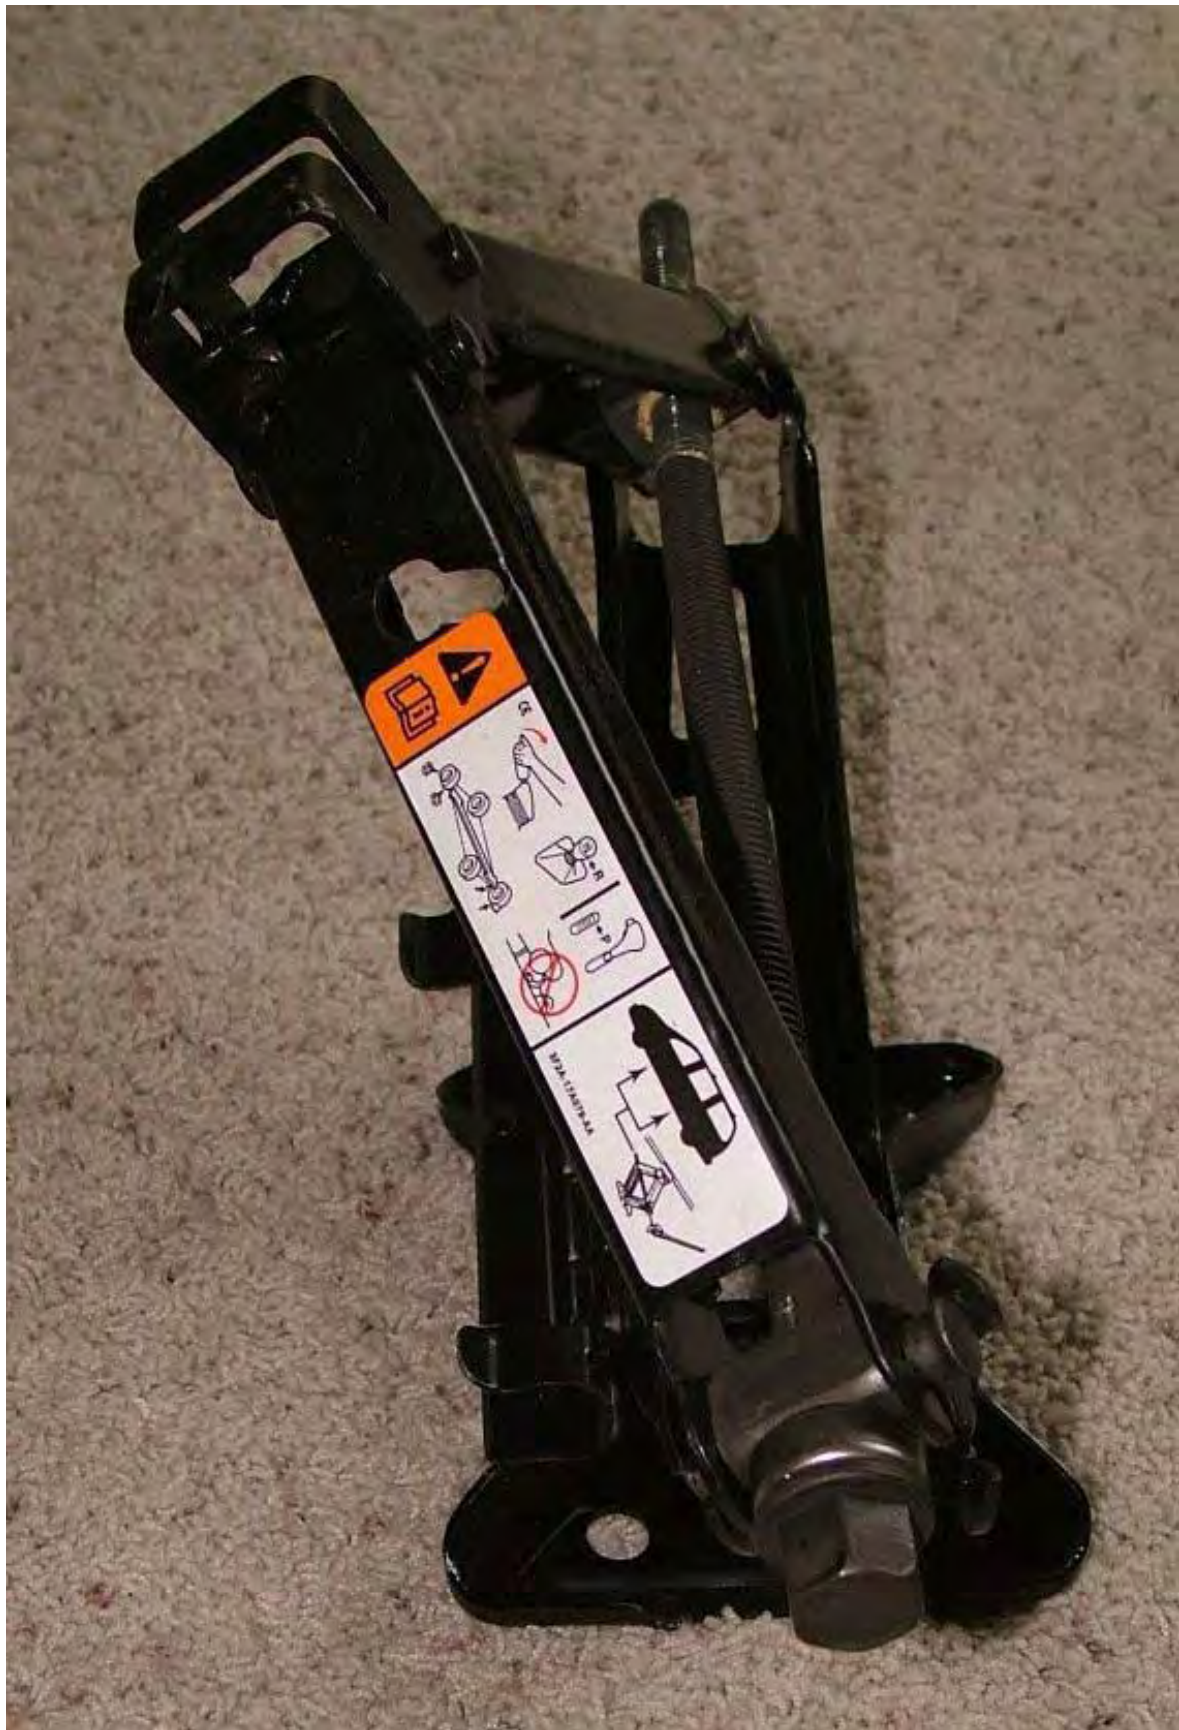
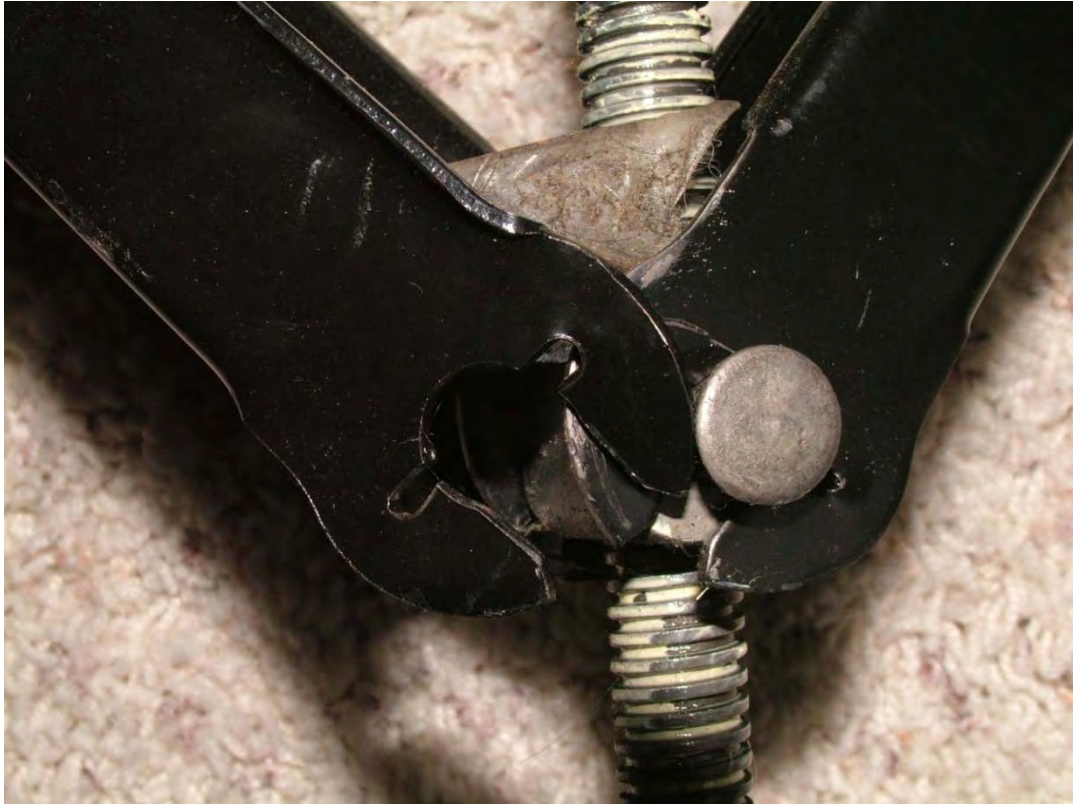
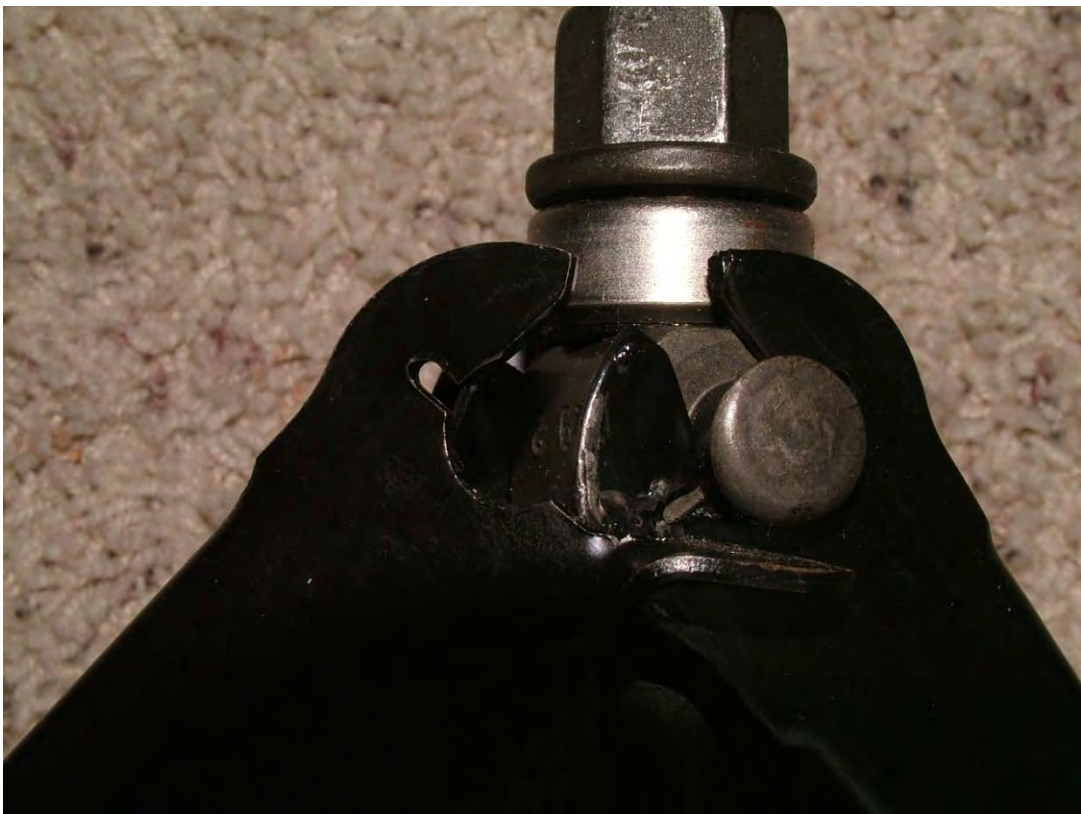
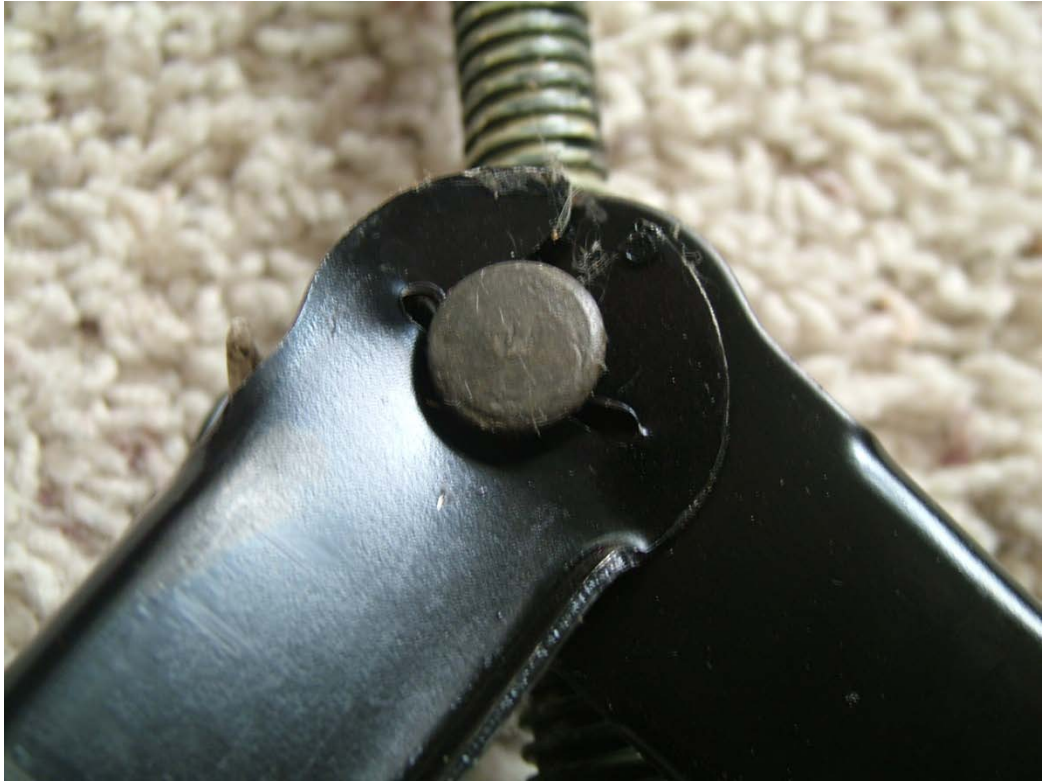
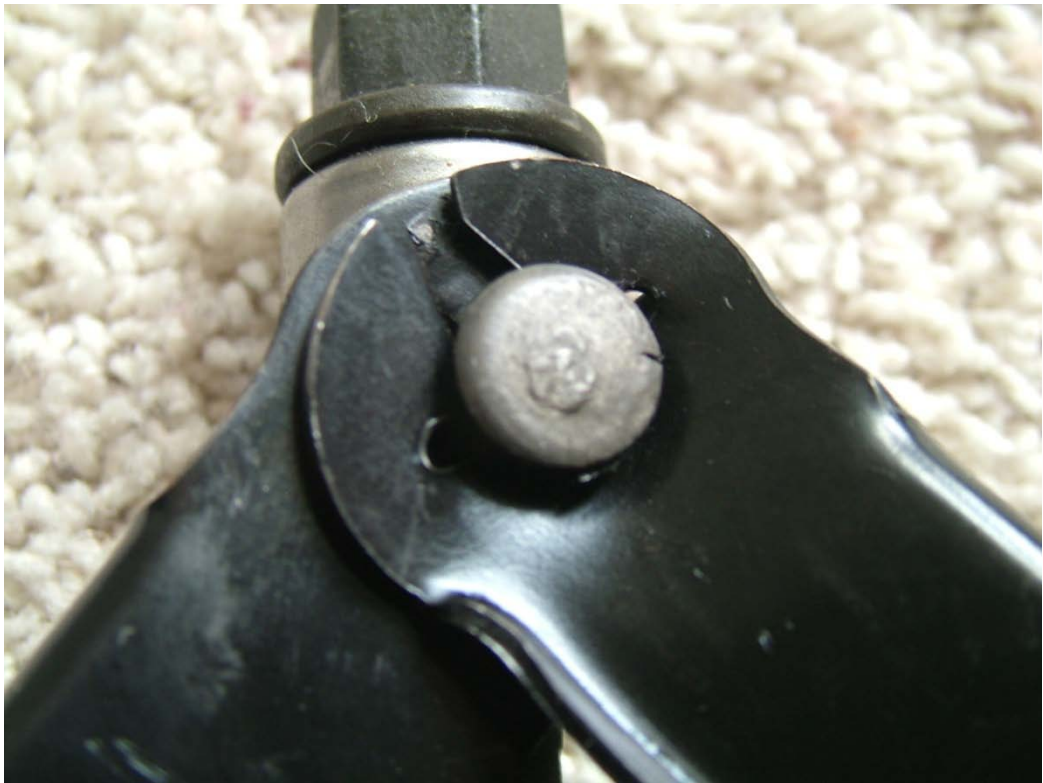
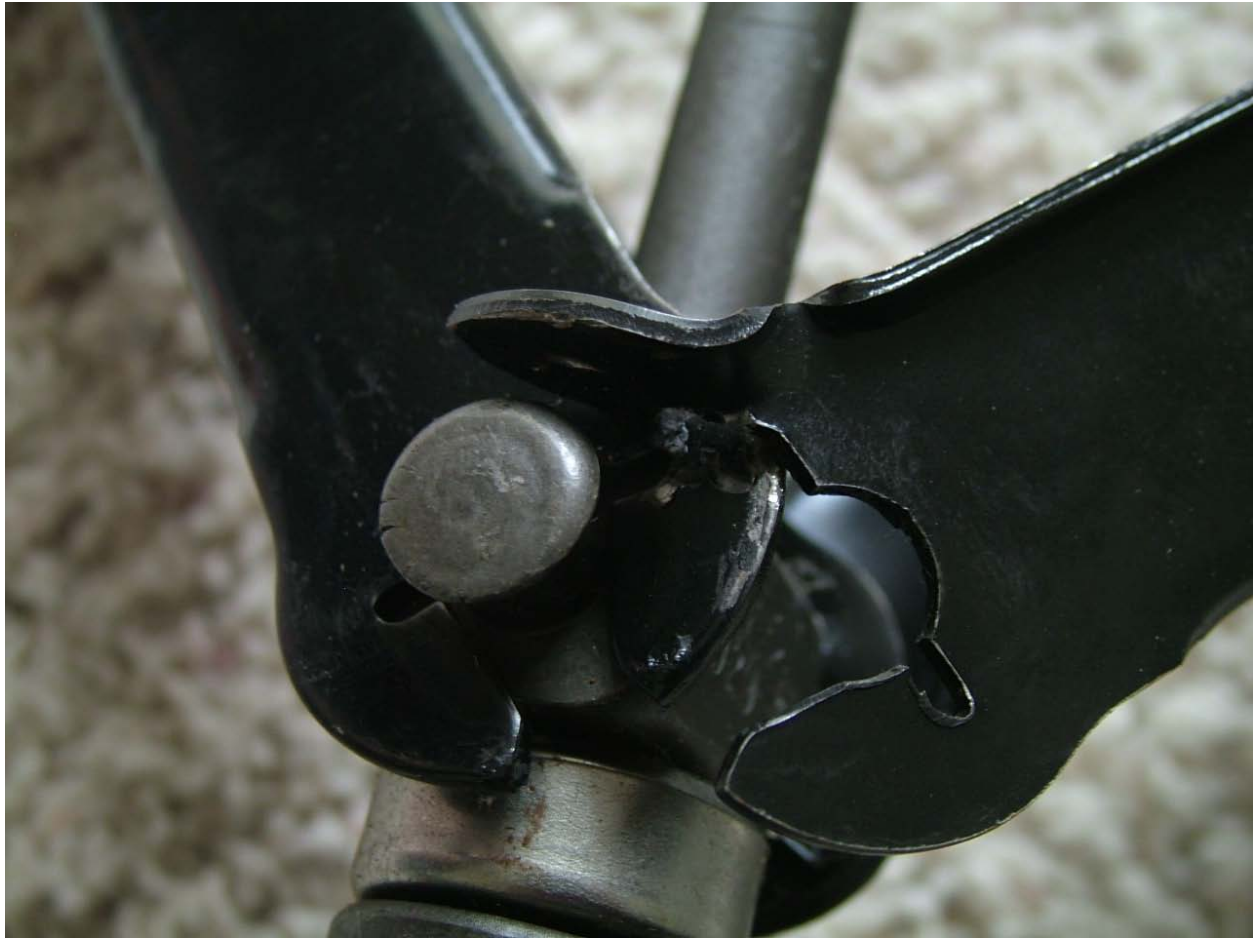
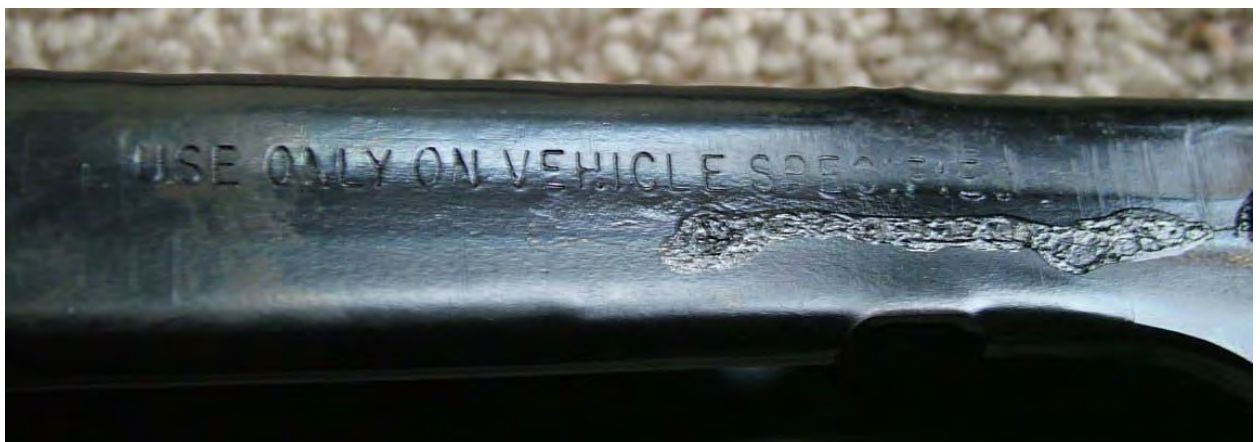
Photos of the failed jack are provided on the following pages. They document the method of failure as well as the original design of the jack. The jack was designed with slots, rather than holes, for the load-bearing pins that squeeze the ends of the jack together to raise the middle of the jack. This method of construction utilizes bending, rather than shearing, to prevent jack failure from side loading as occurred in this instance.
