National Highway Traffic Safety Administration

Vehicle Owner's Questionnaire
To Report Vehicle Safety Defects
1-888-DASH-2-DOT
(1-888-327-4236)
INTERNET:www.nhtsa.dot.gov/hotline

ORIGIN AND CAUSE INVESTIGATION:

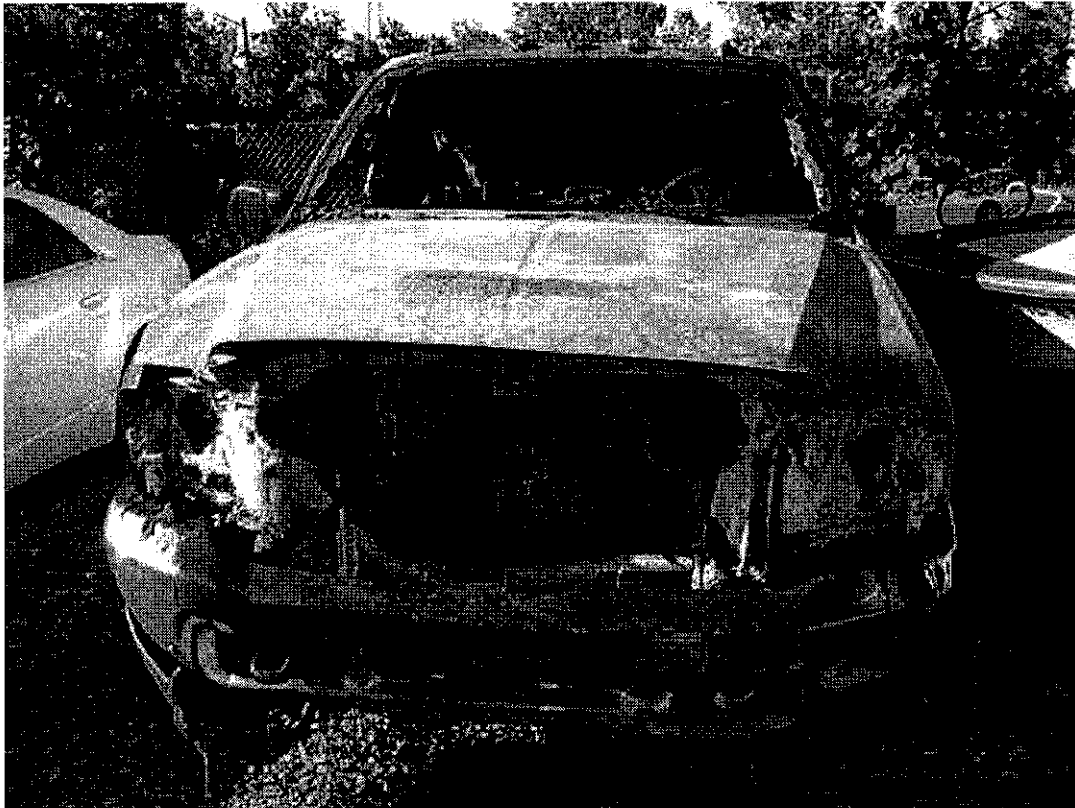
2. A view of the front of the vehicle.

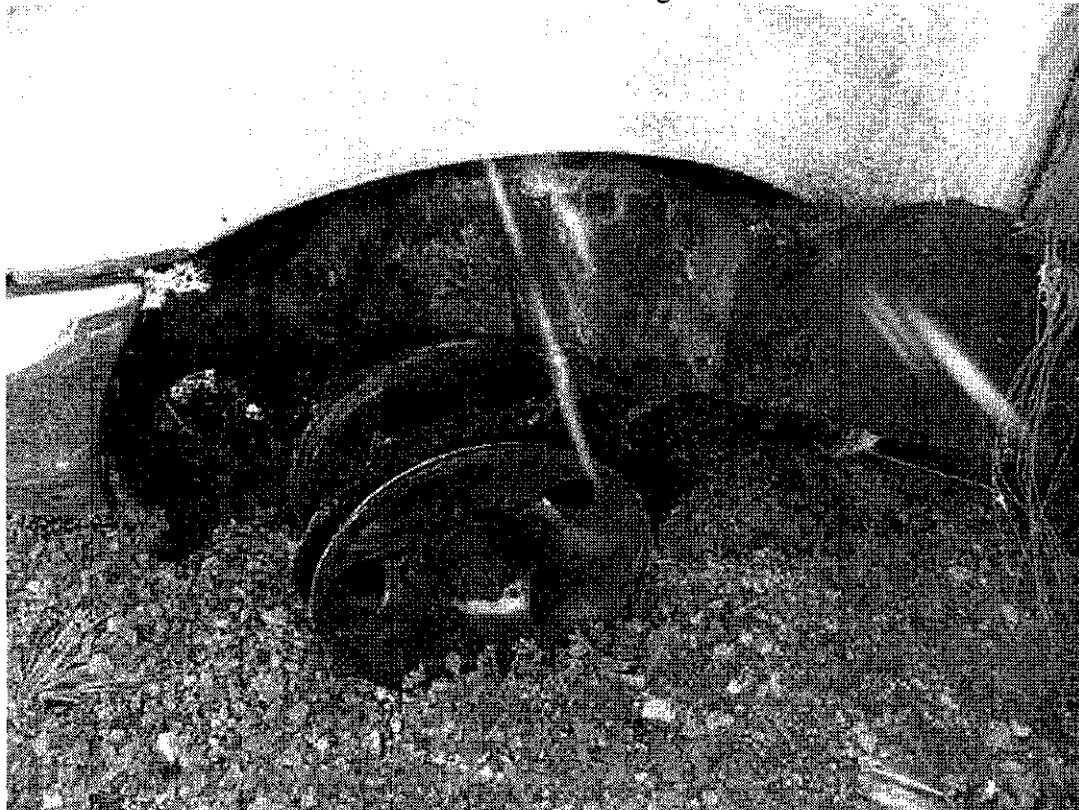
4. A view of the left front tire and wheel fire damaged.

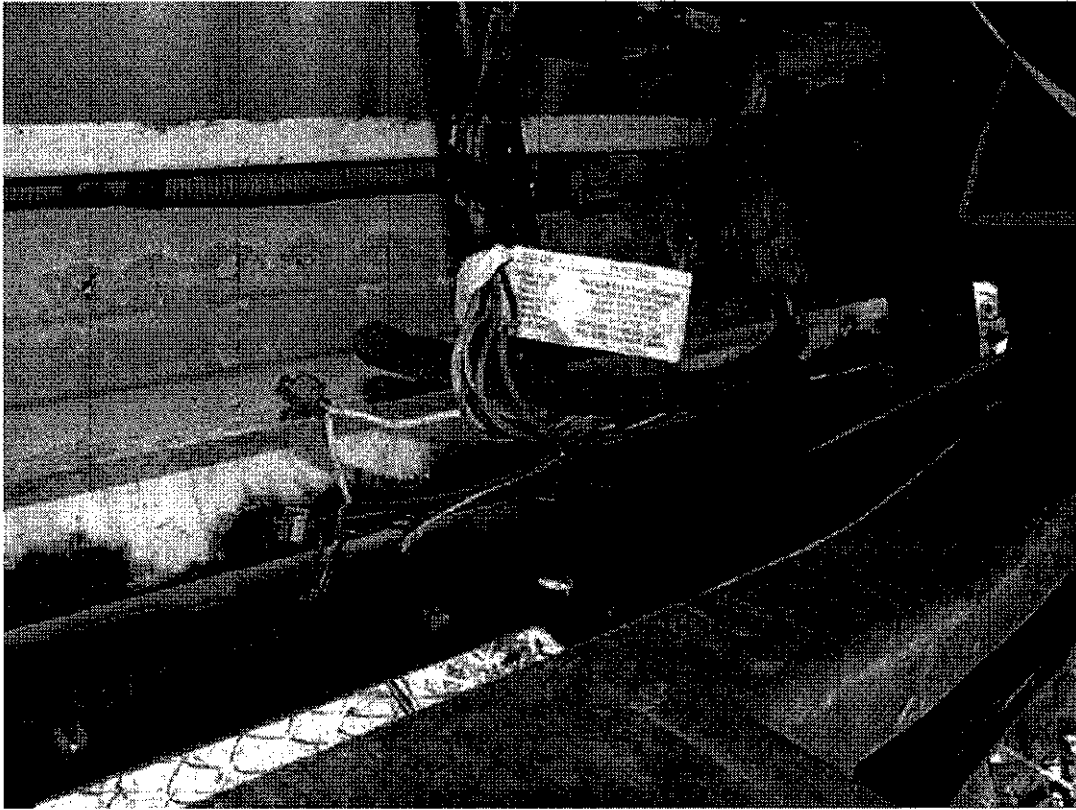
7. A view of the aftermarket wiring spliced into the factory trailer wiring.

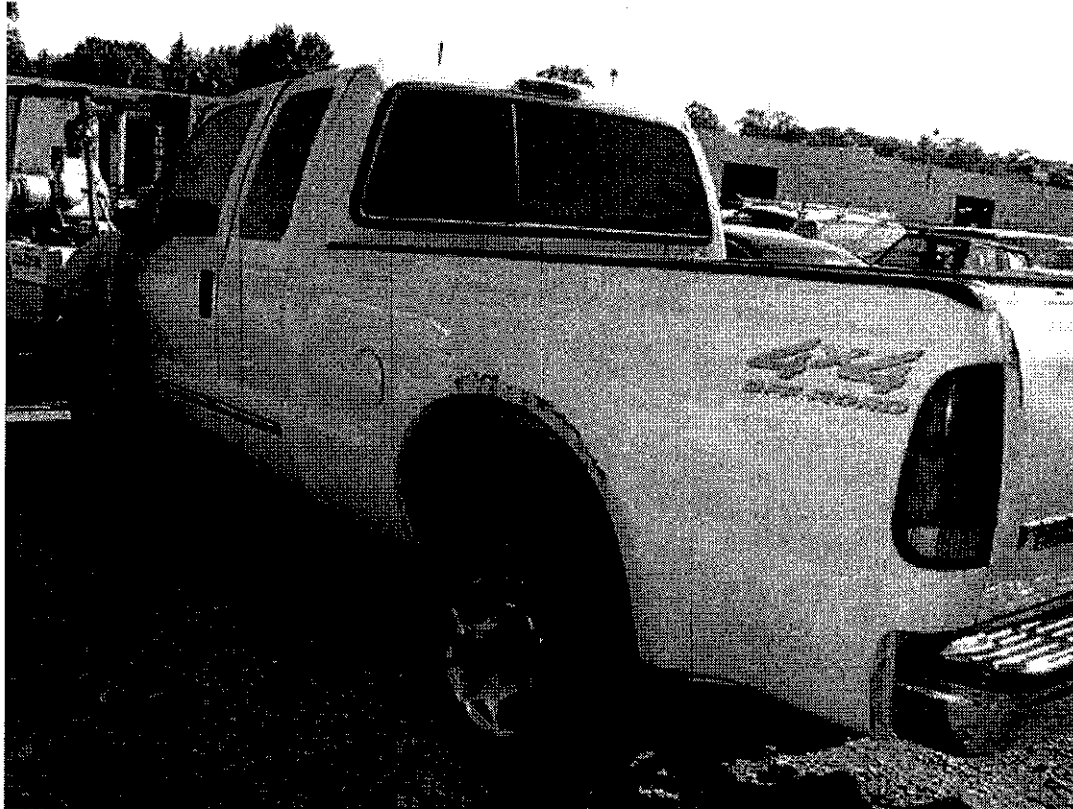
The examination is now focused to the fuel tank, fill tube, and fuel cap, where all are found to be intact and are free of any fuel leakage or fire origin. cursory inspection of the undercarriage reveals it is intact, however the spare tire is missing. The examination continues and is focused to the rear, where there is a trailer hitch and evidence of aftermarket wiring having been connected to the factory trailer wiring, however all of the wiring is intact and undamaged by fire.

14. A view of the fuel cap intact.

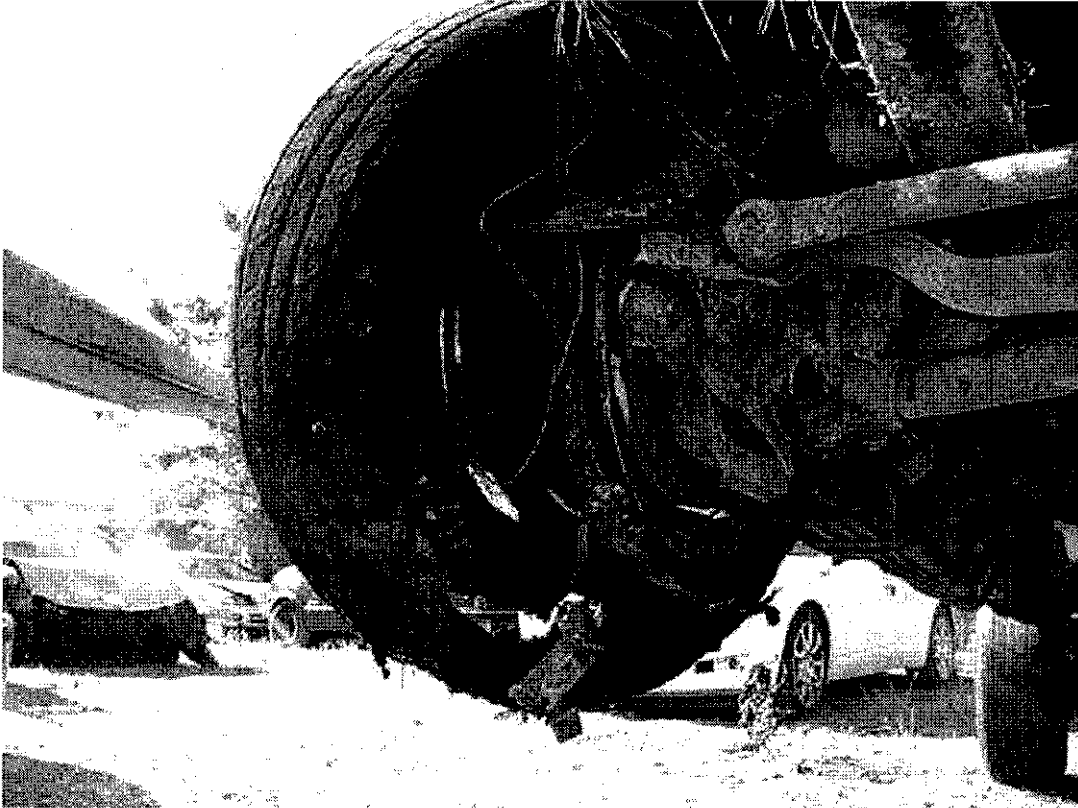
The inspection is focused to the right or passenger side, where the damage is much less pronounced to the right front tire versus the left or driver's side front tire. The examination of the battery in the right front reveals plastic casing and lead posts remaining and no evidence of any fire origin. Inspection of the battery cables reveal they are partially void of insulation but reveal no evidence of any electrical faulting or fire origin. Further, there is still wiring insulation intact on the positive cable traveling down to the starter.

17. A view of the inside of the right front tire.

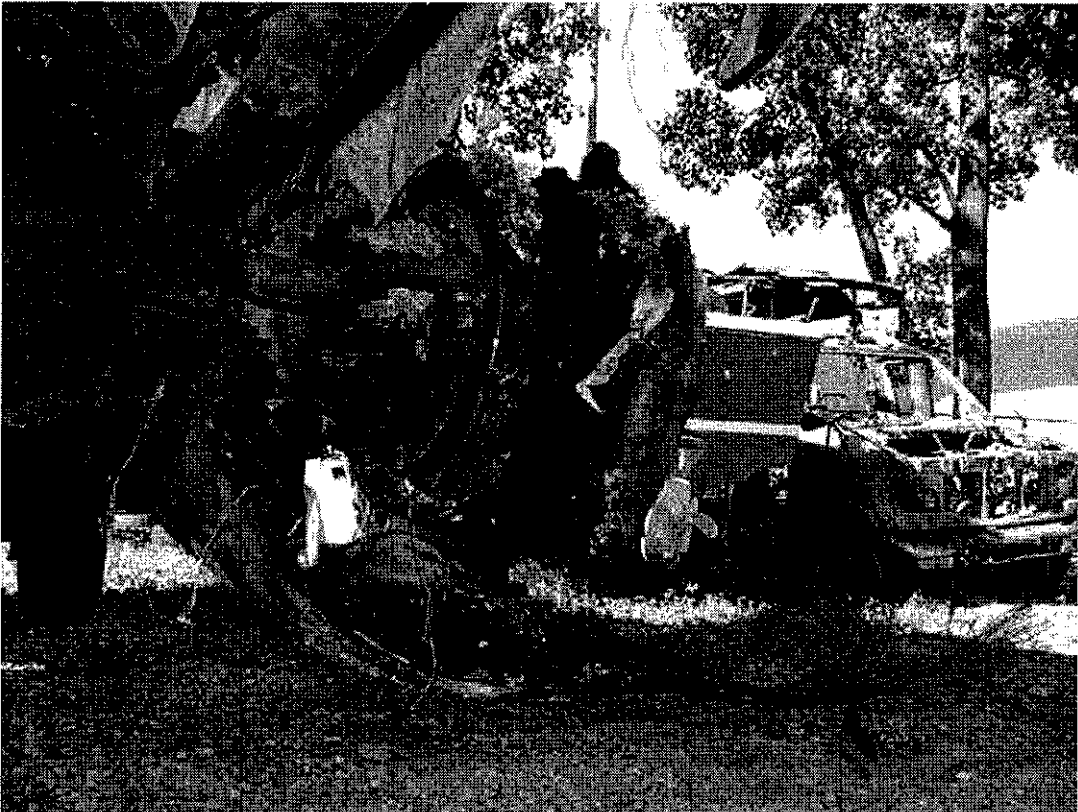
18. A view of the inside of the left front tire.

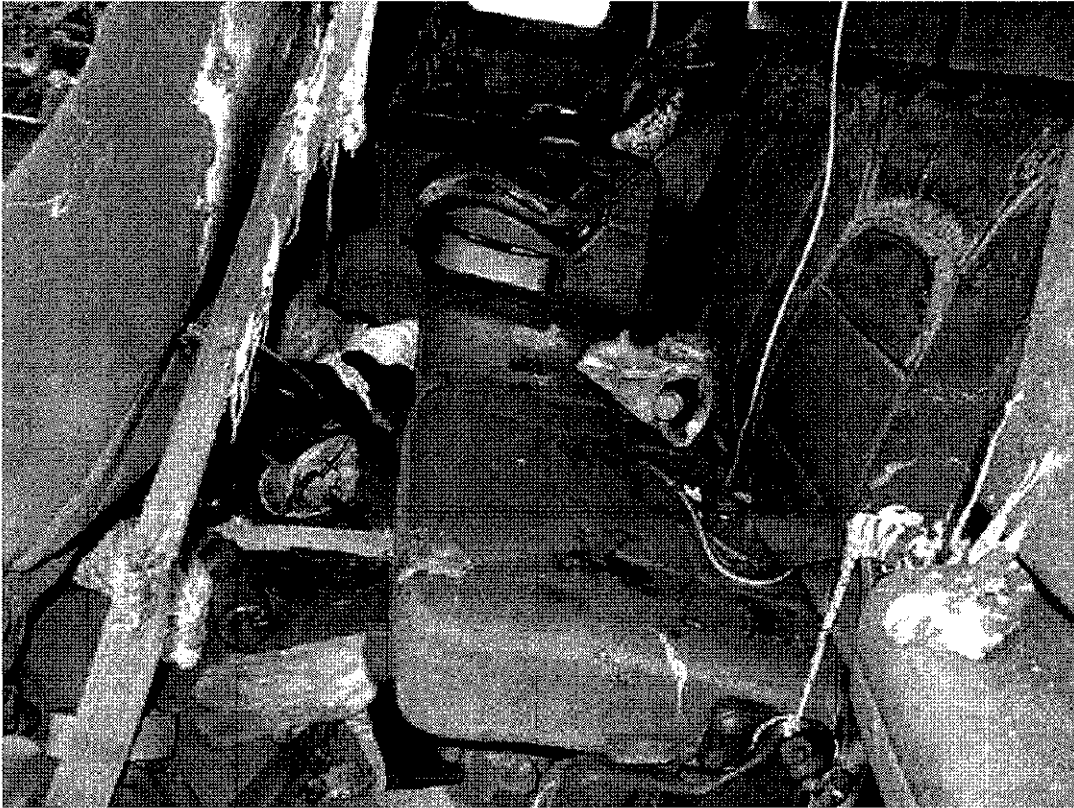
The inspection continues and is focused to the seating, where there is high burning noted to the rear seat where there is a child seat on the passenger side. Inspection further reveals high burning to the front seats, drop down is noted on the bottom seat cushions but no evidence of any fire origin. Inspection of the flooring reveals the carpeting still intact, there are baseball caps, rolls of tape, water bottles, towels, an umbrella, and papers noted, but no evidence of any fire origin. Further inspection of the passenger floor area reveals the remains of the glove box door which has melted and fallen into the floor area during the course of the fire.

21. A view of the rear passenger compartment from the driver's side.

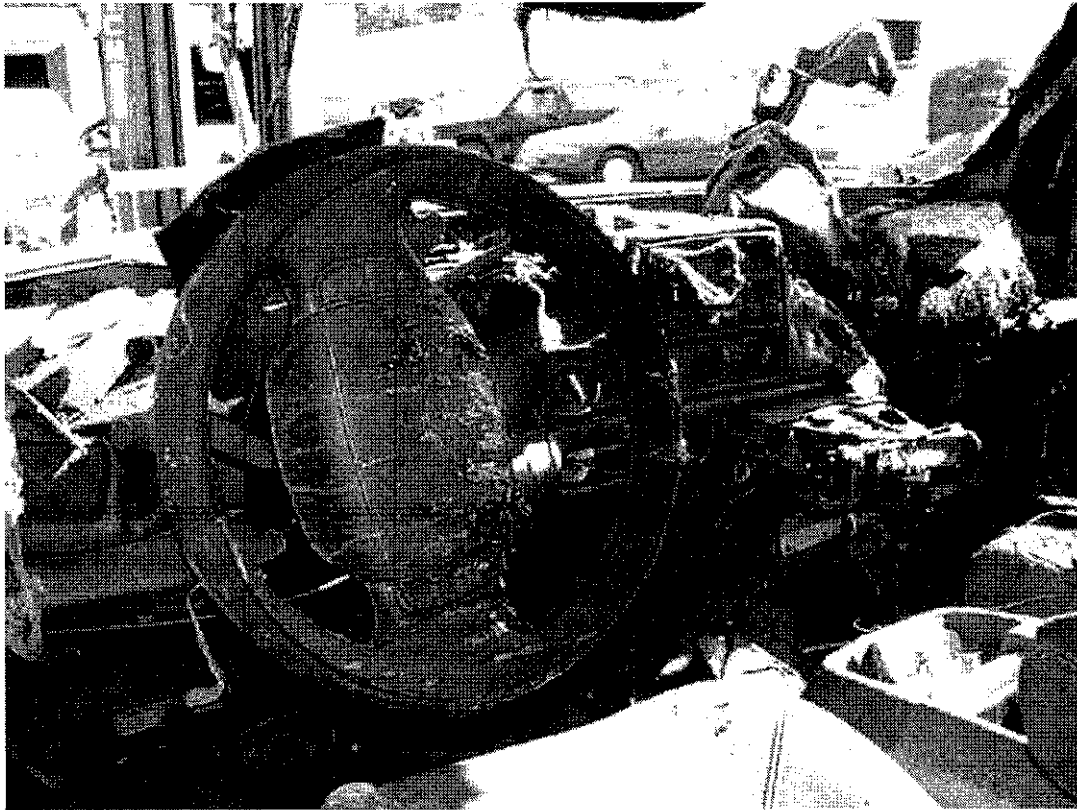
At this time the investigation is focused to the dashboard, where there is exposure fire damage extending from the engine compartment with much of the combustible dashboard panel remaining on the side closest the driver and passenger. Inspection reveals exposure fire damage within the dashboard and to the associated wiring, where the fire has extended through openings in the bulkhead on the right or passenger side. At this time having completed an inspection of the cab area to include the dashboard, no evidence of any fire origin is found.

23. A view of the dashboard from the driver's side.

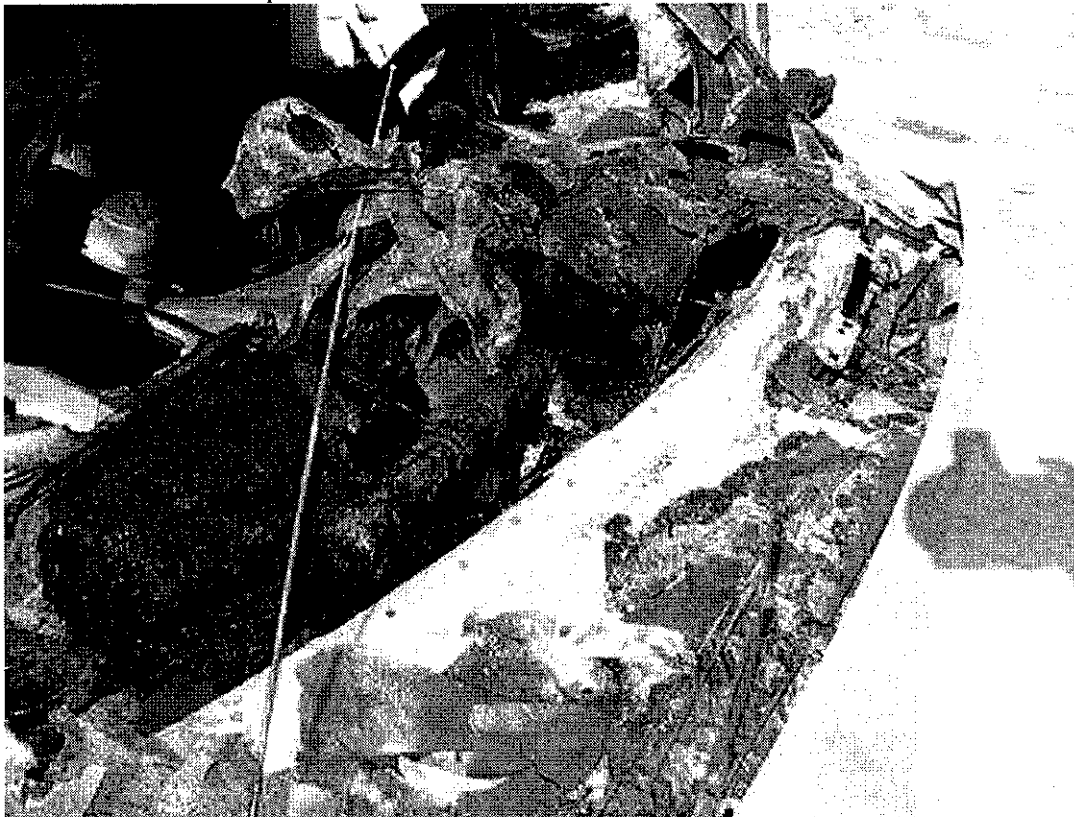
The upper portion of the engine on the driver side of the vehicle sustained the most extensive damage. This included the cowl and hood.

26. A view of the top of the dashboard and cowl area.

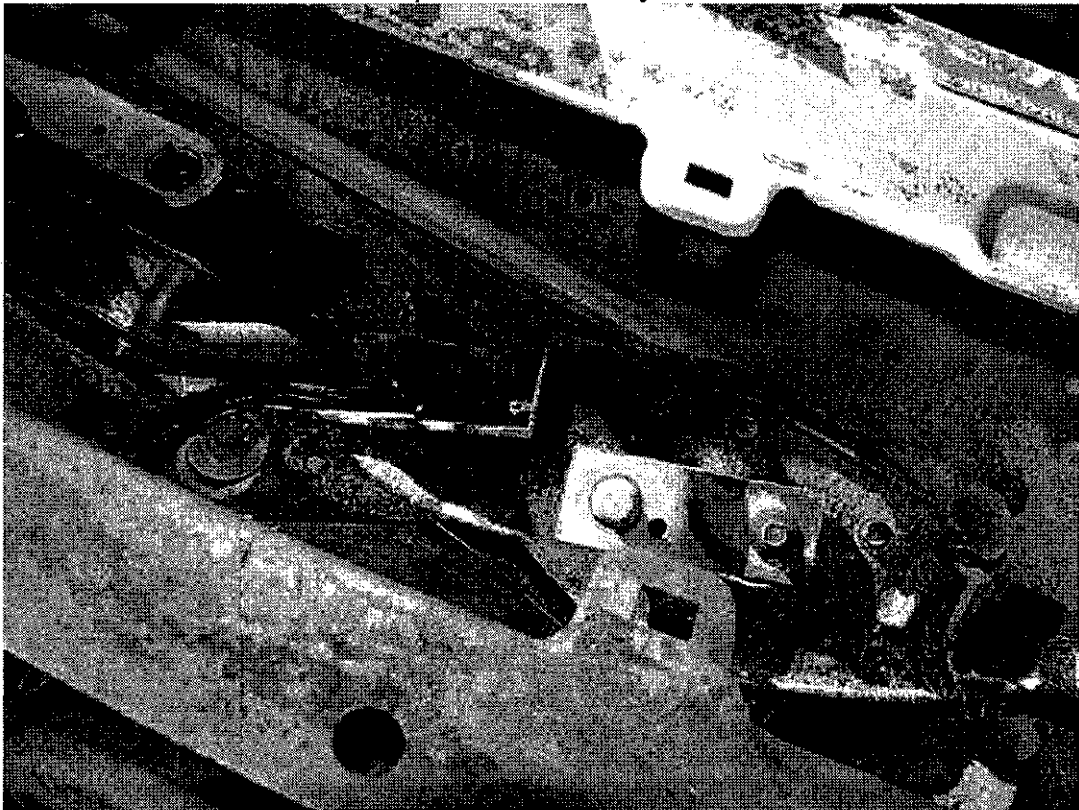
35. A view of the battery and battery cables in the right front.

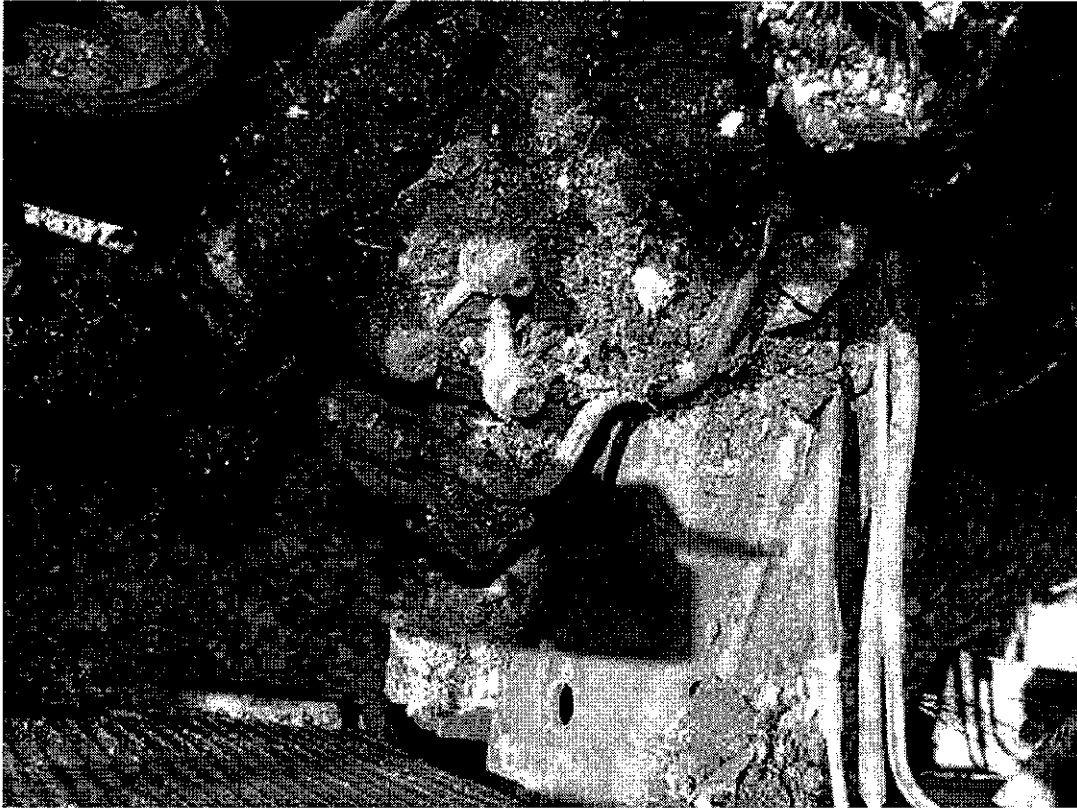
39. A view of the power steering cooler hoses fire damaged in the left front.

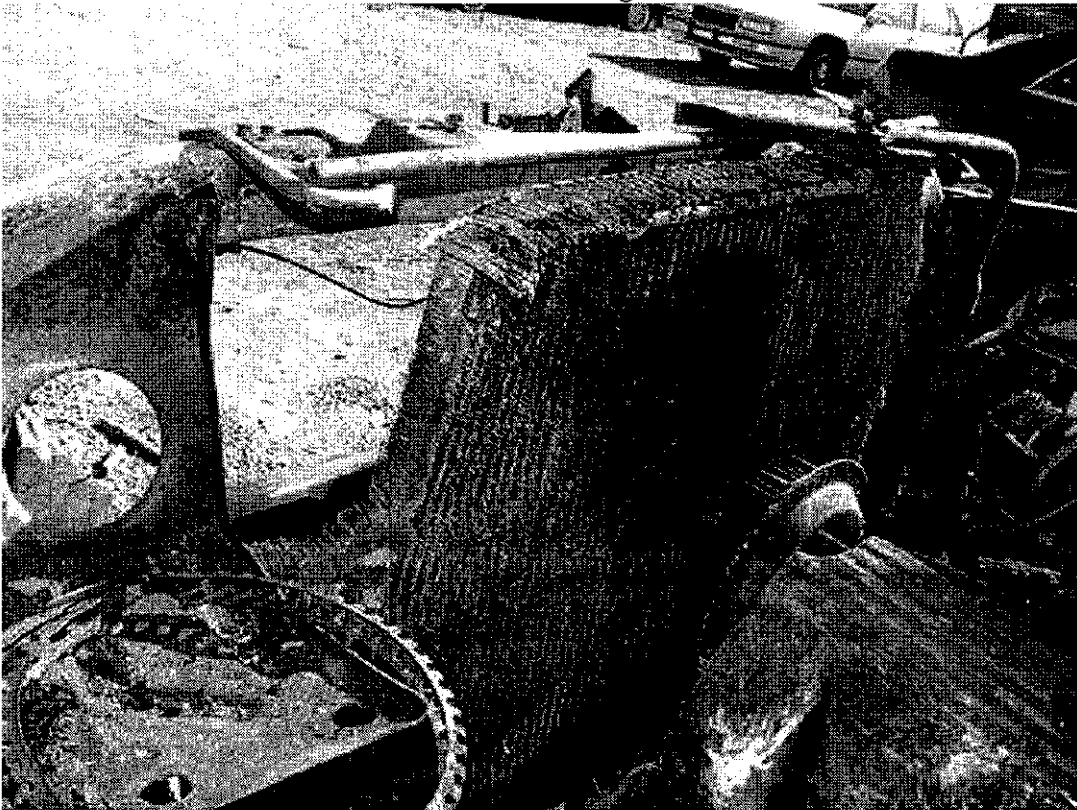
The examination is now focused to the radiator and air conditioning condenser, where melting is noted to the air conditioning condenser and melting is noted to the inside of the radiator, most pronounced on the left or driver's side and is high in nature. The examination continues and the front lower section of the engine compartment reveals the remains of combustible transmission cooler hoses, lower radiator hose and combustible power steering cooler hoses and no evidence of any fire origin.

40. A view of the inside of the radiator fire damaged.

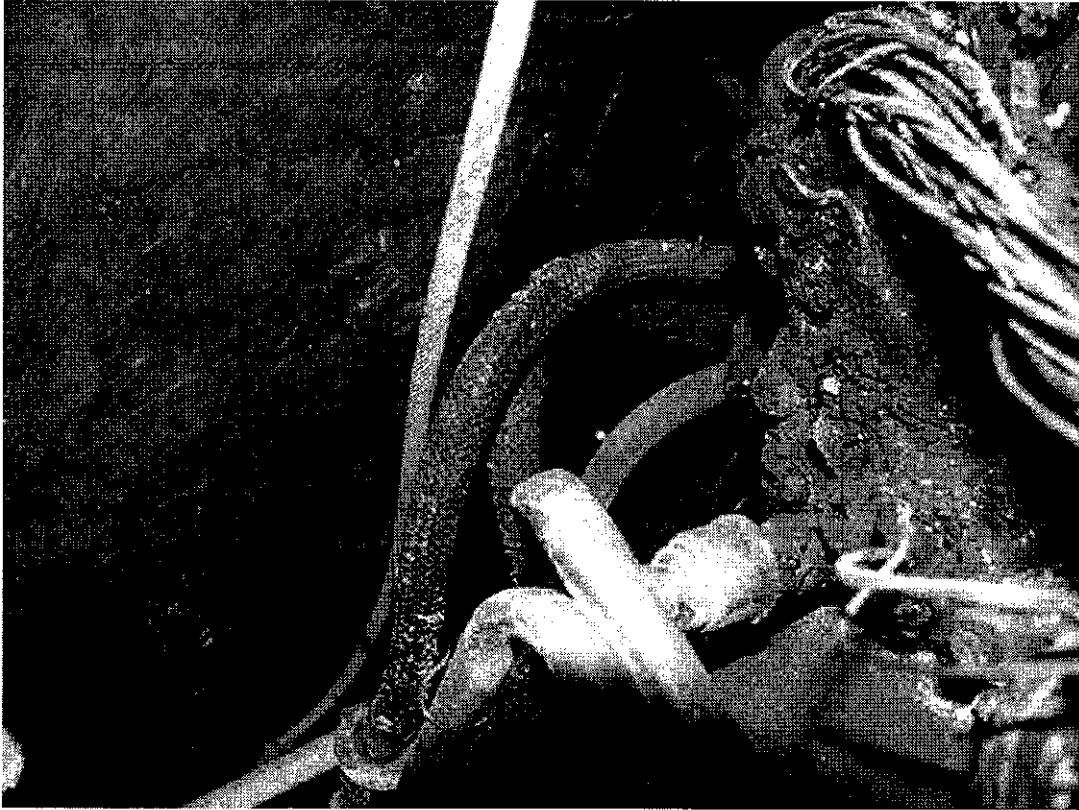
The investigation is focused to the top of the engine, where there are still combustible hoses remaining and combustibles in the area of the coil packs. Inspection of the fuel rails reveal combustibles remaining and the fuel lines still connected to the fuel rails at the rear, and no evidence of any fire origin due to fuel leakage.

41. A view of the fuel lines and connections at the rear of the engine.

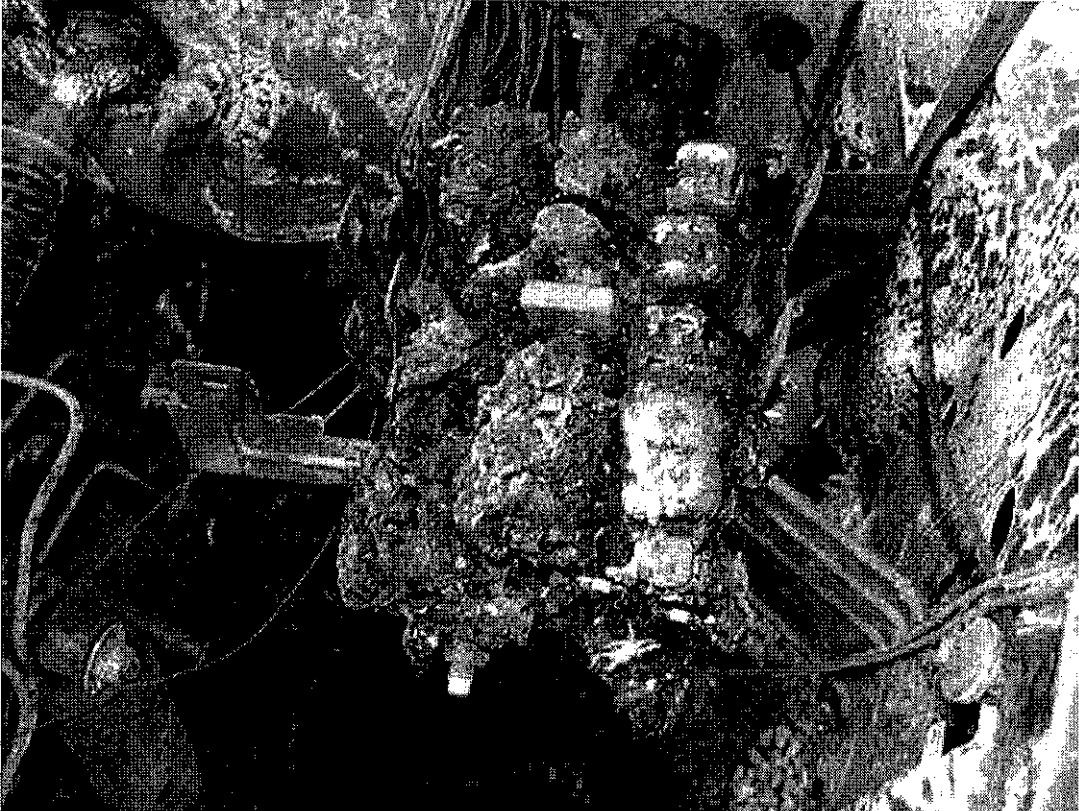
include the main lead traveling to the fuse relay center, but there is no evidence of any electrical faulting. Inspection of the fuse relay center reveals charred combustibles remaining and no evidence of any fire origin. Further inspection of the windshield wiper motor at the cowl reveals exposure fire damage and no evidence of any fire origin within this area.

42. A view of the fuse relay center on the left or driver's side.

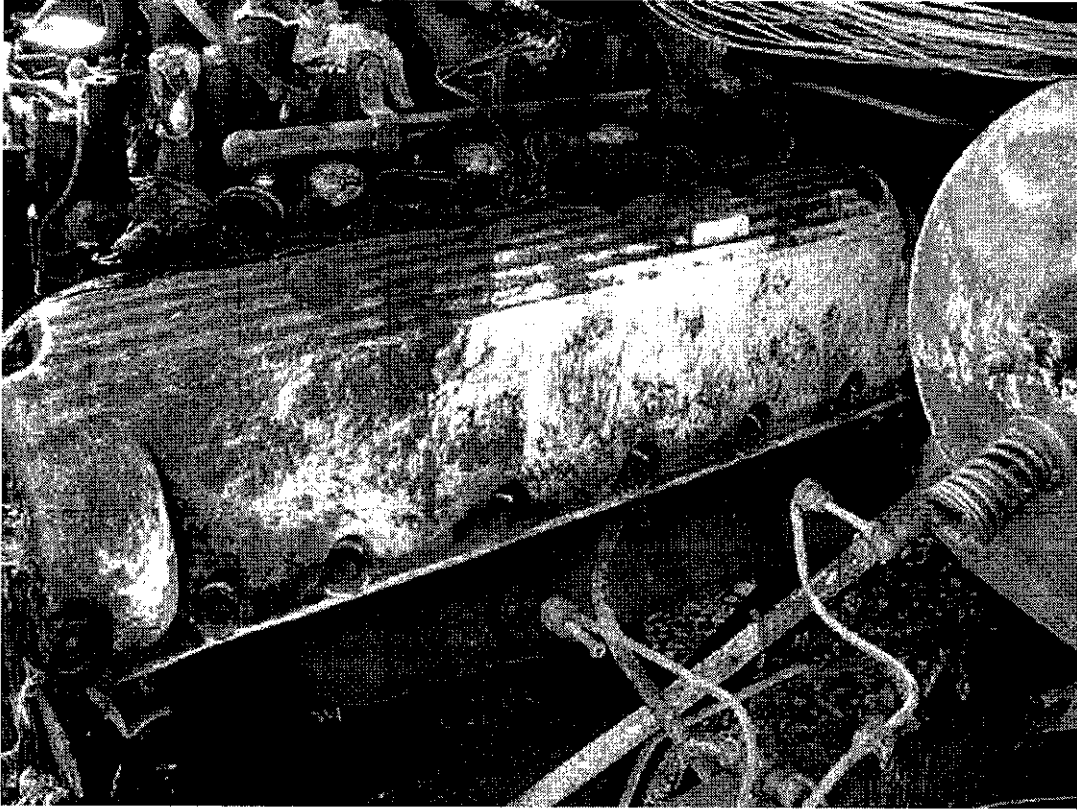
The valve cover on the driver side showed significantly more flame impingement damage than the passenger side valve cover

45. A view of the left valve cover.

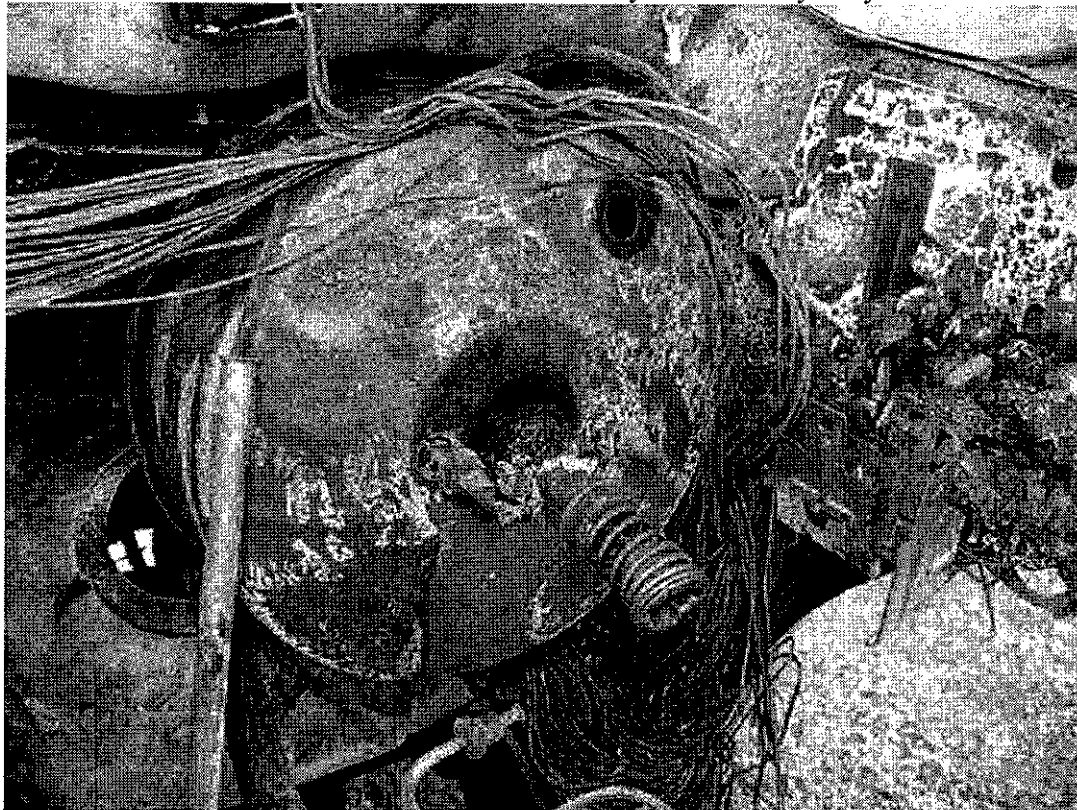
The examination is now focused to the brake booster. Inspection reveals the paint has been consumed and the alloy master cylinder has been almost totally consumed by the fire, with the steel brake lines having melted out of same. Upon searching the suspension components and undercarriage, no remains of the vehicle speed control deactivation switch can be found. The examination is now focused to the valve covers, where the fire damage to the driver's side valve cover, coupled with the fire damage to the inside of the driver's front tire, is all consistent with the fire having originated within the engine compartment on the driver's side in the immediate area of the master cylinder.

Having completed an examination of the vehicle, reviewed an interview obtained from [REDACTED] and [REDACTED] who last operated and discovered the fire, conducted research pertaining to the vehicle, and based upon all of the information known at the time of the preparation of this report, it is the opinion of this Investigator that the fire originated within the left or driver's side rear of the engine compartment, in the immediate area of the master cylinder and brake fluid reservoir, with the fire extending upward and outward from this location causing the damage present. The fire is classified as an accidental fire, electrical in nature. It should be noted that the speed control deactivation switch is located within this area and has been recalled due to the potential for an engine compartment fire and the fire is consistent with this recall. Further, the recall is open/has not been satisfied on this vehicle.

48. A view of the brake booster with the master cylinder destroyed by the fire.
