Vehicle Owner's Questionnaire To Report Vehicle Safety Defects

Make KEYSTONE

Model SPRINTER

Vehicle Component Code: 161000 STRUCTURE: FRAME AND MEMBERS

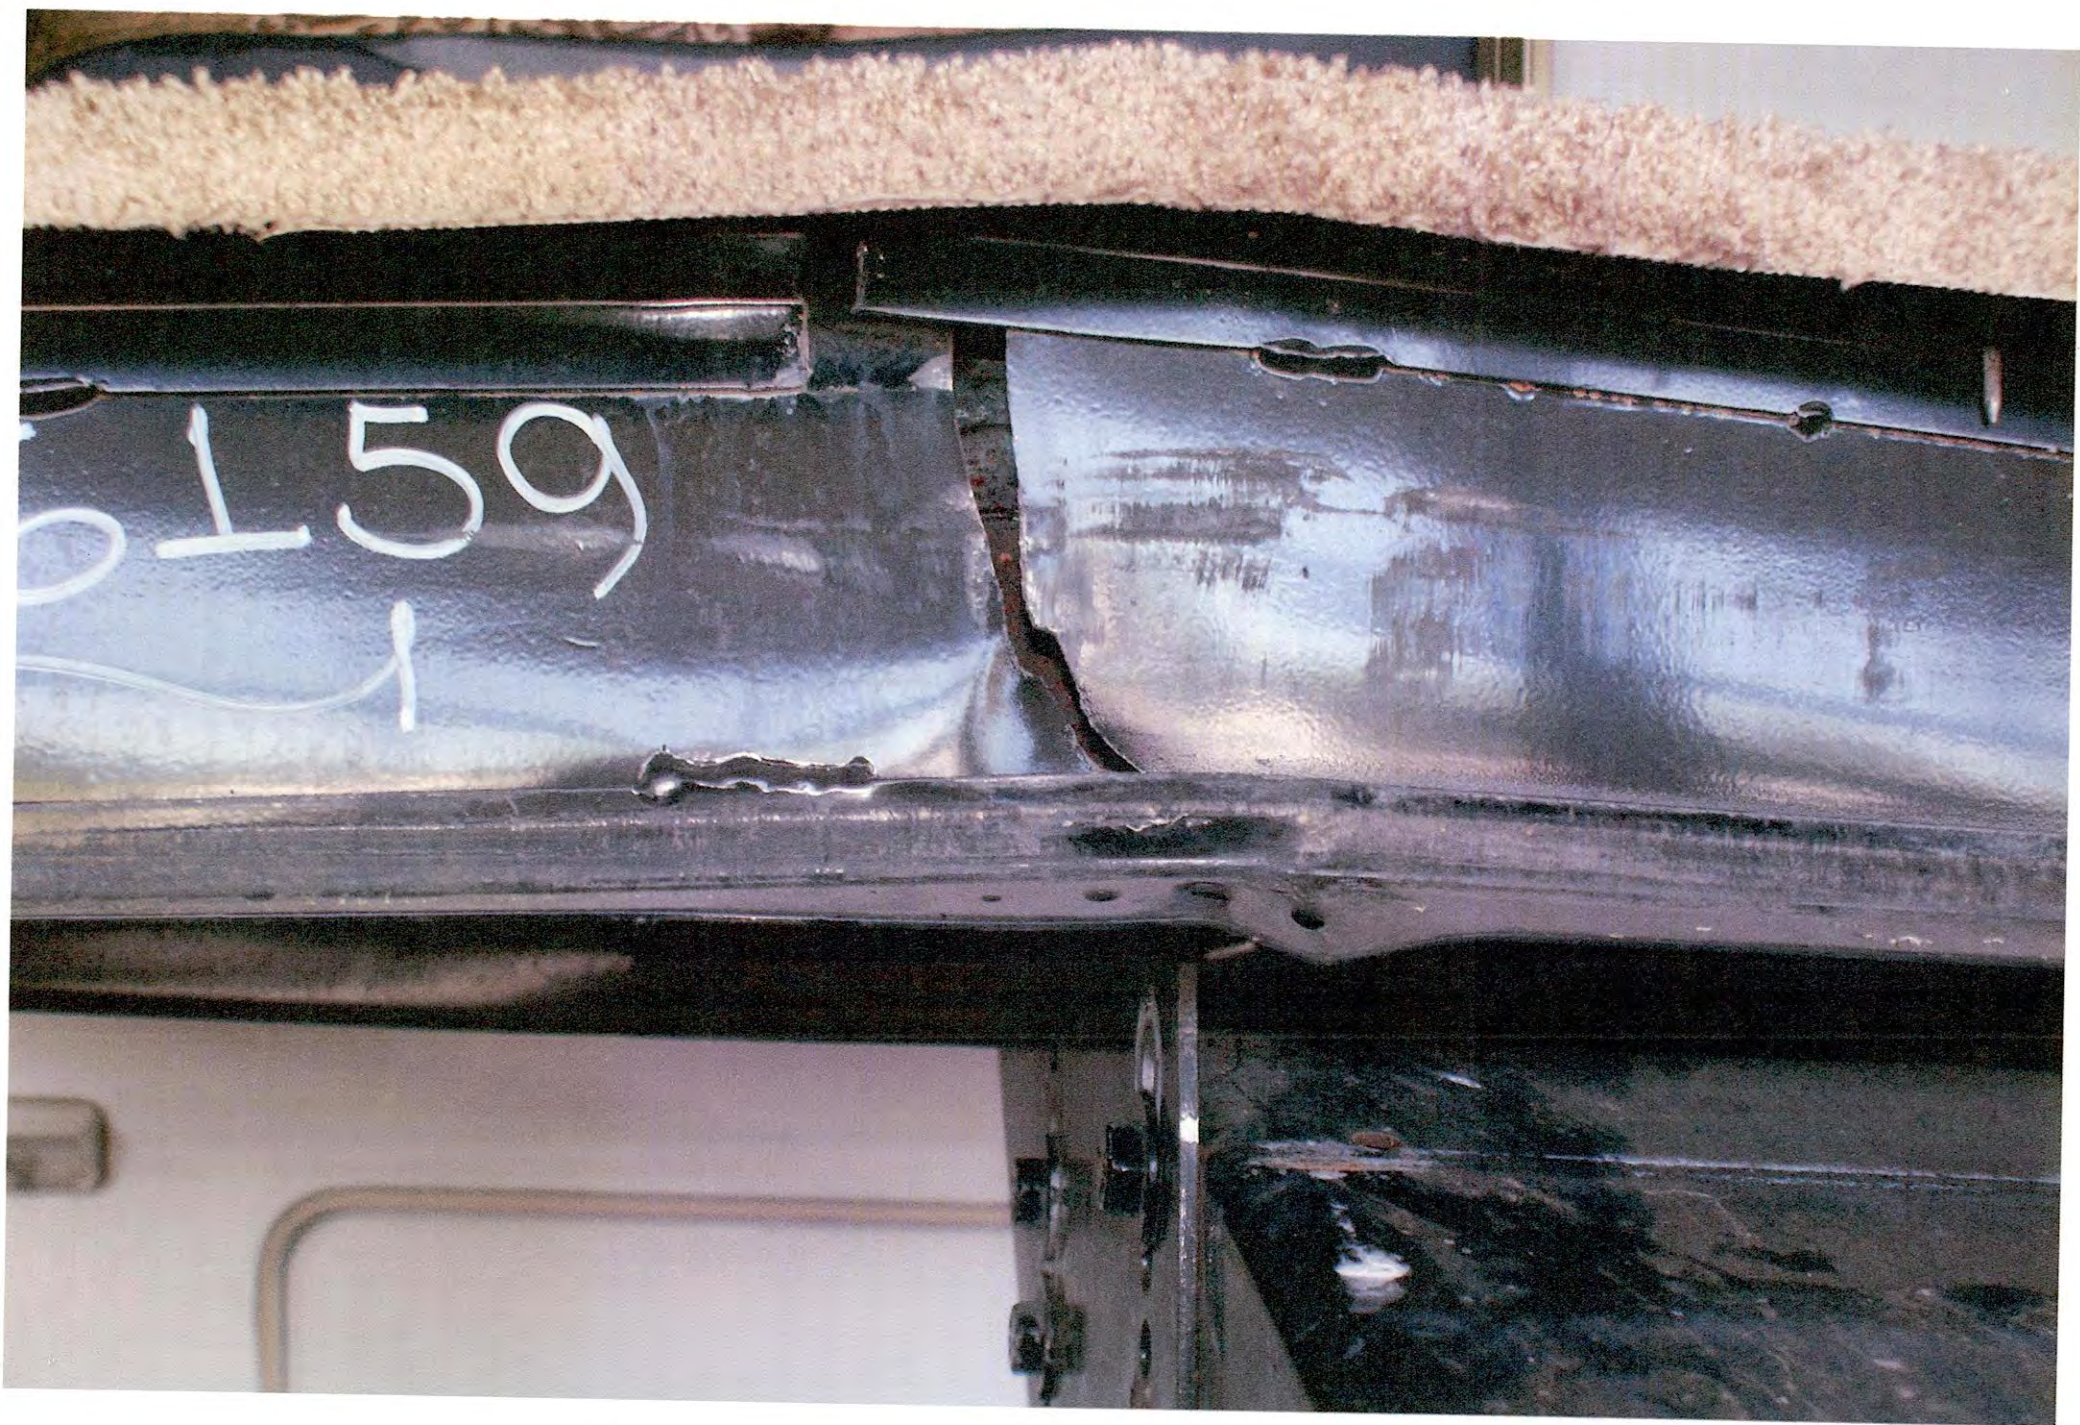
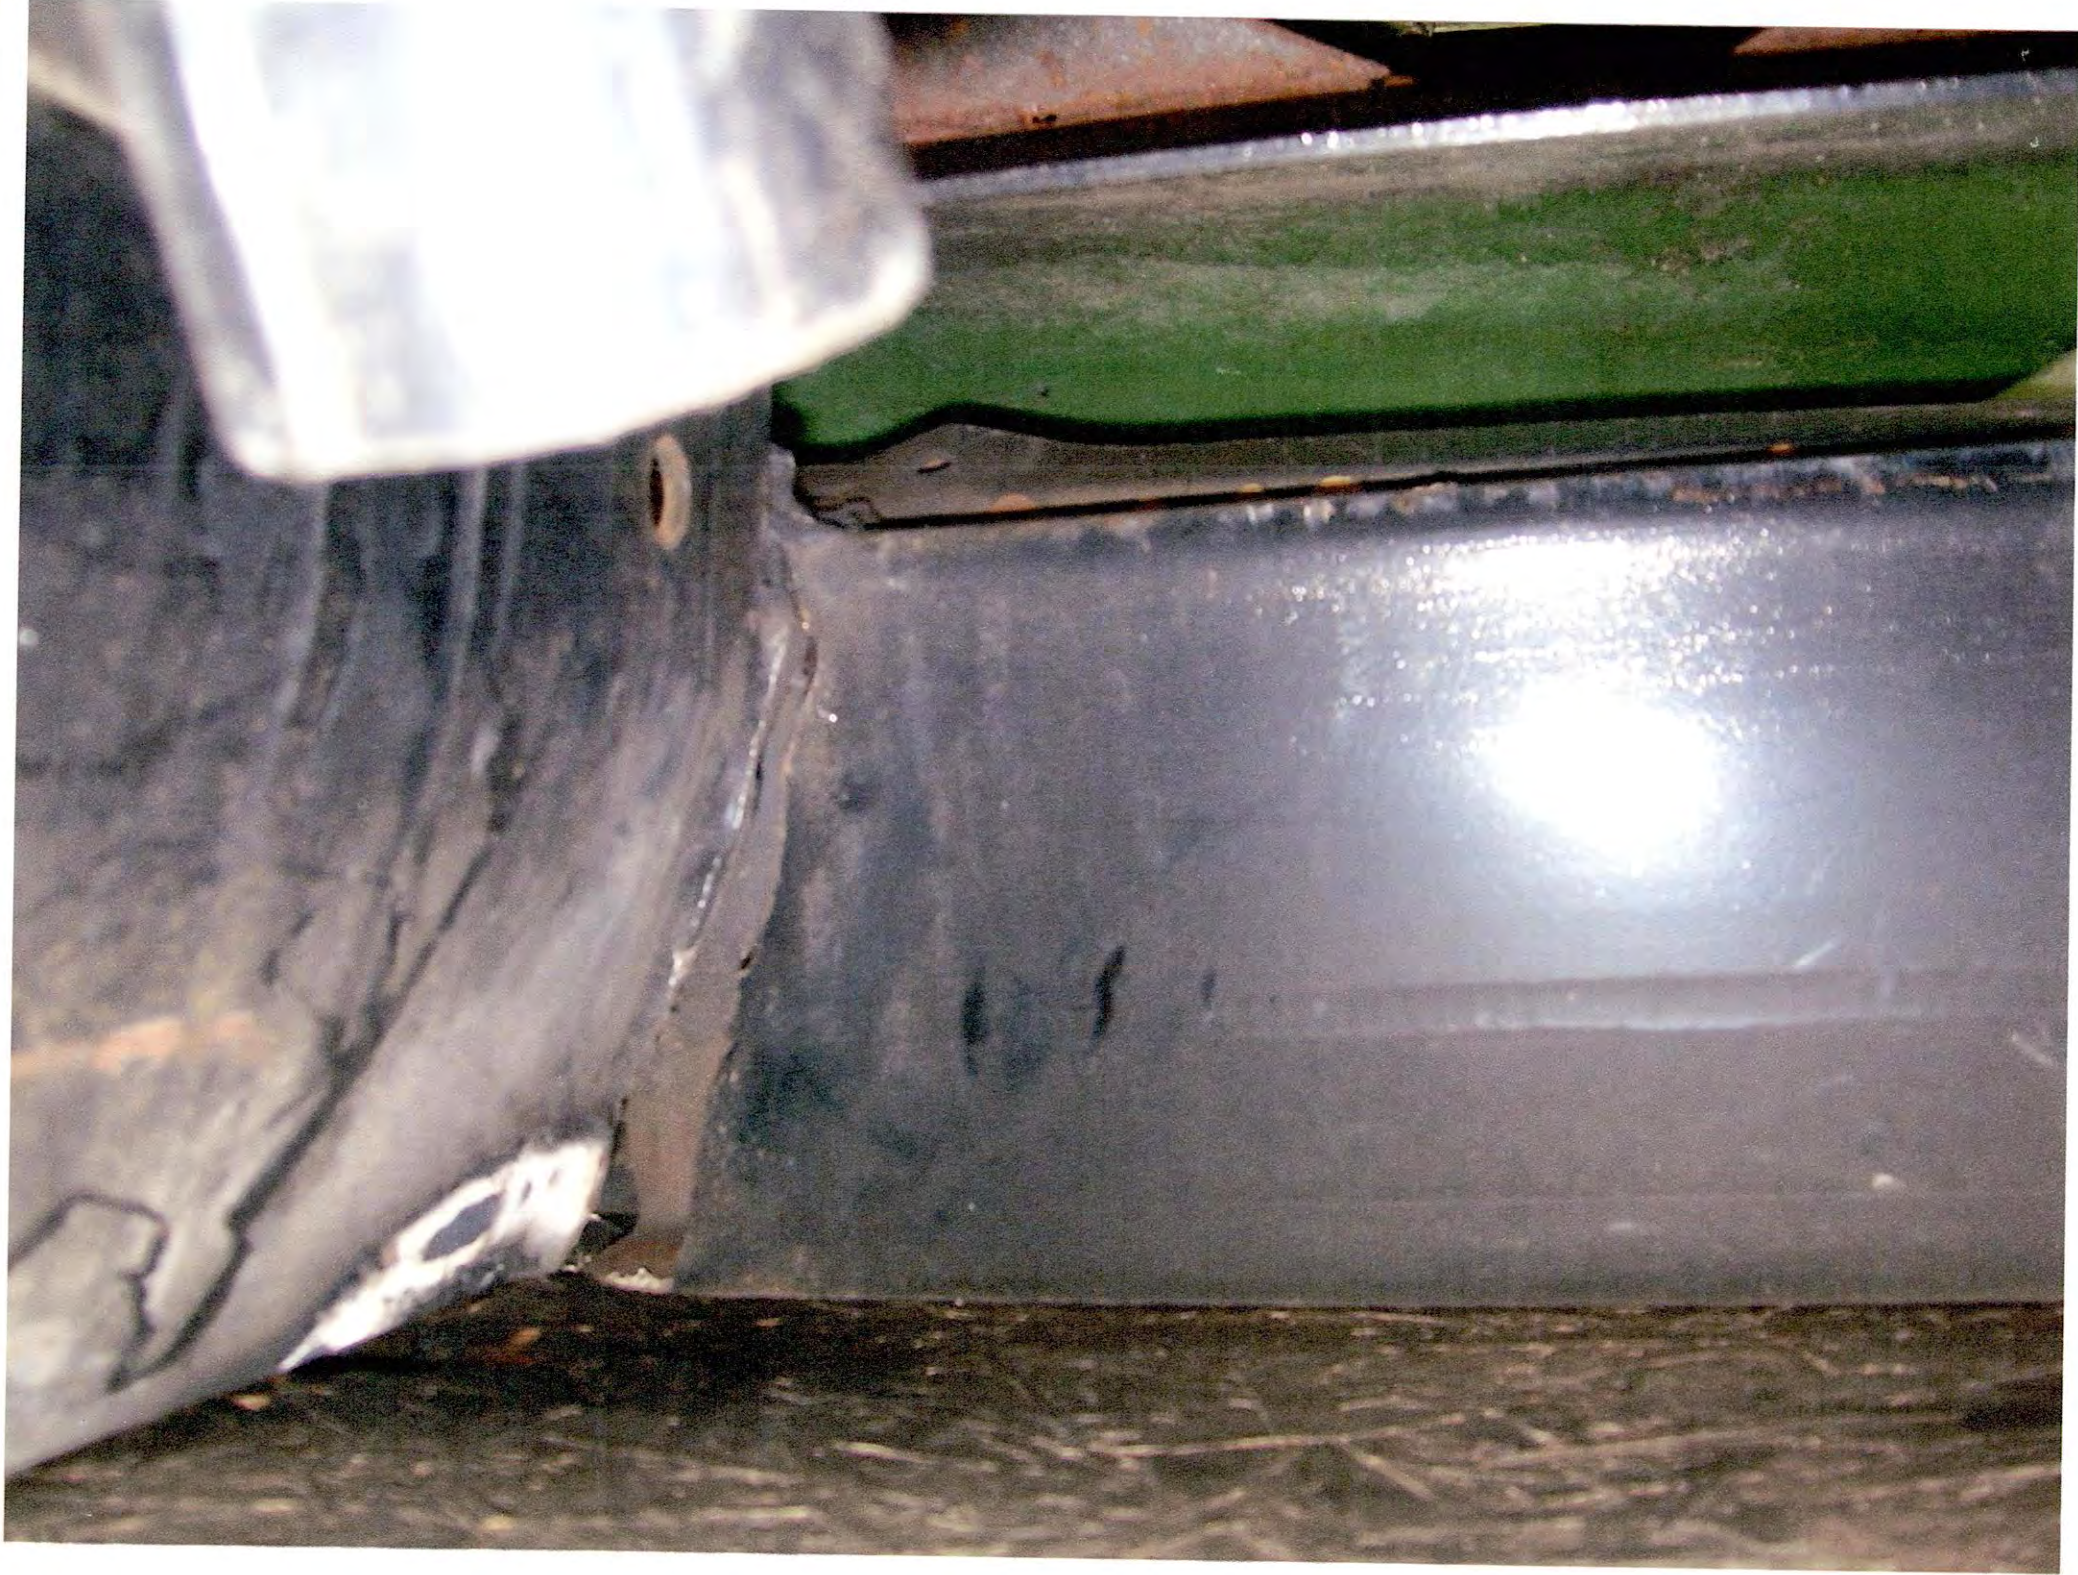
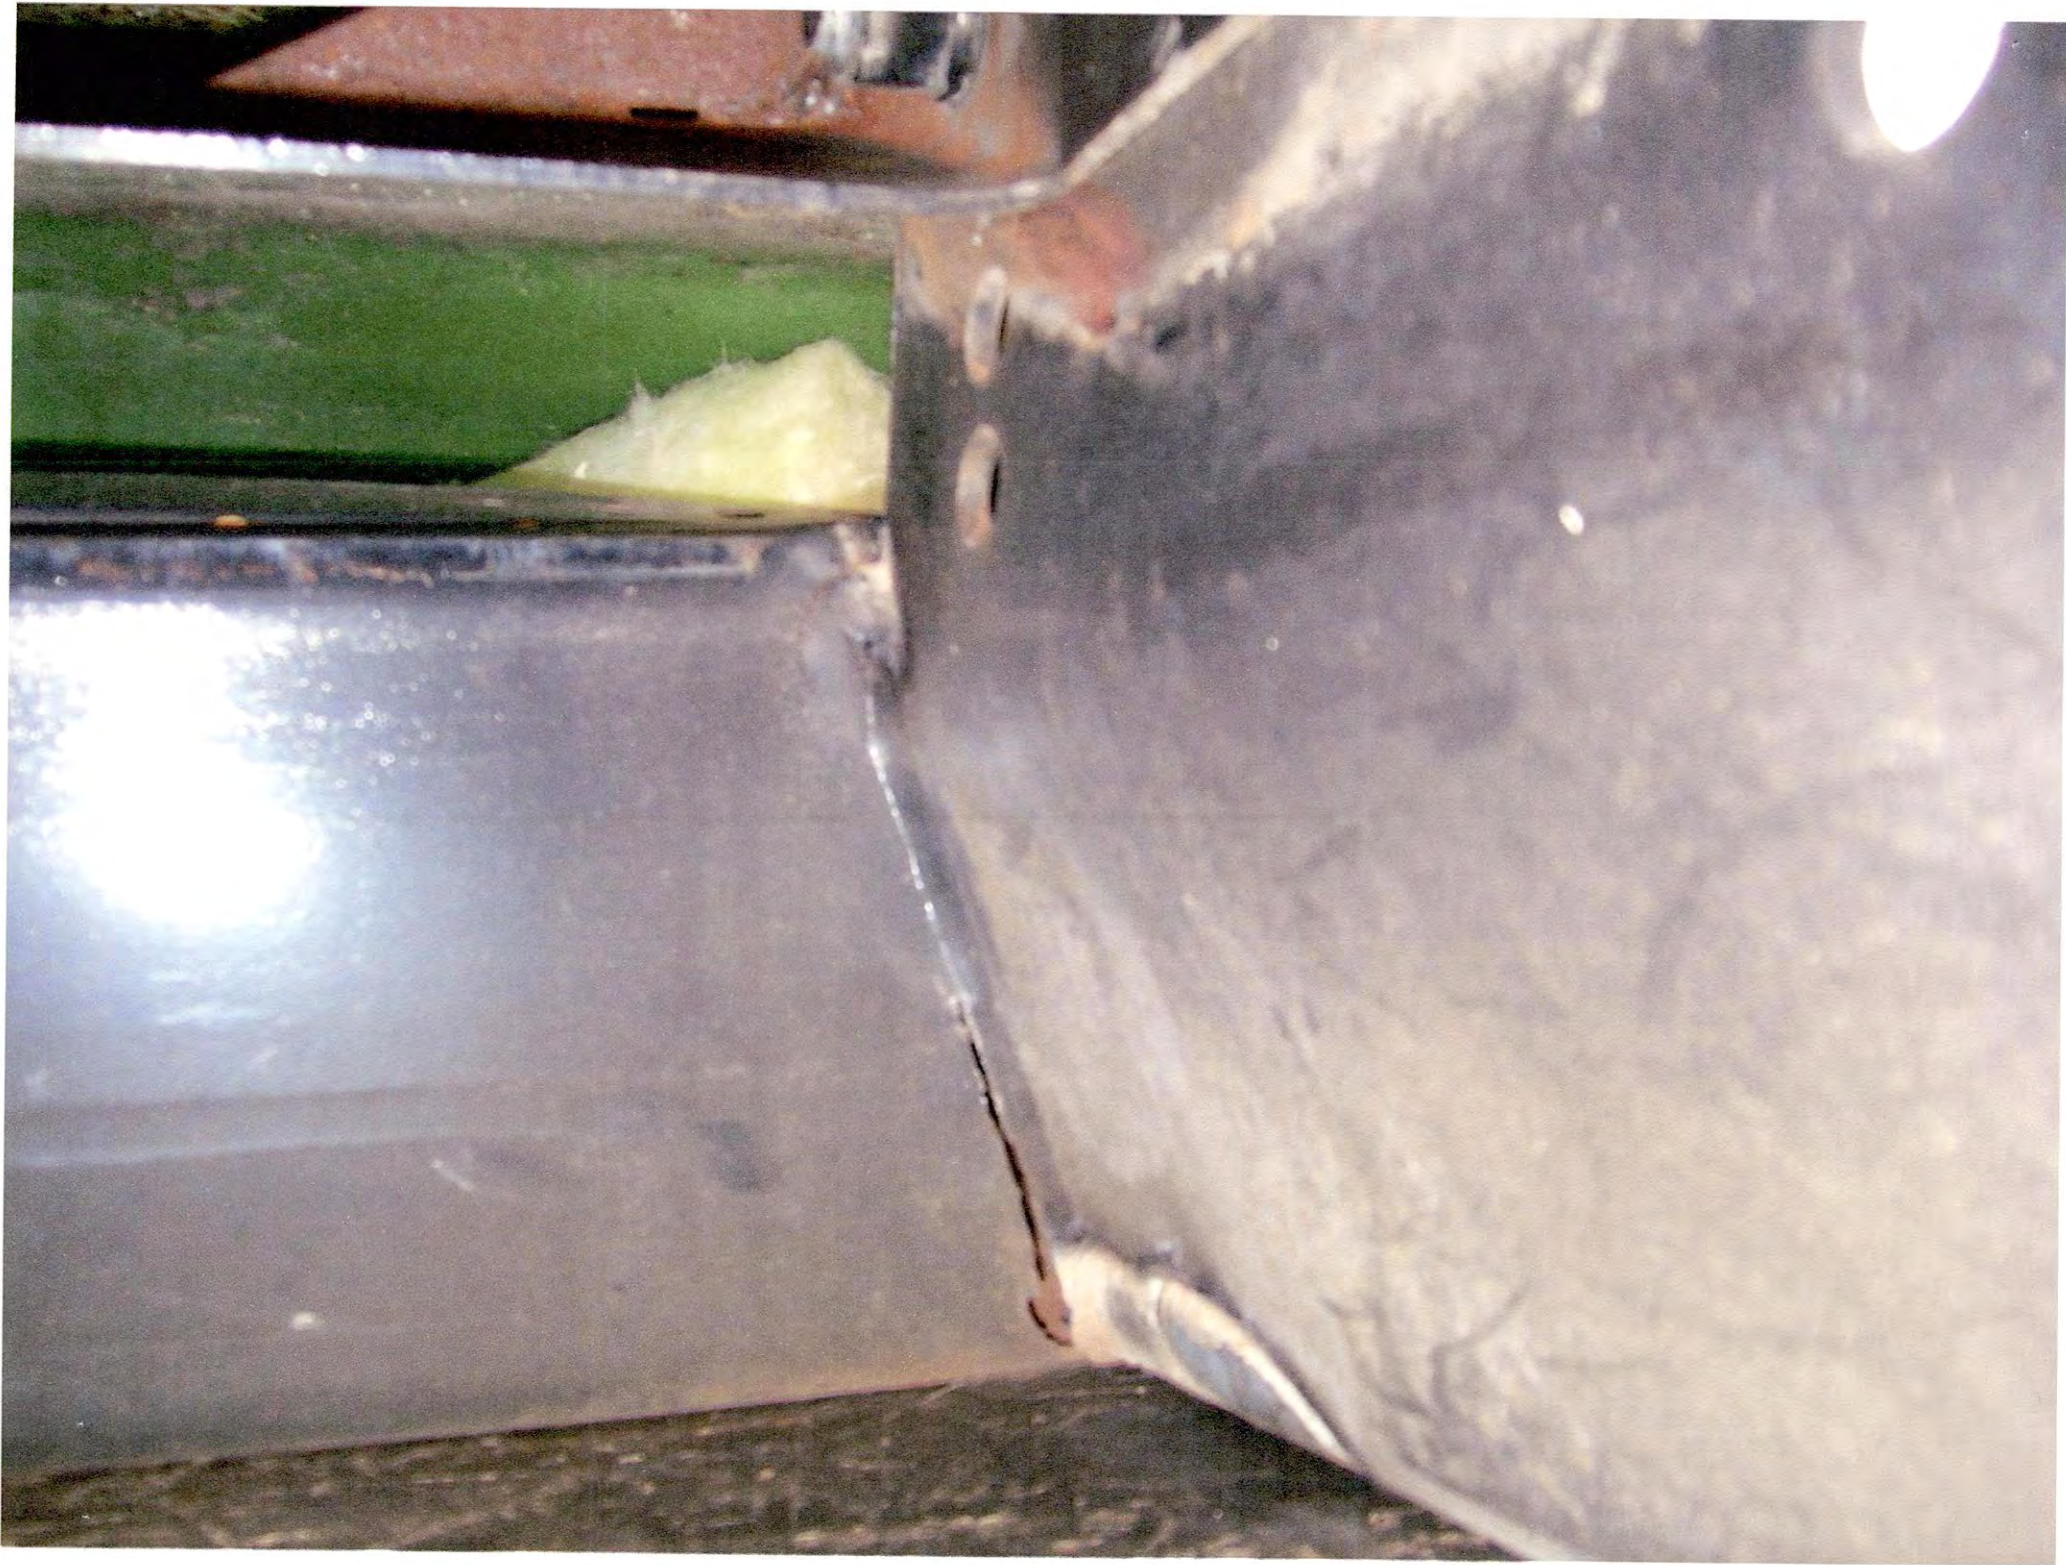
The front beam was bent up into the front closet. The Box and King Pin was only holding by about 2 inches and almost broke off the 5th wheel which caused the 5th wheel to hit the truck. we were told to have the beam replaced with 4 gage tube. they had 11 gage in it which was not strong enough.

Pictures of the beams. If it would of come off we could of killed someone or even ourselves. It was not the right gage tube.

The customers are in transit/visiting our area and the trailer is not towable. The front pin box framing is bent and split on both sides at the front framing above the pin box.

It has twisted the pin box and framing front and rear of the pin box. They had a shop weld and repair the framing so the could continue to travel but it split again. The truck they tow with is a 1 ton dodge stock height 2 wheel drive and the hitch and pin box are installed proper. We are hoping you can help with this repair for the customer as a structural warranty. I would also like too know the parts/material information we will need to complete the repair, and how soon we would be able to get the parts here. The pin box is also twisted and cracked at the mounting holes, would we get this from Lippert as well?
