| <b>Vehicle Owner's Questionnaire</b><br>To Report Vehicle Safety Defects<br>1-888-DASH-2-DOT (1-888-327-4236)<br>INTERNET: www.nhtsa.dot.gov/hotline | | | | |
| 1FMZU73E42Z | | FORD | EXPLORER | 2002 |

**GEAR SELECTOR LEVER - INCREASED EFFORT TO SHIFT FROM DRIVE TO PARK****TECHNICAL SERVICE BULLETIN**

Reference Number(s): 04-22-12, Date of Issue: November 15, 2004

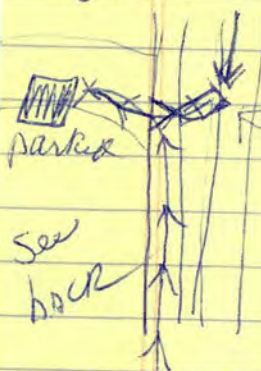
140,000 Last Summer I stopped & put  
in Park - on probably a  
30° incline - ran into store for  
a minute & as I turned  
the car - pulled forward  
& hit wall - Smashing it

Concrete big urn then slowly  
rolled back ward into Traffic  
on main hwy 66 thru M. Am.  
OKls.

four lane  
hit building then rolled  
back into Traffic.  
I had a 74 yr. old lady  
in passenger seat.

WAS hit in Left rear  
corner - Totalled an older car -  
both lady's ~~toes~~ were OK they said.  
I was lucky - the car  
could have been broadsided.

I Took Explorer to my small  
town mechanic - explained what  
happened + the cars other things  
I did - left car - in 2 days fixed  
car for 205.38 - found a  
bullet on ford site -
