**RE: Subaru of America**

**Re: Automobile Manufacturer design flaw  
Exclusive dealership repairs**

**APPLICABILITY:** All Turbo Equipped Vehicles  
**SUBJECT:** Turbocharger Oil Supply Mesh Screen

**NUMBER:** 02-103-07  
**DATE:** 10/19/07

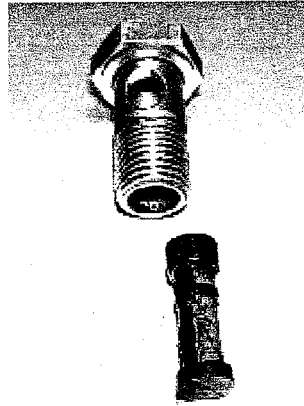
In addition, the mesh screen which is located inside the banjo bolt that secures the turbo-charger oil supply pipe to the back of the right side cylinder head should be checked to make sure it is not clogged or restricted especially if the condition of the oil is questionable or as to when the last oil change was performed. If clogged or restricted, it will reduce or cut off the oil supply to the turbo resulting in failure. The oil supply pipe should also be checked to make sure that there are no obstructions. *Note: The mesh screen is only available with a replacement banjo bolt.*

Banjo bolt and Mesh Screen  
(note direction of screen)

- Make sure the mesh screen is installed in the proper direction; incorrect installation will cut off oil supply to the turbo.

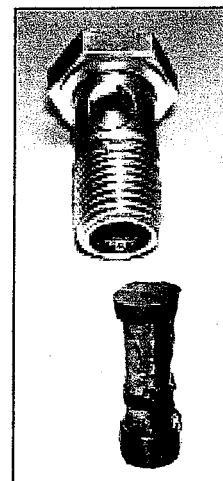
It is possible that the turbo oil supply mesh filter, which is located inside the banjo bolt that secures the turbocharger oil supply pipe to the back of the right side cylinder head, may become clogged thereby preventing oil supply to the turbo resulting in failure. Therefore it is required that this filter screen be checked for obstructions any time a Turbocharger is being replaced for a failure.

If the mesh filter screen is found to be obstructed it should be cleaned or replaced. Obstructions could be sludge due to poor engine oil maintenance or harsh driving conditions. Further diagnosis may be required if significant amounts of sludge, metal, and/or other materials are found in the mesh filter screen. In any turbocharger replacement, sufficient oil pressure to the turbocharger should be verified. Please consult the service manual for the appropriate specification.

- **Note:** The mesh filter screen is only available with a replacement banjo bolt. (P/N 14445AA090) Tightening torque: 29 N•m (3.0 kgf-m 21.4 ft-lb).
- **Note:** Anytime the banjo bolt is removed or replaced, both copper washers must be replaced with new ones.
- Make sure the mesh filter screen is installed in the proper direction; incorrect installation will prevent oil supply to the turbocharger. (Note direction, in picture to the right).
- **Do not confuse** the turbocharger oil supply mesh filter screen with the Active Valve Control System (AVCS) union screw mesh filter screen. Refer to Service Bulletin 02-97-05, dated 10/06/05.

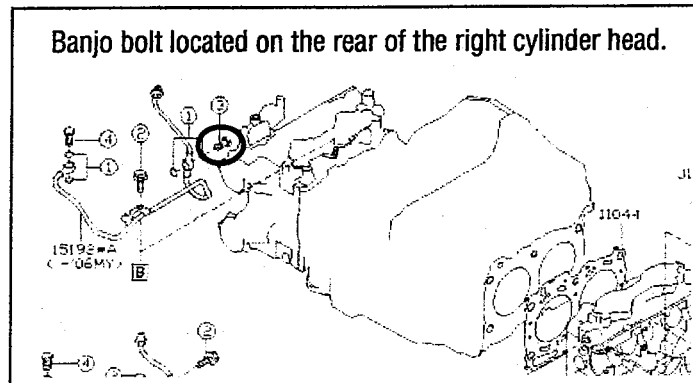
Banjo bolt located on the rear of the right cylinder head.
