| <div style="text-align: center;"> <b>DOT Auto Safety Hotline</b><br/> <b>Vehicle Owner's Questionnaire</b><br/> <b>To Report Vehicle Safety Defects</b><br/> <b>1-888-DASH-2-DOT</b><br/> <b>(1-888-327-4236)</b><br/> <b>INTERNET:www.nhtsa.dot.gov/hotline</b> </div> | | | | FOR AGENCY USE ONLY 100148 | |
| 17 digit Vehicle Identification Number Located at bottom of windshield on driver's side<br>4V4NC9GH15N <span style="background-color: black; color: black;">XXXXXX</span> | | | Make<br>VOLVO | Model<br>VNL | Model Year<br>2005 |

RE: DEFECTIVE LOW BEAM HEADLIGHT ASSEMBLY - 2005 VOLVO/ Ref #10376502

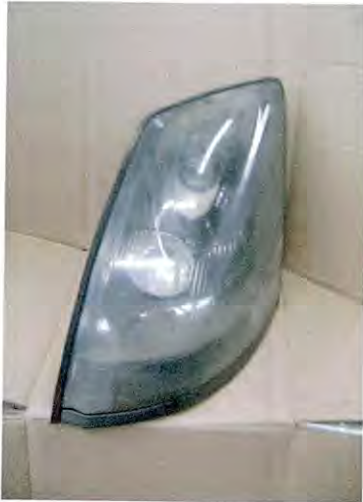
Illustration A . Front view of assembly.

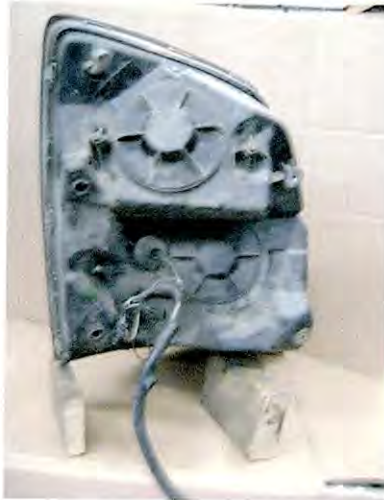
Illustration B. Rear view of assembly

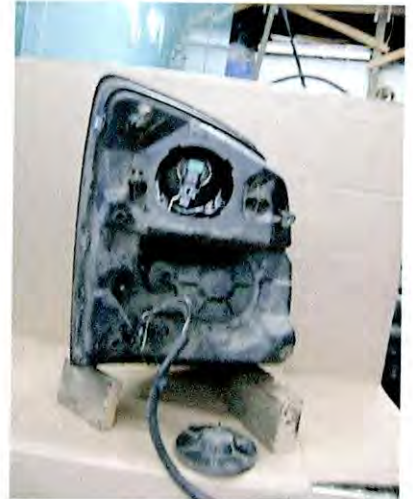
Illustration C. Showing removed cover to replace bulb.

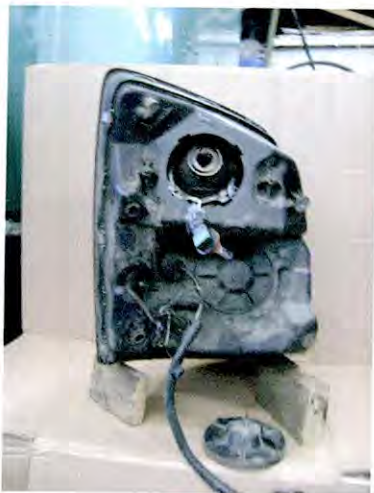
Illustration D. Showing light bulb removed to replace bulb

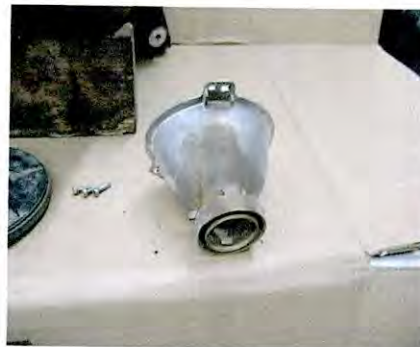
The problem with their solution to the is the reflective surface of the low beam reflector housing, one part of the assembly in question, is either defective or the ventilation of the housing is inadequate to dissipate the heat from the halogen bulb. This results to degradation of the reflective surface which over a period of time reduces the output of the light to well below the minimum required by law long before the 5 years or 638,000 miles mentioned in the report.

Illustration E shows the discoloration on the outside of the housing caused by the build-up of heat. Illustration F. shows the reflective service burned off of the inside of the reflector. Viewing of illustration G shows the reflective surface of a headlight reflector in excess of 12 years old, and yes it is also a Volvo headlight assembly.

Illustration E. Showing reflector removed by taking out 3 screws. Notice burned surface on top.

The part in question is never considered a consumable, such as brake lining, wiper blades, light bulbs, or tires, on any highway vehicle. This part is easily replaceable by removal of three small screws. Replacement of this part is only one step beyond steps required to replace the low beam bulb. This is shown in the included illustrations. Replacement of the light bulb is preformed by steps in illustrations C. and D. At that point, removal of the three Phillips Head screws permit's the low beam housing to be removed and replaced.

Volvo needs to either offer this part separately, or issue a recall on this part and replace these reflectors at no cost to the customers.

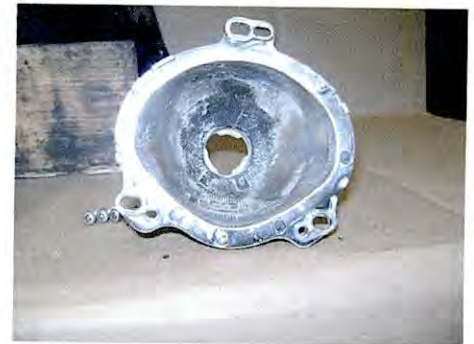
Illustration F. Showing degraded surface inside reflector causing loss of illumination ahead of vehicle.

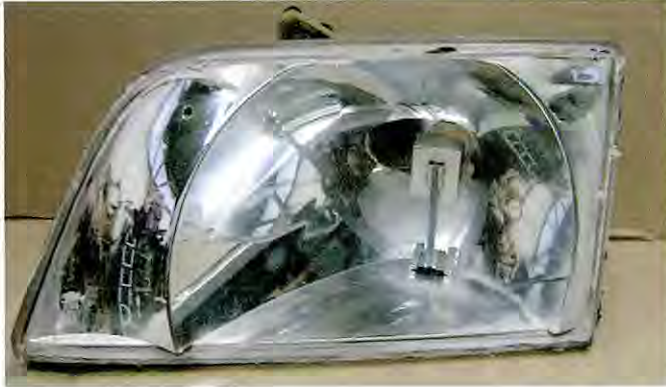
Illustration G shows reflector of 12 year old light assembly.

This is a picture of a headlight assembly from a 1998 Volvo truck. As you can see, the reflective surface is in excellent condition.
