## TRAFFIC CRASH REPORT

10-0044-91

Ohio State Highway Patrol

01162011

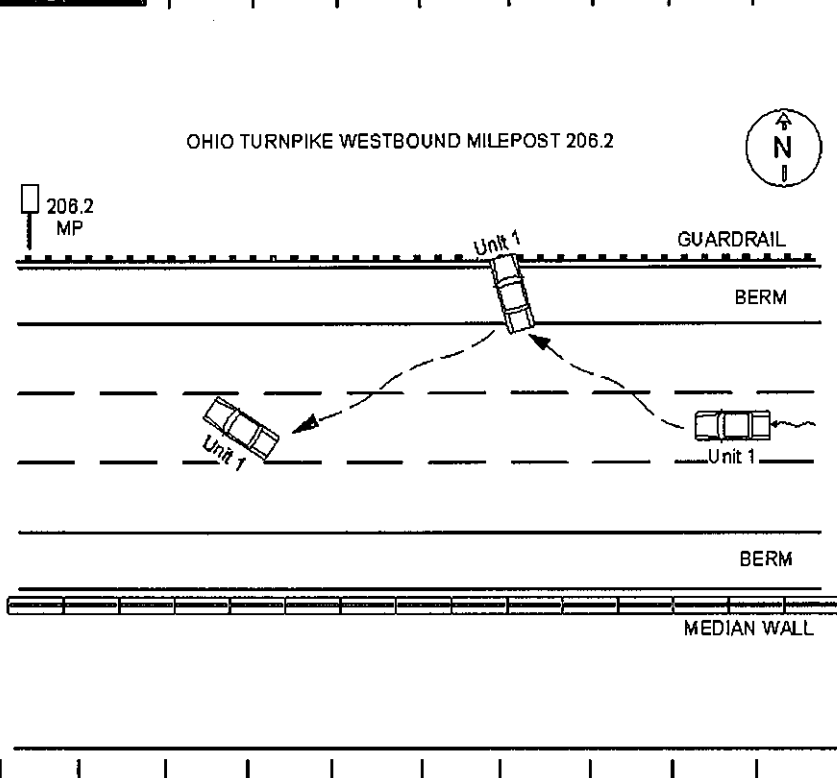
## Diagram

Unit #1 was westbound in the center lane on the Ohio Turnpike at milepost 206.2. Unit #1 had an equipment failure with the rear tires. Unit #1 attempted to pull onto the right berm but lost control due to the equipment failure. Unit #1 went off the right side of the roadw struck the guardrail, and spun to rest in the center lane.

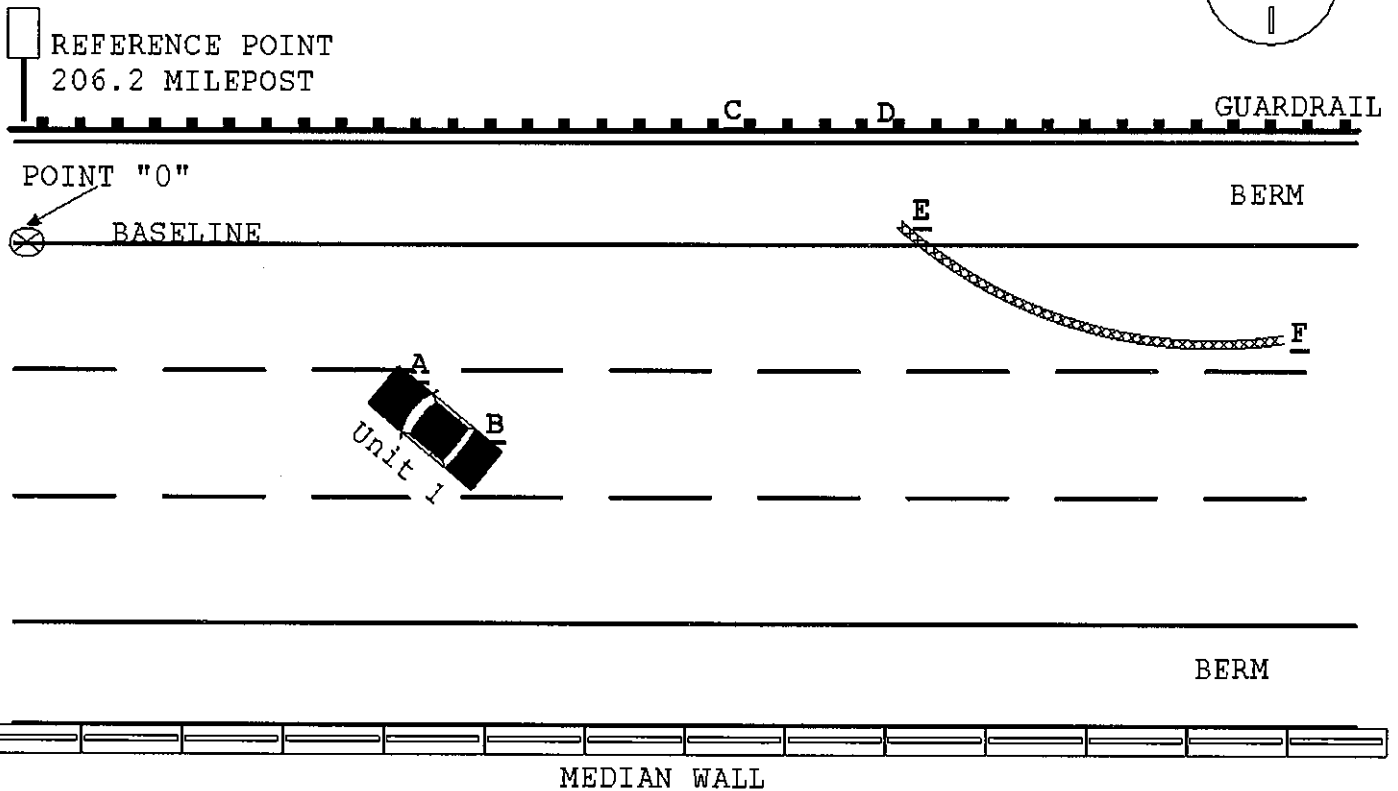
OHIO TURNPIKE WESTBOUND MILEPOST 206.2

- The right rear severed sidewall concurs with the tire mark I found in the right lane leading to impact with the guardrail. The marking had very dark narrow lines at each edge where the rim lips were riding on the deflated tire. Thus showing that for sure the right rear was fully deflated leading into the crash. The left rear did not leave that marking on the roadway.

| A | 195'5"E | 15'10"S | RIGHT FRONT WHEEL |
| B | 203'3"E | 19'5"S | RIGHT REAR WHEEL |
| C | 336'10"E | 11'6"N | END IMPACT WITH GUARDRAIL |
| D | 359'4"E | 11'6"N | BEGIN IMPACT WITH GUARDRAIL |
| E | 360'1"E | 1'6"N | END RIGHT REAR TIRE MARK |
| F | 441'0"E | 8'1"S | BEGIN RIGHT REAR TIRE MARK |
