| <p>DOT Auto Safety Hotline U.S. Department of Transportation National Highway Traffic Safety Administration</p> | | <p>Vehicle Owner's Questionnaire To Report Vehicle Safety Defects 1-888-DASH-2-DOT (1-888-327-4236) INTERNET: www.nhtsa.dot.gov/hotline</p> | | FOR AGENCY USE ONLY 100148 | |
| 17 digit Vehicle Identification Number Located at bottom of windshield on driver's side 1HGCM66396A | | Make HONDA | Model ACCORD | Model Year 2006 | |

Safety Recall: Driver's Seat Position Sensor Harness Replacement

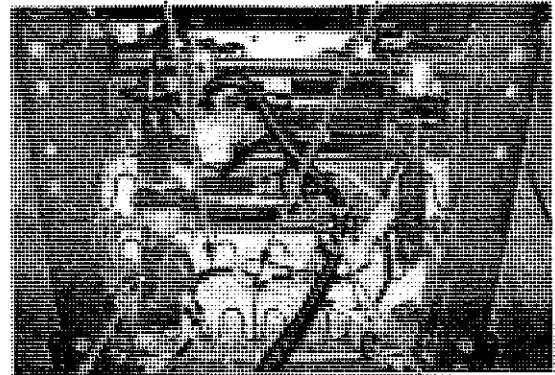
Because of an improperly routed driver's seat position sensor harness and an overtightened wire tie, the seat position sensor harness may be damaged. This may cause the SRS indicator to stay on with DTC 71-1x ("x" can be 0 thru 9 or A thru F) and result in the seat position sensor not being able to detect the seating position of the driver. This could affect the inflation pressure of the driver's front airbag.

SEAT POSITION
SENSOR HARNESS
(Discard.)

WIRE TIE
(Cut and discard.)

- Remove the original seat position sensor harness:

- Disconnect the black seat position sensor connector.
- Remove the brown clip from the seat position sensor cover.
- Cut and discard the wire tie.
- Disconnect the gray connector, and remove the clip from the seat frame.

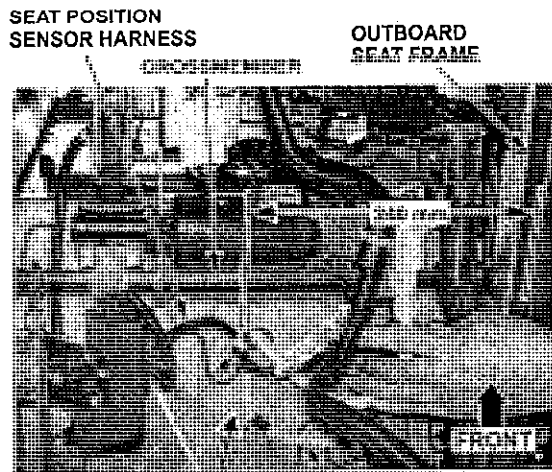
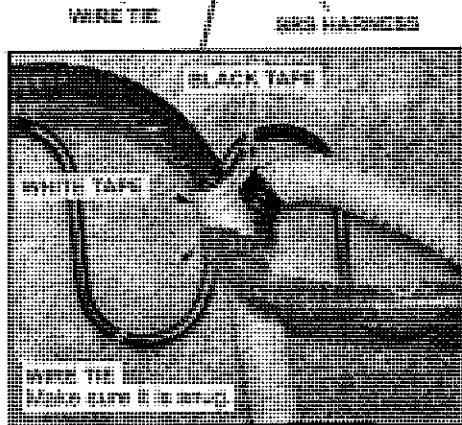
NOTE: If the wire tie is improperly attached, adjusting the seat could damage the seat position sensor harness.

11. Attach the new wire tie:

- The wire tie must be placed around the white tape on the seat position sensor harness, the black tape on the SRS harness, and the correct seat spring.
- The correct seat spring is located behind the front crossmember bar and 240 mm from the outboard seat frame.
- Fasten the wire tie to the straight section of the seat spring, not the curved part.
- The wire tie should be snug. If the wire tie deforms the corrugated tubing, it is too tight. If you can slide a pencil in between the seat position sensor, the SRS wires, and the wire tie, it is too loose.
