U.S. Department  
of TransportationNational Highway  
Traffic Safety  
Administration**Vehicle Owner's Questionnaire**  
**To Report Vehicle Safety Defects**1-888-DASH-2-DOT  
(1-888-327-4236)

**Reference Number: 10394161**

**Narrative Description of Incident, crash and injury**

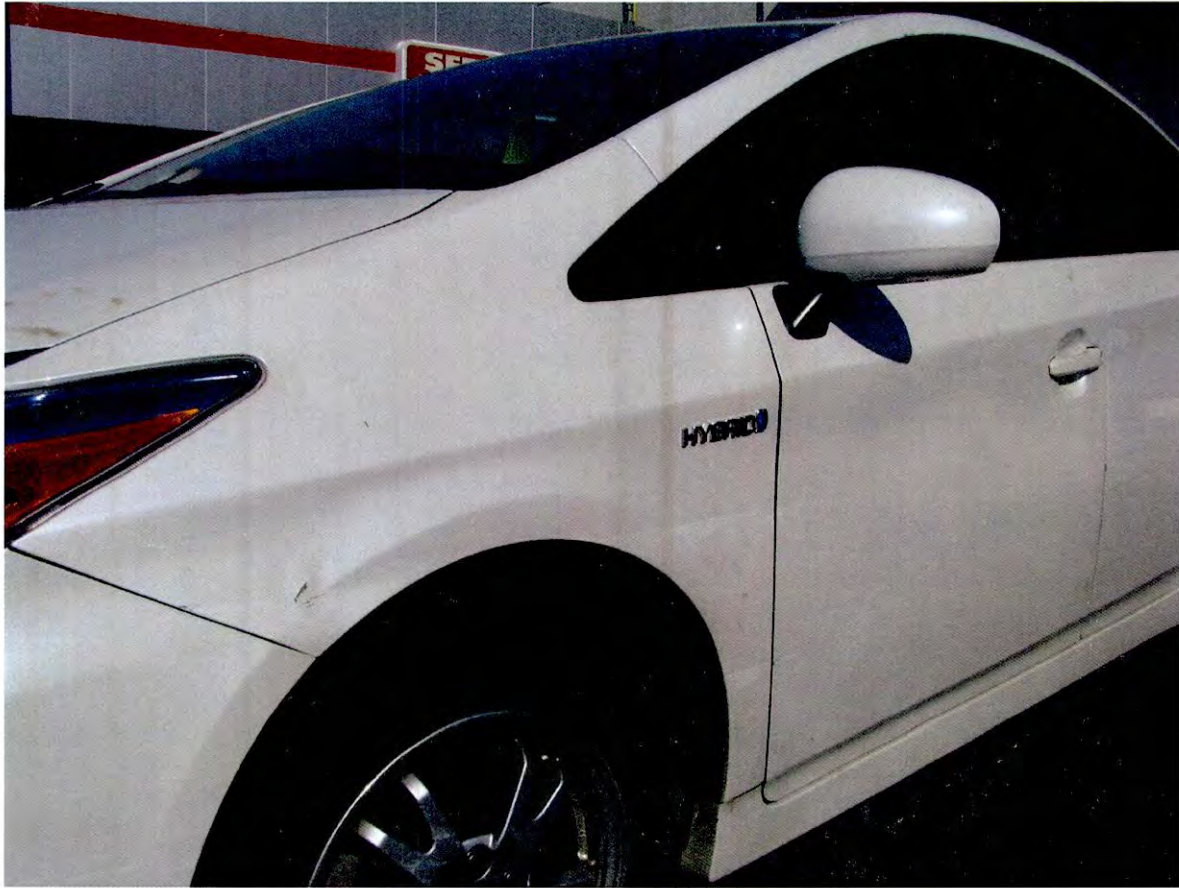
Driver side of vehicle showing light scratches and denting on front quarter panel from light contact with galvanized highway guardrail. Note 0 degree (straight) orientation of left front wheel.

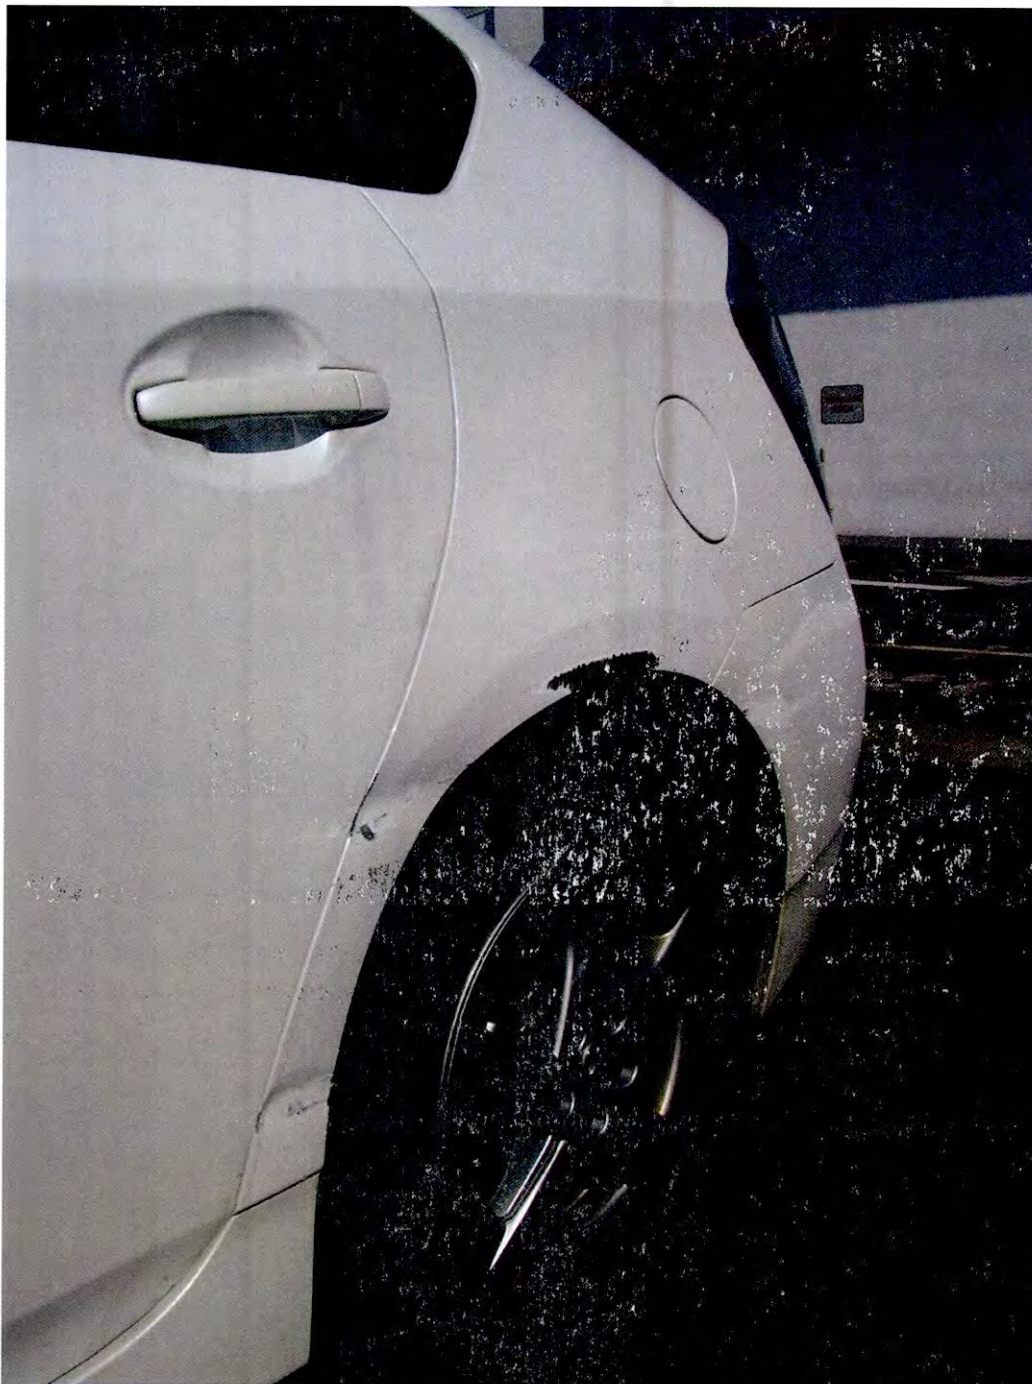
Driver side of vehicle showing scratches and denting on rear quarter panel from light contact with galvanized highway guardrail.

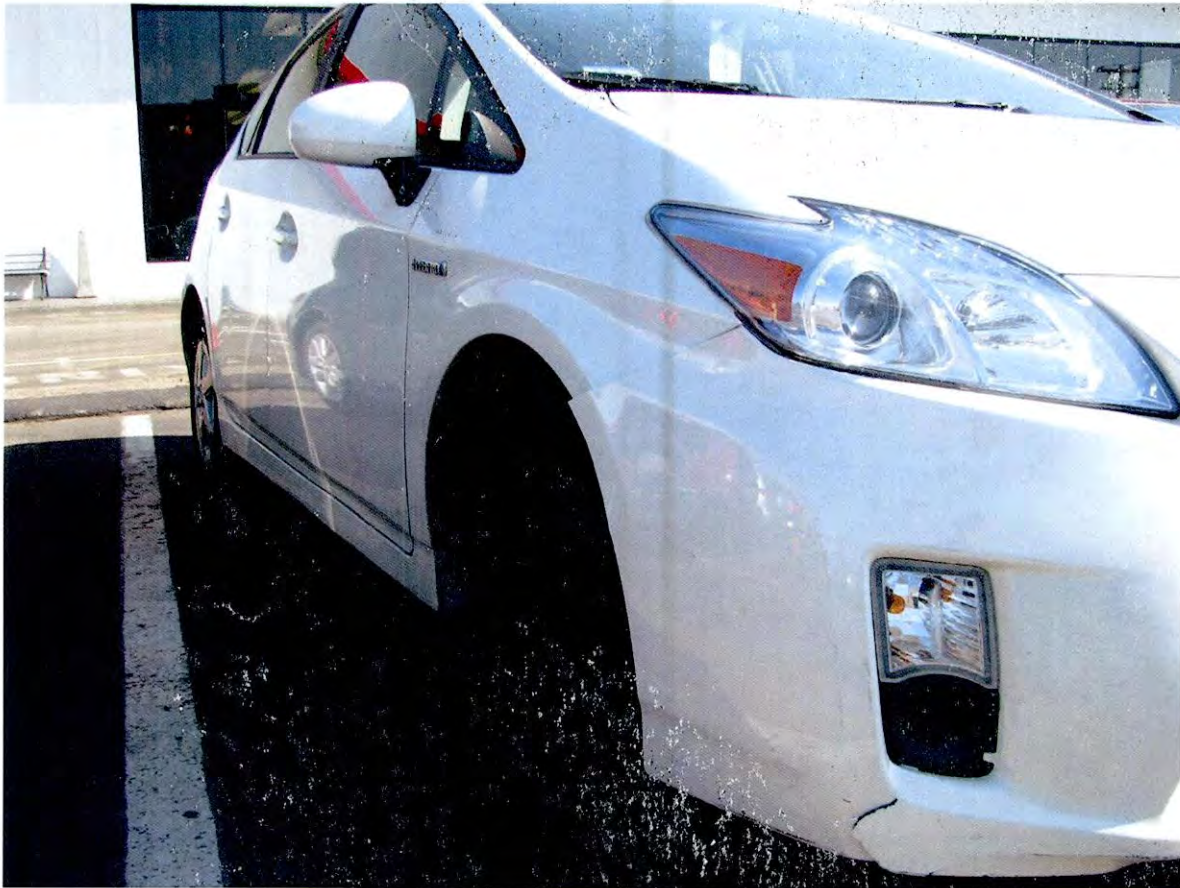
After vehicle was secured onto flatbed it was observed that left-hand front wheel was facing straight ahead while right-hand front wheel was directed right 30-45 degrees. No airbags were deployed and front of vehicle shows no evidence of frontal impact. Vehicle was towed directly to Toyota dealership.

Passenger side of vehicle showing no impact damage to right side. Note plastic bumper panel loosened at right wheel well, 2 inch crack in plastic bumper panel at base. Note also approximately 30 degree orientation of right wheel that is misaligned with left side front wheel.

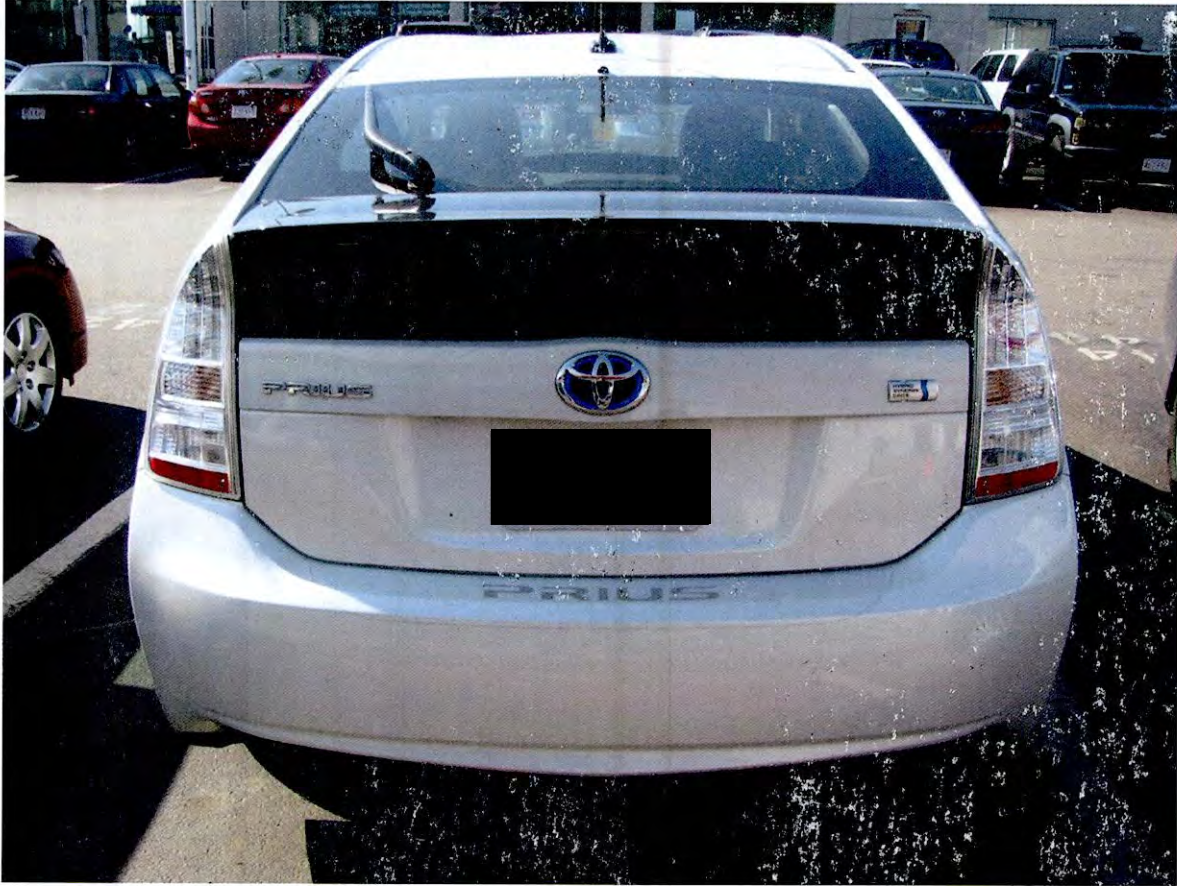
Rear of vehicle with no indication of collision or impact.

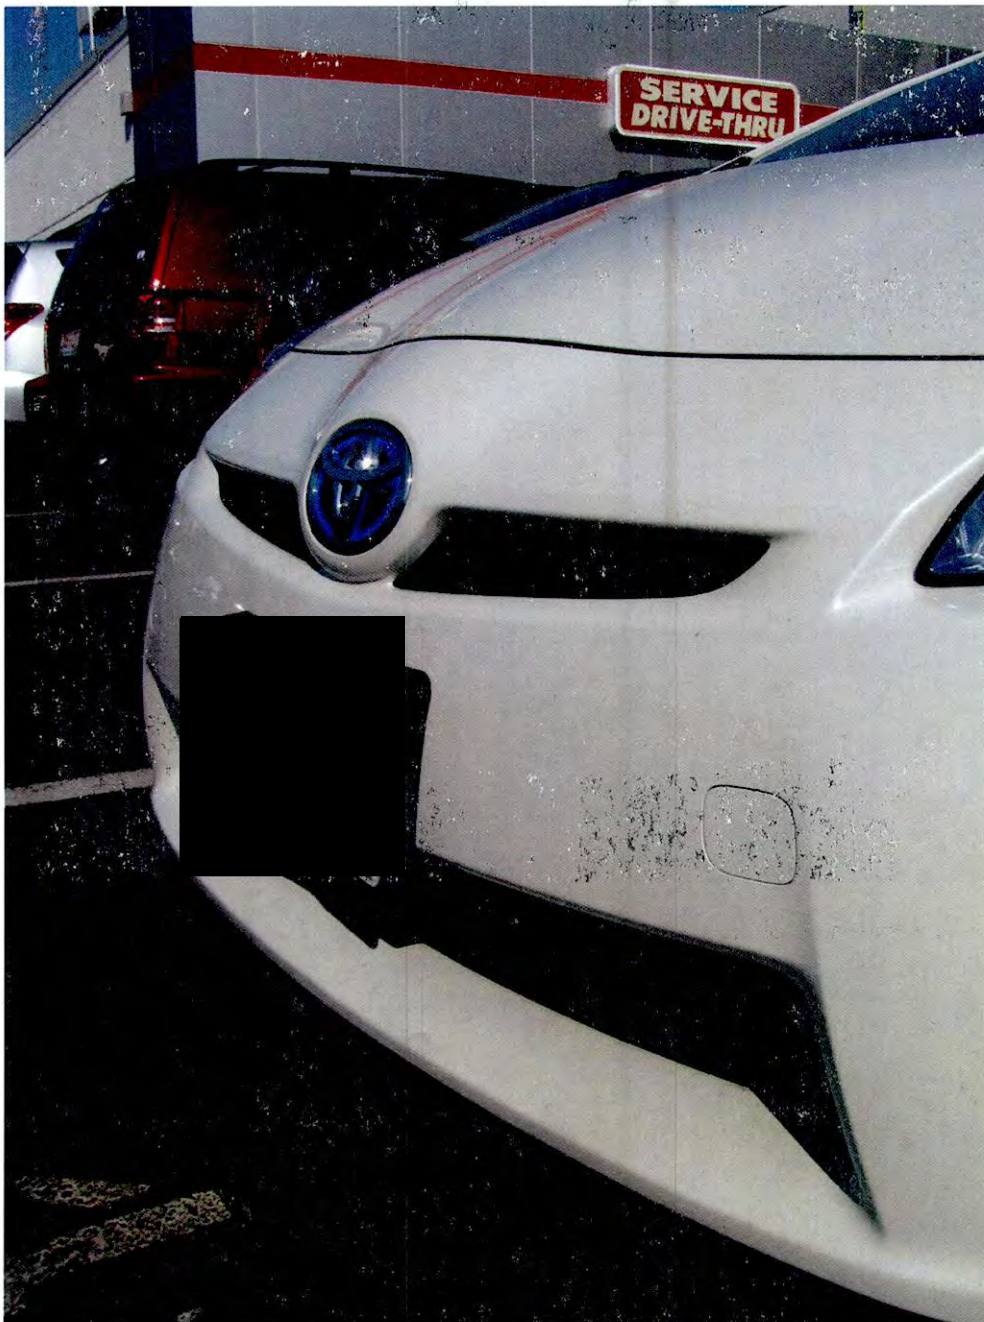
Front of vehicle with no indication of collision or impact.

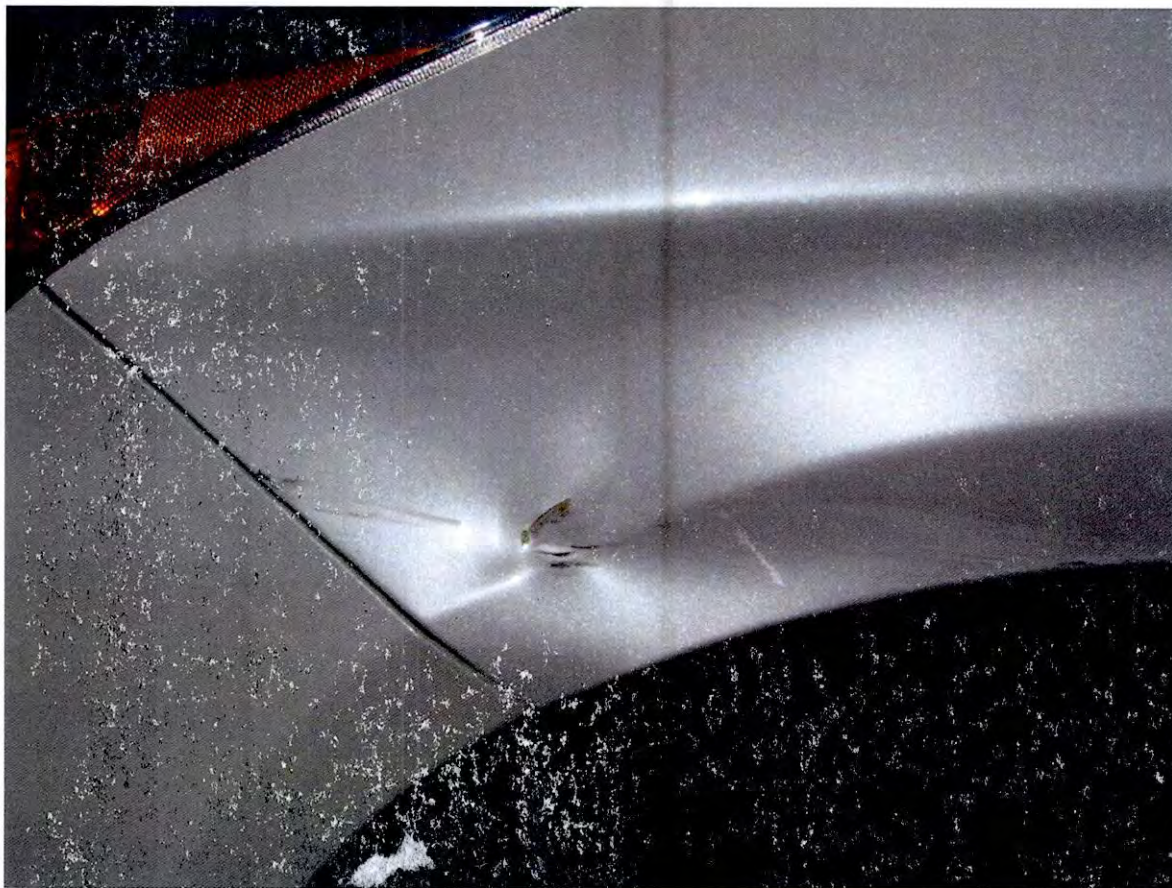
Close image of minor extent of scratch and dent on left front quarter panel from light contact with galvanized highway guardrail.

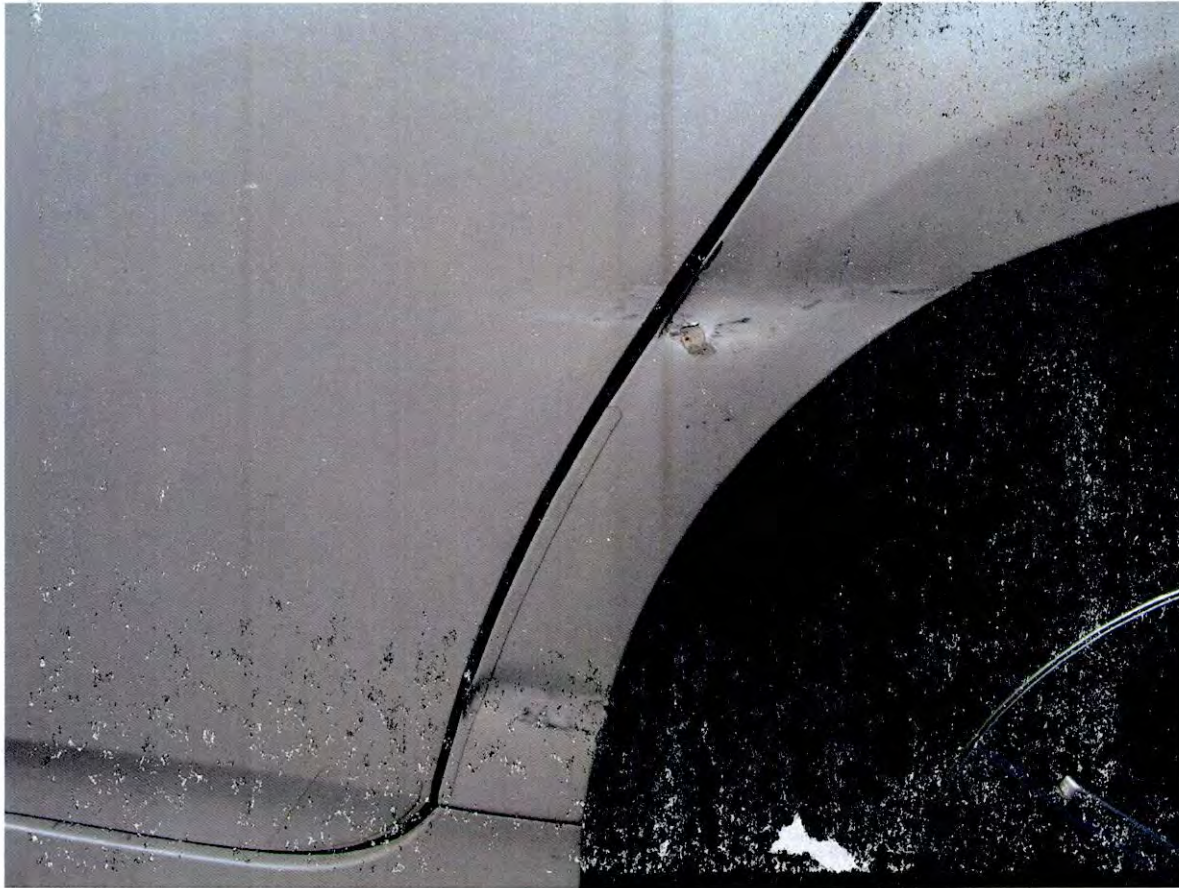
Close image of rear quarter panel showing slight dent and scratching from light contact with galvanized highway guardrail.

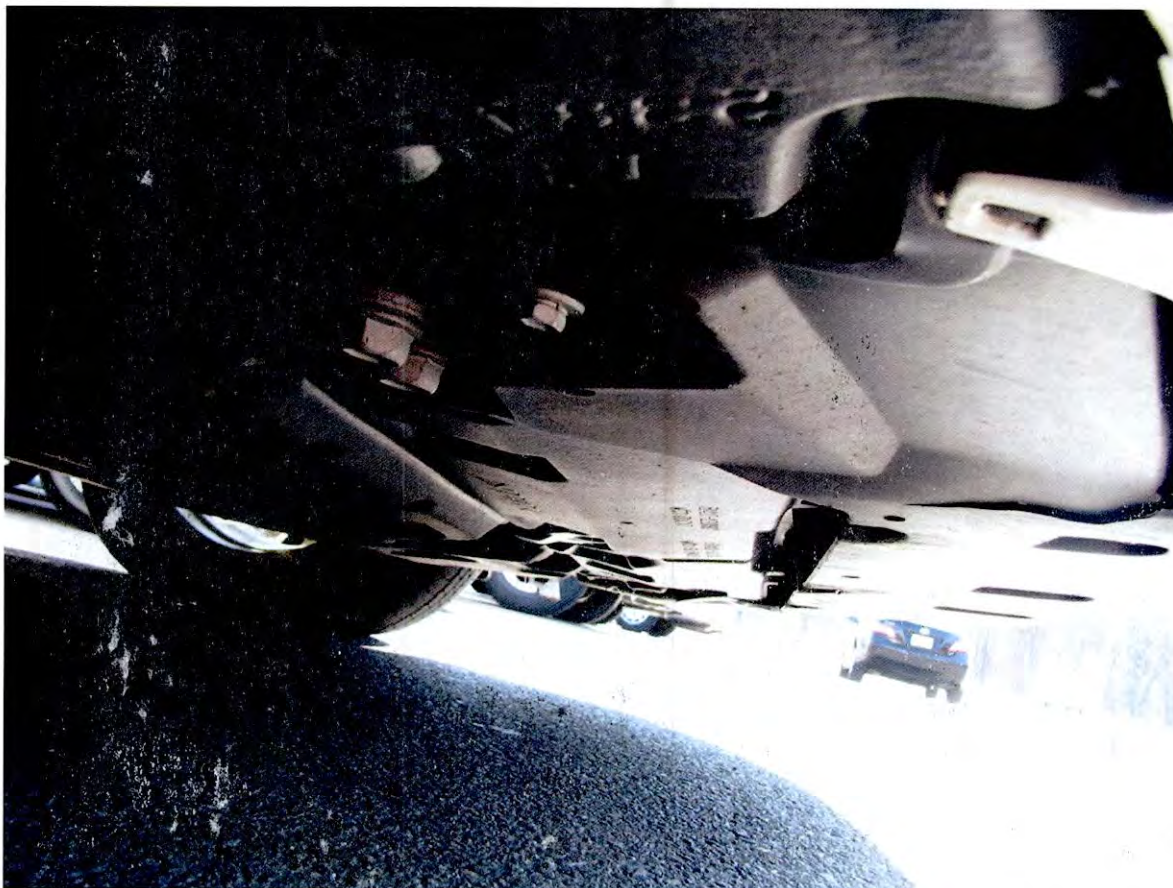
Underpanel of vehicle as seen from right front corner of vehicle. No presence of scratching to indicate under-carriage collision.

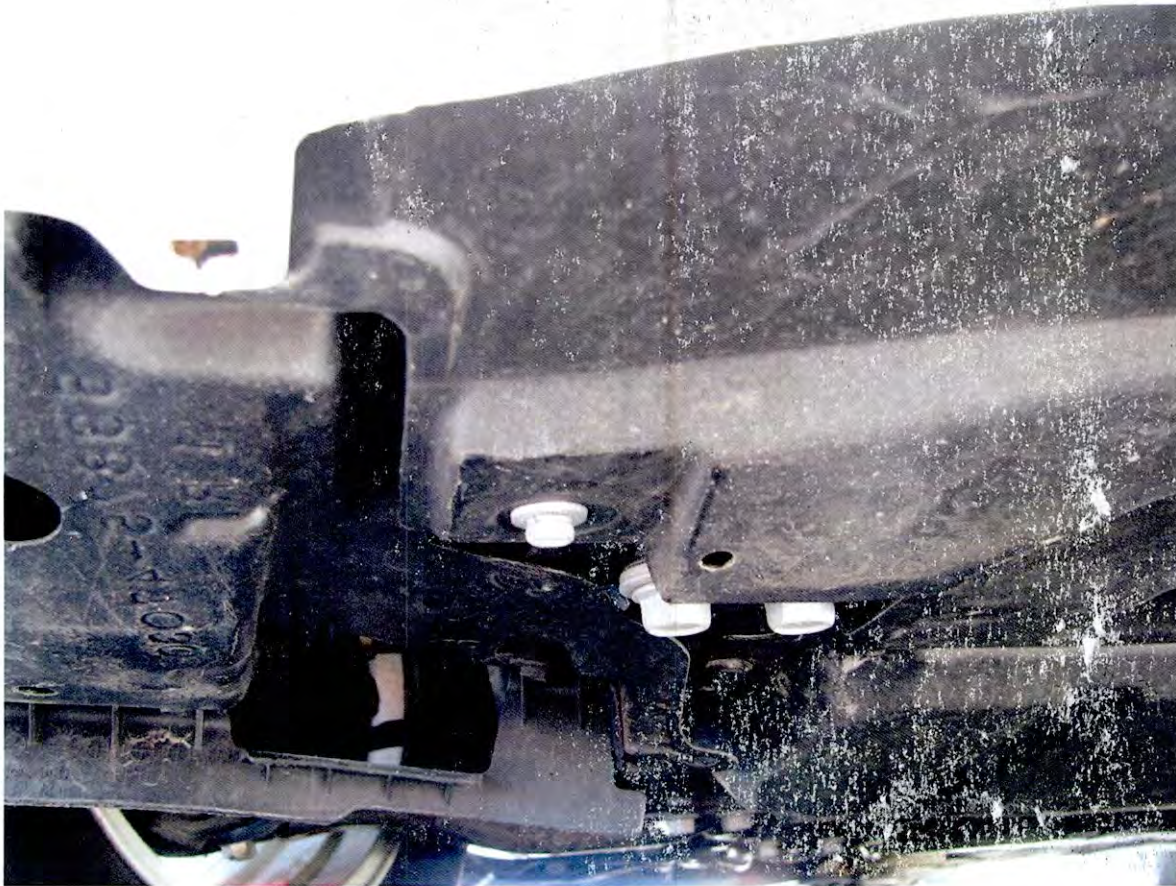
Close shot of plastic undercarriage shielding located at right front wheel (viewed from front of vehicle).  
Note no presence of scratching to indicate under-carriage collision.
