REF: 2006 Range Rover Sport HSE, VIN: SALSF25466A [REDACTED]

Front Differential Problems and Solutions (Range Rover III)

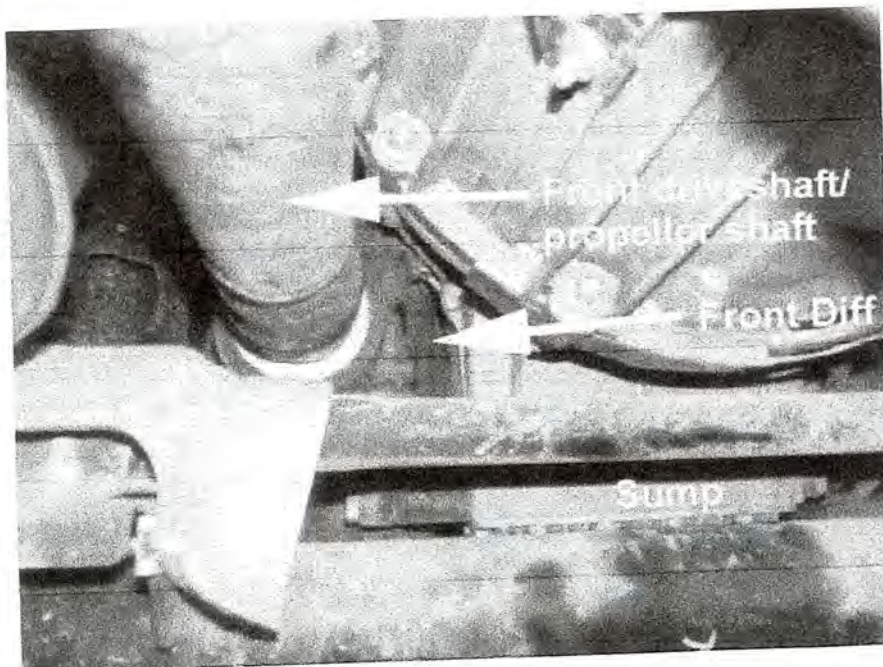
Photo: View (looking forward) of front driveshaft and diff on author's 2004 Range Rover. Note diff mounted on left side of engine crankcase/sump, with driveshaft entering it with no U joint.

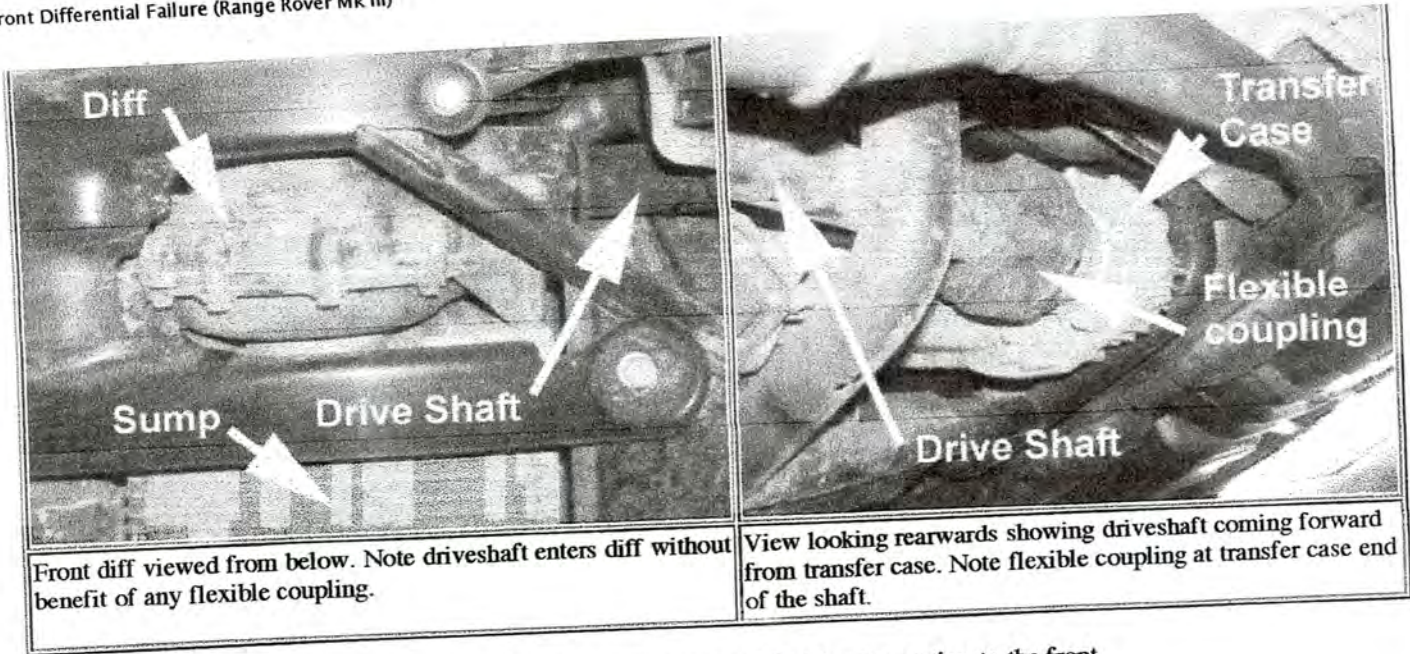
The cause of the problem is stress on the front driveshaft and front diff input due to misalignment. To understand this, we need to elucidate the design of the Range Rover III front drive layout. The front differential is mounted on the left side of the engine crankcase, which was strengthened in the design process to accommodate this arrangement. The front diff receives its input from the front driveshaft which comes forward from the transfer case. Because the engine is bolted directly to the transmission, and the transmission to the transfer case, the designers (not unreasonably) must have assumed the whole structure would be perfectly rigid and the usual arrangement of CV joints, U-joints or flexible couplings used on the front driveshafts of lesser 4X4's would not be needed. Mysteriously, they did provide a flexible coupling at the rear end of the driveshaft, where it attaches to the transfer case, but not on the front end where it goes into the diff.

Accordingly, no problems have been reported at the transfer case end, but the connection to the front differential fails far more frequently than it should, often wrecking the entire diff with it. An obvious cure would be to provide some form of flexible coupling at the front end of the driveshaft, but to date (January 2006) I have not heard of any such cure being adopted by Land Rover.

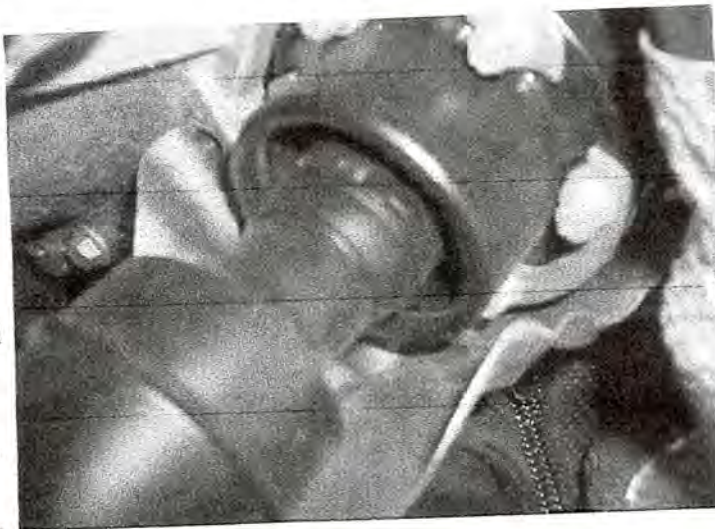
were incorporated in the 2006 model, a CV joint was added at the front as well as the rear of the driveshaft (see photo of front end of driveshaft courtesy of Mark Osen). This was in effect a tacit recognition that the earlier design (omitting any flexible coupling at the front end of the driveshaft) was not satisfactory.

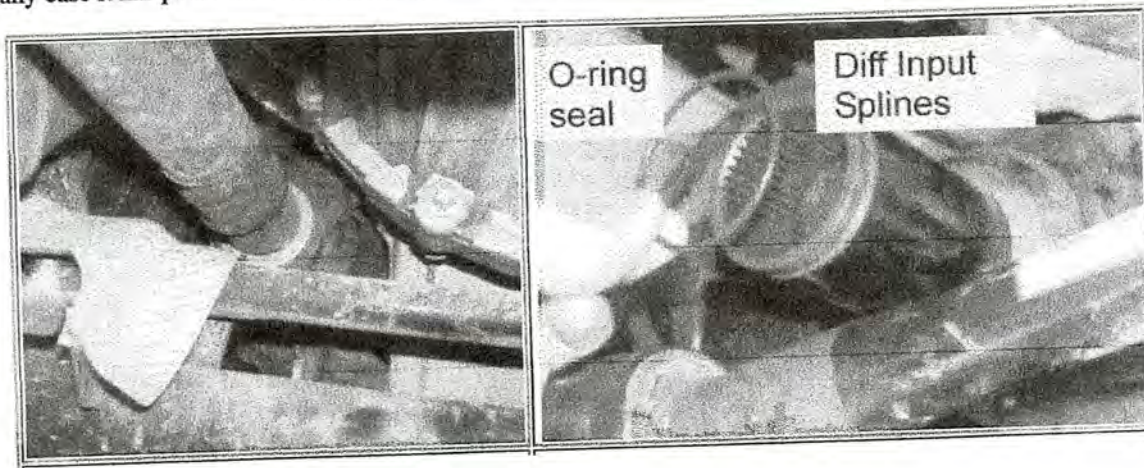
Above: View looking forward along the front driveshaft (propeller shaft) towards front diff. Horizontal bar below driveshaft is the anti-sway bar.

Top Right: Similar view but closer in (adapted from official Land Rover TSB) with driveshaft removed to see the the input splines of the front differential. Anti-sway bar at bottom.

Bottom Right: Closeup of failed splines on diff input tube.

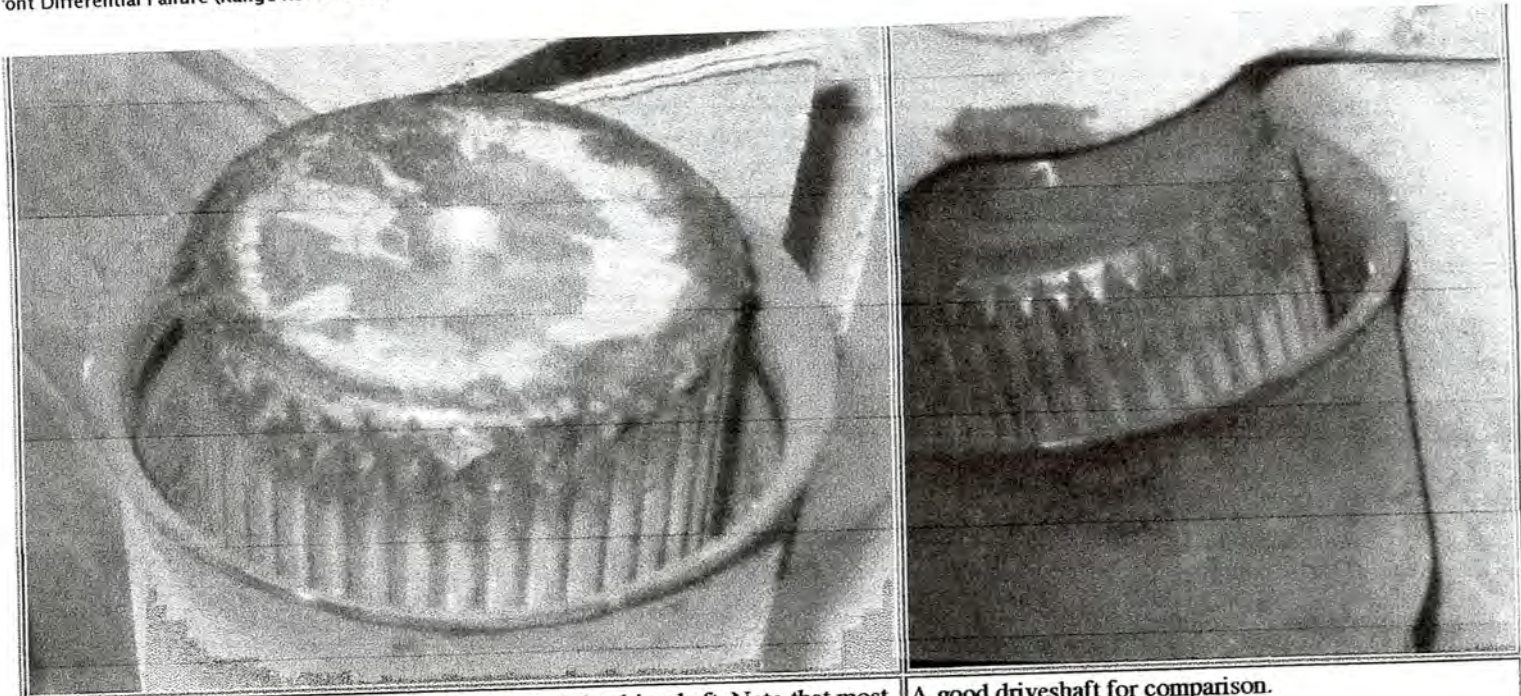
Another set of mangled splines on the front end of the driveshaft. Note that most of the length of the splines is not too badly worn -- most of the wear seems to take place in the diff input tube splines. (Note that again the hole had already been put in the driveshaft but had no effect in preventing the failure).

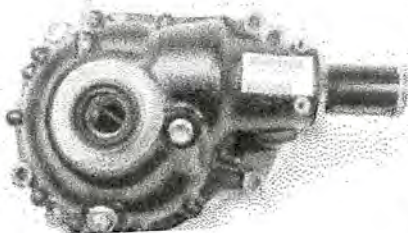
Photo at right: Diff removed from vehicle; input tube has stripped splines.

If the spline wear on the inside of the diff input drive tube is excessive, the official procedure is to replace the entire differential assembly. According to the June 2003 service bulletin, the assembly includes a collapsible spacer that determines the bearing preload, and renewal of the drive tube only can apparently result in rapid failure of the differential bearings.

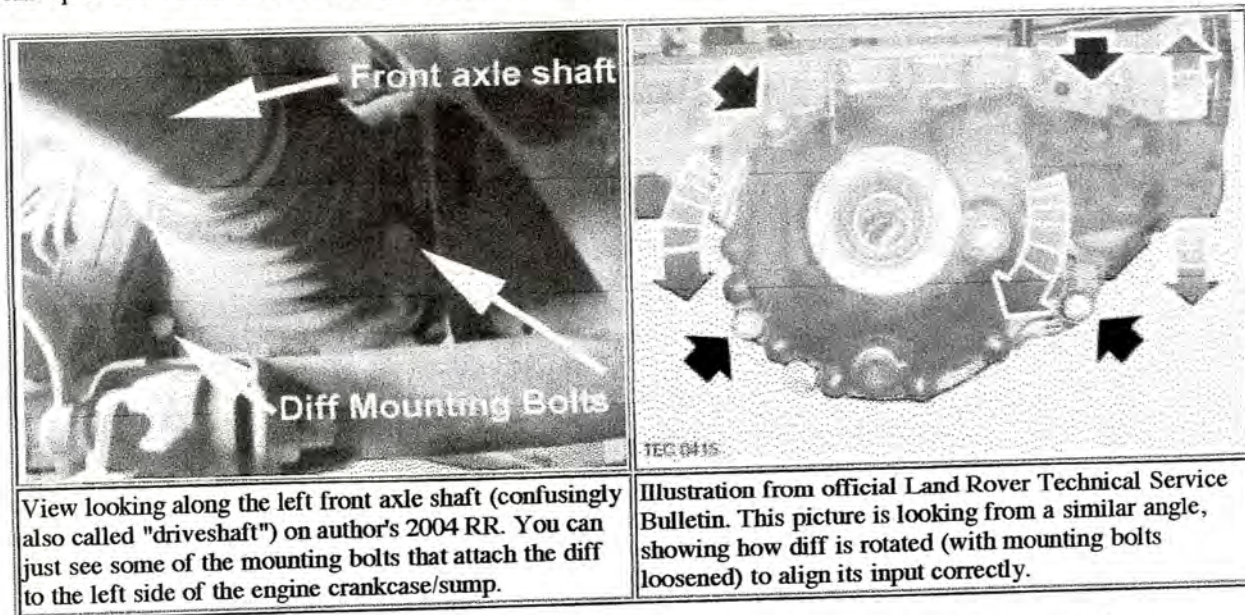
View looking along the left front axle shaft (confusingly also called "driveshaft") on author's 2004 RR. You can just see some of the mounting bolts that attach the diff to the left side of the engine crankcase/sump.

Illustration from official Land Rover Technical Service Bulletin. This picture is looking from a similar angle, showing how diff is rotated (with mounting bolts loosened) to align its input correctly.

If the diff needs realigning, it is a fairly simple matter of loosening the four bolts that mount it to the left side of the engine crankcase, and rotating the diff housing forward or back slightly until the alignment as described above is perfect. The rotation is performed by using the drive shaft as a lever and moving its rear end up or down until the desired alignment is achieved.

When alignment is satisfactory, re-tighten the diff mounting bolts to 81 lb-ft (110 Nm), and re-check the alignment.
