U.S. Department  
of Transportation  
**National Highway  
Traffic Safety  
Administration**

## ODI RESUME

**Subject:** STEERING INTERMEDIATE SHAFT BINDING

Sedona (GQ) Increased [Steering](#) Effort (Chassis -019)

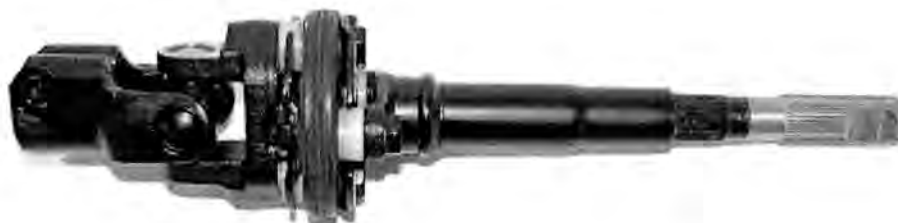
**Steering Intermediate Shaft - PN 0K52Y 32550**[Zoom](#)[Sized for Print](#)

In areas where heavy road salt use occurs, customer complaints have identified increased [steering](#) effort and noise (from the steering intermediate shaft) for the 2002-2005 (GQ) Sedona. The increased effort is usually first noticed at low speeds with noise or rattle. When addressing

such customer concerns, replace the steering intermediate shaft using part number 0K52Y 32550 pursuant to the instructions in this TSB.
