Longview Texas  
July 11, 2011

The purpose of this letter is to report a defect which can lead to loss of air pressure in both (or all four) dual rear wheels simultaneously related to a 2010 Solera by Forest River Motorhome as built on a 2008 Freightliner Sprinter Chassis.

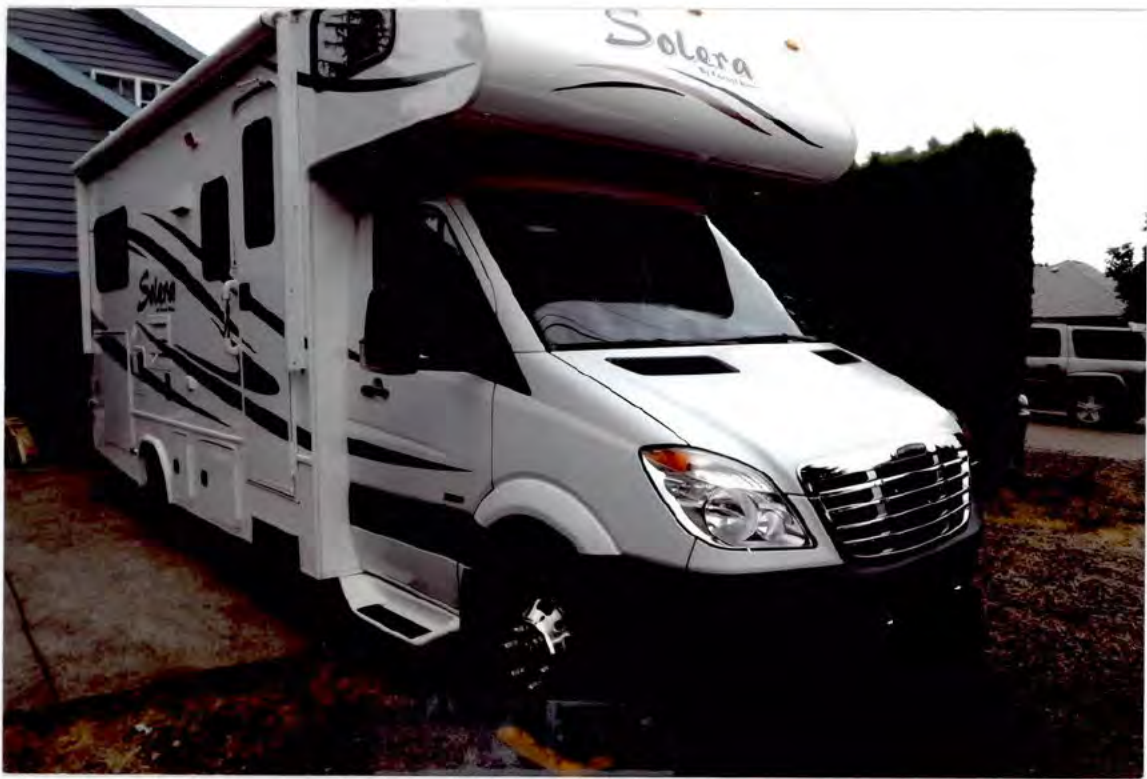
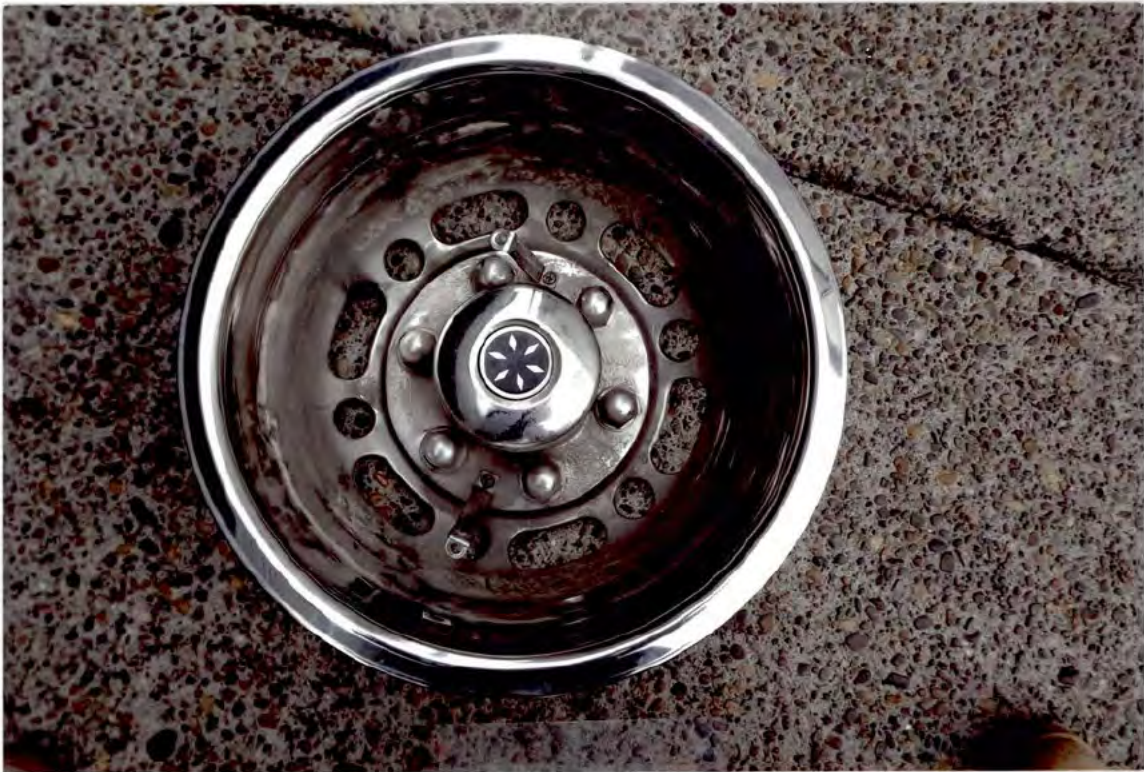
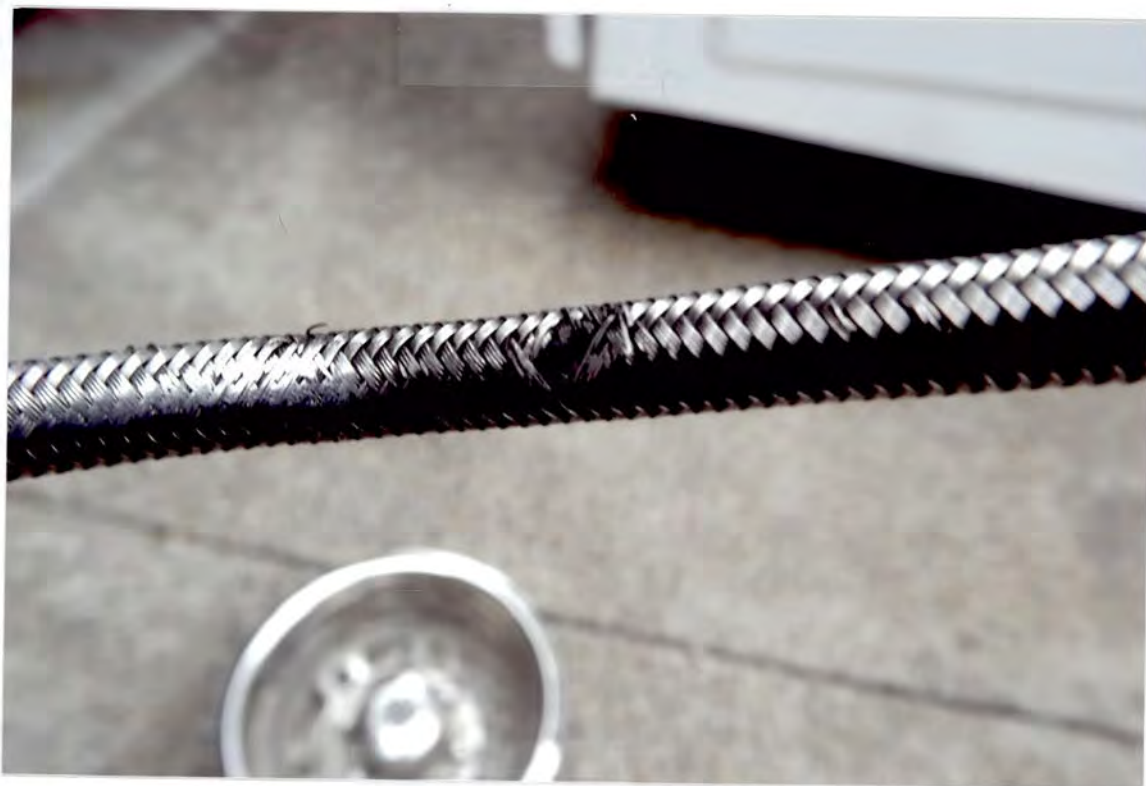
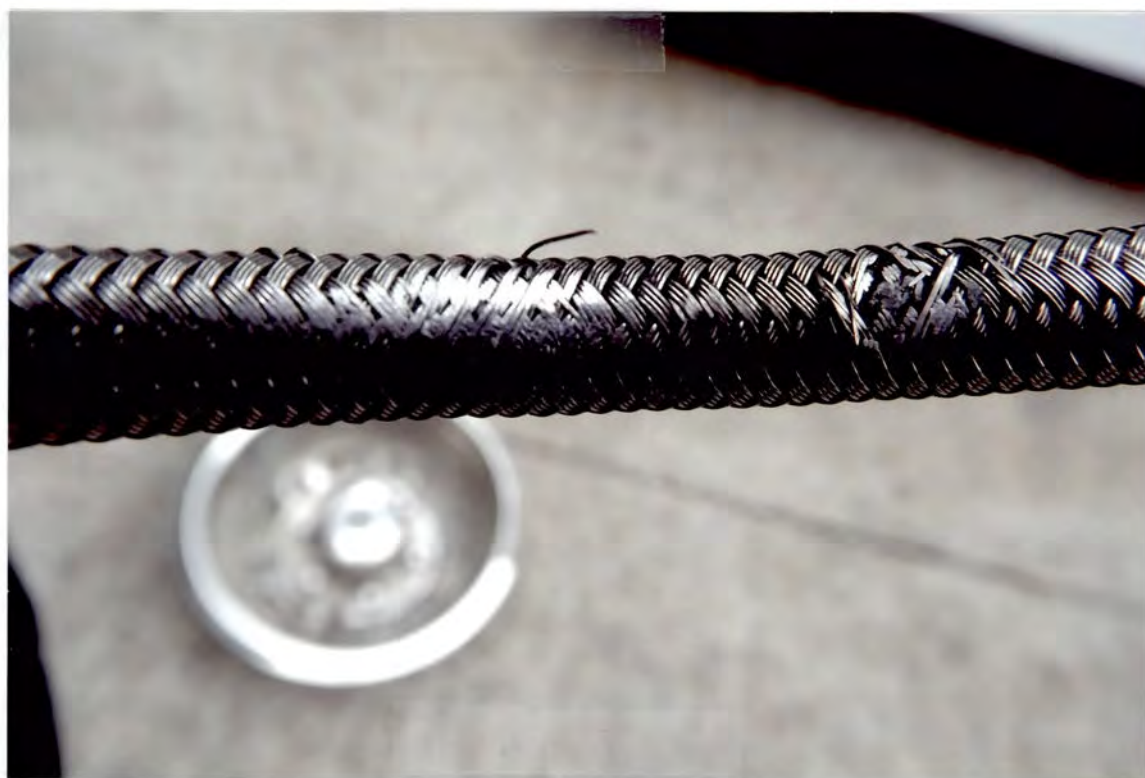
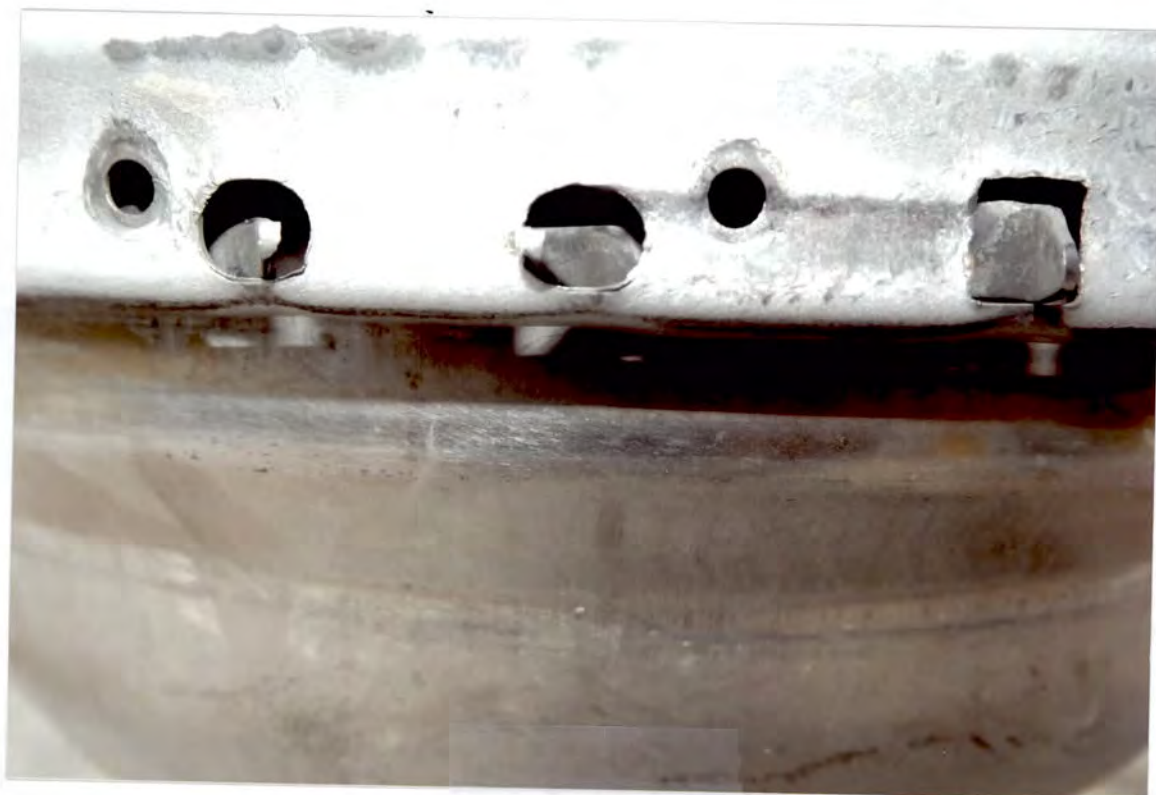
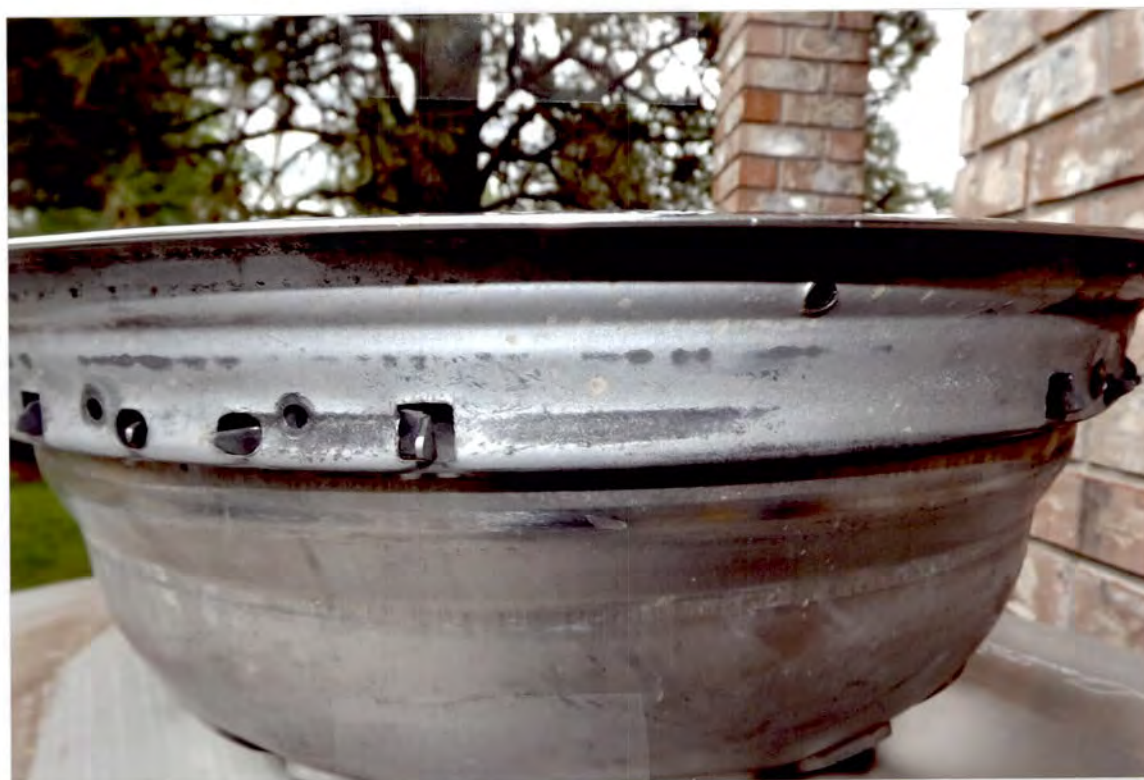
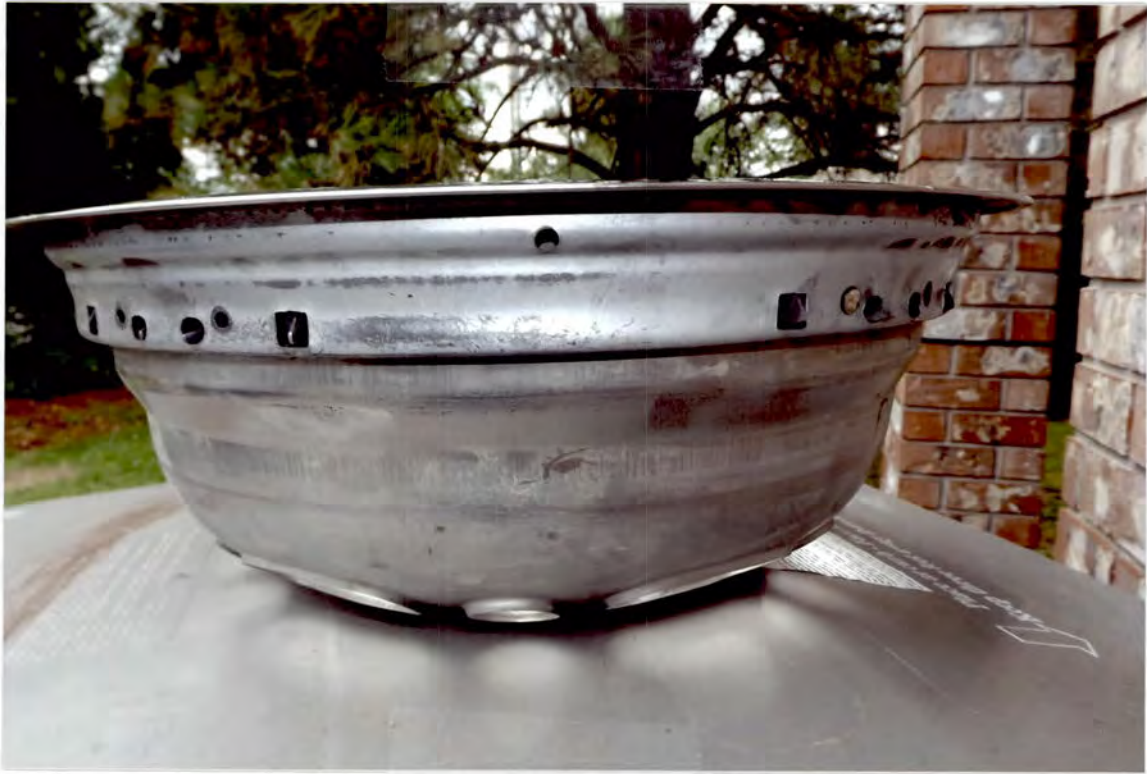
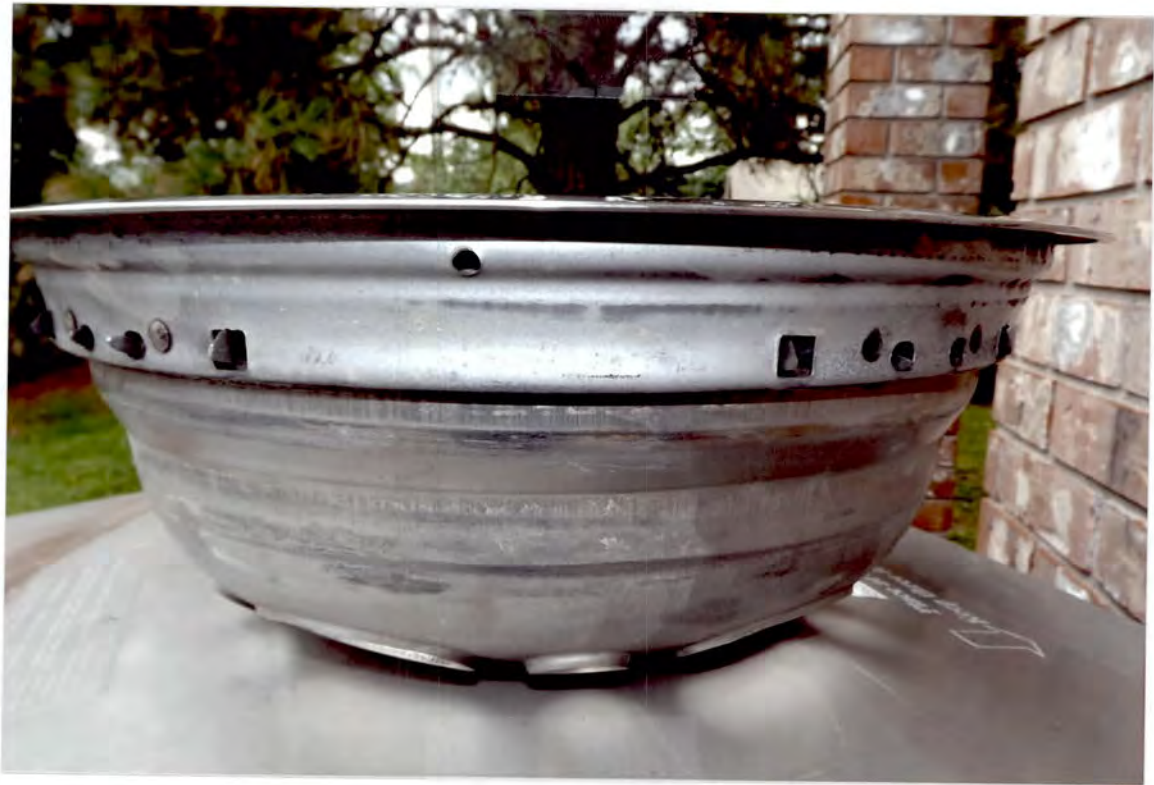
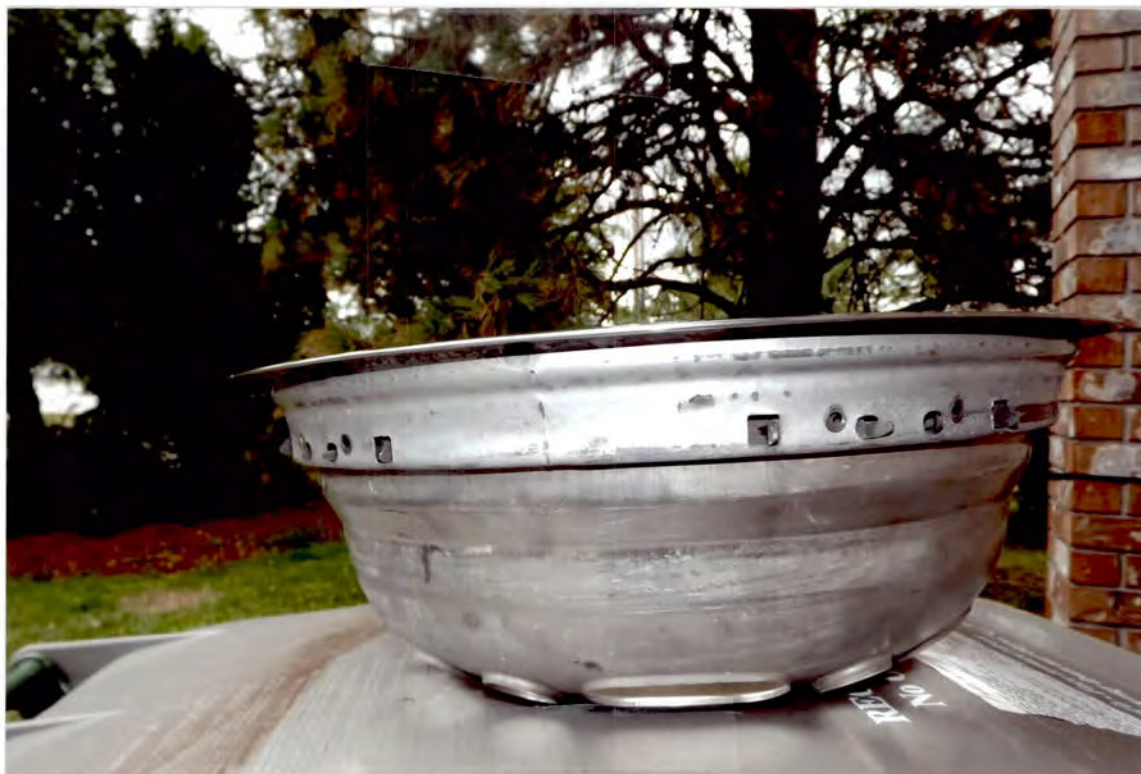
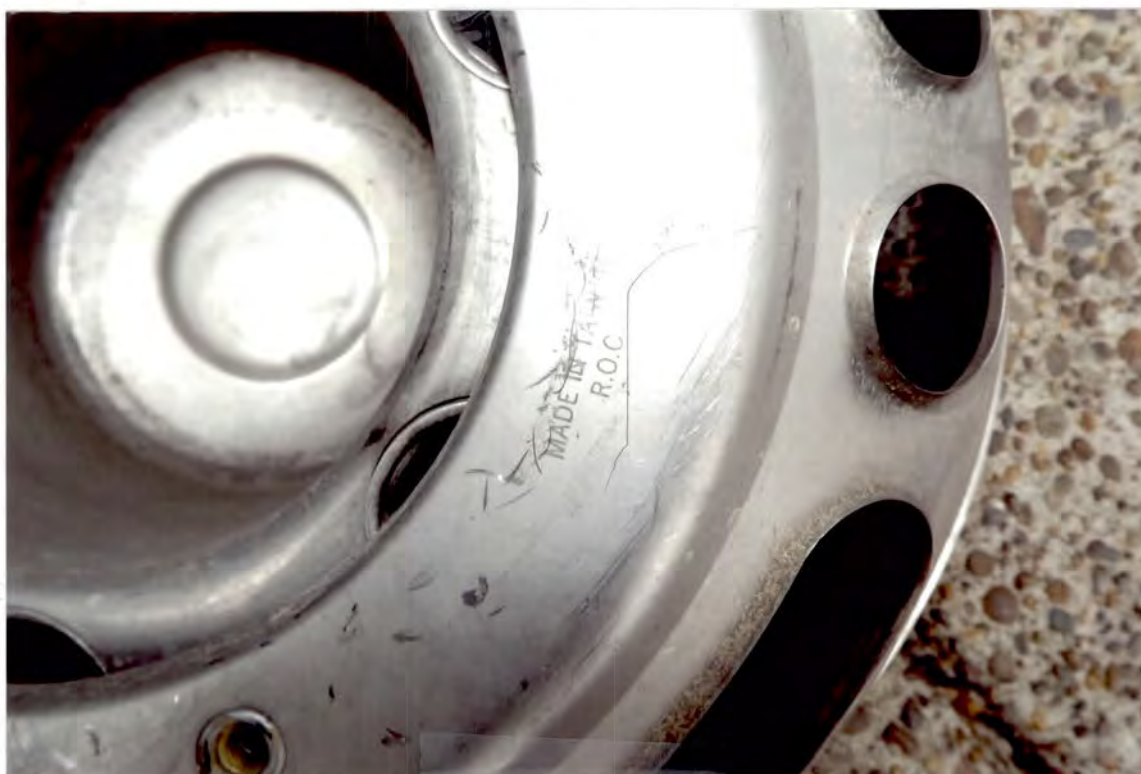
The failure results from the rivets which hold the friction locking devices on the chrome "artificial wheel" wheel covers. Failure of these rivets causes the wheel cover to become loose and attached to the vehicle only by the air valve extension hoses which are attached to the wheel cover with a nut. The rivet failure leads to wear through of the armored extension hoses, and simultaneous rapid loss of air pressure to both dual wheels (and possibly all four) mounted on the rear axle when they eventually separate and allow the wheel cover to depart from the vehicle.

The wheel covers are stamped with a "Tiawan" stamp, but have no other identification. I have enclosed photos showing the rivet failures, the wheel covers, and the wear through an armored valve extension.
