Vehicle Owner's Questionnaire
To Report Vehicle Safety Defects

10424476

Medtec® Type I Field Duty

Bench Seat also know as Squad Bench

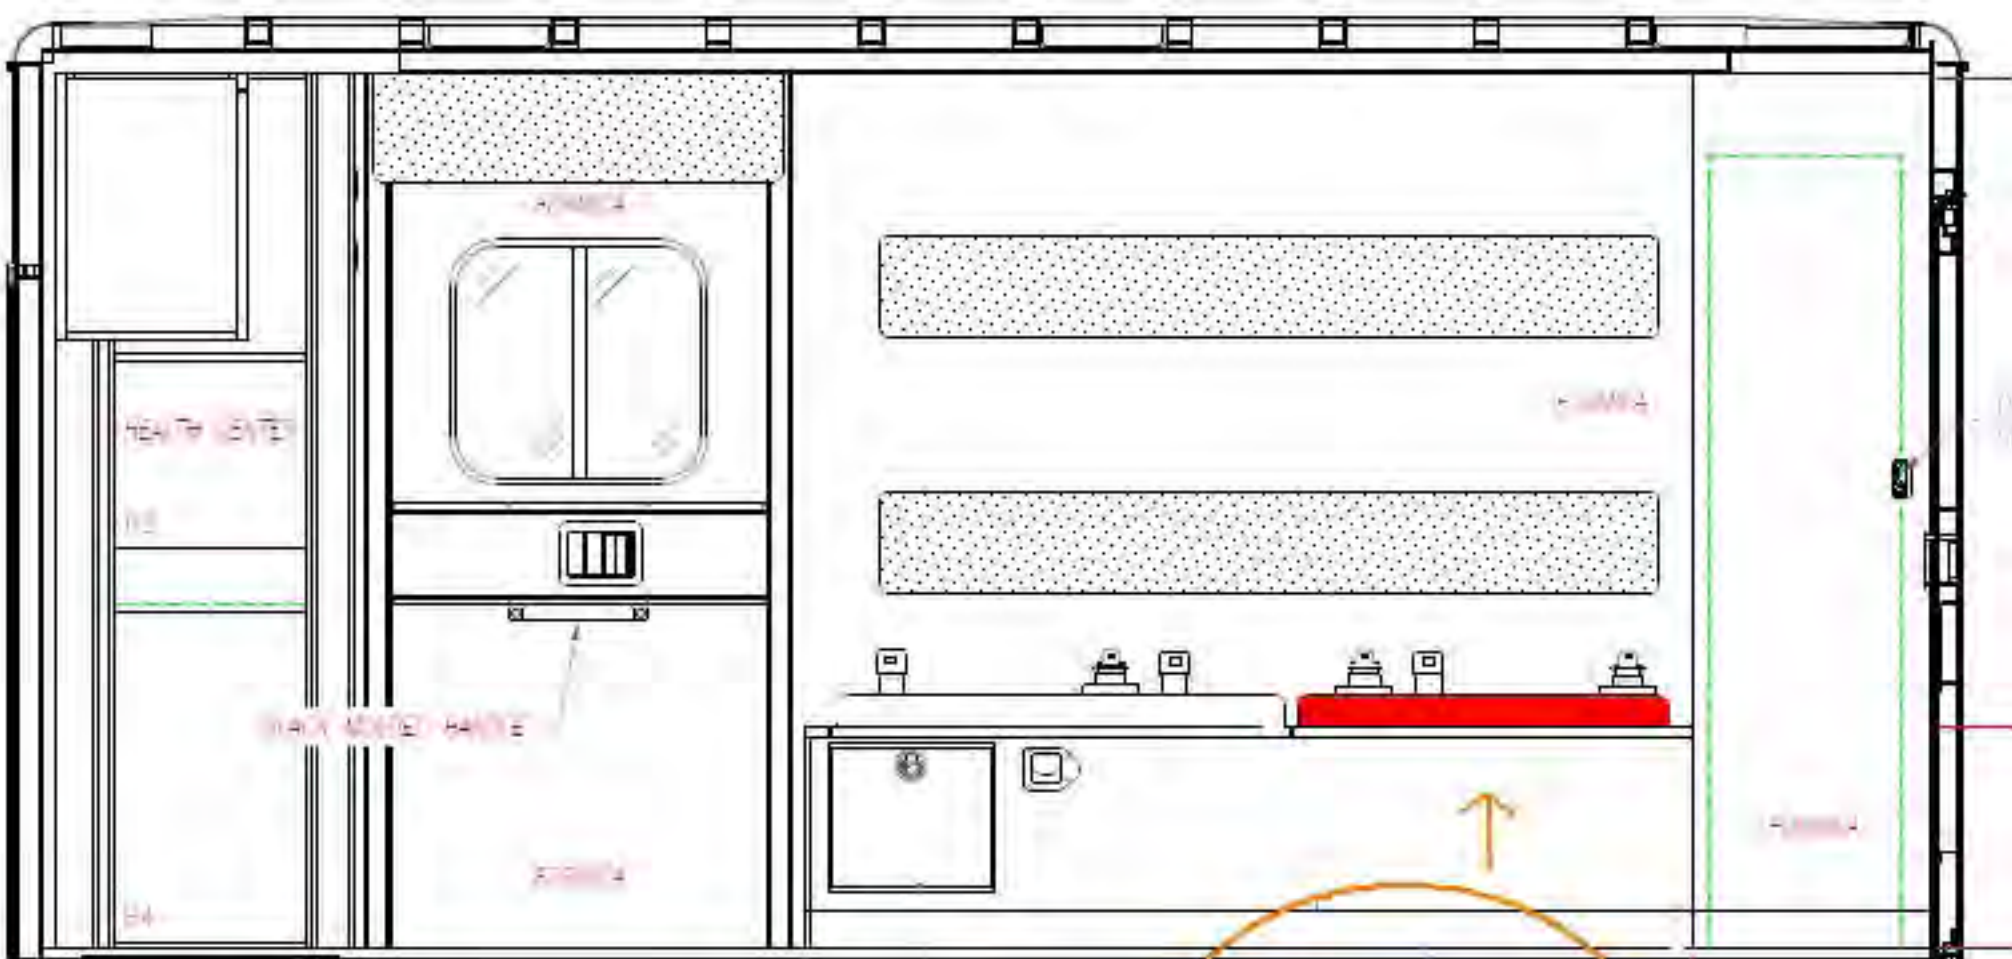
This is the seat however, this is just one drawing of the module, each module is laid out differently but construction techniques are the same.

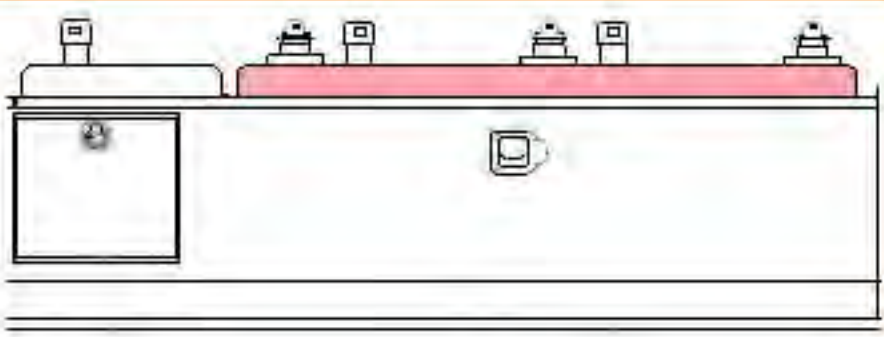
This is how our seats (at New Orleans EMS) are setup. A much longer bench seat (squad bench). It is a typical setup, because EMS agencies utilize the space under the seat to hold spare portable oxygen containers, etc.

See the size of the cushions and the spilt in the hinge. The second cushion in much longer and that corresponds with the compartment

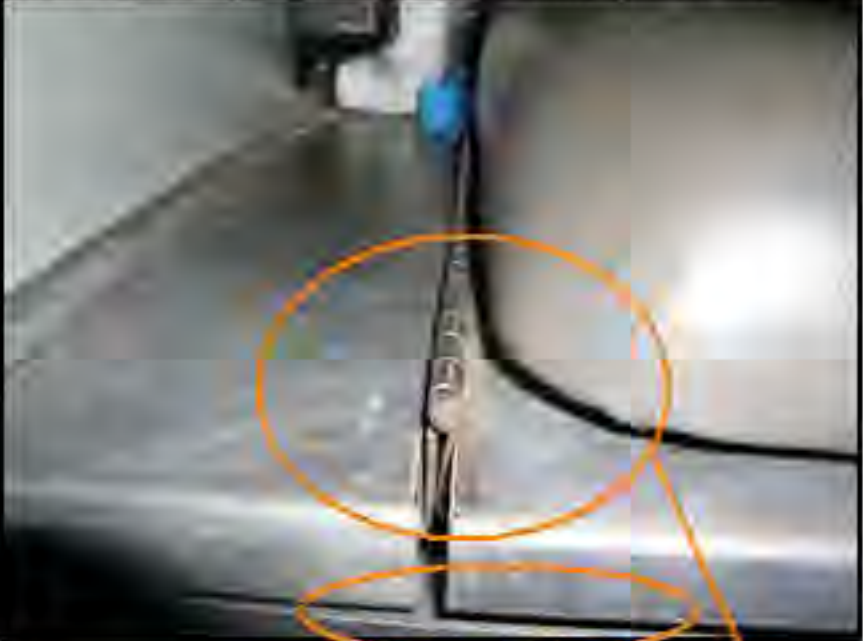
NO EMS old units from 2006 amb bench seat

In the older models, the bench seat sits on top of the compartment. In the new MedTec models, the seat sits on only the front and back but not the sides.

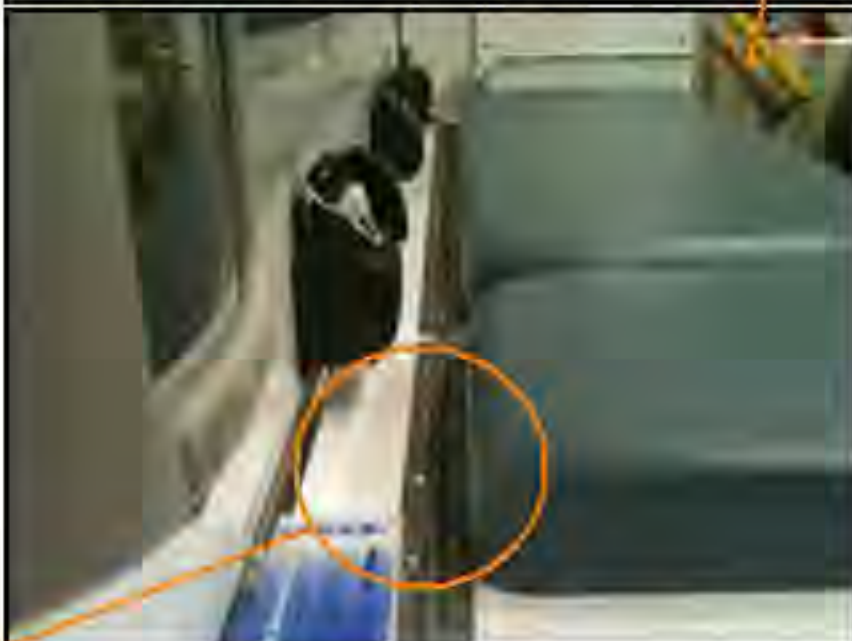
New 2011 MedTec from NO EMS

We have had an expert look at the design. He said it was not sound. The expert's issue with the seat was that the hinge was sitting on top (instead of inbetween/under, as seen in the older models). When the hinge is on top, it acts like a crowbar on the screws. The screw we also small sheet metal screws. The screws are not designed for this use. Those types of screw also are not the best at load bearing and sustaining constant forces (the kind the hinge would be applying to them).

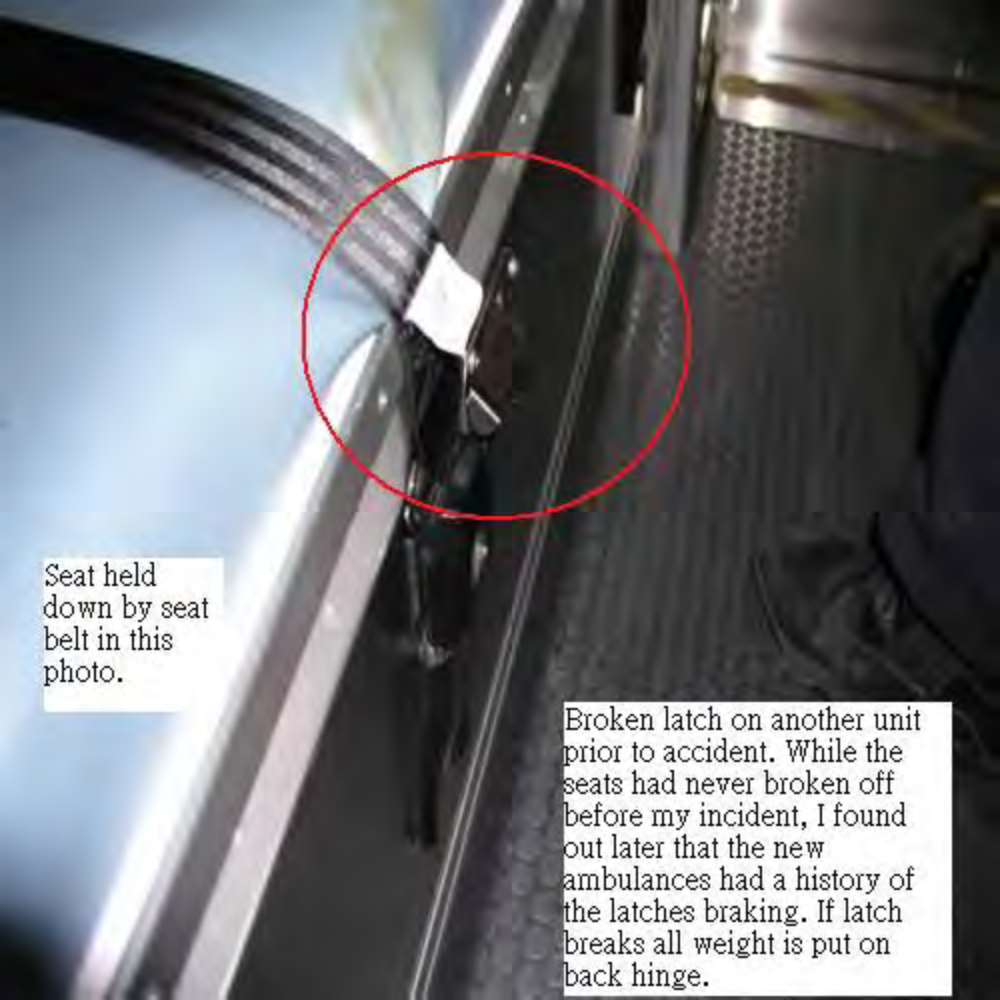
Seat held
down by seat
belt in this
photo.

Broken latch on another unit
prior to accident. While the
seats had never broken off
before my incident, I found
out later that the new
ambulances had a history of
the latches braking. If latch
breaks all weight is put on
back hinge.

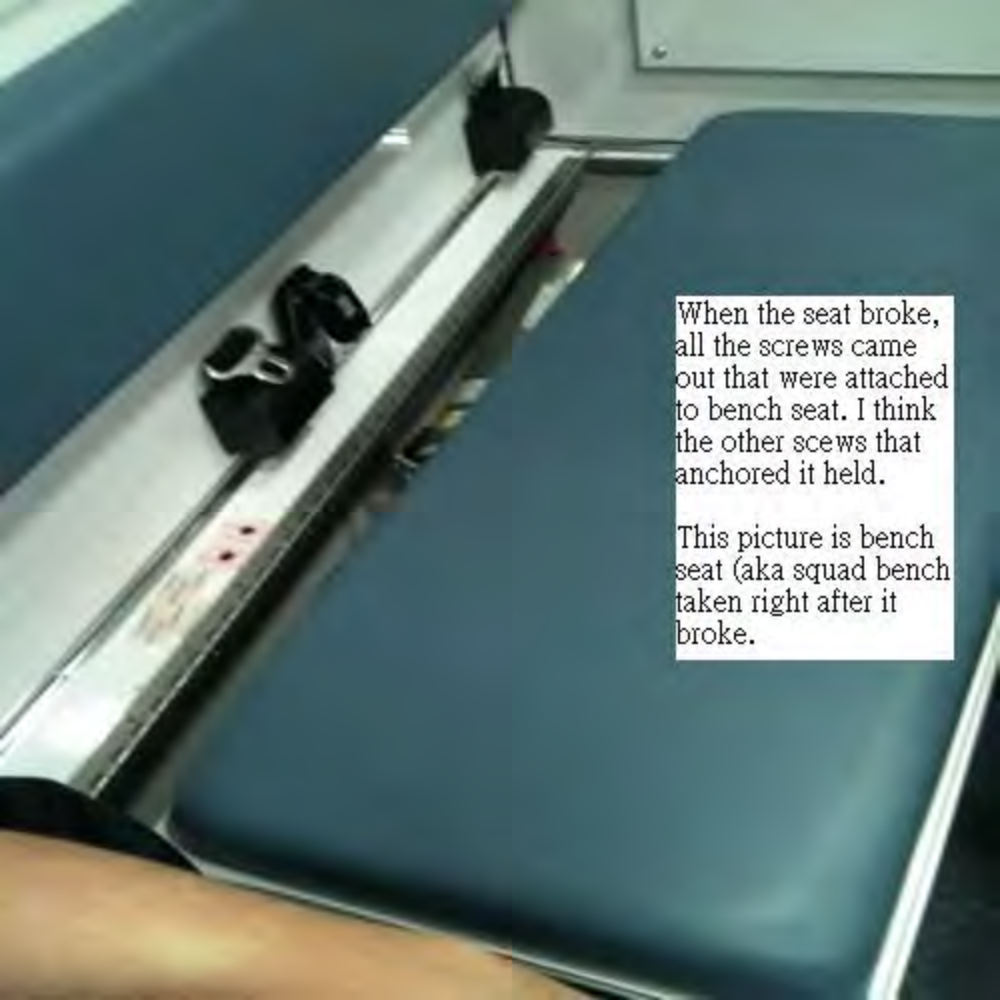
When the seat broke, all the screws came out that were attached to bench seat. I think the other screws that anchored it held.

This picture is bench seat (aka squad bench) taken right after it broke.

When the seat broke off the hinge, it slid forward (arrow 1) and the back started to fall into well (arrow 2) where spare o2 tanks are kept. I fell down along with it.

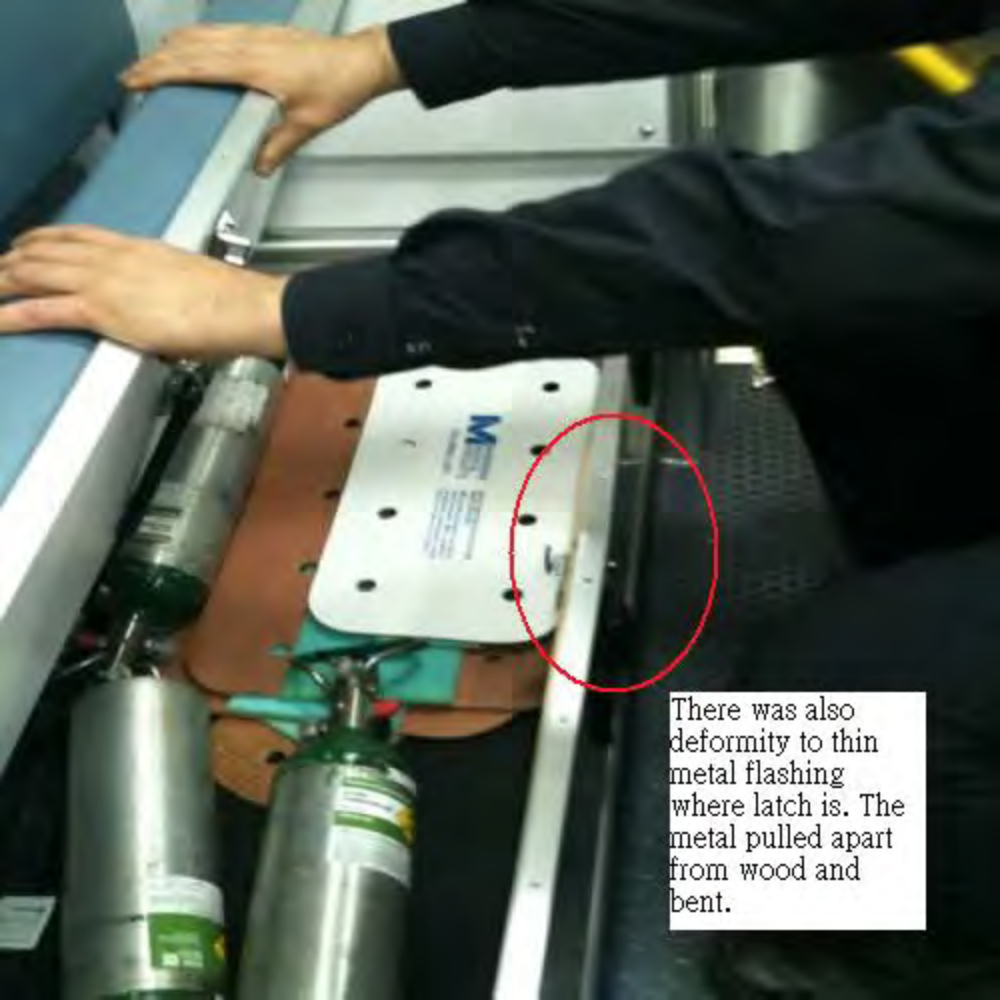
There was also deformity to thin metal flashing where latch is. The metal pulled apart from wood and bent.

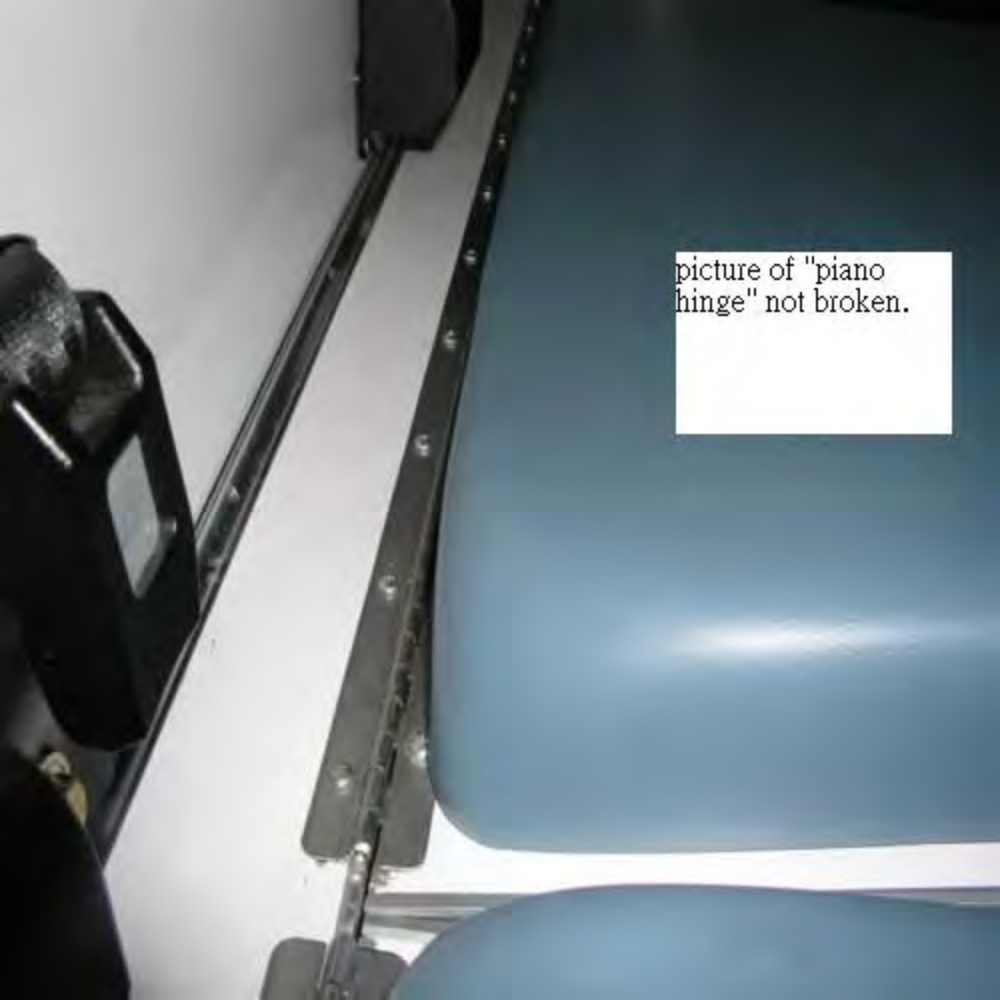
picture of "piano
hinge" not broken.

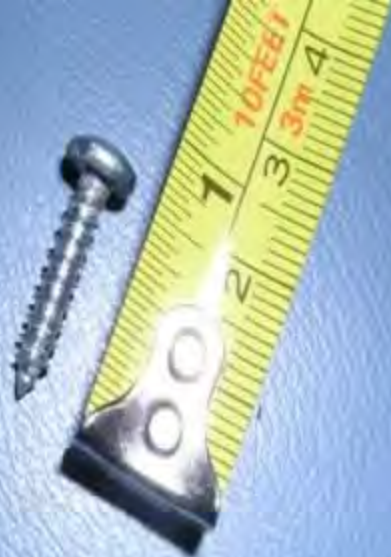
Type of screw originally used to hold piano hinge in place. This screw is what was replaced by the through and through bolt with nut.

Modification only to New Orleans EMS units.
