The purpose of this letter is to notify you of a serious, life-threatening flaw that exists in the design of the BMW R1200RT fuel pump assembly utilized in multiple model years of the R1200RT. In addition to this letter informing BMW of North America of this problem, a copy of this document has been filed as part of a new case with the United States Department of Transportation National Highway Traffic Safety Administration under temporary complaint number JBN1-18051.

A fuel pump failure that occurred in a 2005 BMW R1200RT, VIN WB10388045Z [REDACTED] in September 2011 precipitated the following investigation.

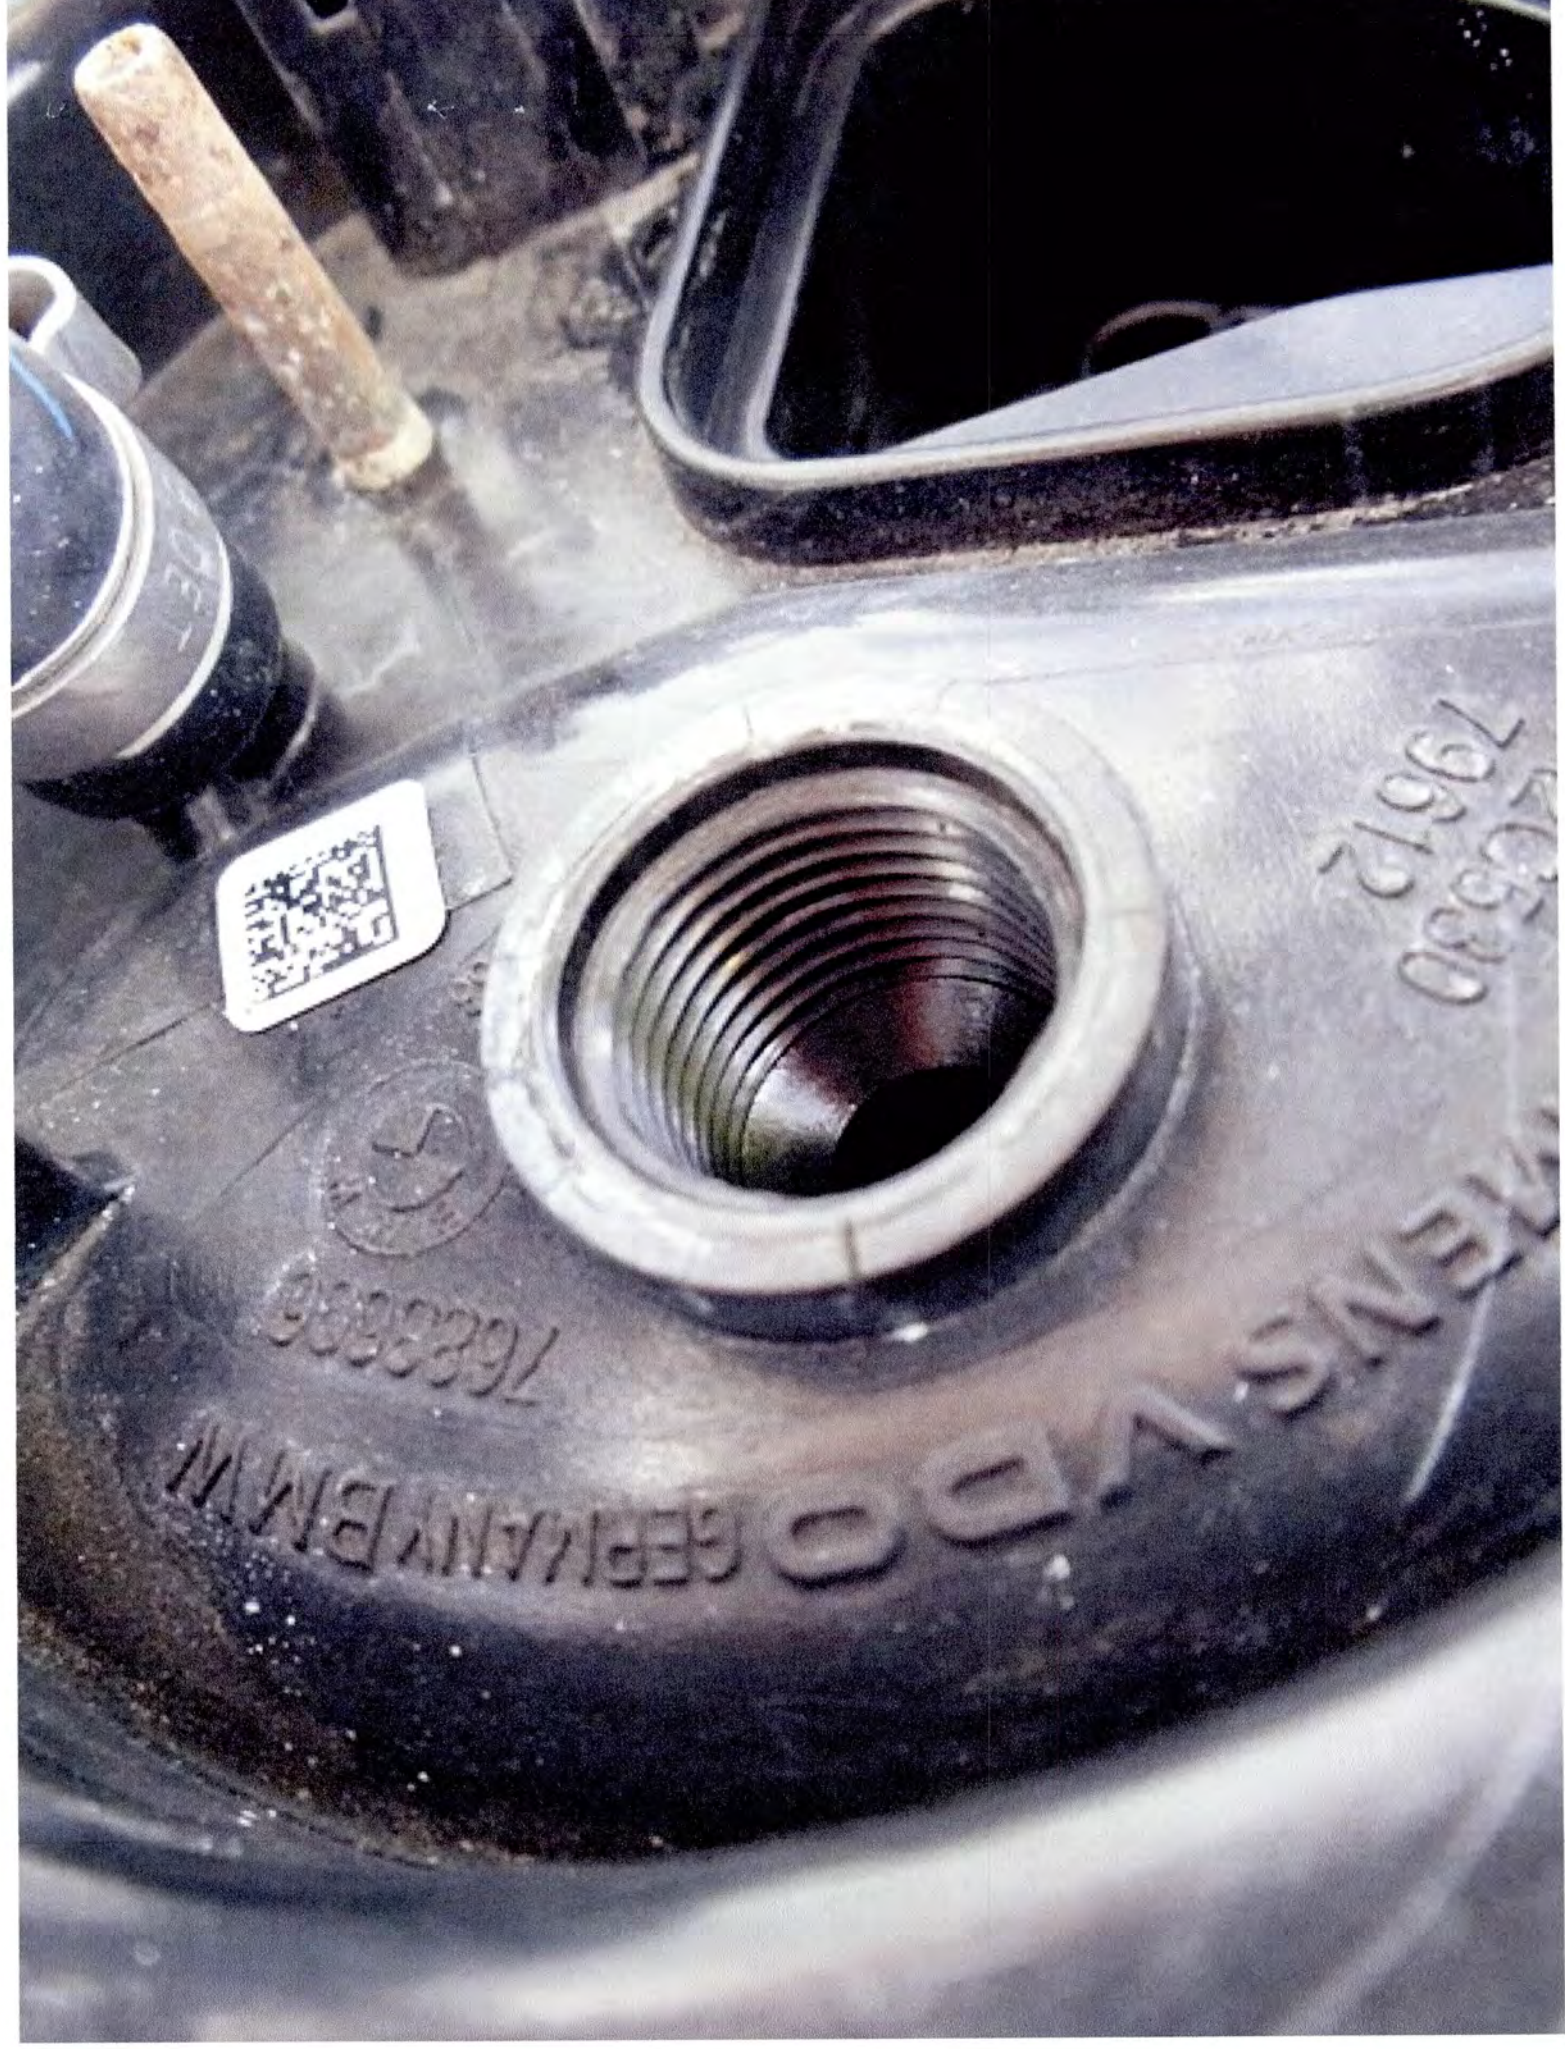
Fuel pump housing high-pressure fuel quick disconnect reinforcement flange cracks under high pressure cycling and leaks, sending raw fuel down the left fairing in close proximity of the vehicles left exhaust pipe and ignition system components. The vehicle's fairing effectively captures the fuel vapors creating a significant risk for fire. In addition, leaking fuel, streaming along the left fairing is exhausted on the rider's left leg, creating significant risk for the rider even after dismounting the vehicle. A photograph of the typical failure mode is contained within this letter.

Examination of the fuel pump assembly suggests that the high-pressure fuel quick disconnect reinforcement flange was inadequately designed for the fuel pump outlet

pressures. BMW's choice of a non-metallic (composite) pump housing combined with a composite high-pressure disconnect fitting was unwise and the failure mechanism is obvious. High pump pressure expands the composite high-pressure fitting causing it to radially load the fuel pump high-pressure quick disconnect flange. Over time, pressure cycling causes the quick disconnect reinforcement flange to crack in multiple locations allowing fuel to leak. A relatively easy (and inexpensive) fix for this design flaw would be to use a metallic quick disconnect fitting which would alleviate the radial loading of the high pressure quick disconnect reinforcement flange.

1. That BMW of North America issue an immediate voluntary recall of all R1200RT fuel pump assemblies with designs similar to that found in 2005 BMW R1200RT, VIN WB10388045Z [REDACTED]
2. That BMW of North America then repair or replace defective fuel pump assemblies at no expense to the owner.
3. That BMW of North America contact all owners who purchased replacement fuel pumps for the impacted series of vehicles and issue full refunds to those owners who indicate that the fuel pump was replaced due to a leaking high pressure quick disconnect reinforcement flange.
4. That BMW of North America redesign their fuel pump assemblies to eliminate pressure cycling stress fractures in the high pressure quick disconnect reinforcement flange.
