Thank you for your correspondence concerning your model year (MY) 2000 Buick Century vehicle. Your letter was received by the National Highway Traffic Safety Administration's (NHTSA) Office of Defects Investigation.

2000 Buick Century V6-3.1L VIN J

**Bulletin No.:** 09-06-03-004D

**Subject:** Intermittent No Crank/No Start, No Module Communication, MIL, Warning Lights, Vehicle Messages or DTCs Set by Various Control Modules - Diagnosing and Repairing Fretting Corrosion (Disconnect Affected Connector and Apply Dielectric Lubricant)

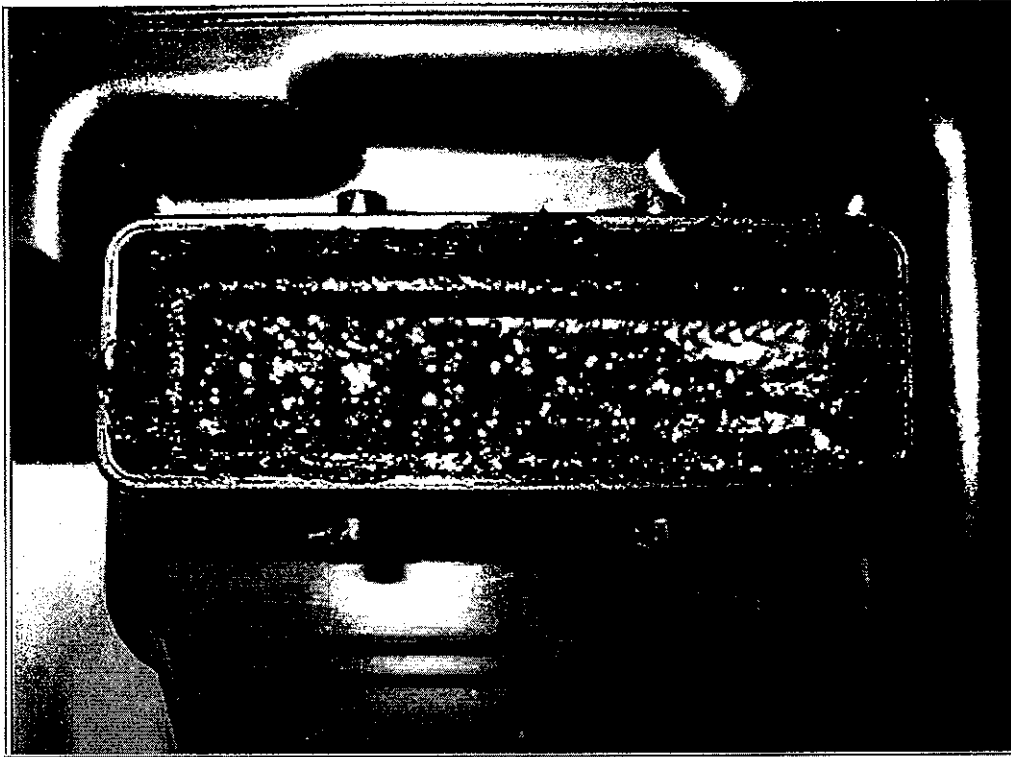
Fretting corrosion looks like little dark smudges on electrical terminals and appear where the actual electrical contact is being made. In less severe cases it may be unable to be seen or identified without the use of a magnifying glass.

**DO NOT** apply an excessive amount of dielectric lubricant to the connectors as shown, as hydrolock may result when attempting to mate the connectors. Use **ONLY** a clean nylon brush that is dedicated to the repair of the conditions in this bulletin.

3. With a one-inch nylon bristle brush, apply dielectric lubricant to both the module/component side and the harness side of the affected connector(s).
  4. Reconnect the affected connector(s) and wipe away any excess lubricant that may be present.
  5. Attempt to duplicate the condition by using the following information:
    - DTC Diagnostic Procedure
    - Circuit/System Description
    - Conditions for Running the DTC
    - Conditions for Setting the DTC
    - Diagnostic Aids
    - Circuit/System Verification
- If the condition cannot be duplicated, the repair is complete.
- If the condition can be duplicated, then follow the appropriate DTC, Symptom or Circuit/System Testing procedure (refer to SI).
