**Vehicle Owner's Questionnaire**  
To Report Vehicle Safety Defects  
1-888-DASH-2-DOT  
(1-888-327-4236)  
INTERNET: www.nhtsa.dot.gov/hotline

Reference No.  
10430011

Thank you for providing me with my case information with regards to the brake failure on my 2003 GMC Sierra 1500. The following is a description of the incident, failure and crash resulting from this failure:

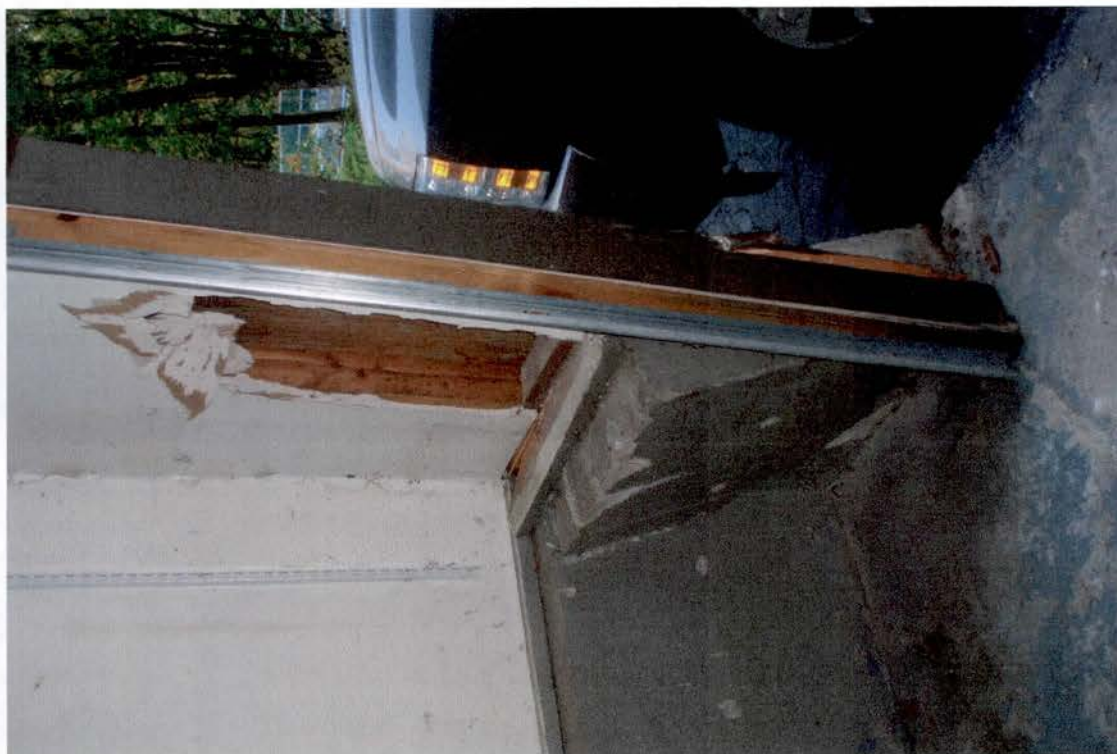
PHOTO B

The vehicle crashed into the concrete foundation of my parent's home causing both major damage to the foundation as well as damage to the hood and bumper of the vehicle.

Attachment 4: Photos showing damages (photos A & B) and required repairs (photo C) to home.
