From: [Wells, Cynthia CTR \(NHTSA\)](#)
To: [Fogle, Brenda CTR \(NHTSA\)](#)
Subject: FW: Gas hose stress crack
Date: Wednesday, November 09, 2011 3:47:12 PM
Attachments: [Propane Stress Crack1.jpg](#)
[Propane hose tear.jpg](#)
[Gas1a.jpg](#)
[gas2a.jpg](#)
[gas3.jpg](#)
[gas4.jpg](#)
[gas5.jpg](#)
[rwservlet.pdf](#)

Reference No.
10433994

Make
COACHMEN

Model
FREELANDER

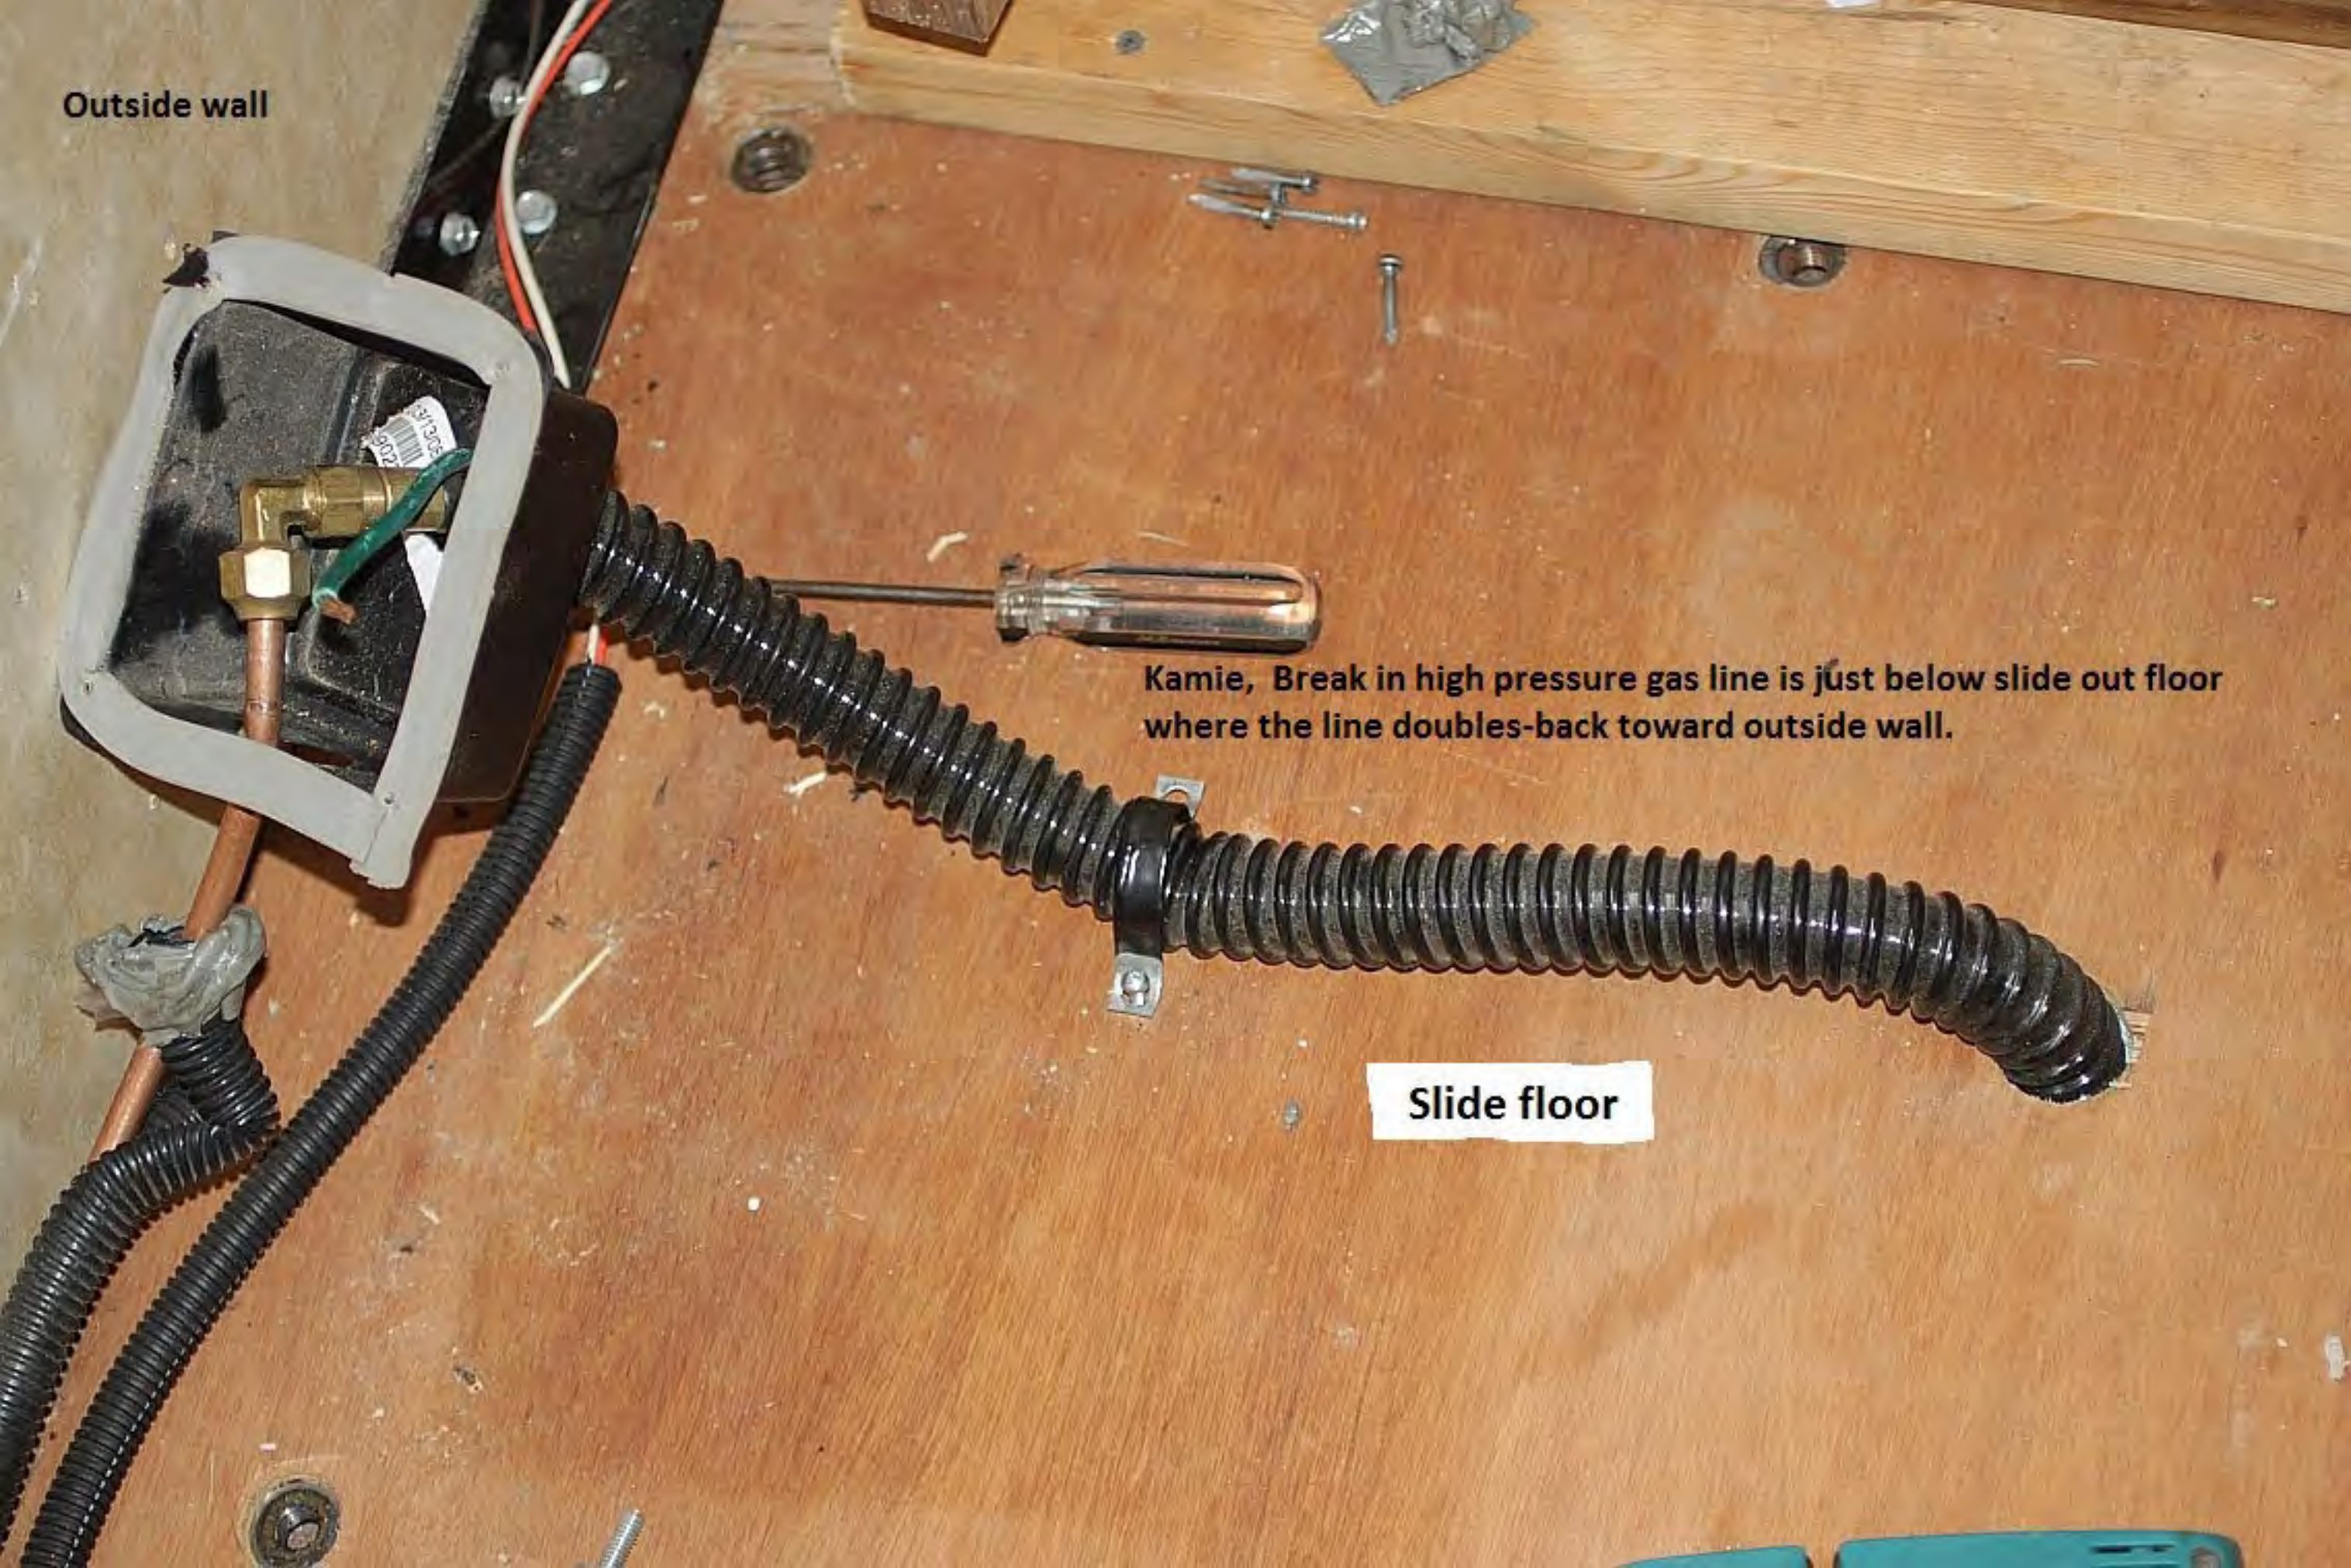
Outside wall

Kamie, Break in high pressure gas line is just below slide out floor where the line doubles-back toward outside wall.

Slide floor

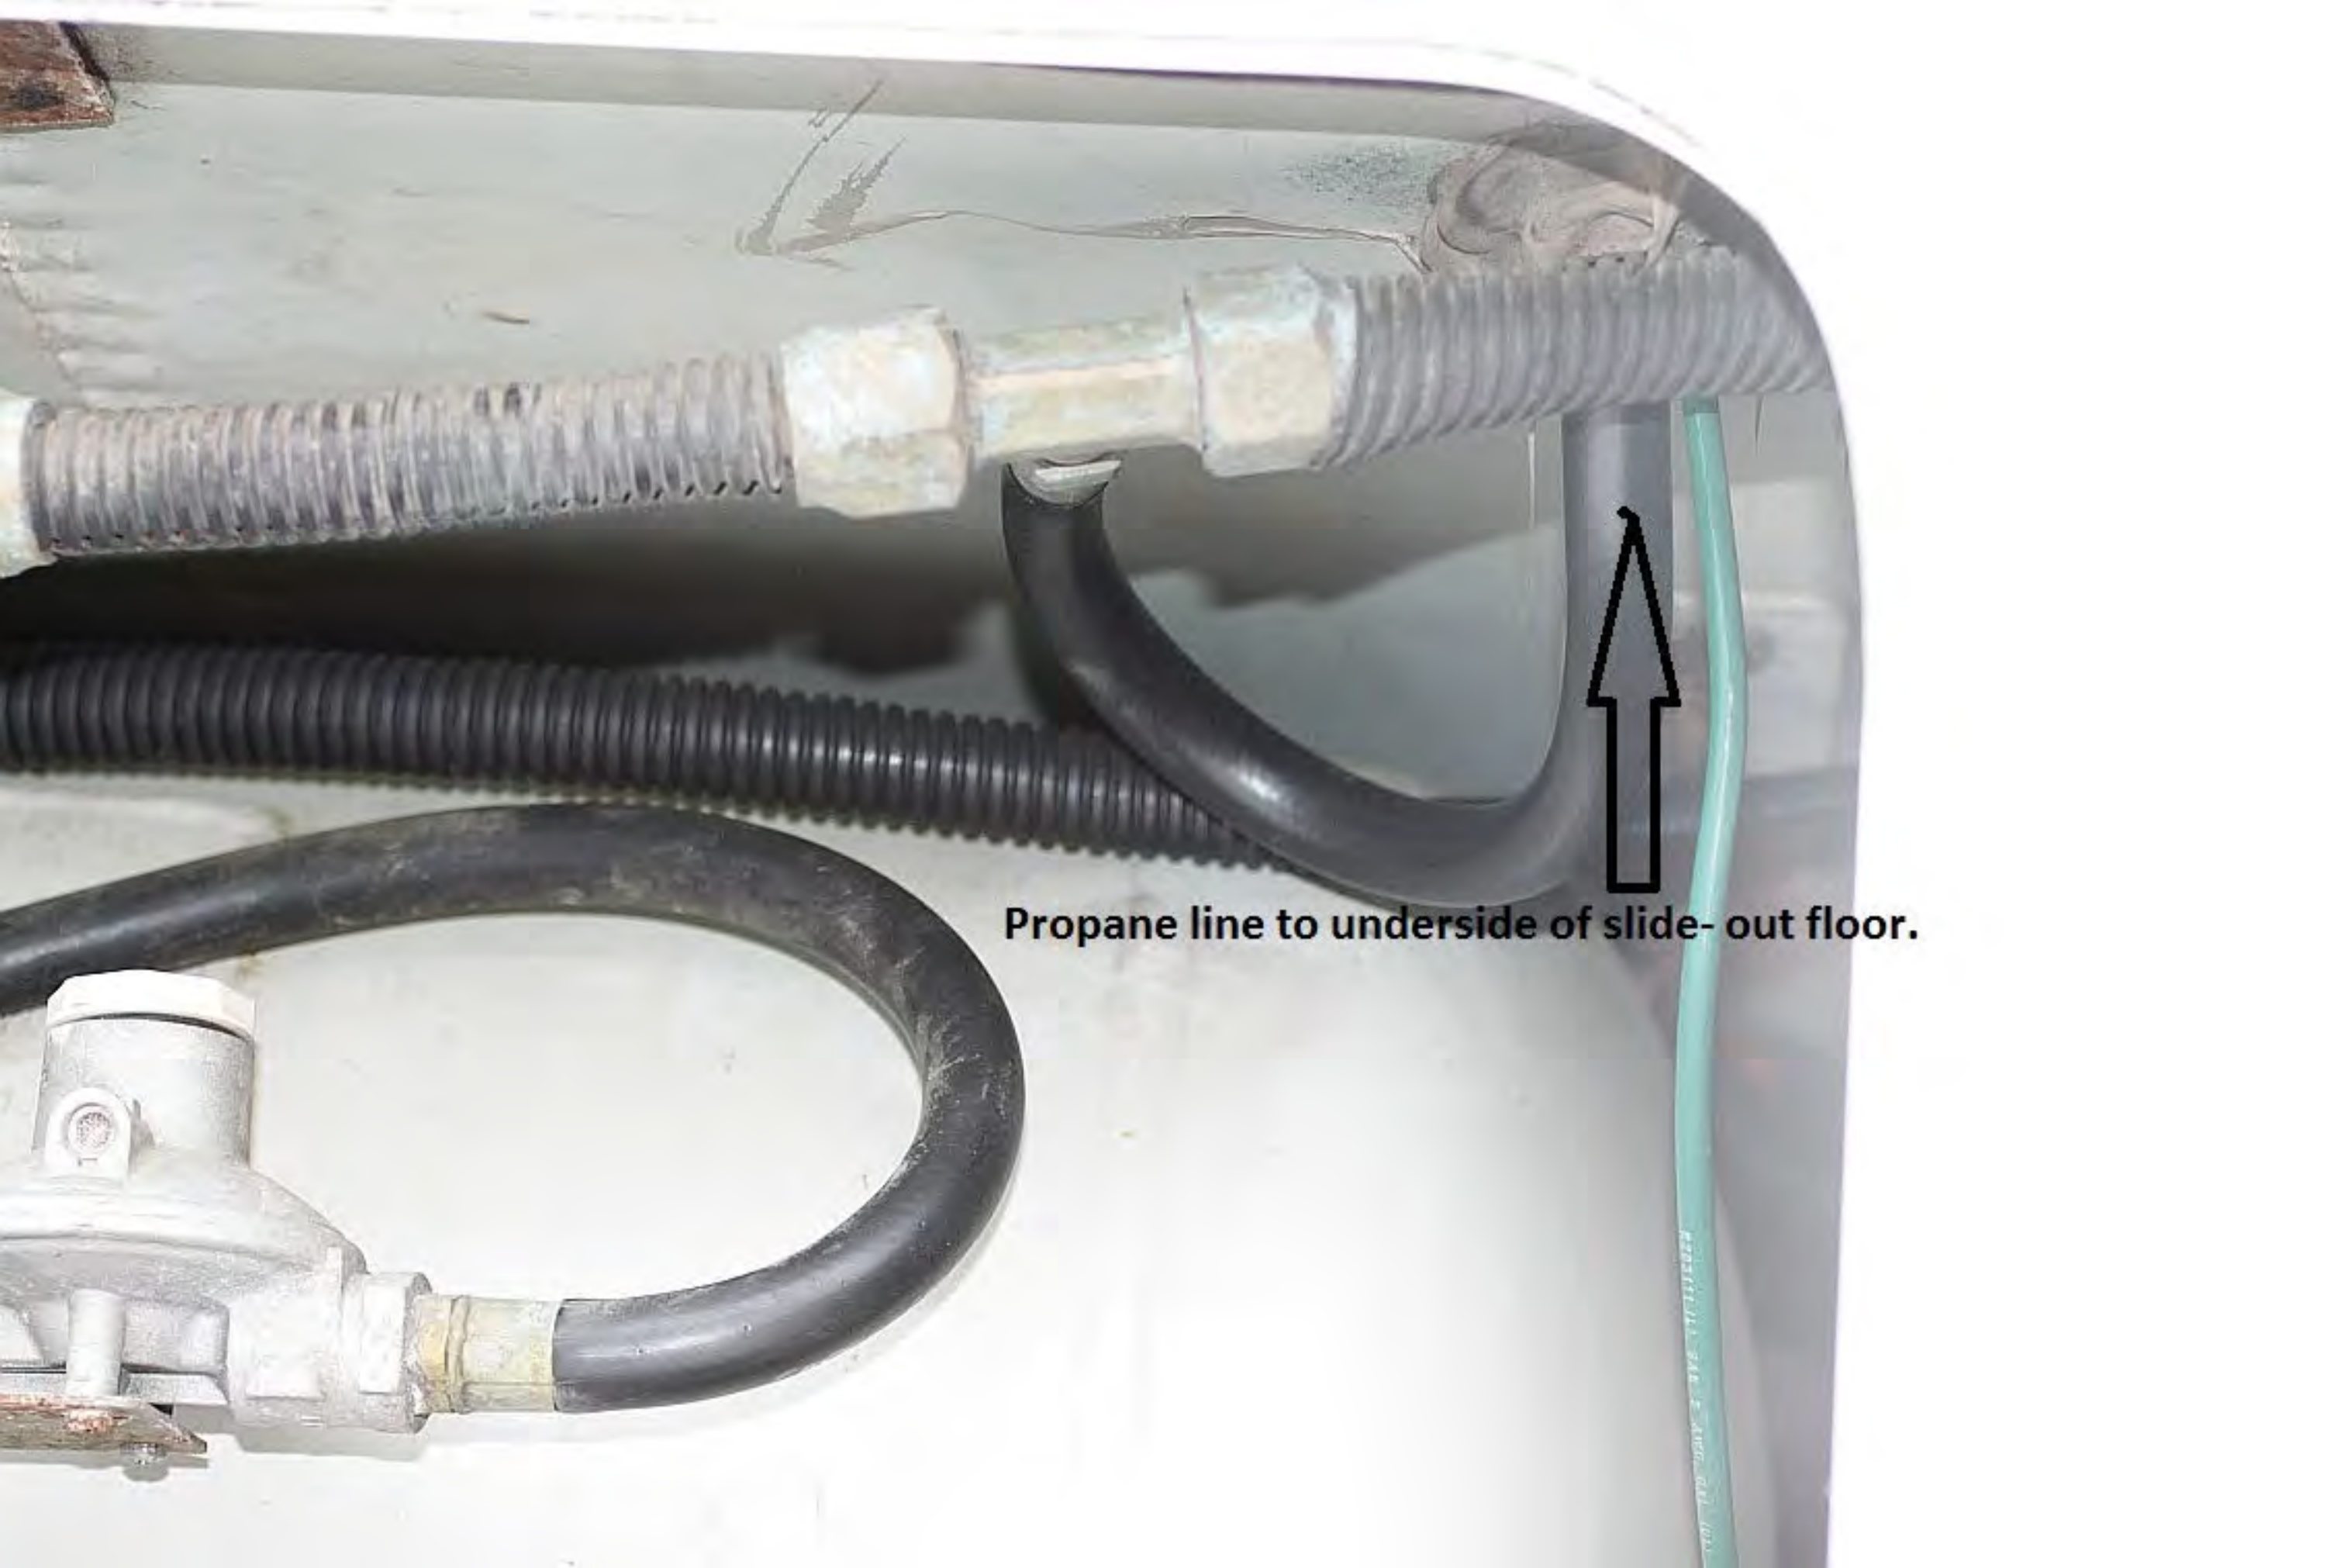
Propane line to underside of slide- out floor.

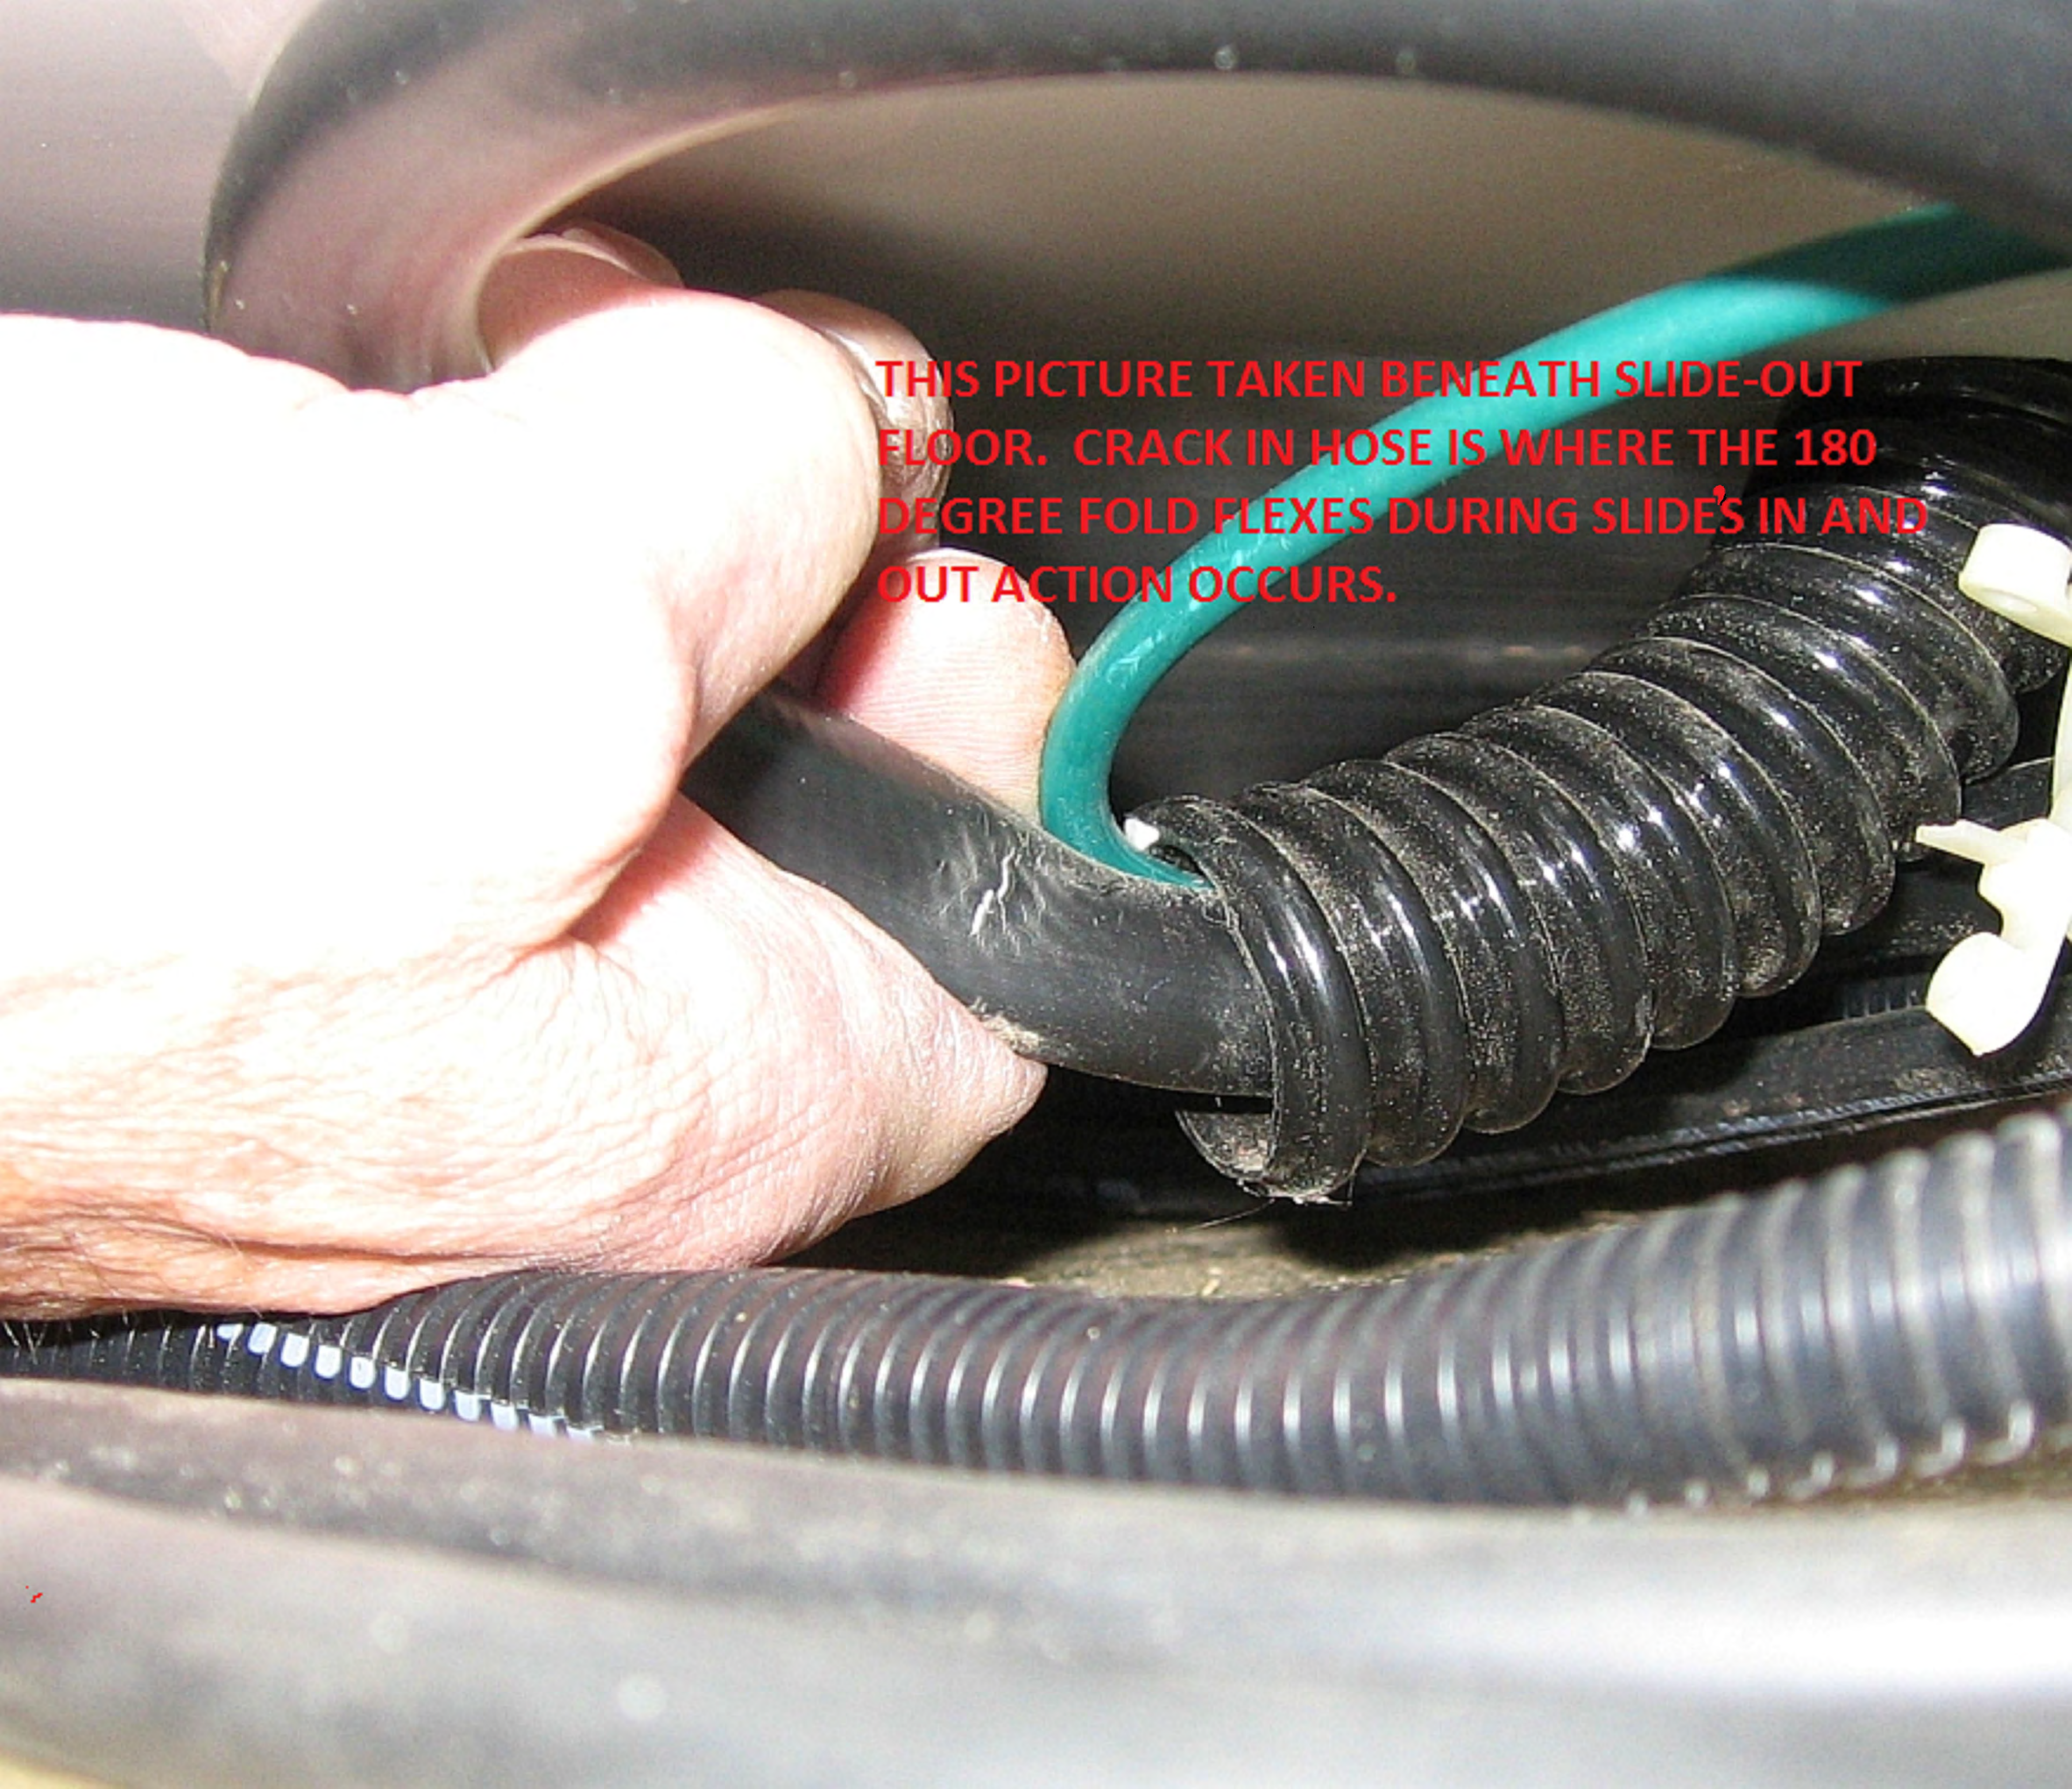
THIS PICTURE TAKEN BENEATH SLIDE-OUT FLOOR. CRACK IN HOSE IS WHERE THE 180 DEGREE FOLD FLEXES DURING SLIDE'S IN AND OUT ACTION OCCURS.
