Re: Toyota Prius Steering, Upper Intermediate Extension Shaft #2, Manufacturing Defect  
w/resp/to Recall 12V-537 (Lower Intermediate Extension Shaft #1, Manufacturing Defect)

Vehicle: [REDACTED] Subject Vehicle 2005 Toyota Prius  
VIN: JTDKB20U953 [REDACTED] MfgDt 10/04  
Issue: Alleged Steering Malfunction

05Prius  
Data & Analysis, Steering Failure

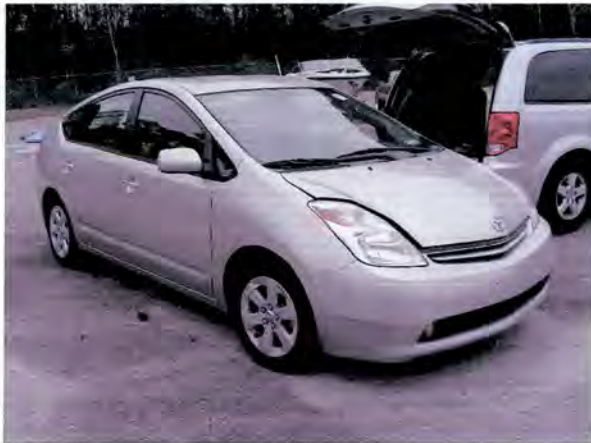
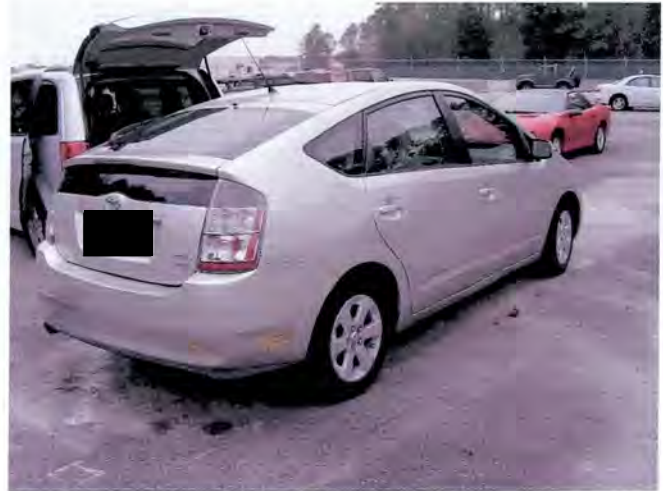
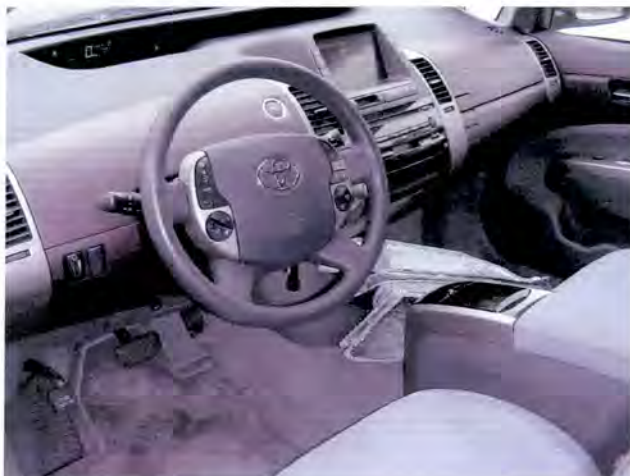
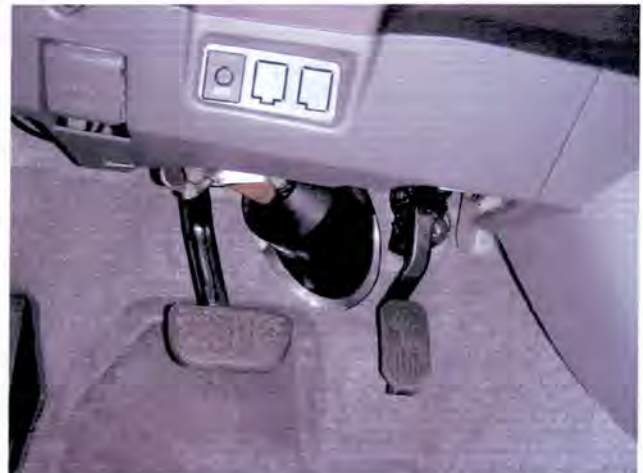
Exhibit C.1 The SV as found.

1. On 4Jan13, I flew to Jacksonville FL Naval Air Station (JAX, NAS), and inspected the subject vehicle (SV) in the base impound lot. My activities included retrieval of ECM and SRS data and an inspection of the occupant compartment steering column components [no lift was available to allow for inspection of the lower components]. On immediate vehicle viewing, the subject vehicle steering wheel was shown by [REDACTED] to rotate multiple turns, in both directions, with no resistance and no response of the front wheels. I made a video of that demonstration. Exhibit C.1 shows the SV as found. Note the upper intermediate steering shaft #2 seen hanging over brake pedal.

Note the upper intermediate steering shaft #2  
hanging over brake pedal

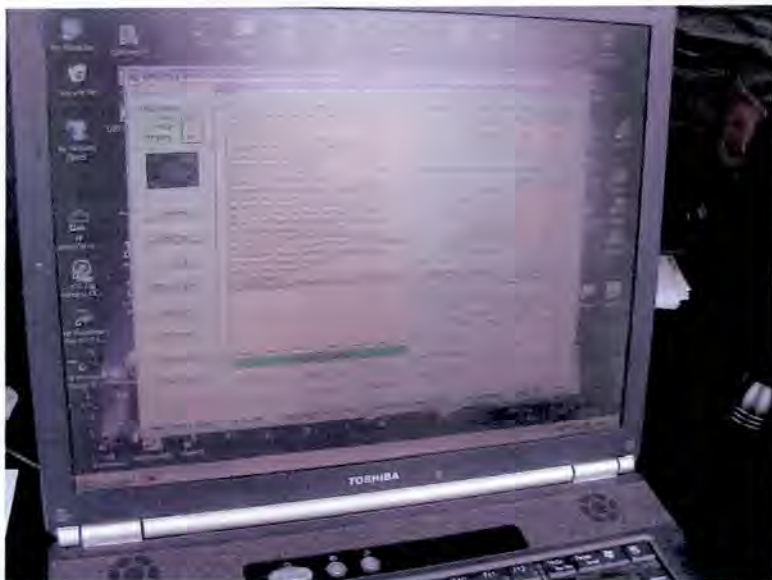
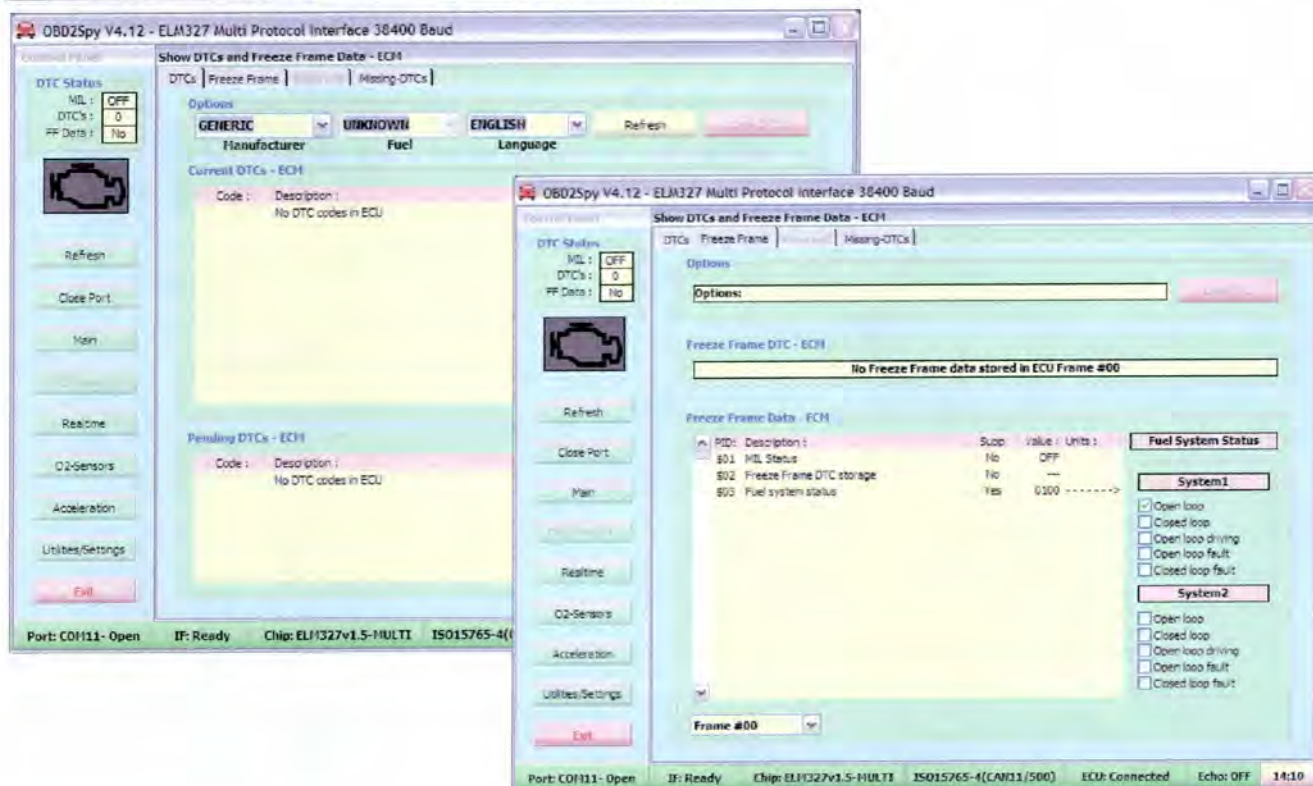
2. My first inspection step was to interrogate the ECM [engine control computer] with OBD2Spy v4.12 and AutoEnginuity V11.0 scanners. The ECM evidenced no DTCs and no Freeze Frame data on either scanner. See Exhibit C.2.

Exhibit C.2. Interrogation of ECM [engine control computer] with OBD2Spy v4.12 and AutoEnginuity V11.0 scanners. The ECM evidenced no DTCs and no Freeze Frame data on either scanner.

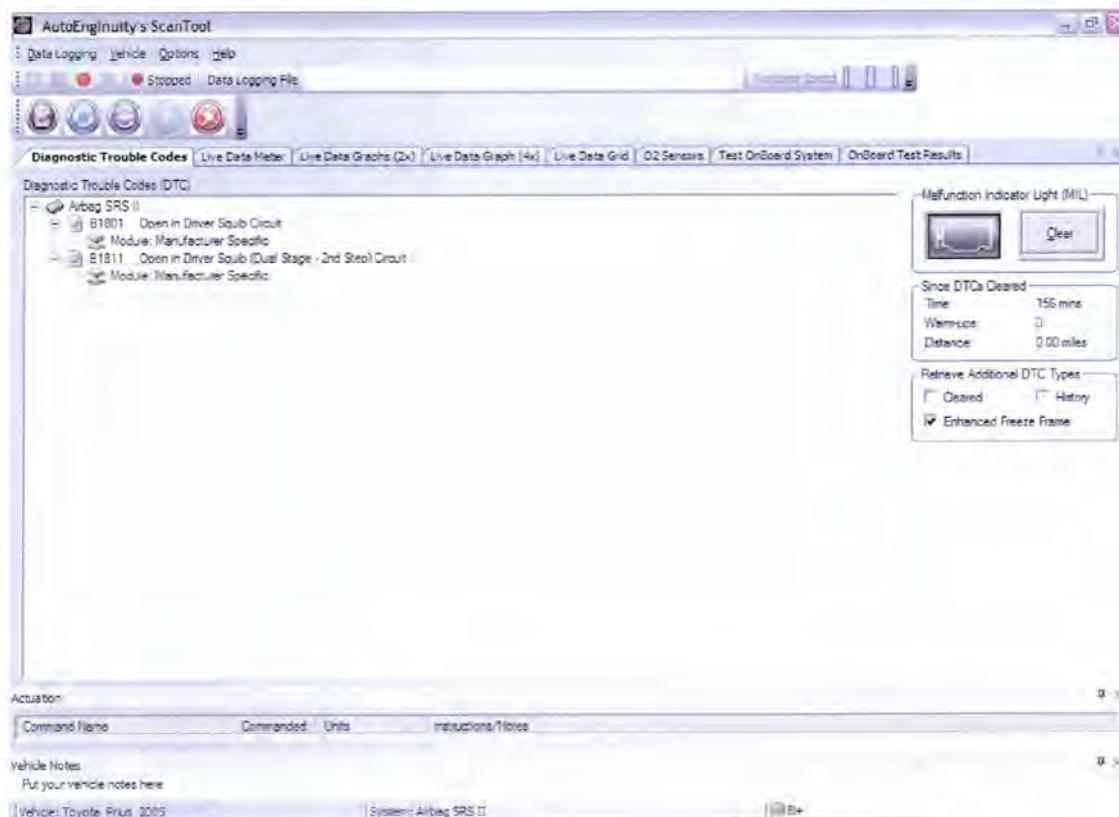
3. Next, the SRS ECU [EDR] was interrogated with AutoEnginuity V11.0 scanner and a Bosch CDR v 8.10. No event data was saved in the EDR. DTCs B1801 [Driver Squib Stage 1 = open] and DTC B1811 [Driver Squib Stage 2 = open] were retrieved from the SRS ECU. These are entirely consistent with the unrestricted steering wheel which clearly ruptured the clockspring [used to connect to driver airbag squib 1 and squib 2]. See Exhibit C.3.

See Exhibit C.3. The SRS ECU [EDR] was interrogated with AutoEnginuity V11.0 scanner and a Bosch CDR v 8.10. No event data was saved in the EDR. DTCs B1801 [Driver Squib Stage 1 = open] and DTC B1811 [Driver Squib Stage 2 = open] were retrieved from the SRS ECU. These are entirely consistent with the unrestricted steering wheel which clearly ruptured the clockspring [used to connect to driver airbag squib 1 and squib 2].

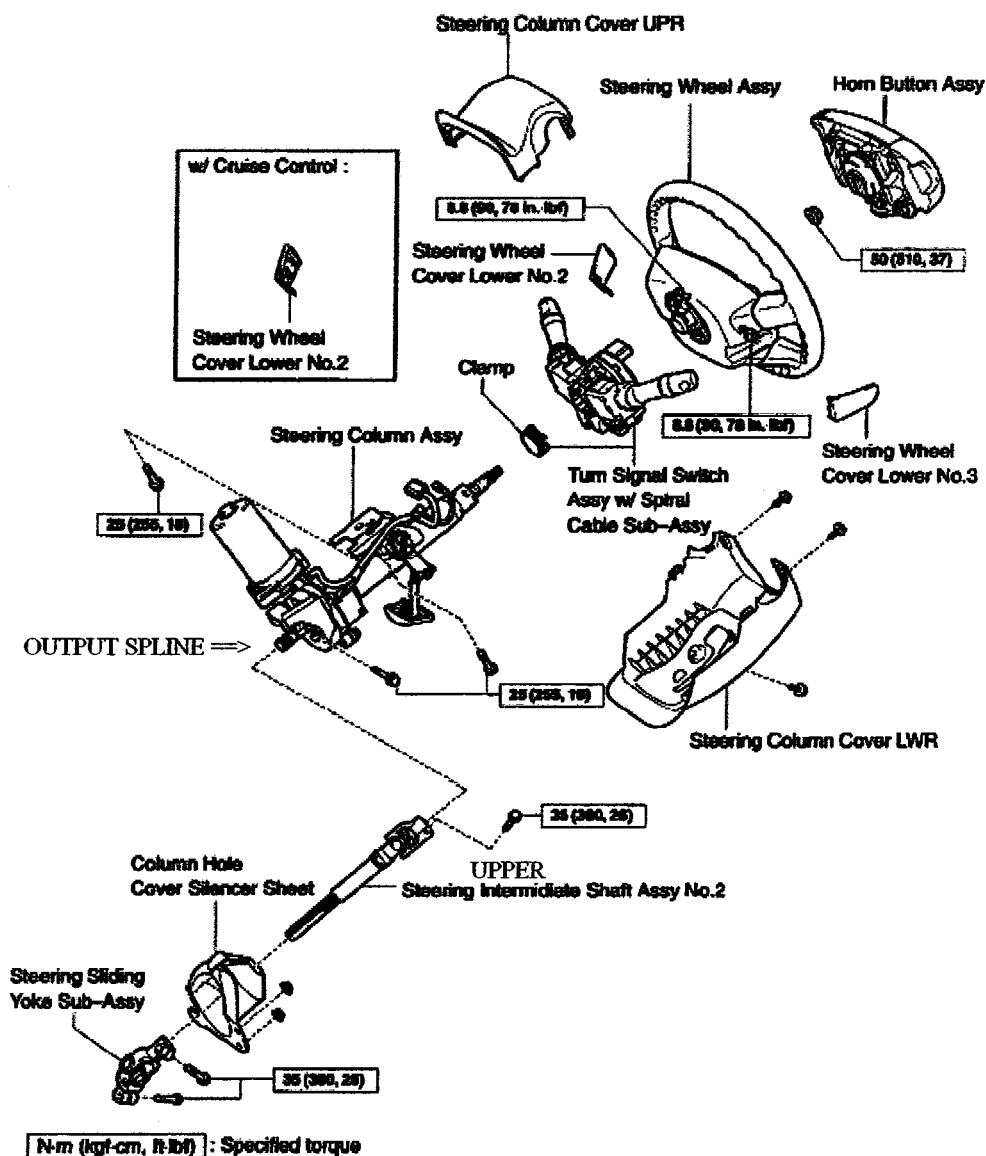
Exhibit C.4.1 Upper half of the steering column linkage. The steering column linkage in the subject 2005 Prius consists of two intermediate shafts and an electric power assist top column. Note annotated power assist output spline and upper intermediate shaft #2.

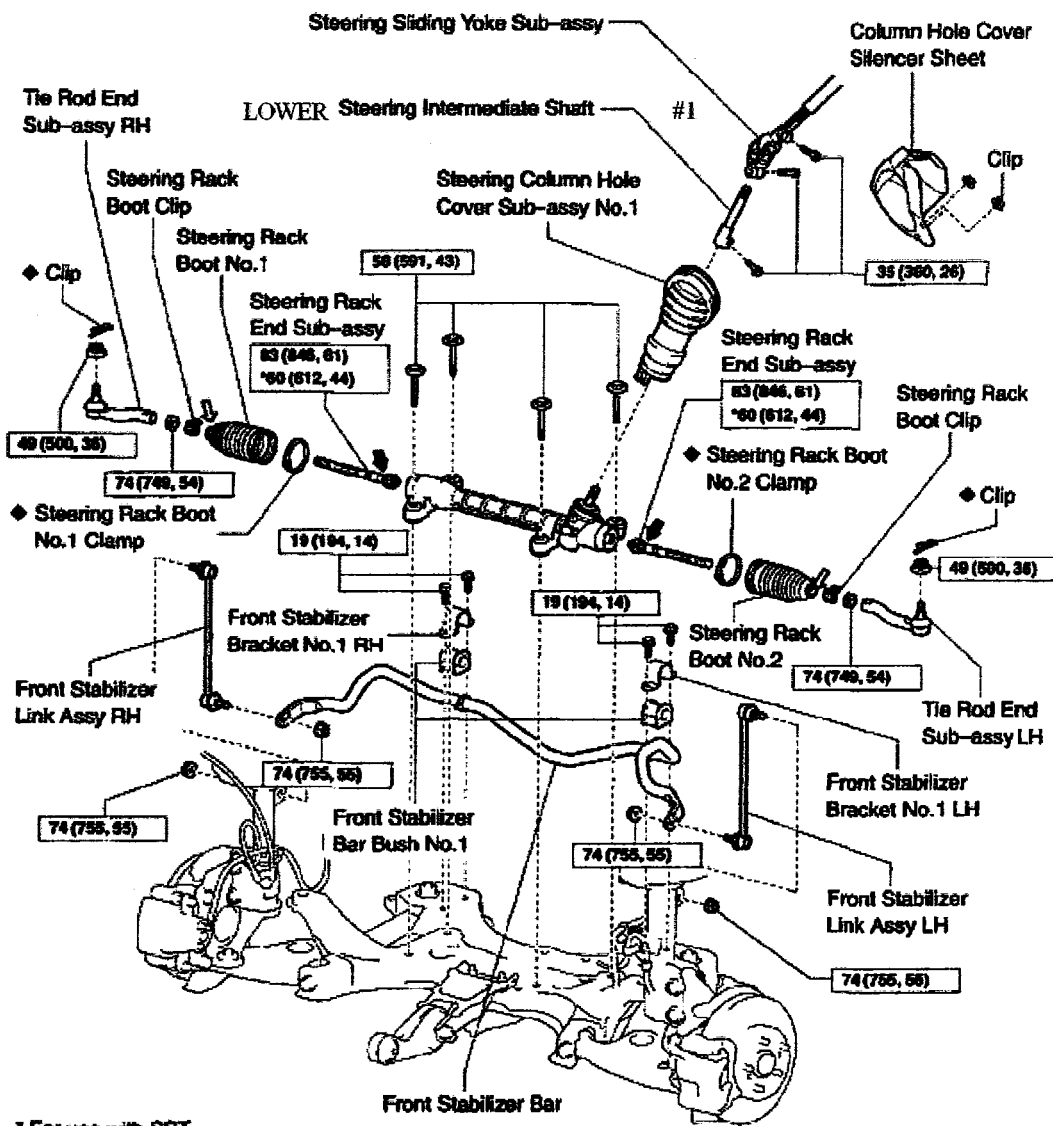
Exhibit C.4.2 Lower half of the steering column linkage. Note annotated lower intermediate shaft #1.

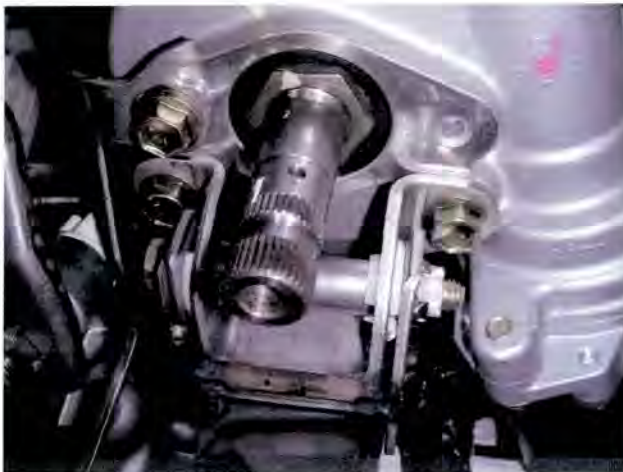
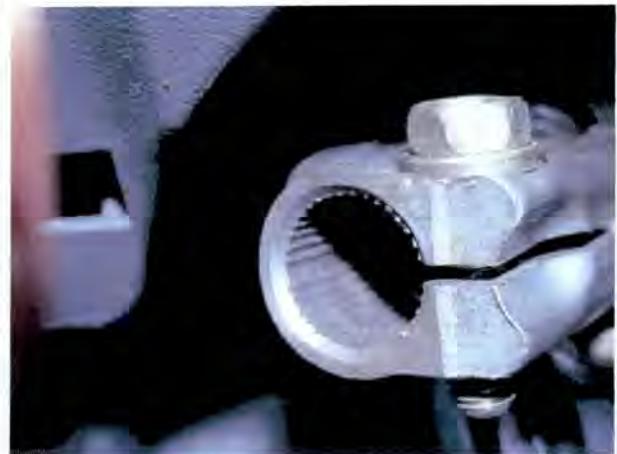
8. Inspecting the upper column for possible causes of this, I found that the upper steering intermediate shaft [#2] had separated from the exit spline of the power assist column output. This separation had no observable or known intervening cause such as a collision or abusive usage. The upper steering column intermediate shaft #2 separation is not part of the Toyota Steering Recall 12V-537 or any of its predecessor versions. See Exhibit C.8.

Exhibit C.8. Showing the upper steering intermediate shaft [#2] as found separated from the exit spline of the power assist column output. This separation had no observable or known intervening cause such as a collision or abusive usage.

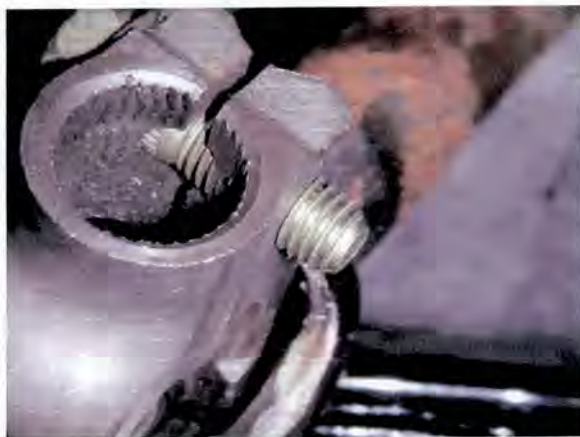
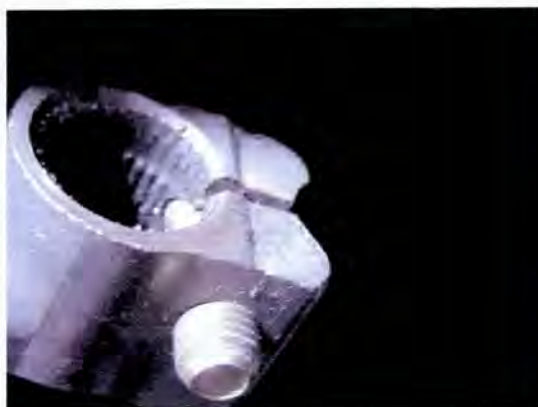
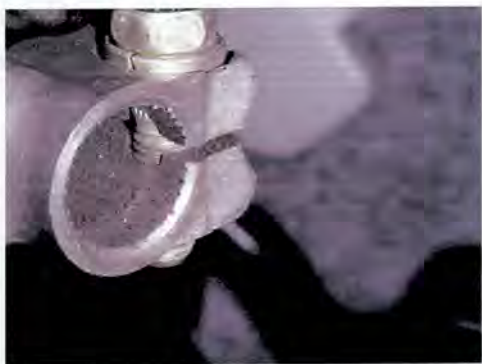
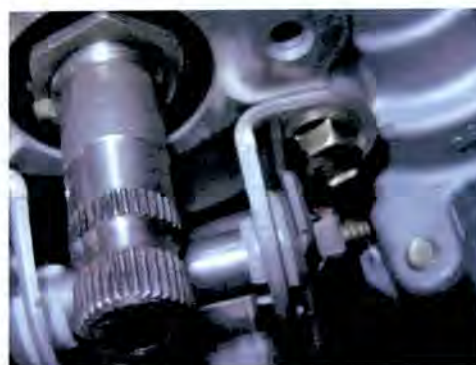
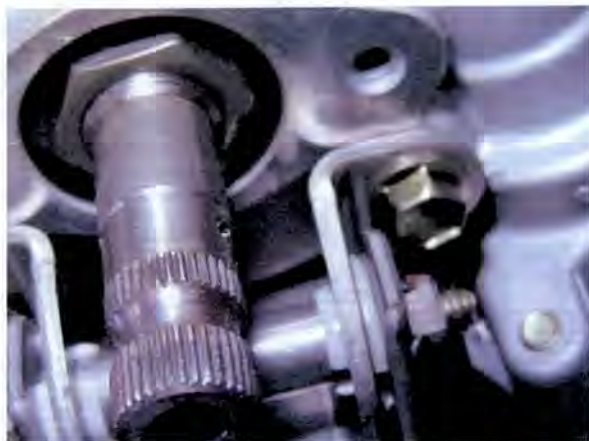
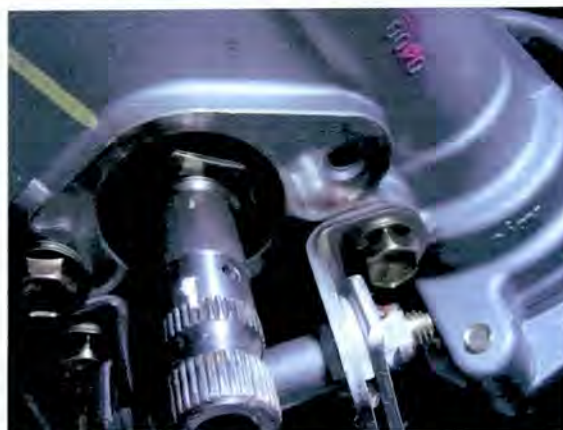
9. Exhibit C.9 shows the upper mating end of the upper end of the upper steering intermediate shaft #2 and the fact that its internal splines are mechanically worn away for approximately 1/4 of the intended mating distance [with the power assist exit spline]. It should be noted that the upper intermediate shaft #2 is actually part of a sliding link, and the malfunction portion was intended by design to have been locked onto the power assist exit spline. This lock function is accomplished by its affixing bolt occupying the machined annulus in the power assist exit spline, as well as 'cinching up' the intermediate shaft #2 internal spline connection [this is a venerable mechanical design, conceptually similar to the manner in which many bicycle pedals are locked onto the bicycle drive gear axle]. There was no deformation of the power assist exit spline indicating a possible drag-over of the locking bolt.

10. Since the locking bolt was found intact in the intermediate shaft, and was no deformation of the power assist exit spline indicating a possible drag-over, the locking bolt could not ever have been properly locked onto the power assist exit spline. Additionally, a careful examination of location of the rust marks on the power assist exit spline show that the upper intermediate shaft #2 was only installed on approximately the first third of the power assist exit spline. Its intended design [based on proper locking bolt position would have been for complete coverage of the upper intermediate shaft #2 spline with the power assist exit spline - with the locking/cinching bolt residing in the power assist exit spline annulus. Exhibit C.9 shows the SV bolt and the power assist exit spline annulus.

11. Exhibit C.9 also shows that the worn section of the upper intermediate shaft #2 spline coincides with the approximate [NON-rust mark delineated, covered] portion of the power assist exit spline.

Exhibit C.9 shows the upper mating end of the upper end of the upper steering intermediate shaft #2 and the fact that its internal splines are mechanically worn away for approximately 1/4 of the intended mating distance [with the power assist exit spline]. It should be noted that the upper intermediate shaft #2 is actually part of a sliding link, and the malfunction portion was intended by design to have been locked onto the power assist exit spline. Note metallurgical debris inside spline cavity.

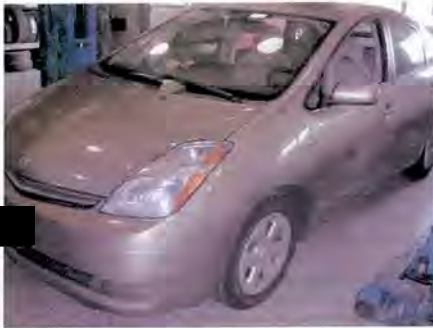
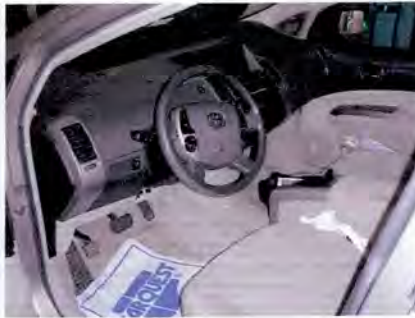
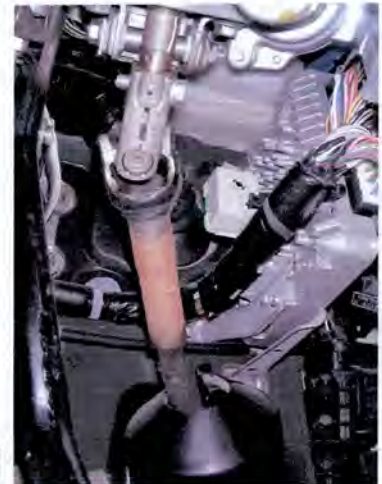
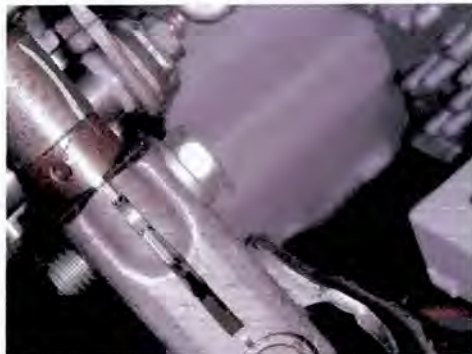
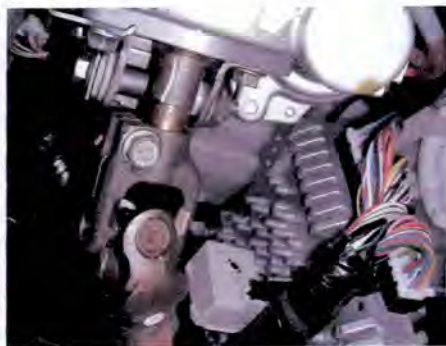
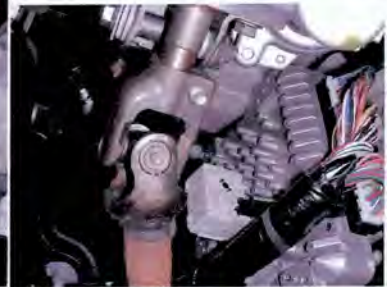
To confirm the applicability of my exemplar, I checked the part #s of the OEM upper steering intermediate shaft #2 for both model years. It turns out that Toyota installed a new P/N 45260-47052 on vehicle production after Nov05 and specified that same P/N as superceding the OEM shaft P/N for any replacements on 2005 MY vehicles. Thus the mechanical design for both model years is by definition, identical.

Exhibit 12 A photo sequence showing that exemplar vehicle and its upper intermediate steering shaft #2 assembly on the exemplar power assist exit spline annulus. These photos clearly show, with no ambiguity, that a proper installation includes the cinching bolt properly residing in the power assist exit spline annulus.
