**Vehicle Owner's Questionnaire**  
To Report Vehicle Safety Defects  
1-888-DASH-2-DOT  
(1-888-327-4236)  
INTERNET: www.nhtsa.dot.gov/hotline

Repository   
Reference No.  
10452347

17 digit Vehicle Identification Number Located at bottom of windshield on driver's side: WBAEV53423 [REDACTED]  
Make: BMW Model: 330I Model Year: 2003  
Date Purchased: [REDACTED] Dealer's Name and Telephone Number: [REDACTED] Engine: [REDACTED] Fuel Type: [REDACTED]  
Original Owner:  Dealer's City: [REDACTED] State: [REDACTED] Zip Code: [REDACTED]  
Transmission Type: [REDACTED]  Antilock Brakes  Cruise Control Powertrain: [REDACTED] Multiple Failure: [REDACTED] Incident Date(s): 19-MAR-2012

## Recall Campaign No. 11V-438: Lamps in Rear Quarter Panel

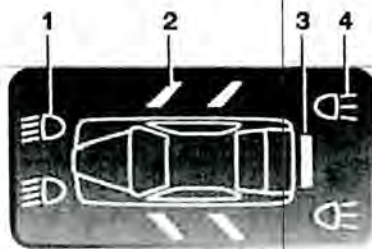
3. The image below, from the Owner's Manual, depicts the warning symbol (see icon "4") that is displayed in the vehicle's "message center" in the instrument panel if the tail lamp or brake lamp is experiencing this condition.

4. If one of the tail lamp warning symbols appear (4), please drive carefully and cautiously, as the driver of the vehicle behind you may not notice that one of the rear lamps are not working.
5. If this condition is present, and if you feel unsafe, please contact BMW Roadside Assistance at 1-800-332-4269 immediately to have your vehicle brought to the nearest authorized BMW center.
6. BMW recommends that you always wear your safety belt and that all passengers are properly seated and restrained at all times.
7. If you are not the only driver of this vehicle, please advise all other drivers and passengers of this important information.
