Vehicle Owner's Questionnaire
To Report Vehicle Safety Defects
1-888-DASH-2-DOT
(1-888-327-4236)
INTERNET: www.nhtsa.dot.gov/hotline

Repository
Reference No.
10454800

17 digit Vehicle Identification Number Located at bottom of windshield on driver's side
5J6RM3H50C [Redacted]
Make HONDA Model CR-V Model Year 2012
Date Purchased 3/31-12 Dealer's Name and Telephone Number Round Rock Honda 512-244-9000
Original Owner Dealer's City Round Rock State TX Zip Code 78664
Engine: No: Cylinders Fuel Type: reg
Transmission Type auto Antilock Brakes Cruise Control Powertrain
Multiple Failure: rear window blew out & crumbled Incident Date(s) 03-APR-2012

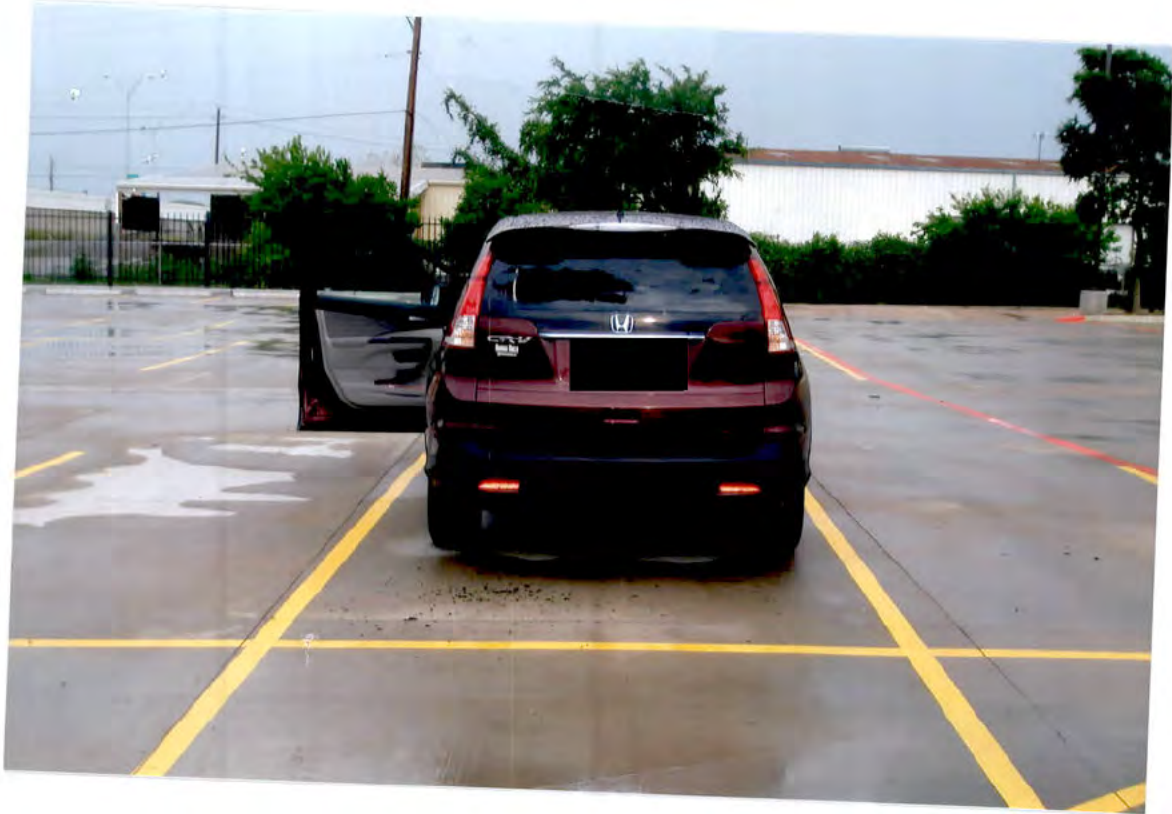
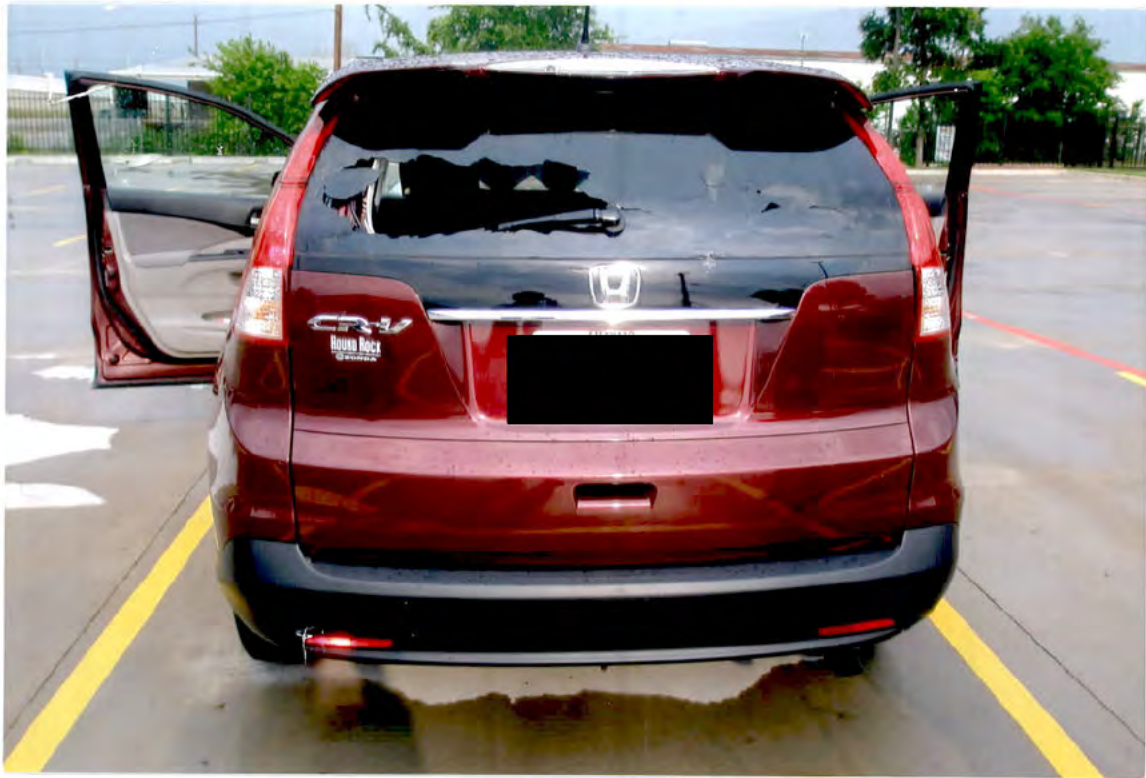
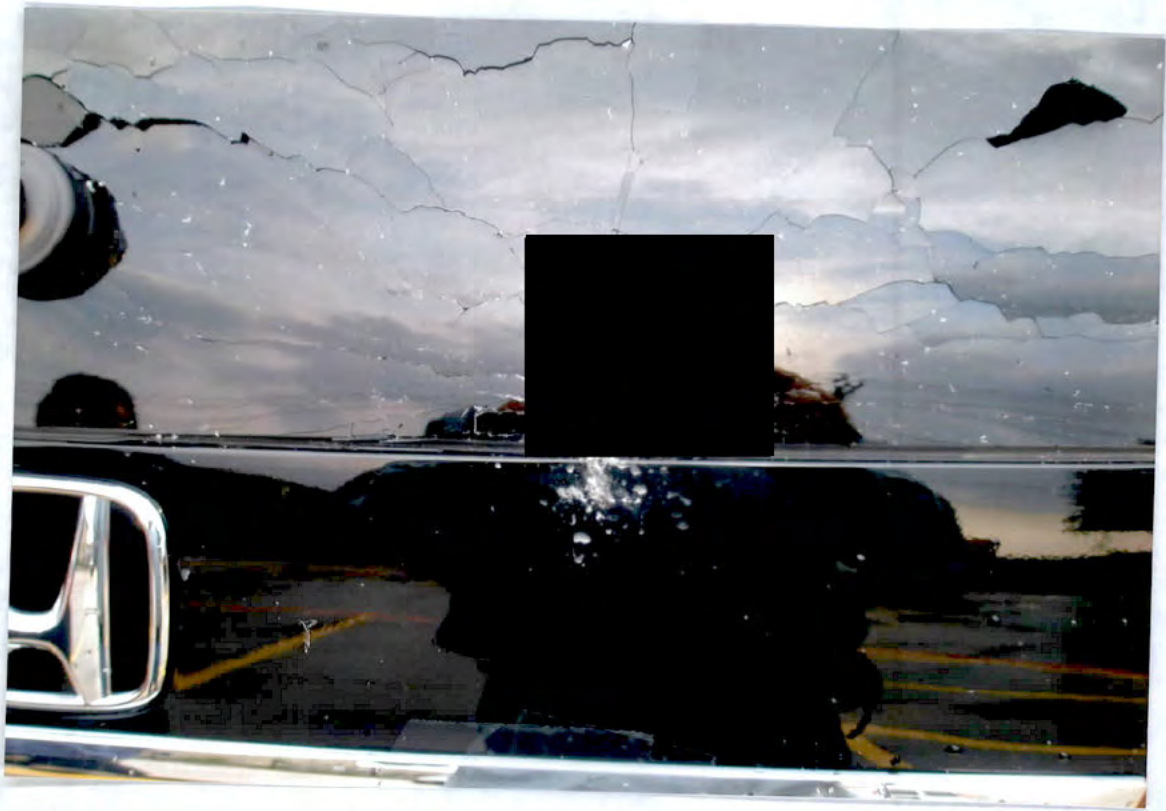
TL* THE CONTACT OWNS A 21012 HONDA CRV. THE CONTACT STATED THAT HE REAR LIFT GATE WINDOW WAS STRUCK BY A ROCK AND CAUSED THE WIPER BLADE TO SEPARATE FROM THE WINDOW AS THE GLASS EXPLODED AND SHATTERED INTO SEVERAL PIECES. THE VEHICLE WAS NOT REPAIRED. THE MANUFACTURER WAS MADE AWARE OF THE FAILURE. THE FAILURE AND THE CURRENT MILEAGE WAS 115.

When I approached the car, I saw the glass shards behind the car on the ground. The rear window was shattered in tiny small pieces that caused bleeding when touched. When I closed the driver door, more glass crumbled in the car as it fell apart. With the assistance of coworkers, the damaged area was covered with plastic sheeting and duct tape. None of us who witnessed this had ever seen "safety glass" act like this. I took the vehicle to the dealer where I purchased the car—Round Rock Honda.

My first concern is that the plastic strip on the rear door with the Honda symbol vibrates and can cause the rear window to shatter.

RE: 10454800 - Pictures
[REDACTED] Car damage
glass pieces

The desire for resolution that I have would be to have all the safety glass on my vehicle replaced with safety glass that behaves and protects like I have seen glass do in the past. The glass performance in this incident is frightening.
