**DOT Auto Safety Hotline**  
**Vehicle Owner's Questionnaire**  
**To Report Vehicle Safety Defects**  
**1-888-DASH-2-DOT**  
**(1-888-327-4236)**  
**INTERNET:www.nhtsa.dot.gov/hotline**

Reference No.  
10472958

Re: 2013 Visa 19 ERD (serial number INL1DTH22D1 [REDACTED])  
Faulty axle, excessive tire wear and blowout

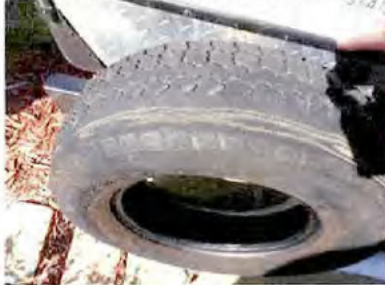
Exhibit 1

On August 22, 2012, while towing the trailer outside Enfield, N.C., its driver's side tire blew out. The tire's inward treads had worn completely down to the cords while the outward treads showed only limited wear (see photo exhibits 1 through 3). The passenger's side tire also showed excessive inward tread wear, though not as extreme as the driver's side tire (see photo exhibits 4 and 5).

**Driver side tire (blow-out tire)**

We replaced the tires at a cost of \$233.82 (copy of the receipt is included) in order to finish our trip home to Florida. Subsequently, we found numerous posts on the internet by owners of 19' Visas who had experienced the same tire wear problems. Many of the comments blame the Lippert 3500 lb GVW axle (see photo exhibits 8 and 9). Whether our trailer's axle came from the factory bent or misaligned is unknown. What is known is that when one inspects our trailer's wheels, the amount of toe out is readily apparent, especially on the driver's side. Simply replacing the tires will not resolve the issue.

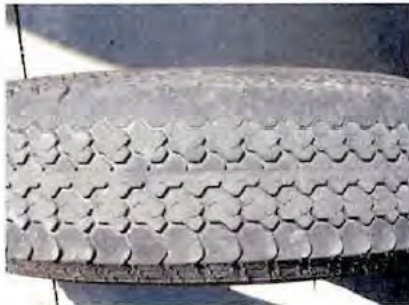
Exhibit 4

**Passenger side tire (excessive wear)**

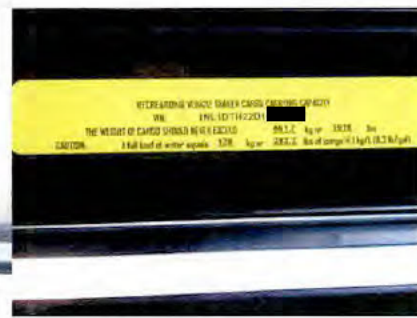
Exhibit 7

There is no way that the tire wear could have been due to overloading. The trailer's fresh, grey and black water holding tanks had always been empty when towed. The items carried in the trailer were weighed individually, totaled (485 lbs. on the trip from Florida to New York State and 605 lbs. on the return trip) and distributed 60% forward of the axle and 40% rearward. These weights were substantially less than the cargo capacity limit of 1018 lbs posted on the inside door frame of the trailer (see photo exhibits 6 and 7).

**Stated Cargo Capacity of Visa 19' ERD on door**
