**From:** [Wells, Cynthia CTR \(NHTSA\)](#)  
**To:** [Nelson, Carla CTR \(NHTSA\)](#)  
**Subject:** FW: Request add to the public file for VOQ 10491941  
**Date:** Monday, January 14, 2013 11:06:58 AM  
**Importance:** High

Thank you for spending the time on the phone with me today. Pls forward copies of the (removed) Iota transfer switch and environment (depicting the extent of damage) when you get the chance.

**ITS-50R**

**AUTOMATIC TRANSFER SWITCH**

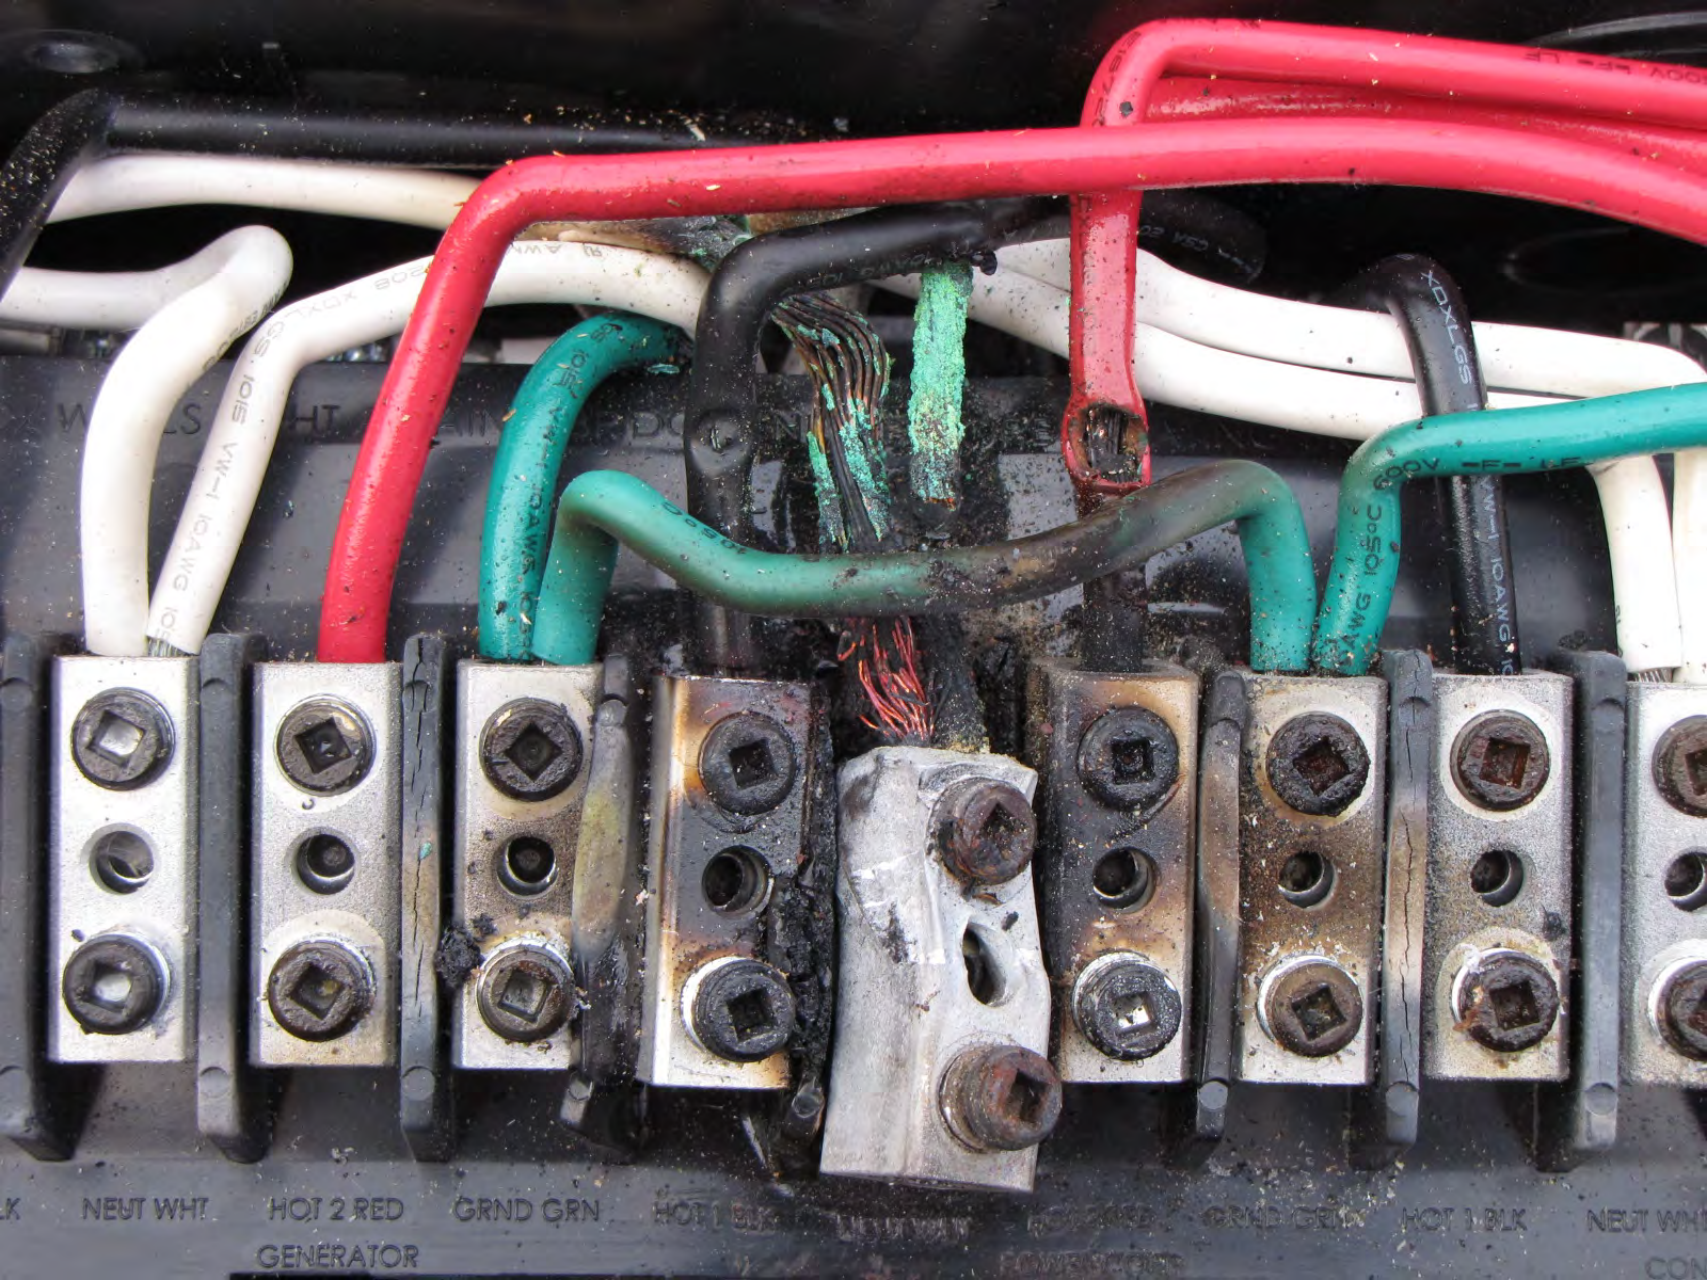
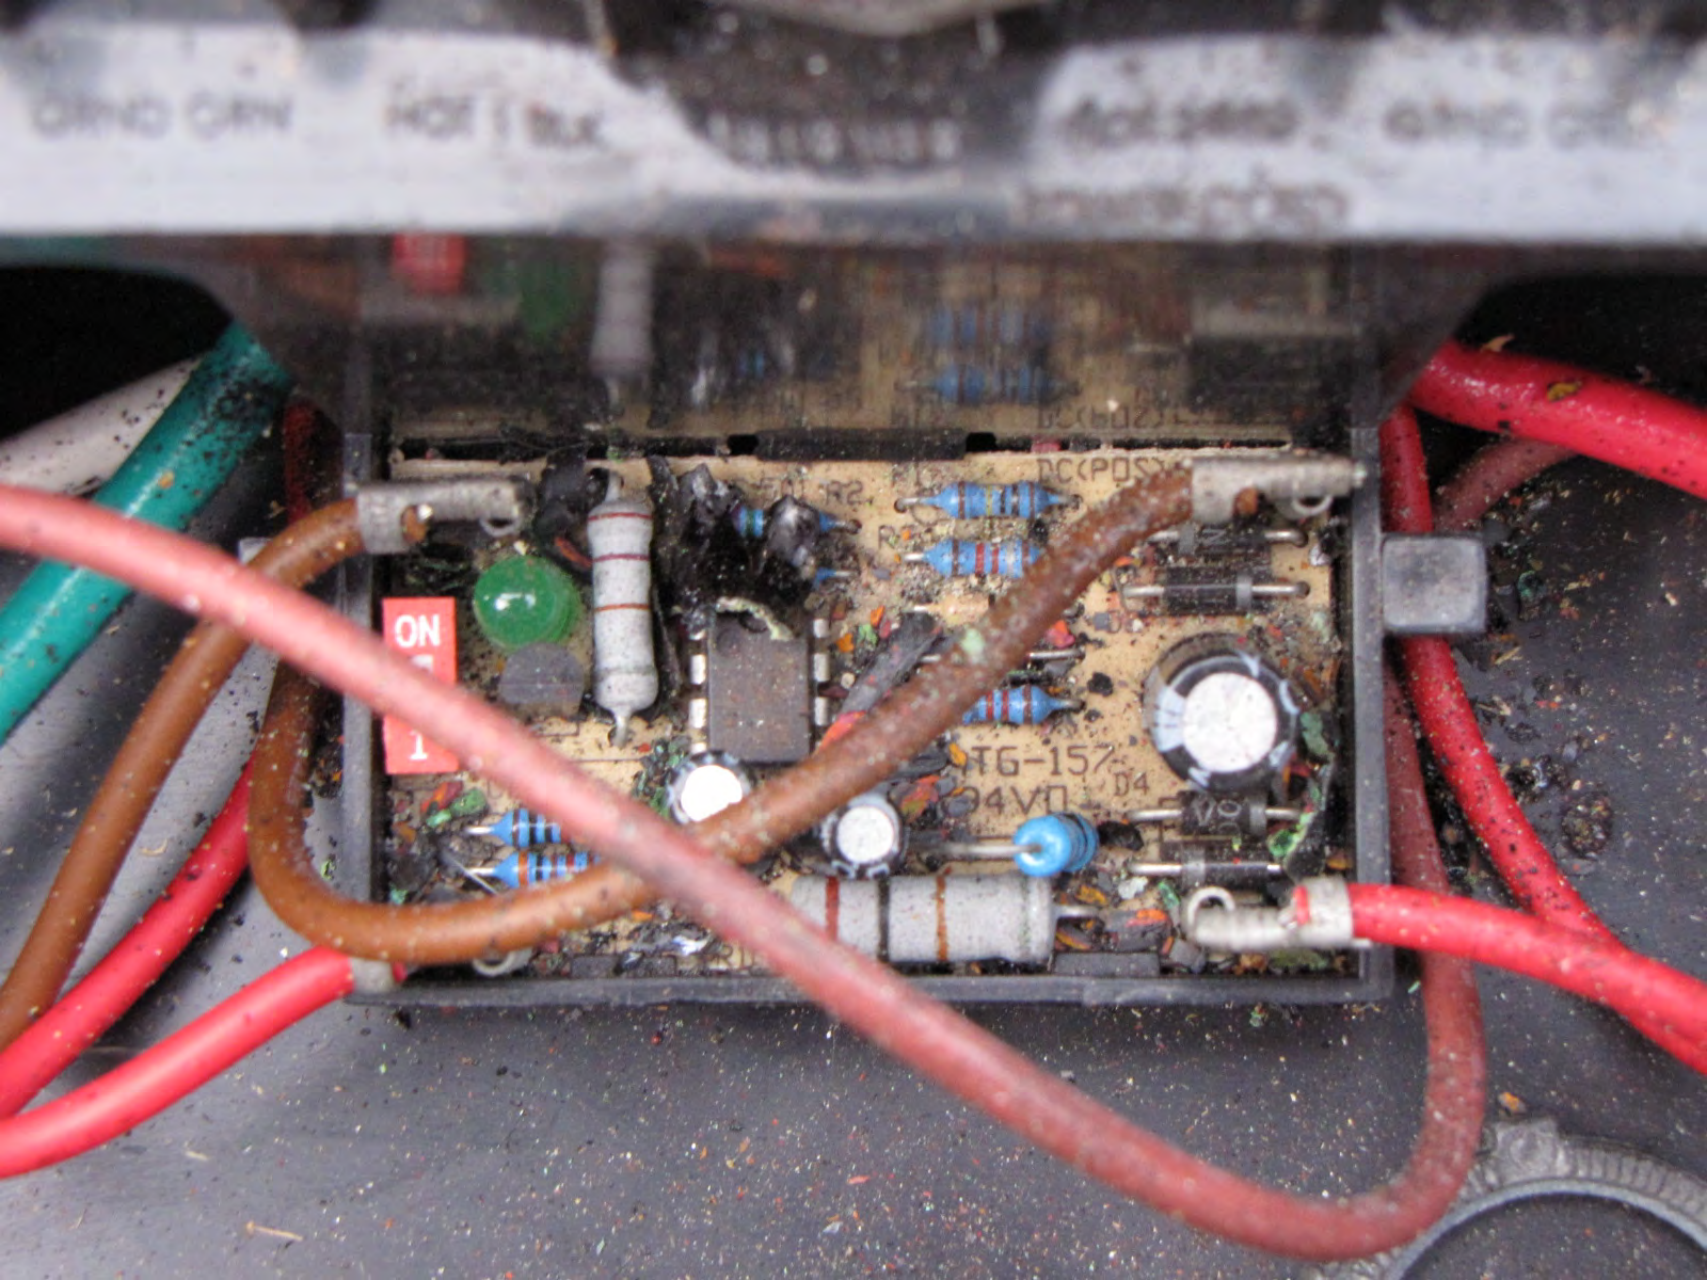
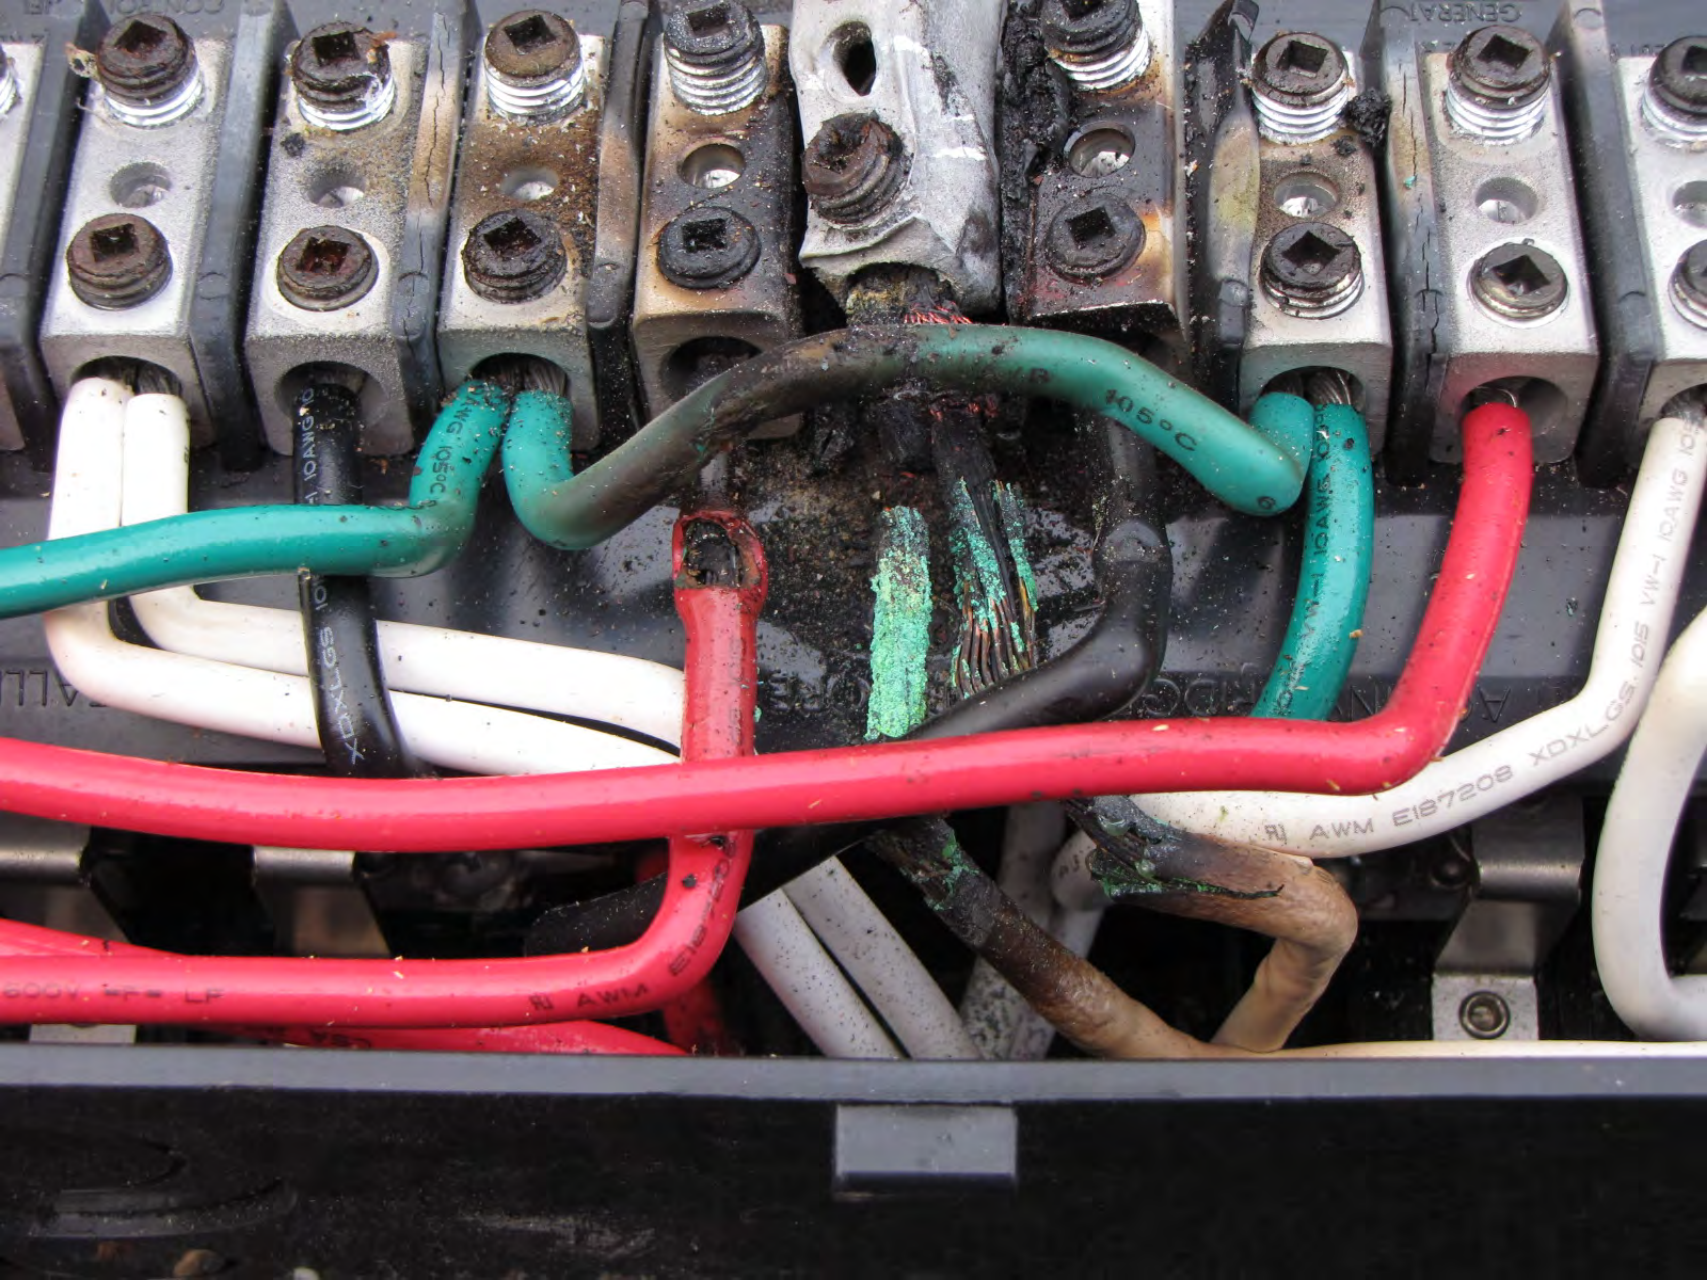
I certainly appreciate the quick response to my online complaint. As discussed I am including pictures of the transfer switch. If you have any further questions, please don't hesitate to contact me. I will be on official travel in Tampa, Florida, all next week, so it would be best to reach me on my cell phone [REDACTED].

fix numerous electrical problems I now firmly believe are directly related to this switch beginning to fail in December 2012.
