**MULTIDISCIPLINARY ACCIDENT INVESTIGATION TEAM NARRATIVE/DIAGRAM**

**SL-42-12**

## MAIT SUPPLEMENTAL

This investigation was conducted by the California Highway Patrol (CHP) Southern Division Multidisciplinary Accident Investigation Team (MAIT).

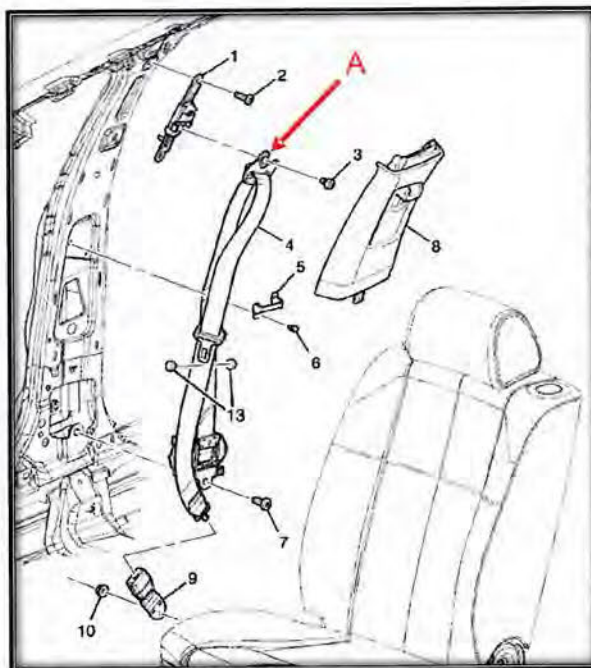
**Figure 1:** Parts diagram

The diagram depicted in Figure 1 is a parts diagram<sup>1</sup> listing replacement restraint system components for Vehicle #2.

Item A is commonly referred to as a Guide Loop. The guide loop provides an anchor location for the belt at the B-pillar.

The parts diagram in Figure 1, describes Item 1 as an "Adjuster/shoulder belt/Guide." Item 1 consisted of a track section which was mounted to the B-pillar structure of the vehicle (Figure 2, Item B) and a locking mechanism which slid along the track section to allow adjustment of the guide loop height (Figure 2, Item C). For the purposes of this report, the track section (Figure 2, Item B) will be referred to as the Guide Loop Track. The component depicted in Figure 2, Item C will be referred to as the Guide Loop Adjustment Mechanism.

Item 8 (Figure 1) will be referred to as the Upper Trim Section.

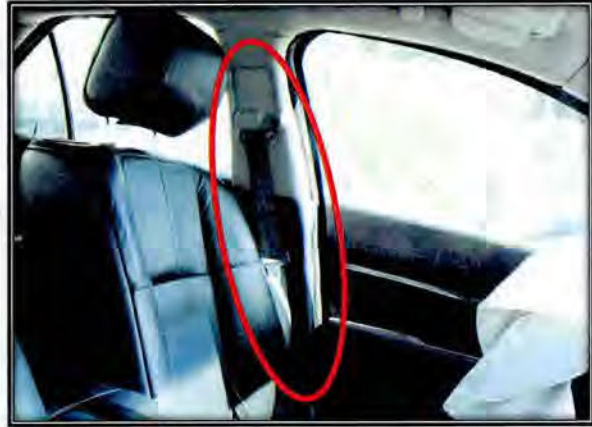
Figure 3: Left front restraint

The left front seat restraint was found in the retracted position with the latch plate hanging alongside the B-pillar (Figure 3). The latch plate was in good condition and showed no deformations. The latch plate moved freely along the restraint webbing. The plastic covering the latch plate showed an imprint consistent with occupant loading of the seatbelt webbing. When extended, the seatbelt webbing showed signs of occupant loading.

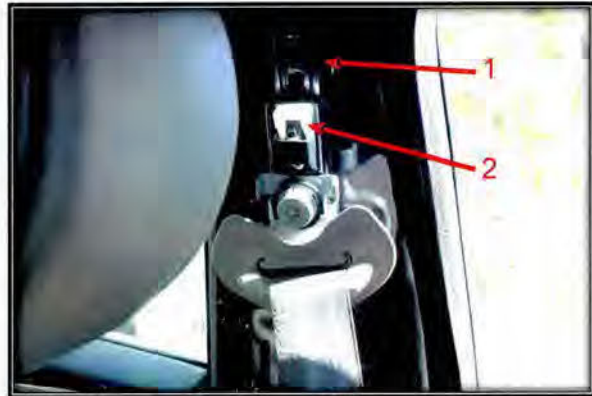
Figure 4: Left front restraint guide loop.

The upper trim panel was removed from the B-pillar to expose the driver seat restraint guide loop anchor point. The guide loop track was mounted to the B-pillar structure (Figure 4, number 1). The guide loop was attached to the guide loop adjustment mechanism to allow vertical adjustment of the guide loop by depressing a button (Figure 4, number 2). By depressing the button, a locking pin disengaged from the guide loop track allowing for adjustment of the guide loop to four distinct locations along the track. At each of the four adjustment locations, an audible click was heard and the Guide loop was securely locked in position.

With the button depressed and the guide loop moved to the lowest possible position, the audible click was not consistently heard without manipulating the guide loop upward to engage the locking device.

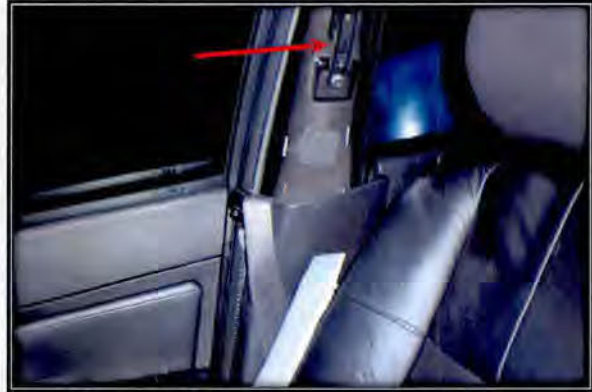
**Figure 5:** Right side B-pillar

The right front seat restraint was found in the extended position. The B-pillar guide loop and upper trim panel were found detached from the B-pillar (Figure 5). The B-pillar guide loop track was still mounted on the B-pillar (Figure 5, arrow)

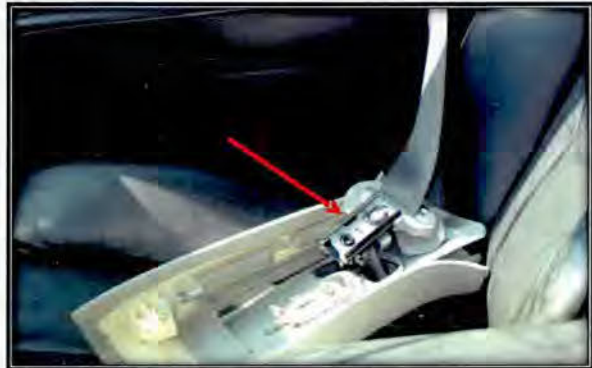
**Figure 6:** Right front restraint guide loop

The right front seat restraint webbing was looped through the guide loop and through the upper trim panel. The guide loop and B-pillar upper trim panel were located on the right front seat cushion (Figure 6). The guide loop adjustment mechanism (Figure 6, arrow) was detached from the guide loop track but still attached to the guide loop.

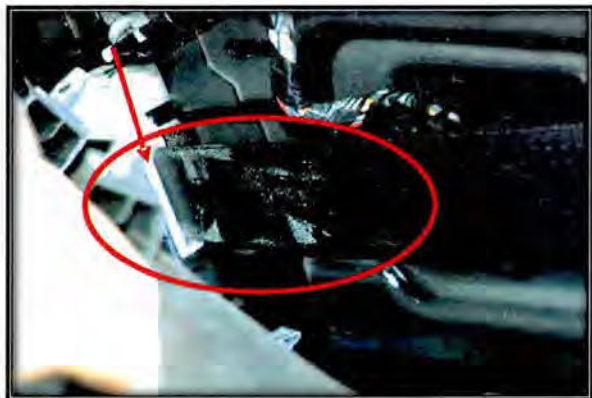
**Figure 7:** Right front seat restraint webbing

White plastic transfer was located on the webbing of the right front restraint near the retractor (Figure 7, circle). This plastic transfer was consistent with the plastic guide which surrounded the belt as it entered the retractor (Figure 7, arrow).

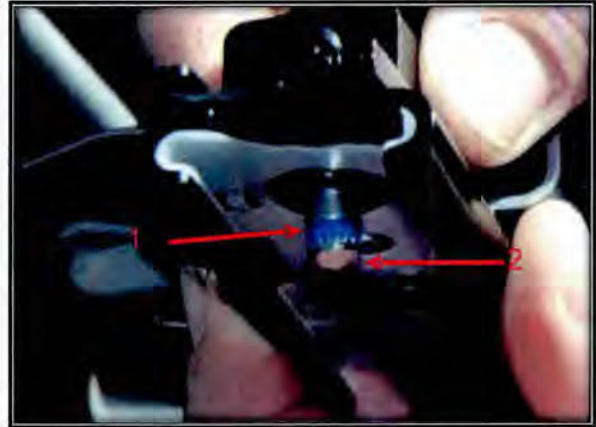
**Figure 8:** Guide loop adjustment mechanism

The guide loop adjustment mechanism contained a sliding pin (locking pin) which appeared to be designed to engage with corresponding holes in the guide loop track. The locking pin moved freely from the extended position to the retracted position (Figure 8, number 1). The button which was observed on the undamaged driver side guide loop adjustment mechanism was not located on the passenger side guide loop adjustment mechanism. Additionally no tension spring or other device was present to provide a positive force to engage the locking pin into the guide loop track.

Wear marks were visible on the end of the locking pin (Figure 8, number 2).

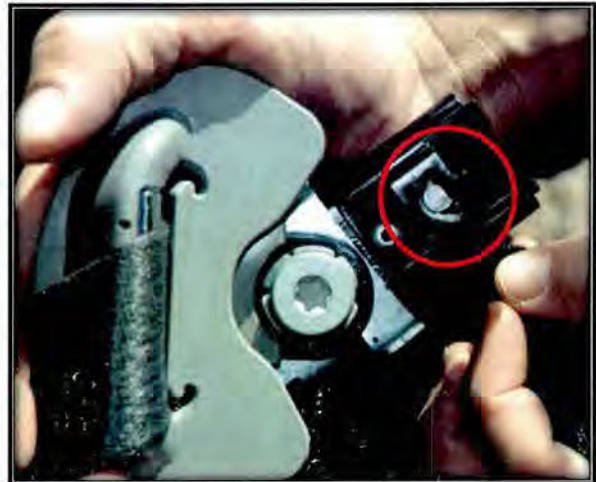
**Figure 9:** Outboard face of guide loop adjustment

A section of the plastic casing of the guide loop adjustment mechanism, outboard of the locking pin, was broken outward and away from the locking bolt (Figure 9).

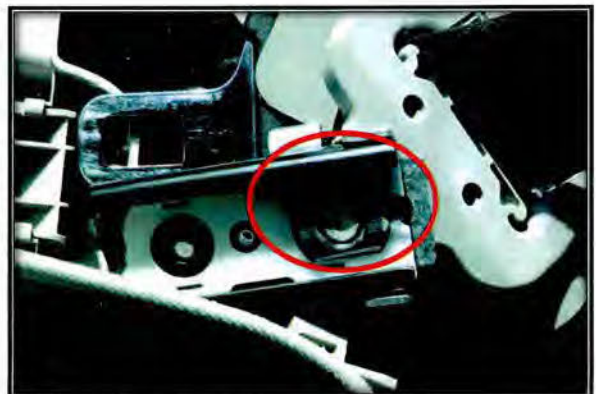
**Figure 10:** Outboard face of guide loop adjustment mechanism

Scoring was noted to the outboard face of the guide loop adjustment mechanism. The scoring was located near the end of the fastener which attached the guide loop and the guide loop adjustment mechanism (Figure 10).

These score marks were consistent with the damage to the outboard face of the guide loop adjustment mechanism (page 10, Figure 10) and were likely caused when the guide loop adjustment mechanism slid downward and off the guide loop track during the collision.

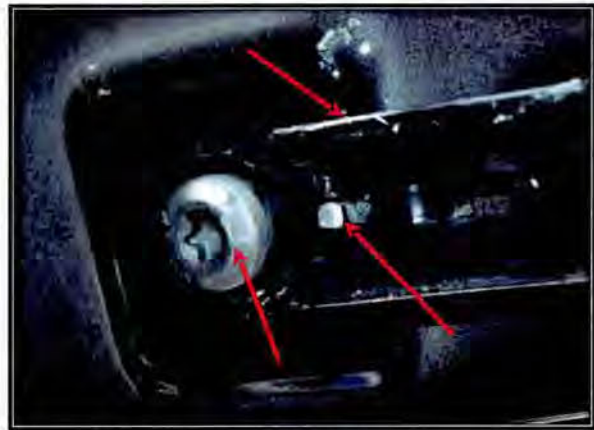
**Figure 11:** Lower section of guide loop track and bolt

Score marks were visible on the lower end of the guide loop track and the head of the lower fastener connecting the guide loop track to the B-pillar (Figure 11).

Based on the score marks on the head of the guide loop track lower fastener and lower section of the guide loop track (Figure 11) and scoring to the outboard face of the guide loop adjustment mechanism (page 10, Figure 10), it appeared that the guide loop adjustment mechanism slid off the lower end of the guide loop track. As the guide loop adjustment mechanism slid down the guide loop track, interaction between the end of the locking pin (page 10, Figure 8) and the head of the loop guide track lower fastener (Figure 11) likely pushed the locking pin outboard causing the damage to the plastic casing of the guide loop adjustment mechanism (page 10, Figure 9) and detachment of the adjustment button and tension spring.

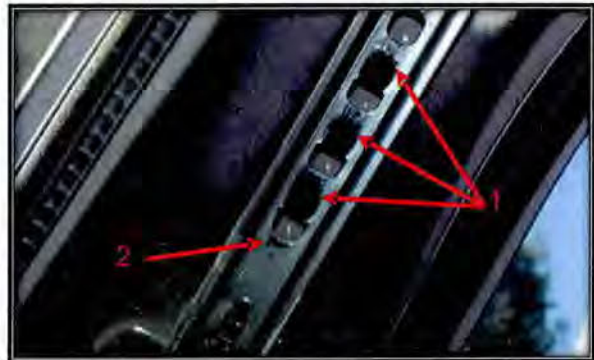
**Figure 12:** Guide loop track

The guide loop track showed marking between the four adjustment slots due to contact with the locking pin (Figure 12, number 1).

Contact marks were also visible below the lowest adjustment position in the guide loop track, indicating that locking bolt had previously been adjusted below the lowest adjustment slot (Figure 12, number 2).

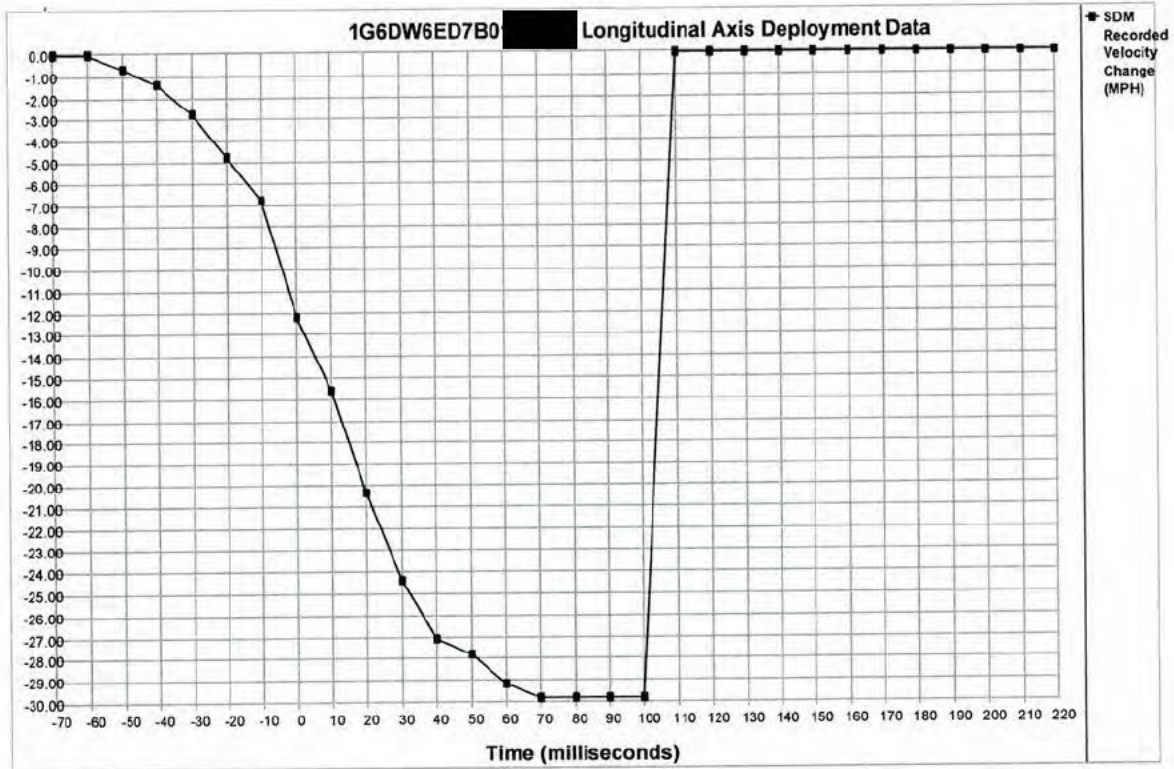
| SDM Longitudinal Axis Recorded Velocity Change (MPH) | 0.00 | 0.00 | -0.68 | -1.36 | -2.71 | -4.74 | -6.78 | -12.20 | -15.59 | -20.33 | -24.40 | -27.11 | -27.79 | -29.14 | -29.82 |
| SDM Longitudinal Axis Recorded Velocity Change (MPH) | -29.82 | -29.82 | -29.82 | 0.00 | 0.00 | 0.00 | 0.00 | 0.00 | 0.00 | 0.00 | 0.00 | 0.00 | 0.00 | 0.00 | 0.00 |

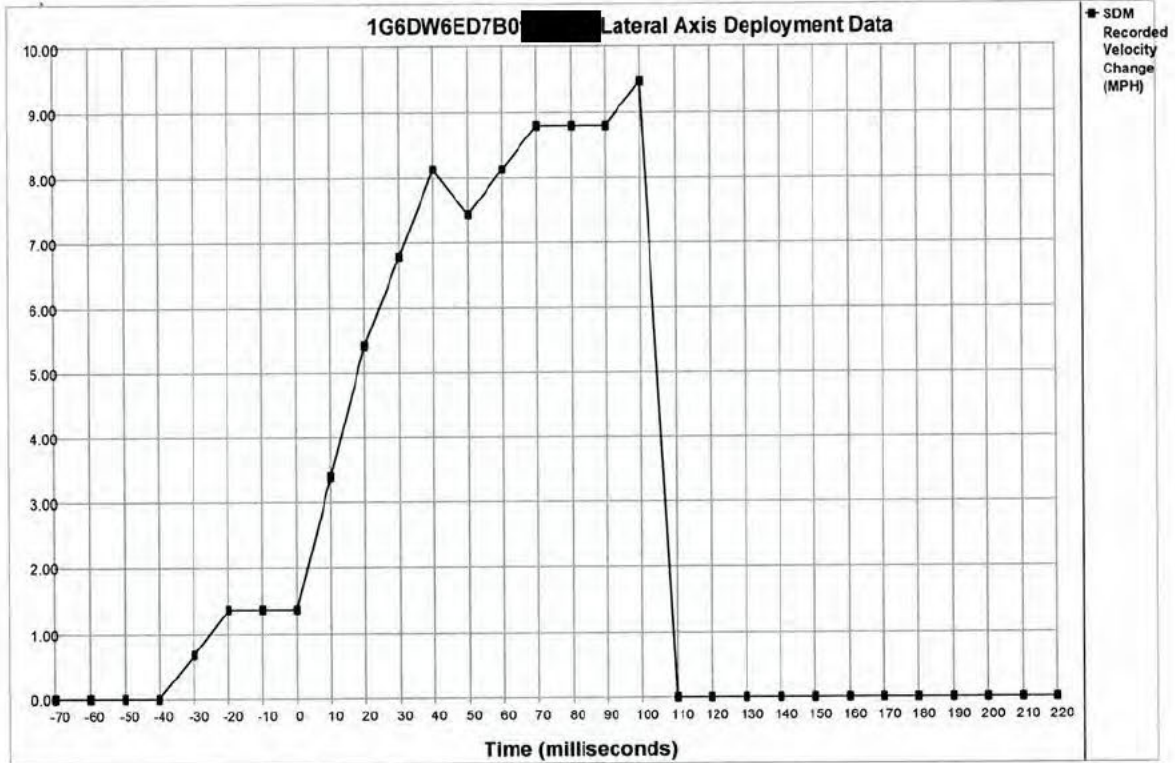
| SDM Lateral Axis Recorded Velocity Change (MPH) | 0.00 | 0.00 | 0.00 | 0.00 | 0.68 | 1.36 | 1.36 | 1.36 | 3.39 | 5.42 | 6.78 | 8.13 | 7.45 | 8.13 | 8.81 |
