**National Highway  
Traffic Safety  
Administration**

NVS-216 nam  
Ref. No. 10496526

## 2013 Nissan-Datsun Altima Sedan L4-2.5L (QR25DE)

2013 ALTIMA WITH QR25 ENGINE; NOISE FROM THE HYDRAULIC ELECTRIC POWER STEERING (H-EPS)

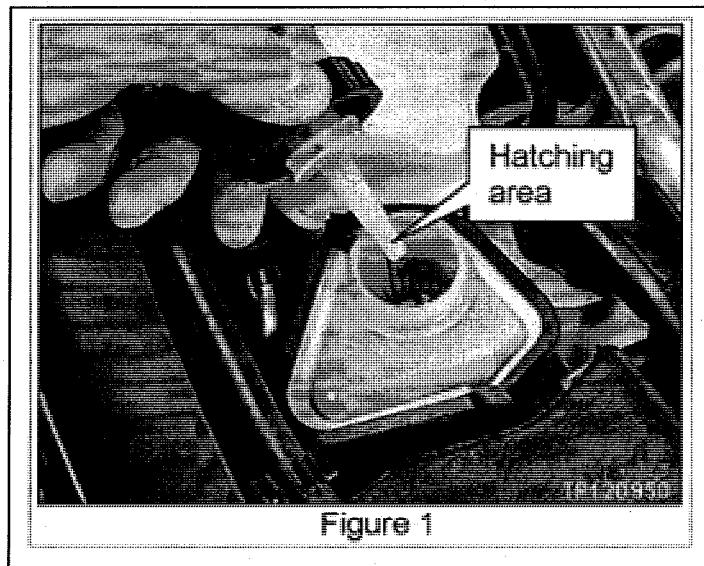
1. Check the Hydraulic Electric Power Steering (H-EPS) fluid level.

^ Check fluid level with the ignition OFF and fluid temperature between Go - 30°C (32 - 86°F).

^ Power steering fluid level should be within the hatching area of the indicator on the power steering reservoir tank cap.

^ If fluid is needed, use only genuine NISSAN E-PSF or equivalent.

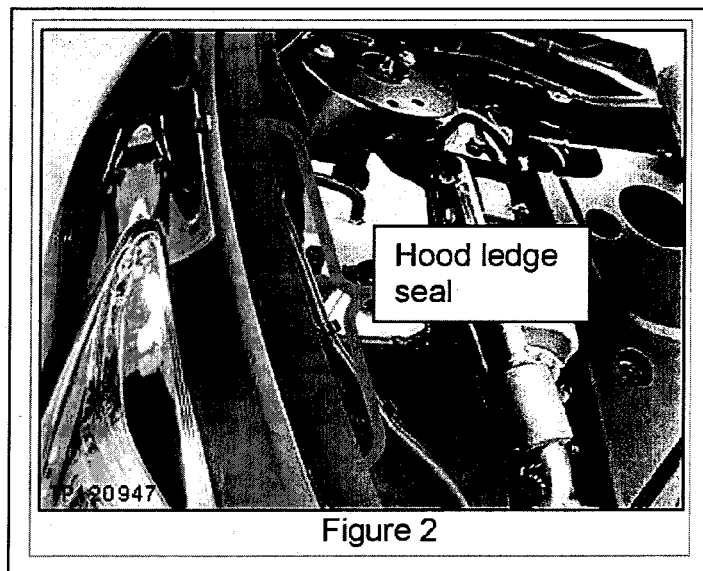
2. Make sure right front hood ledge

^ seal is installed correctly.

^ Install seal correctly, or

^ If damaged, replace seal, or If missing, install a seal.

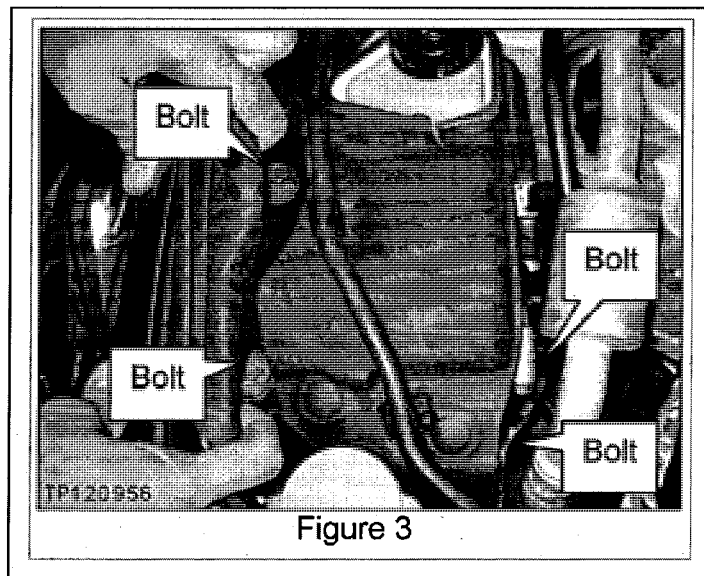
3. Make sure there is no binding on the H-EPS pump mounting isolator as follows:

- a. Loosen the 4 H-EPS pump mounting bolts.
- b. Move the H-EPS pump a small amount from side to side.
- c. Tighten the mounting bolts.

Torque to:

13.5 N.m (1.4 kg-m, 10 ft-lb)

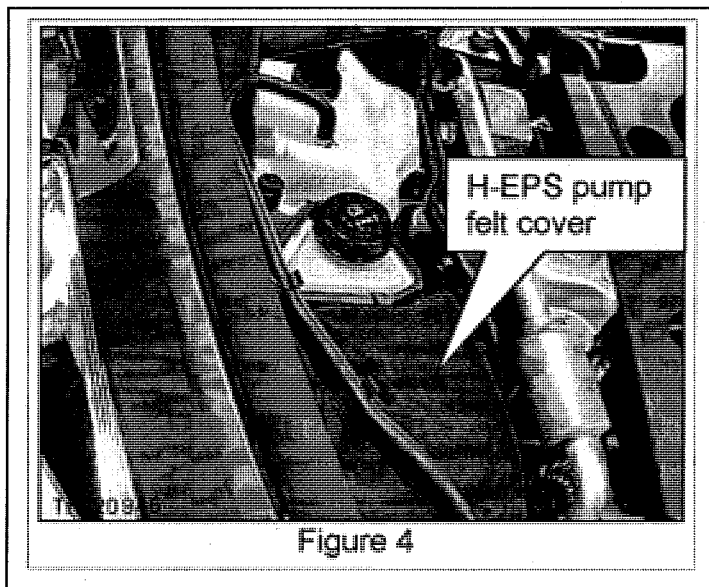
4. Make sure the H-EPS pump felt cover is installed correctly.

^ Install felt cover correctly, or

^ If damaged, replace felt cover, or If missing, install a felt cover.

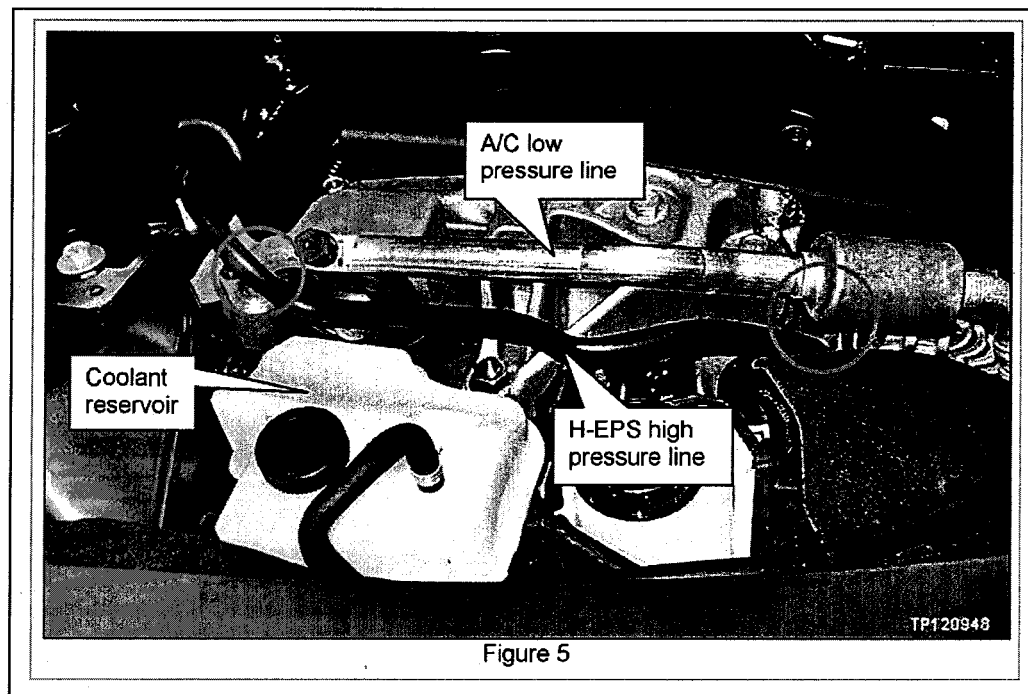
5. Make sure the H-EPS high pressure line and the A/C low pressure line are not touching (see Figure 5).

^ Check the 2 locations circled in Figure 5.

6. Make sure the H-EPS high pressure line is not touching the coolant reservoir (see Figure 5).

^ If the lines are touching, reposition the lines so they are not touching.

^ Make sure the coolant reservoir is mounted correctly (locator boss must be seated in mounting hole).

^ If needed, reposition the H-EPS line so it is not touching the reservoir.

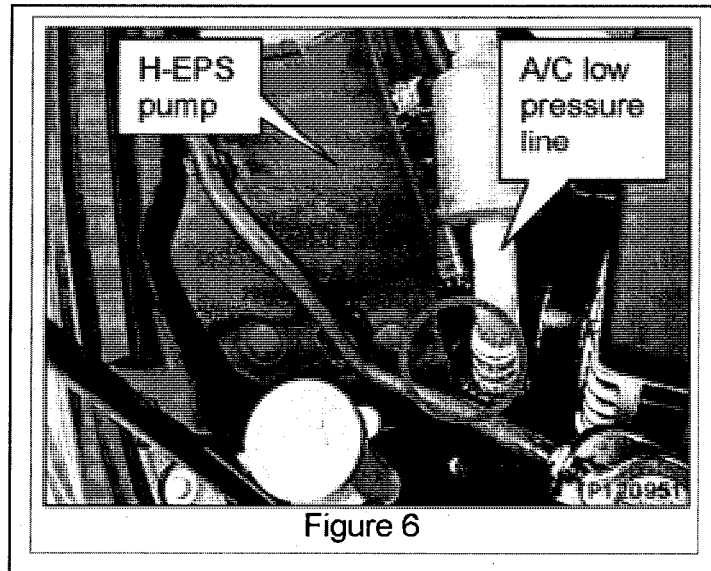
7. Make sure the A/C low pressure line is not touching the H-EPS pump.

^ Check the location circled in Figure 6.

^ If needed, reposition the A/C low pressure line so it is not touching the H-EPS pump.

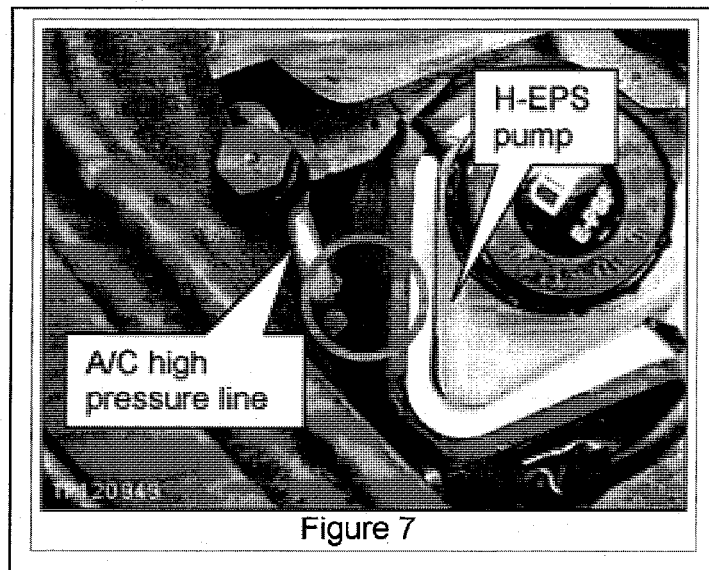
8. Make sure the A/C high pressure line is not touching the H-EPS pump.

^ Check the location circled in Figure 7.

^ Wiggle the H-EPS pump and observe the A/C high pressure line. If it moves it is touching.

^ If needed, reposition the A/C high pressure line so it is not touching the H-EPS pump.

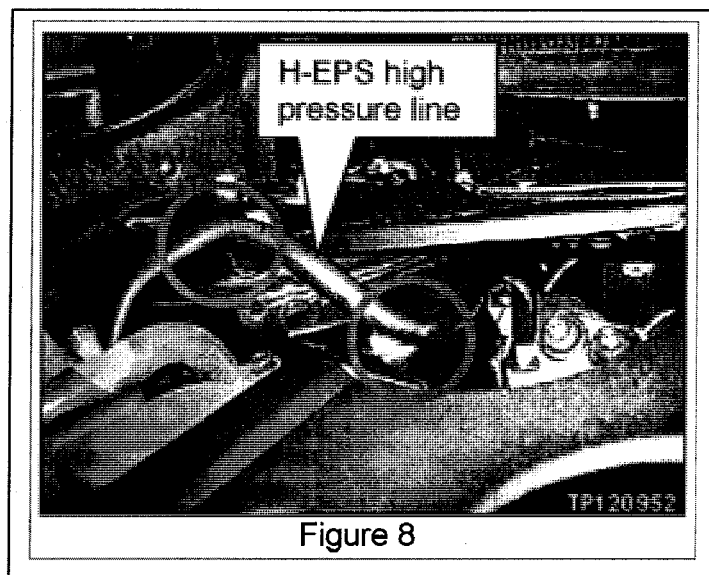
9. Make sure the H-EPS high pressure line is not touching the strut tower brace or the torque rod mounting bracket.

^ Check the two locations circled in Figure 8.

^ If needed, reposition the H-EPS high pressure line so it is not touching.

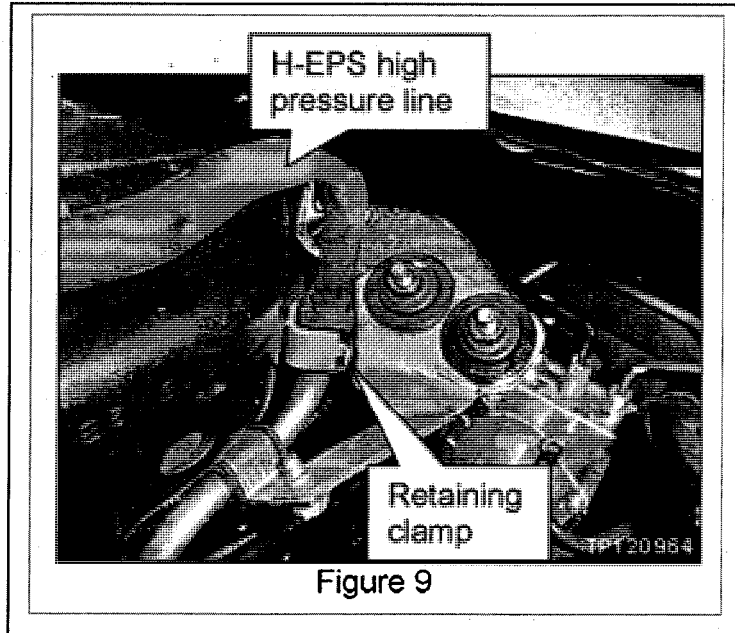
10. Check the H-EPS high pressure line retaining clamp shown in Figure 9.

^ Make sure the clamp is secured correctly.

^ Figure 9 shows a clamp that is not secured correctly.

^ If the clamp is loose like the one shown in Figure 9, replace the H-EPS high pressure line.

^ Refer to the Service Manual for replacement information.

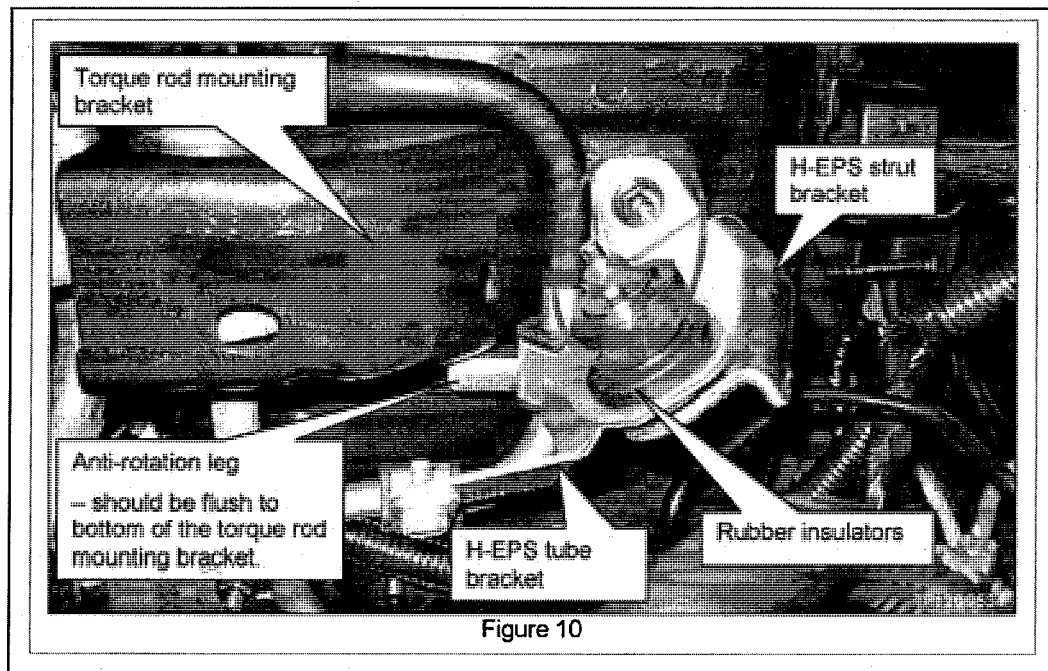
11. Make sure the anti-rotation leg of H-EPS strut bracket is flush to the bottom of the torque rod mounting bracket (see Figure 10).

12. Make sure the H-EPS strut bracket and the H-EPS tube bracket are not touching (see Figure 10).

^ There should be a gap between them all the way around.

13. Use a torque wrench to check the torque on the 3 H-EPS bracket nuts circled in Figure 10.

^ Torque specification: 4.9 N.m (0.49 kg-m, 3.6 ft-lb, 43 in-lb).

^ If needed, reposition the H-EPS strut bracket so the anti-rotation leg is flush to bottom of the torque rod mounting bracket.

^ Make sure the rubber insulators are seated properly.

^ If needed, reposition the brackets so they are not touching.

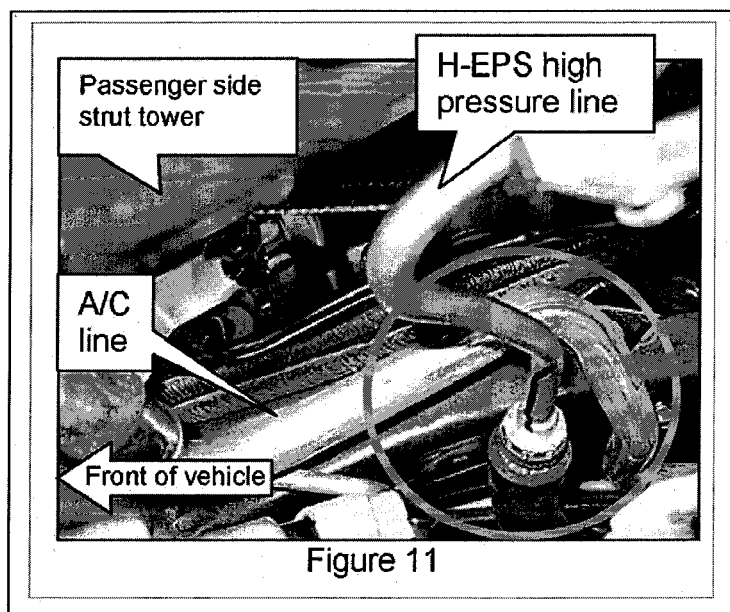
14. Make sure the H-EPS high pressure line is not touching the A/C line or vehicle body.

^ Check the area circled in Figure 11.

**NOTE :** The view in Figure 11 is downward from the inboard side of the passenger side strut tower.

^ If needed, reposition the lines so they are not touching.

^ If needed, reposition the H-EPS line so it is not touching the vehicle body.

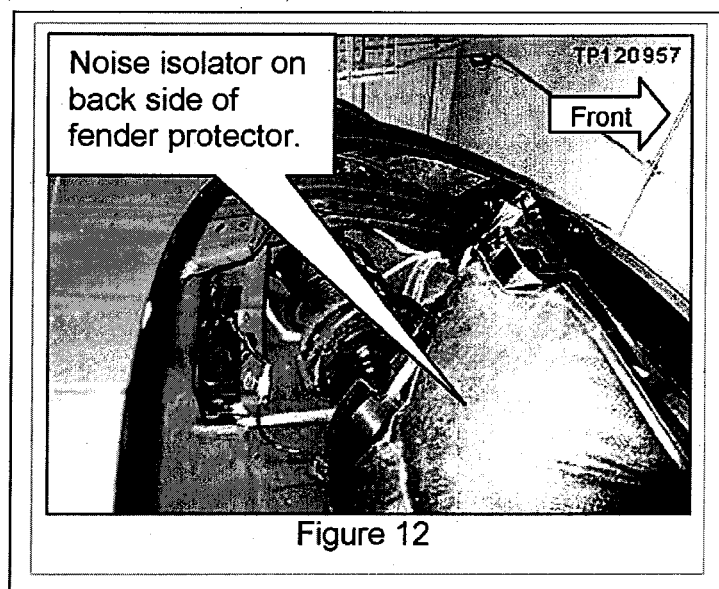
15. Make sure the noise insulator is installed inside the RH (passenger side) front fender protector:

c. Confirm the insulator is in place.

^ Make sure the insulator is installed correctly, or

^ If damaged or missing, replace the fender protector with insulator.

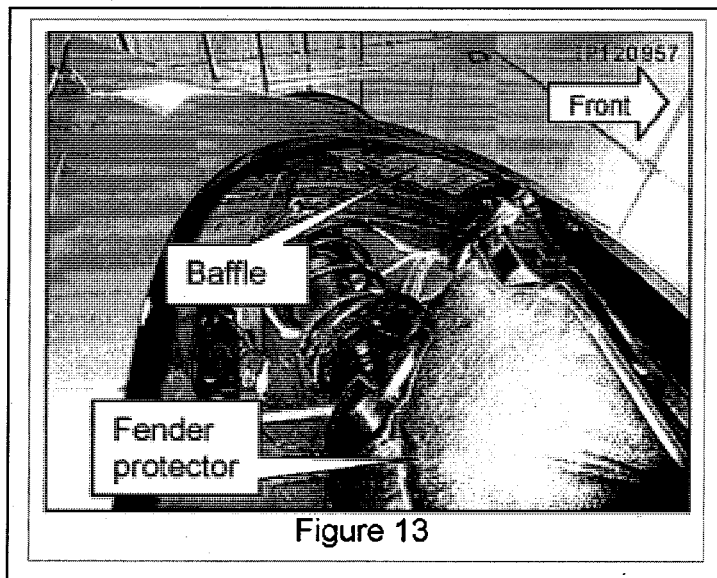
16. Make sure the baffle is positioned properly inside the RH (passenger side) front fender.

^ The baffle should be flush against the fender.

^ When the fender protector is installed there should be no gap between the fender protector and the baffle.

^ If needed, reposition the baffle or install a new one.

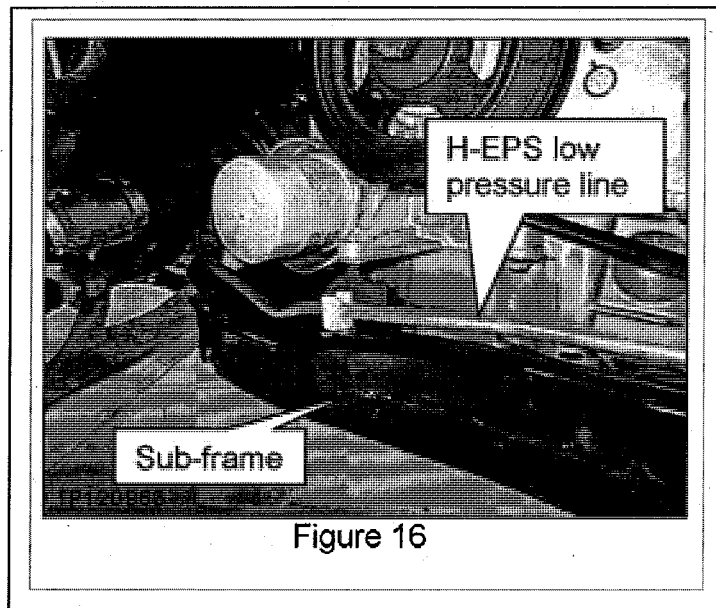
17. Make sure the H-EPS low pressure line is not touching the sub-frame near the front of the engine.

^ If needed, reposition the H-EPS low pressure line so it does not touch the sub-frame.

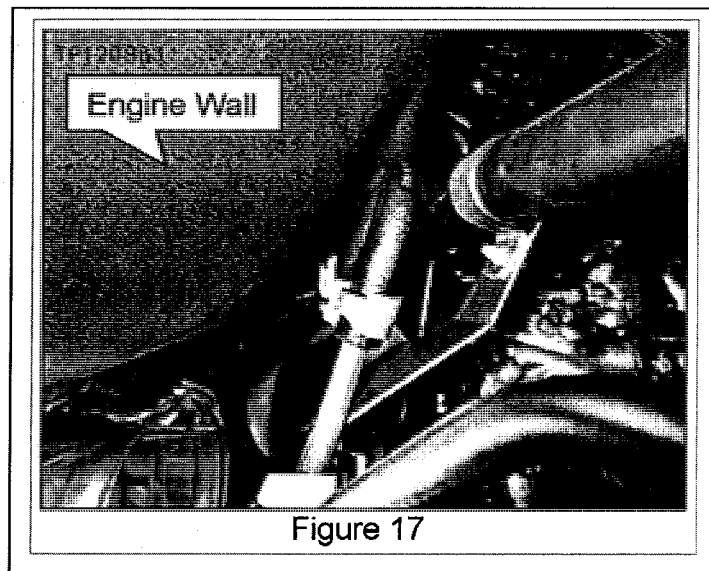
18. Make sure the H-EPS lines under the vehicle are not touching surrounding parts.

b. Visually check the routing of the under-vehicle H-EPS lines.

^ If needed, reposition the H-EPS lines so they are not touching any surrounding parts.
