CL-10521340-2251

I am the owner of a 2005 Dodge Neon with an unreliable steering wheel horn circuit. In other words, the horn sometimes fails to honk. I replaced the steering wheel "clock spring" and guess what, the clock spring has no ground circuit; it's only a three wire device. It appears to be the correct part; the new clock spring has precisely the same stock number as the original Chrysler clock spring.

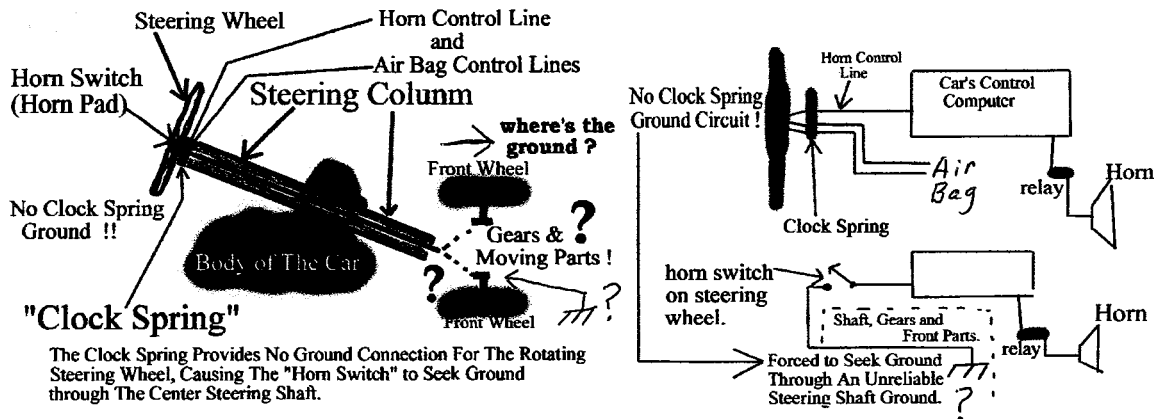
As far as I can tell, electrical ground is achieved through the movable steering shaft parts, rather than a separate ground through the clock spring. There's a "strut ground" associated with Neon's front end, however, strut grounds sometimes become disconnected.

**Think about this: Steering wheel horn ground passes through the steering shaft rather than the clock spring. Maybe I'm wrong, but I think this is a reliability problem and a safety issue.**

Ask Chrysler this question: Are you sure that you can maintain a good electrical ground amidst grease, oil and moving parts without a solid electrical connection. Many electronics people would look at this arrangement with unhappiness. How come there's no clock spring ground. Look at my visual aids below:
