DOT Auto Safety Hotline
Vehicle Owner's Questionnaire
To Report Vehicle Safety Defects
1-888-DASH-2-DOT
(1-888-327-4236)
INTERNET: www.nhtsa.dot.gov/hotline

17 digit Vehicle Identification Number Located at bottom of windshield on driver's side 1N4AL11D22C [REDACTED]	Make NISSAN	Model ALTIMA	Model Year 2002
Date Purchased	Dealer's Name and Telephone Number	Engine: No: Cylinders	Fuel Type:
Original Owner <input type="checkbox"/>	Dealer's City	State	Zip Code
Transmission Type <input type="checkbox"/> Antilock Brakes <input type="checkbox"/> Cruise Control	Powertrain	Multiple Failure:	Incident Date(s) 05-JUL-2013

This notice is sent to you in accordance with the requirements of the National Traffic and Motor Vehicle Safety Act. Nissan has decided that a defect that relates to motor vehicle safety exists in some 2002-2003 model year Nissan Altima vehicles equipped with the 2.5 liter engine.

NTB03-070d

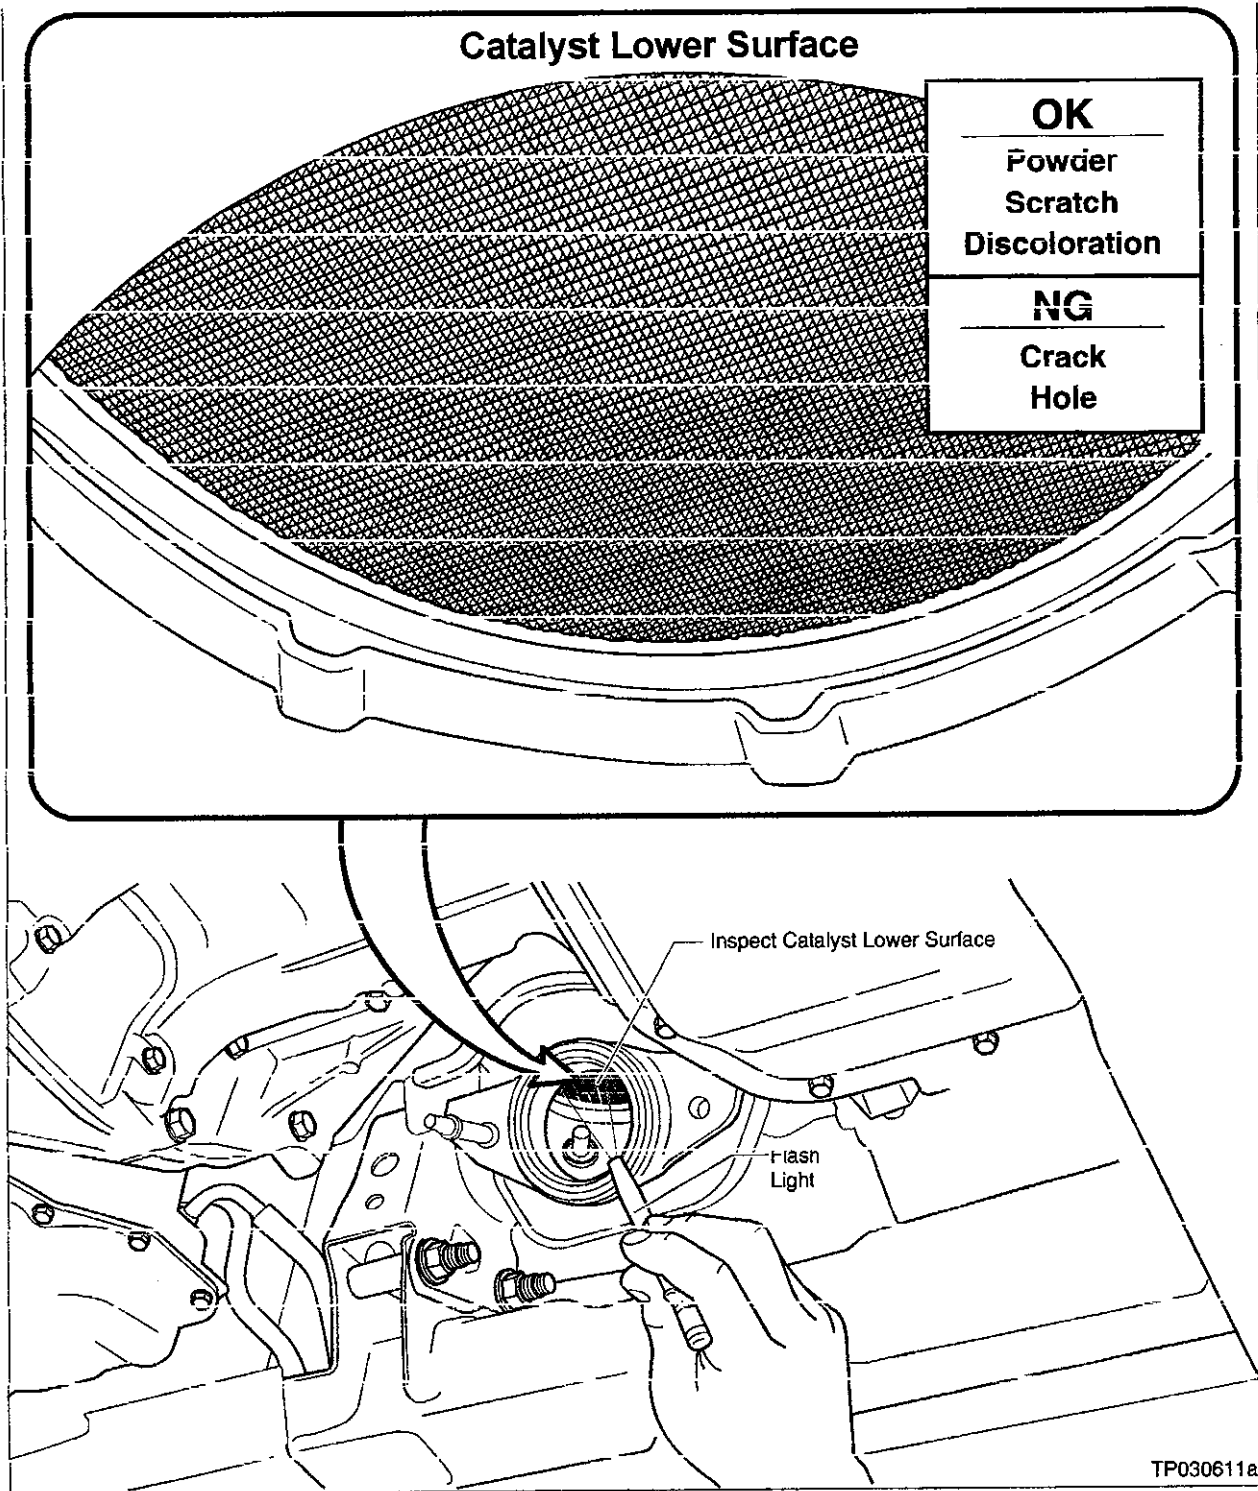
Figure D4

IMPORTANT: Make sure you inspect the entire lower surface. You are looking for cracks or holes in the lower surface.
