<p>DOT Auto Safety Hotline Vehicle Owner's Questionnaire To Report Vehicle Safety Defects 1-888-DASH-2-DOT (1-888-327-4236) INTERNET: www.nhtsa.dot.gov/hotline</p>		FOR AGENCY USE ONLY 100148	
U.S. Department of Transportation National Highway Traffic Safety Administration		Date Received 04-DEC-2013	Repository <input type="checkbox"/> Reference No. 10554796
OWNER INFORMATION (Type or Print)			
Name [REDACTED]		Daytime Telephone Number [REDACTED]	E-mail Address
Address [REDACTED]		Evening Telephone Number	
City ALBANY	State OH	Zip Code [REDACTED]	
<i>The information you provide will be used to identify potential safety-related defects. We may share your information with the applicable vehicle manufacturer during an investigation or recall in accordance with the routine uses described in the agency's Privacy Act notice. See 49 FR 53971 (Sep. 3, 2004).</i>			
VEHICLE INFORMATION			
17 digit Vehicle Identification Number Located at bottom of windshield on driver's side 5TBBT4417YS [REDACTED]		Make TOYOTA	Model TUNDRA

Model Year 2000	
Date Purchased 7/5/00	Dealer's Name and Telephone Number Don Wood Automotive (740) 593-6641		Engine: No: Cylinders 8
Original Owner <input checked="" typ

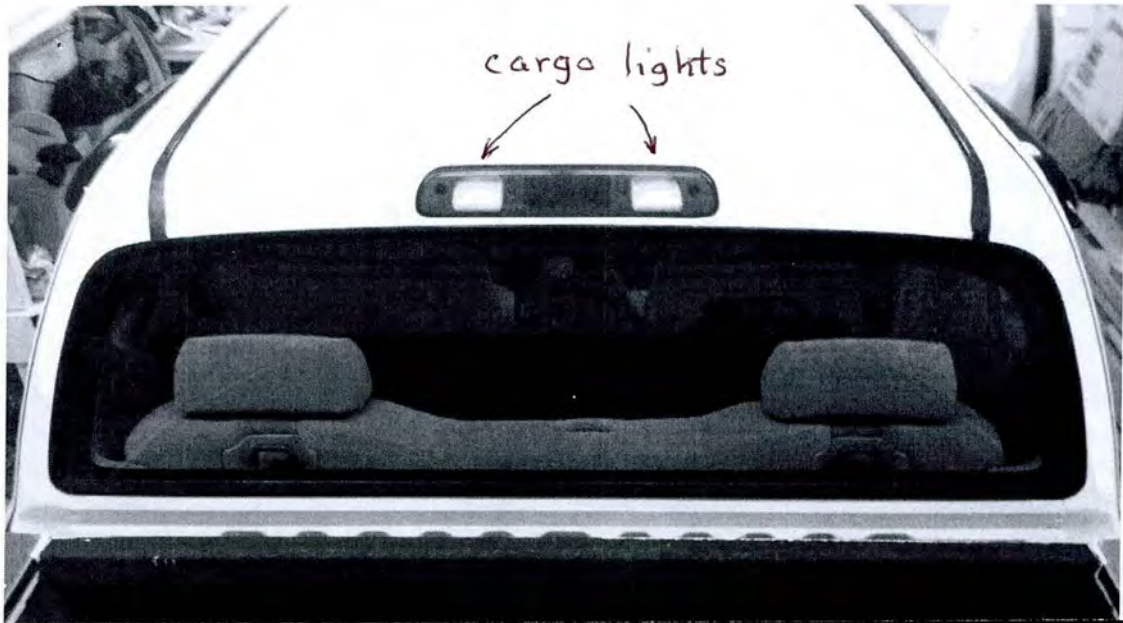
cargo lights

Plastic Housing is melted
both above and below
both cargo lamps

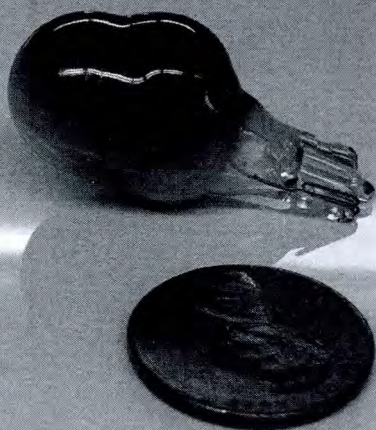
Right side Cargo lamp

Burned out cargo lamp.
Notice how the bulb is
deformed where the plastic
housing dripped (melted) down
on the bulb. It melted the
glass!

Notice melted plastic
housing above and below
bulb

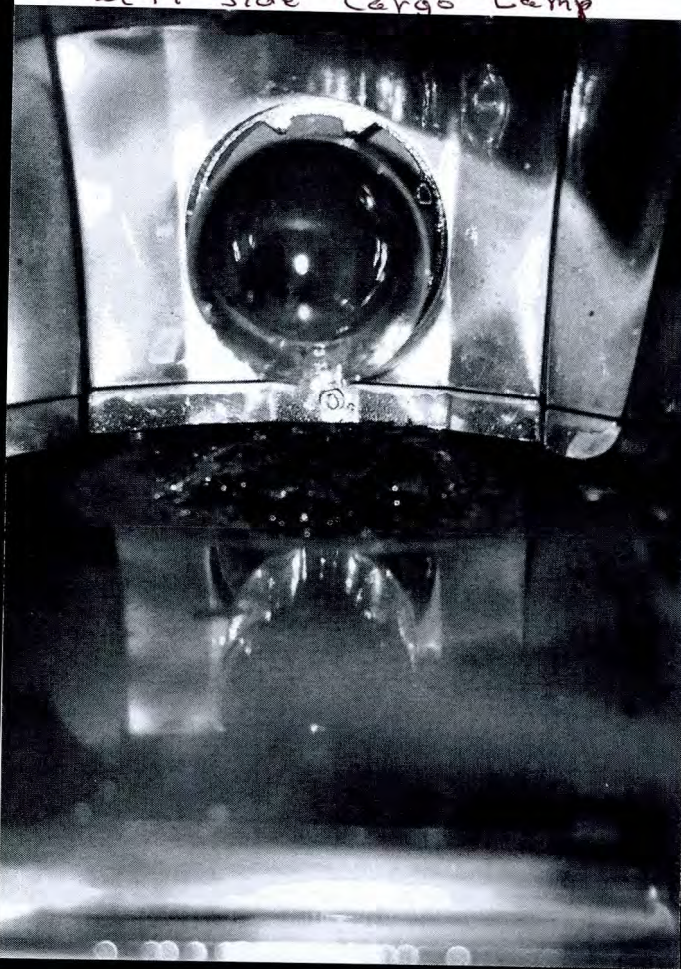
Left side Cargo Lamp

Although bulb is still working,
Notice housing is melted
above and below bulb.

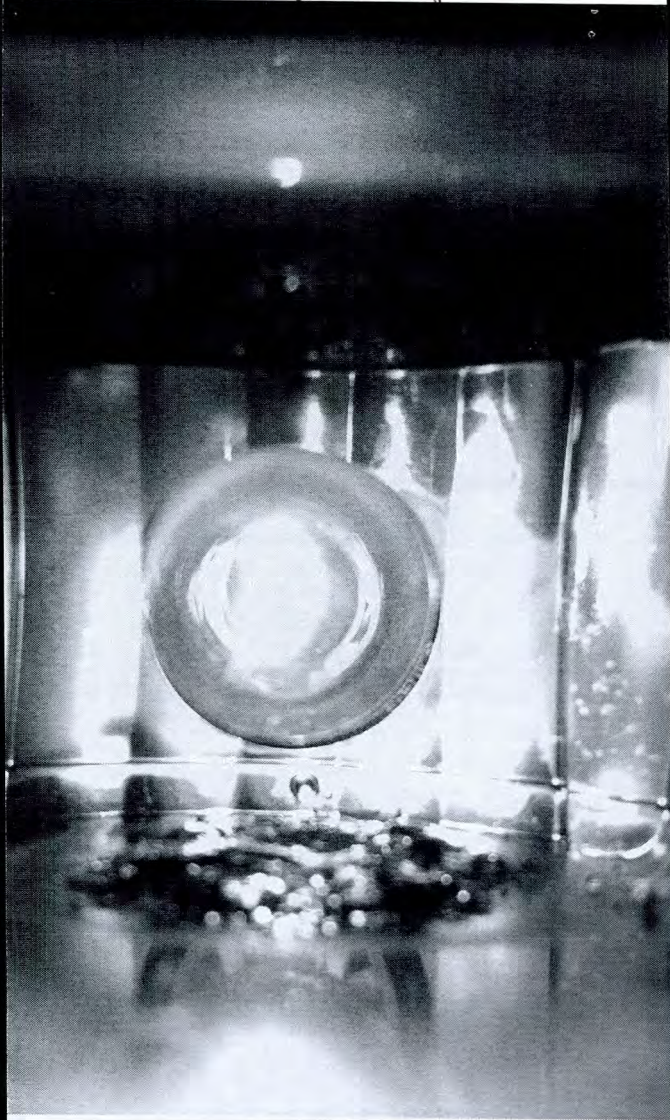
Left side Cargo Lamp

Bulb is "on"

Notice melted plastic housing
above and below bulb.
