| | | <b>Vehicle Owner's Questionnaire</b><br>To Report Vehicle Safety Defects<br>1-888-DASH-2-DOT<br>(1-888-327-4236)<br>INTERNET: www.nhtsa.dot.gov/hotline | | Date Received<br>14-APR-2014 | |
| 4F2CZ94194K | | MAZDA | | TRIBUTE | |
| TL* THE CONTACT OWNS A 2004 MAZDA TRIBUTE. THE CONTACT STATED THAT THE REAR PASSENGER SIDE SHOCKS WAS SEPARATING FROM THE VEHICLE. THE VEHICLE WAS NOT TAKEN FOR INSPECTION OR REPAIRS. THE MANUFACTURER WAS NOT NOTIFIED OF THE ISSUE. THE FAILURE MILEAGE AND THE CURRENT MILEAGE WAS 169,000. This vehicle appears to have been made on same assembly line as the same year FORD ESCAPE. Please see same failure on same model year(s) FORD ESCAPES. The seems to be many. IF there is ever an investigation on the ESCAPES + NOT THE TRIBUTE IT WOULD BE AN INJUSTICE. IT IS THE SAME VEHICLE. (AS WELL AS THE MERCURY MARINER) I AM INCLUDING PICTURES OF THE Problem BOTH Before + After Repair | | | | | |

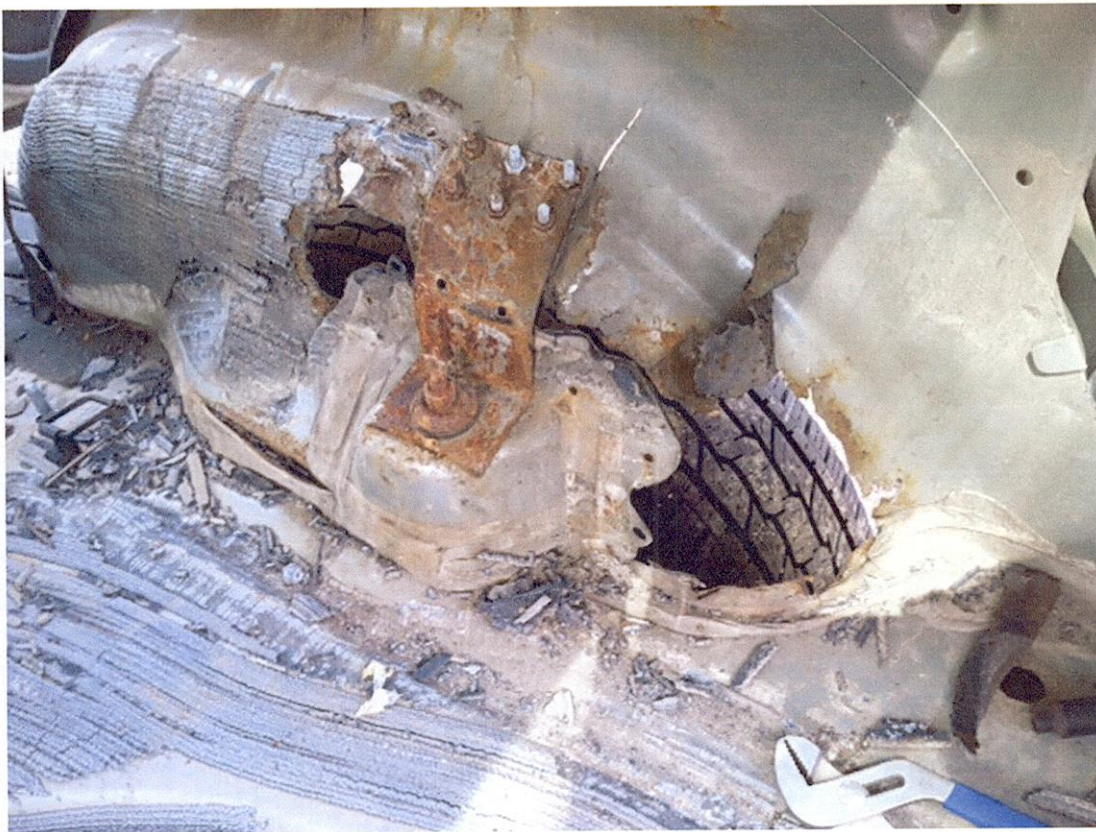
2004 Ford Escape: Rusted out shock mount and seat belt mount

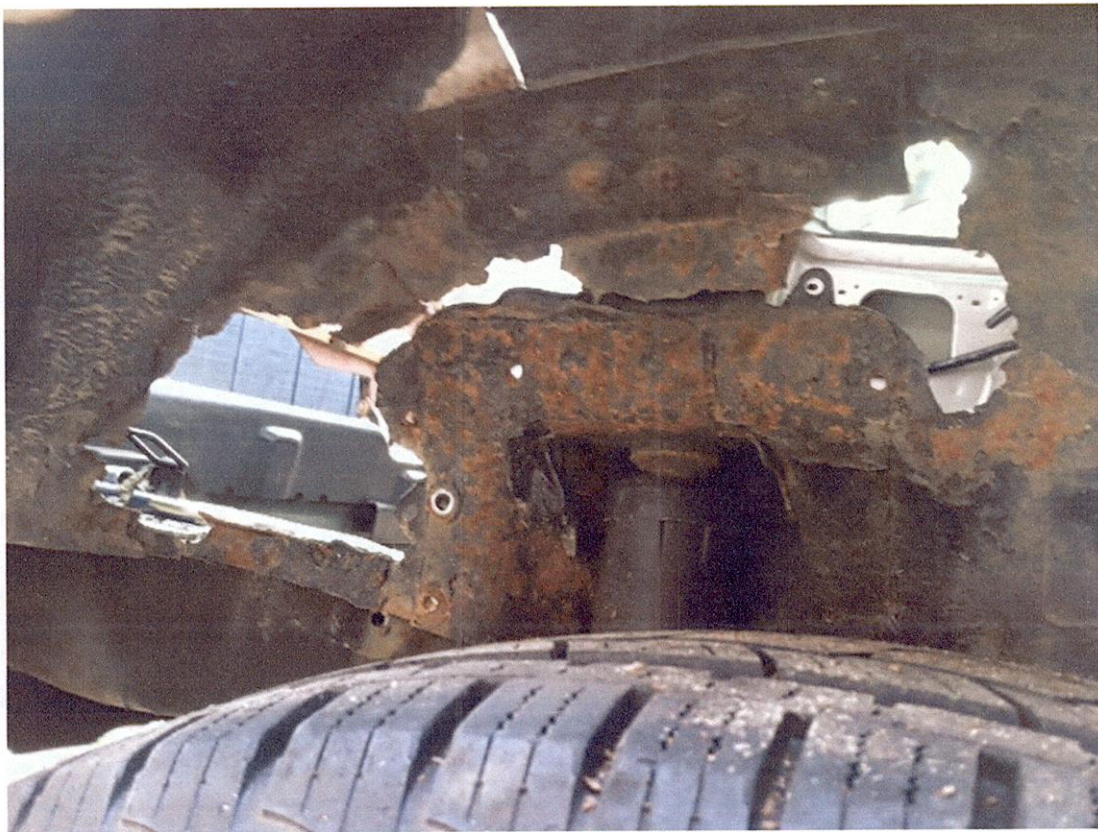
2004 Ford Escape: Rusted out shock mount and seat belt mount

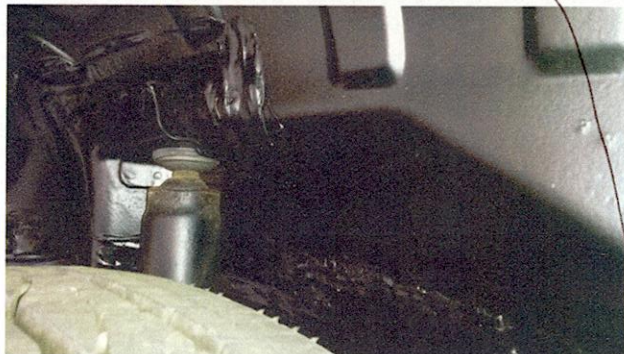
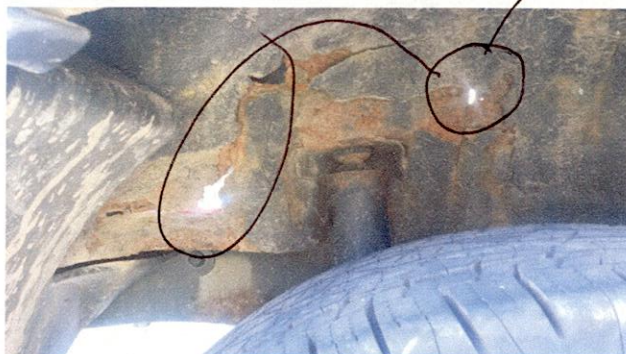
Light showing Through

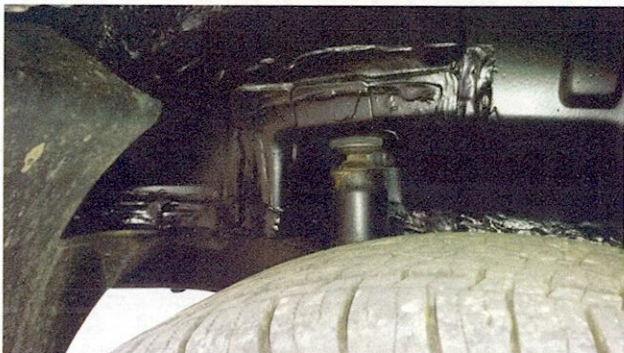
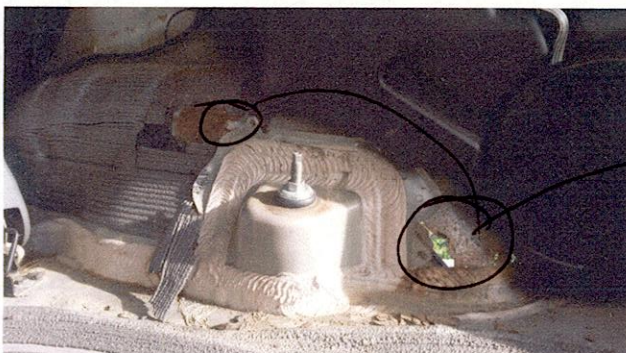
SEE THROUGH
