**Vehicle Owner's Questionnaire**  
**To Report Vehicle Safety Defects**  
**1-888-DASH-2-DOT**  
**(1-888-327-4236)**  
**INTERNET: www.nhtsa.dot.gov/hotline**

3N1BC13E68L Make  
NISSANModel  
VERSAModel Year  
2008

**From:** [REDACTED]  
**To:** [Chan, Steve \(NHTSA\)](#)  
**Subject:** Re: Your report to NHTSA (ODI #10610795); Ref: 2008 Nissan Versa Airbag Inadvertent deployment  
**Date:** Wednesday, November 19, 2014 7:37:15 PM

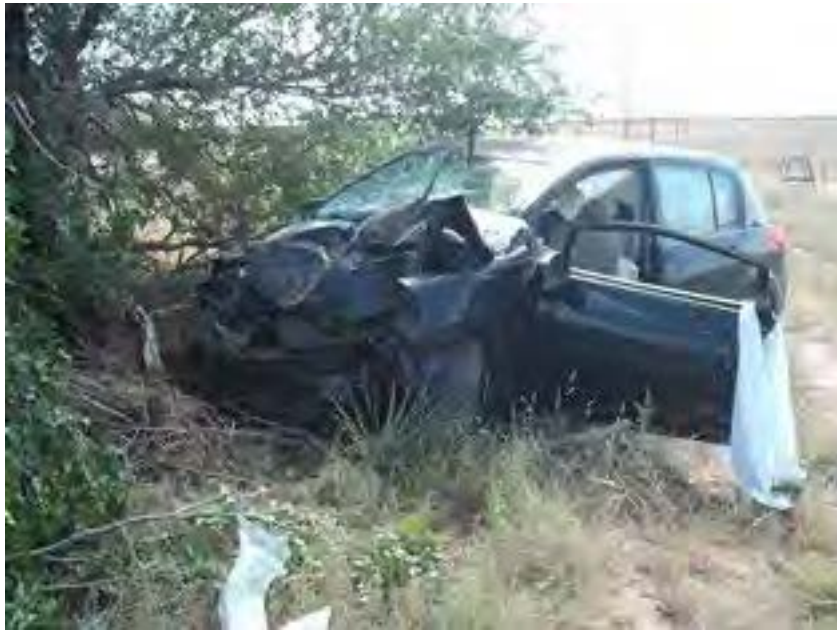
**PHOTO #3**

PHOTO DEPICTING UNIT 1'S LEFT SIDE/ FRONT END DAMAGE

| Photo # | Description of Photograph |
|---|---|
| 3 | PHOTO DEPICTING UNIT 1'S LEFT SIDE/FRONT END DAMAGE |

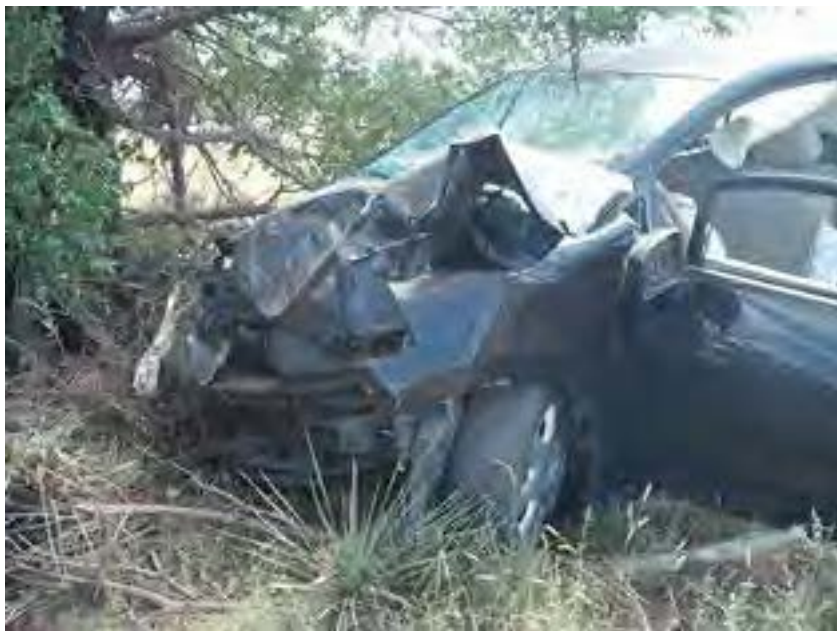
**PHOTO #4**

PHOTO DEPICTING UNIT 1'S FRONT END AND DAMAGE

| Photo # | Description of Photograph |
|---|---|
| 4 | PHOTO DEPICTING UNIT 1'S FRONT END AND DAMAGE |

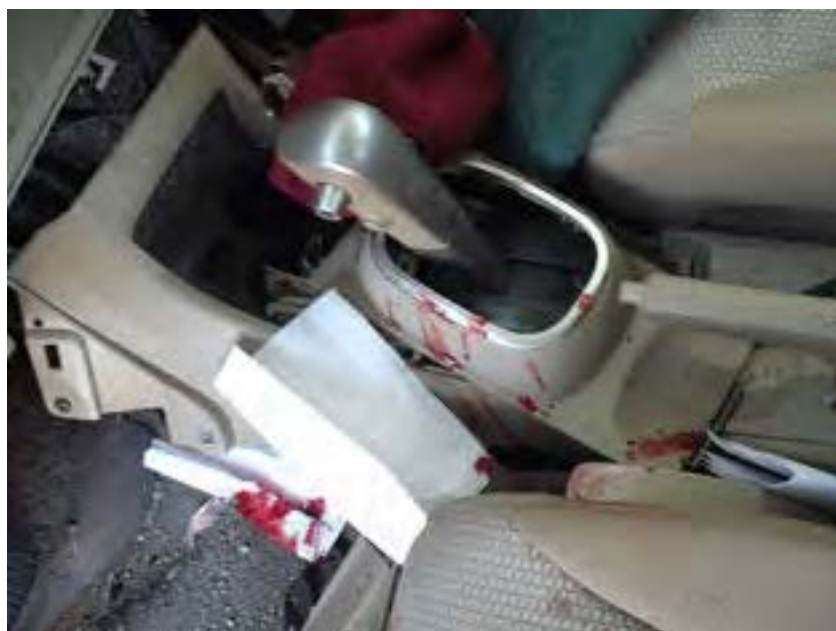
**PHOTO #20**

PHOTO OF UNIT 1'S CENTER CONSOLE INDICATING DAMAGE TO INTERIOR OF VEHICLE AND TRANSMISSION GEAR PLACEMENT

The vehicle's transmission was the "drive" gear. The air conditioner was being utilized. It is unknown whether the radio was being utilized due to a lack of power. The vehicle was not equipped with any auxiliary lights, radios, radar detectors, or cigarette plug adaptors.

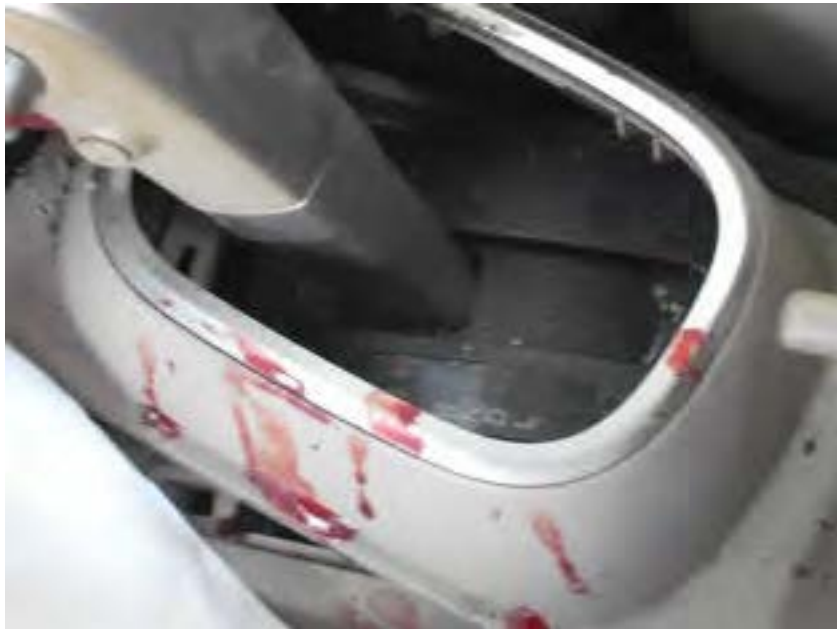
**PHOTO #21**

PHOTO OF UNIT 1'S GEAR SHIFT DEPICTING GEAR PLACEMENT

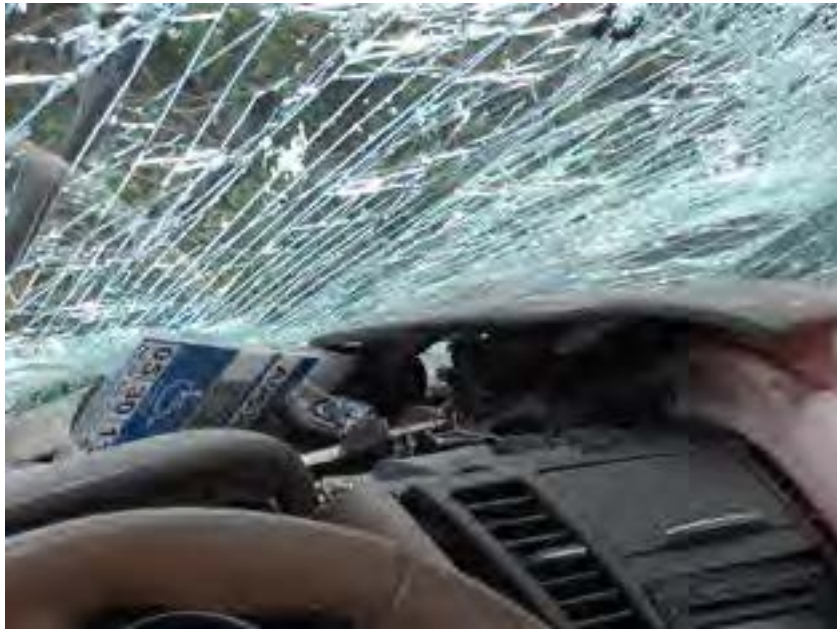
**PHOTO #27**

PHOTO OF UNIT 1'S WINDSHIELD DAMAGE & REAR VIEW MIRROR DISPLACEMENT

| Photo # | Description of Photograph |
|---|---|
| 27 | PHOTO OF UNIT 1'S WINDSHIELD DAMAGE AND REAR VIEW MIRROR DISPLACEMENT |

I observed unit 1 to have a broken windshield and bent steering wheel. Unit 1's gas / brake pedal were bent and pushed inward toward the center console. Unit 1's emergency brake was in the down position and had not been used to the best of my knowledge. Unit 1's emergency brake is equipped in the center console area of the vehicle.

Unit 1's rearview mirror was displaced and I observed a disabled permit on the dash board. There was a walking device, miscellaneous travel equipment, and personal items in the vehicle's rear seat and floor board.

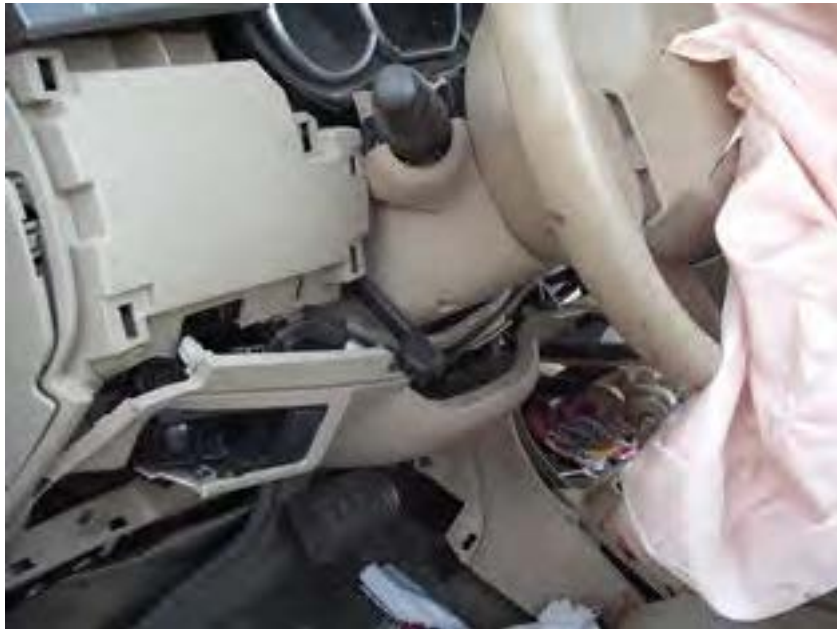
**PHOTO #31**

PHOTO OF UNIT 1'S DRIVER SIDE STEERING COLUMN DEPICTING DAMAGE TO VEHICLE CONTROLS & STEERING COLUMN

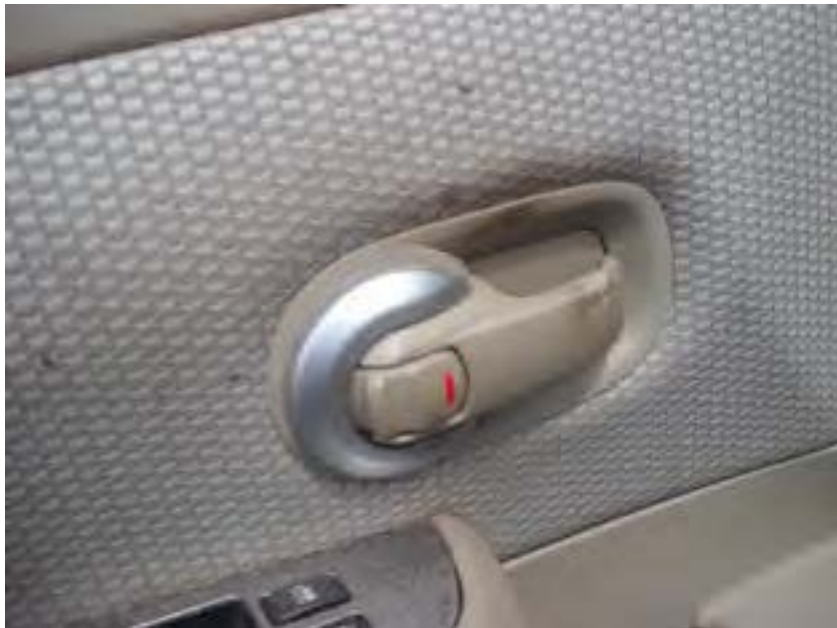
**PHOTO #32**

PHOTO OF UNIT 1'S DRIVER SIDE DOOR PANEL DEPICTING THE DOORS UNLOCKED POSITION

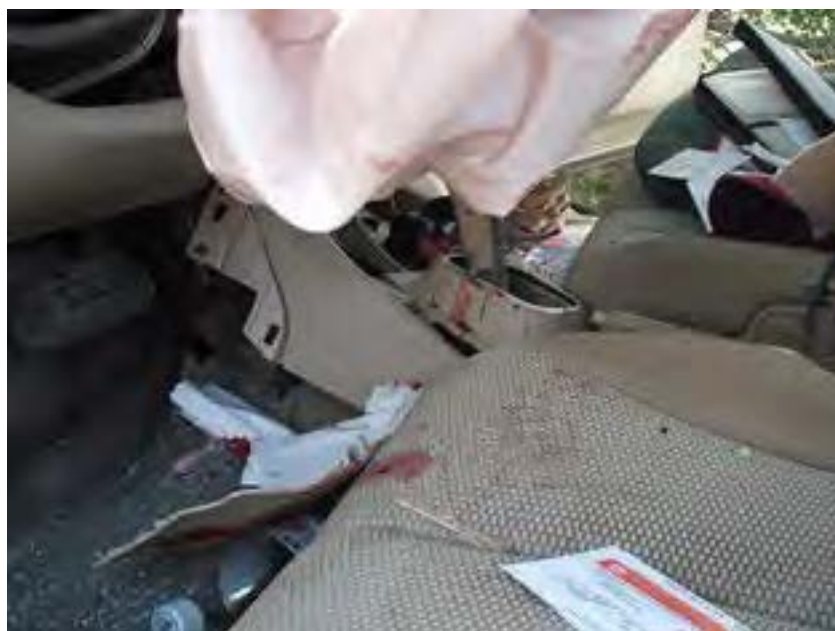
**PHOTO #33**

PHOTO OF UNIT 1'S FLOOR BOARD AREA DEPICTING BLOOD EVIDENCE & DAMAGE TO THE CENTER CONSOLE

I observed both front seat belts to have been used and the driver side seat belt was cut by EMS personnel in order to remove [REDACTED]. I observed a large amount of blood splatter in the following areas of the vehicle: Steering wheel, driver air bag, driver door, windshield, driver seat, driver floor board, driver safety belt, dash board, radio console, center console, emergency brake, passenger seat, passenger seat belt, passenger air bag, and passenger door.

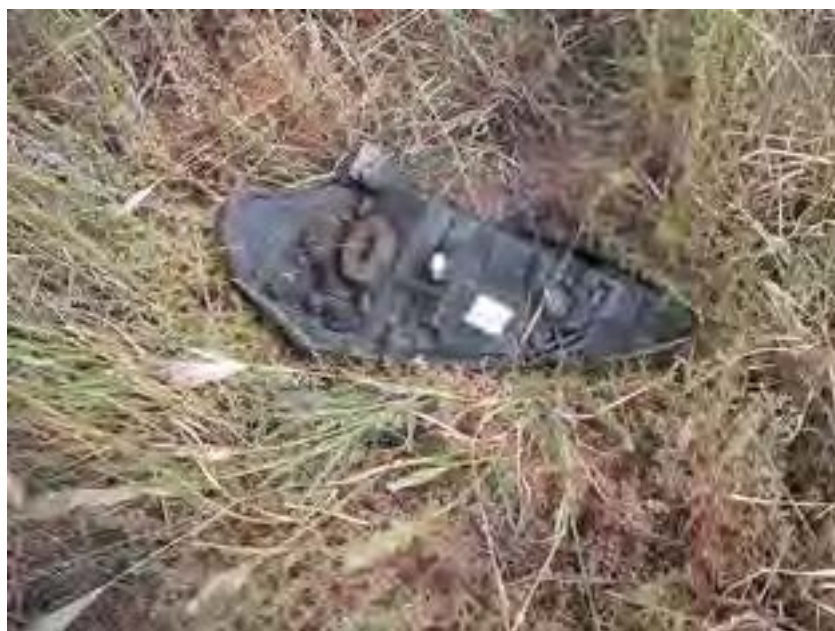
**PHOTO #34**

PHOTO OF UNIT 1'S DRIVER SIDE HEAD LAMP DEPICTING ITS DISPLACEMENT FROM THE VEHICLE

As I continued to document evidence from the crash, I observed the vehicle's right side headlamp had become displaced when the vehicle struck the tree and came to final rest approximately 39.92 feet east of the final resting area of unit 1.

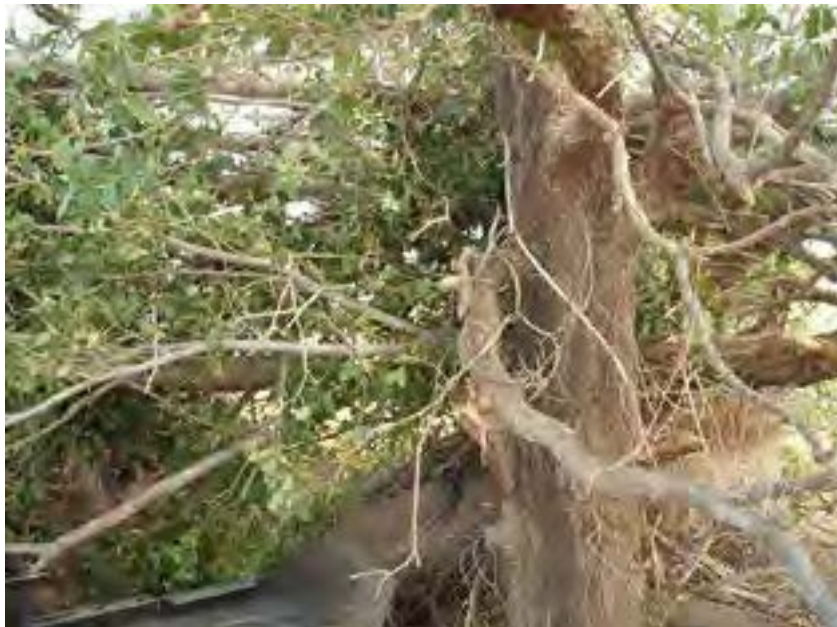
**PHOTO #38**

PHOTO OF THE DAMAGE THE TREE INCURRED DUE TO THE COLLISION

As I collected information for the crash report, I observed that unit 1 was only approximately six feet south of a pair of large trees growing alongside [REDACTED] I also observed the tree that had been struck was broken in half and the roots completely unearthed from the ground.

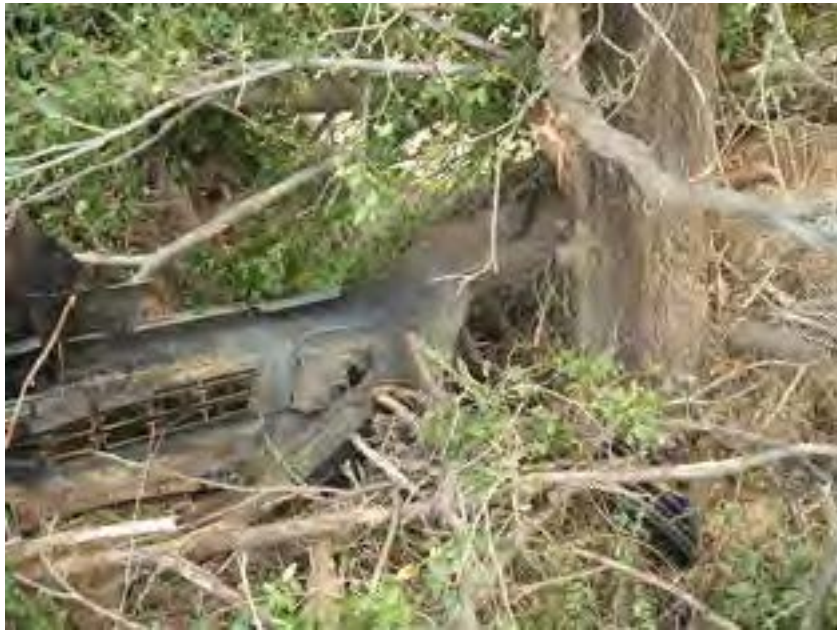
**PHOTO #39**

PHOTO OF UNIT 1'S FRONT BUMPER AND DAMAGE TO TREE DUE TO THE COLLISION

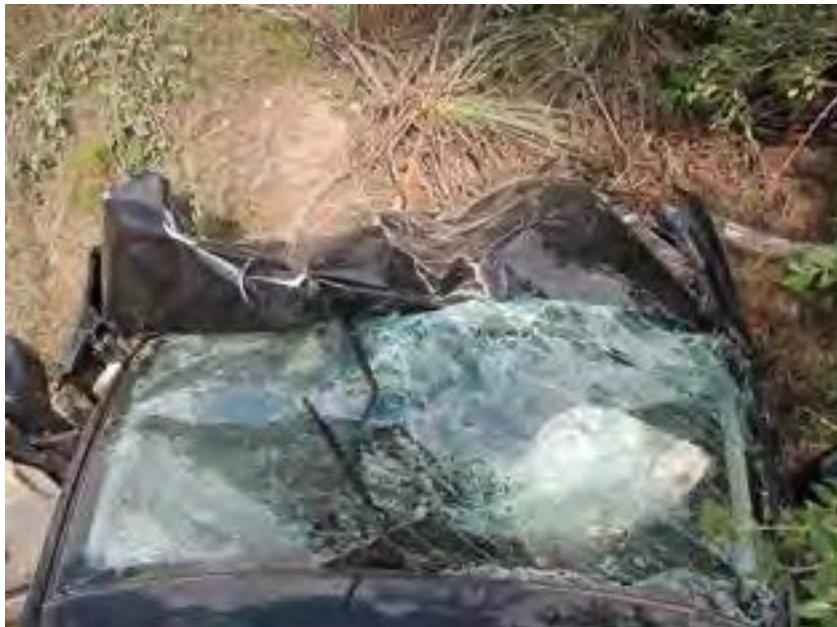
**PHOTO #42**

TOP VIEW OF UNIT DEPICTING DAMAGE TO UNIT 1'S FRONT END

Vehicle #1 sustained severe damage during the crash. Vehicle #1 has one damage rating which is described as: 12-FD-4. Vehicle #1 received damage to the following articles equipped in and on the vehicle during the crash:

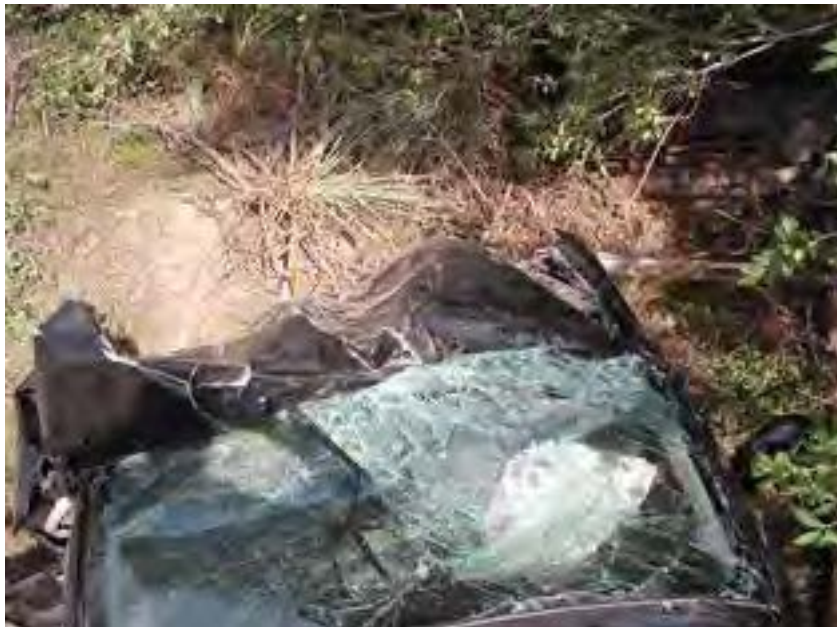
**PHOTO #46**

TOP VIEW OF UNIT 1'S FRONT END DEPICTING DAMAGE TO ITS RIGHT FRONT SIDE

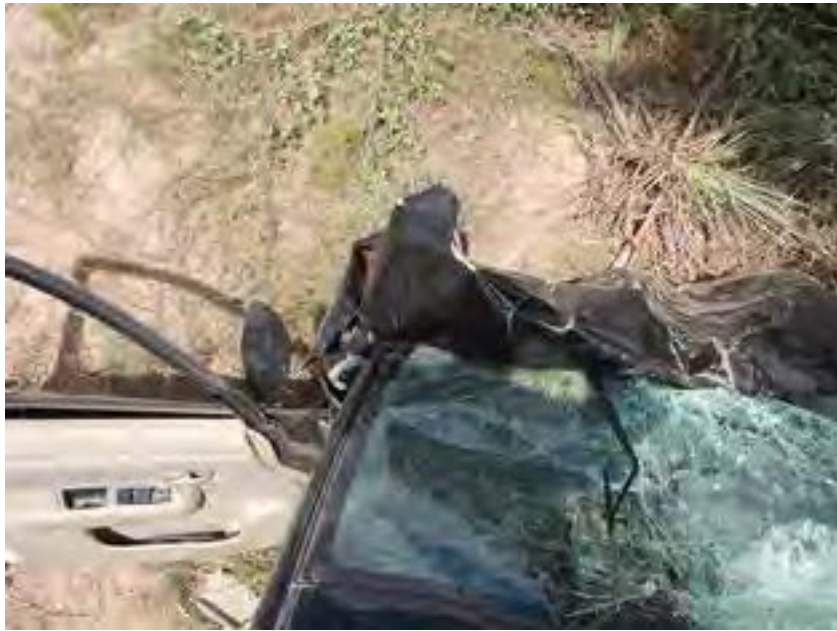
**PHOTO #47**

TOP VIEW OF UNIT 1'S FRONT END DEPICTING DAMAGE TO ITS LEFT FRONT SIDE

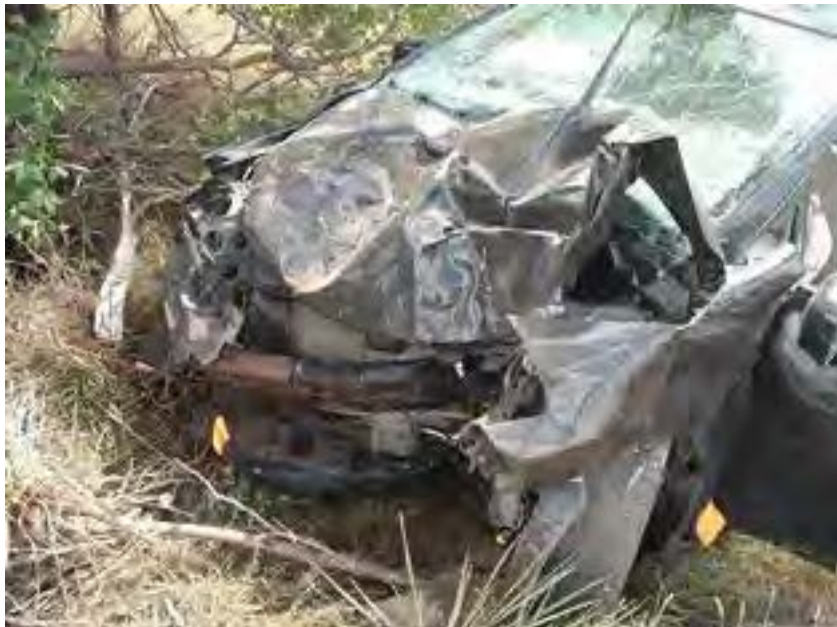
**PHOTO #50**

VIEW OF UNIT 1'S FRONT END DAMAGE FROM A LOWER LEVEL ANGLE

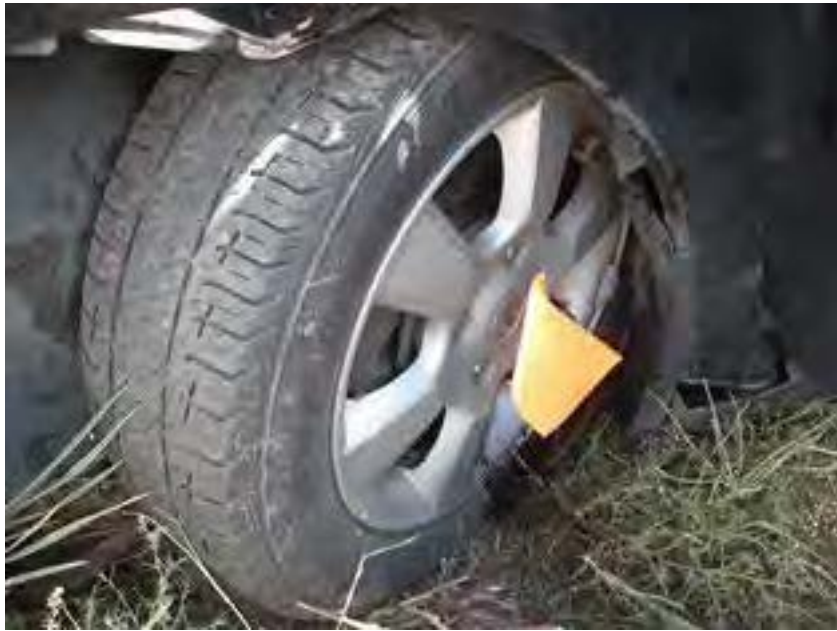
**PHOTO #51**

PHOTO OF UNIT 1'S LEFT FRONT TIRE AND WHEEL DEPICTING TYPE, SIZE, AND DAMAGE TO WHEEL WELL

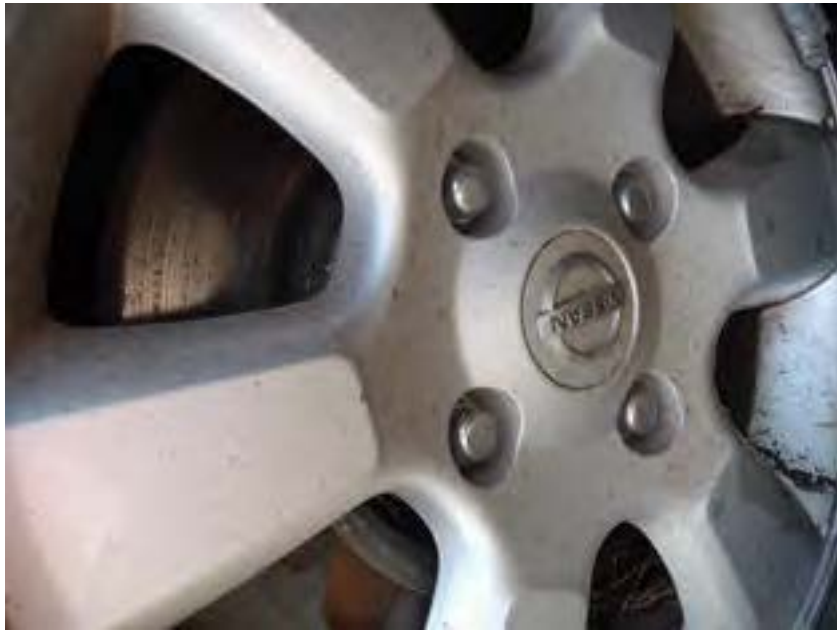
**PHOTO #61**

PHOTO OF UNIT 1'S FRONT LEFT TIRE DEPICTING LUG NUT PLACEMENT AND LACK OF DAMAGE

The two front tires and wheels were also in good repair. The tread depth was good and the wear pattern was normal. Both tires had approximately 30 pounds of air pressure in them at the time of the crash.
