C1-10630810-9865

I am writing this letter to bring to the NHTSA's attention what I believe is an unsafe and indifferent recreational vehicle industry. This general indifference starts at component manufacturing and perpetuates itself throughout the recreational vehicle industry. In this letter I am going to attempt to convey my case to you as to what I believe is clearly a case of industry irresponsibility and a general lack of safety concern for their customers. I will present evidence of poor component manufacturing, improper component installation, unsafe slide-out room design, and a general lack of concern at the RV sales end. This safety issue affects many RV brands that use the "Lippert Flex Guard rail" but I will focus on my specific RV trailer the "Fun Finder 189FD" manufactured by Cruiser RV located in Howe, IN.

My Failure Analysis

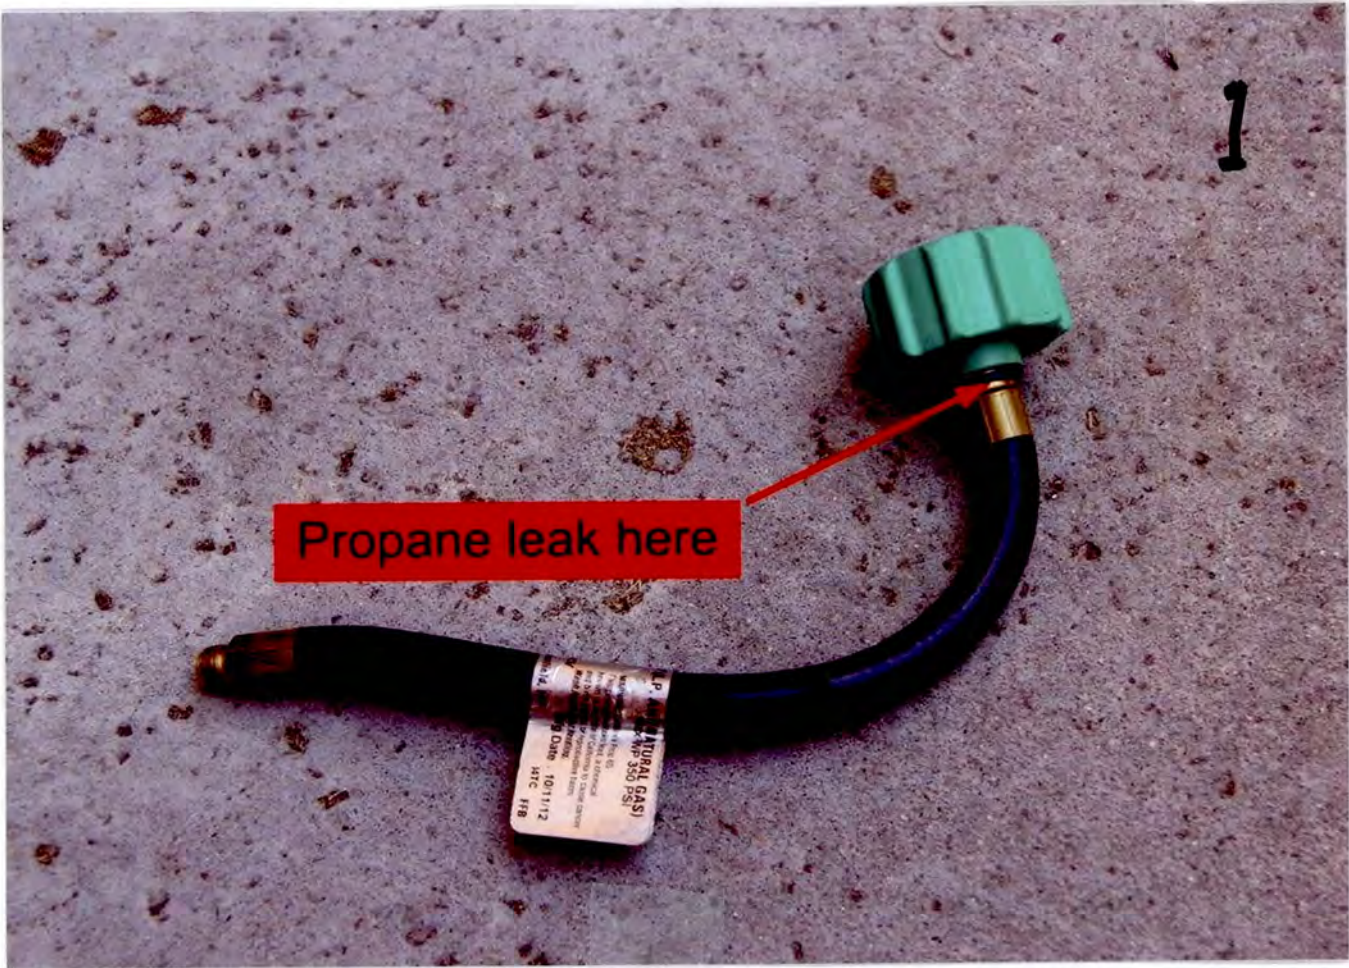
1

In the span of just two weeks (June 24 to July 15, 2014) I experienced two propane leaks! The first leak was a leaky propane bottle hose connector that I discovered while camping at Lake Tahoe CA on June 24, 2014. I replaced both hoses at my own expense. (See photo 1)

Propane leak here

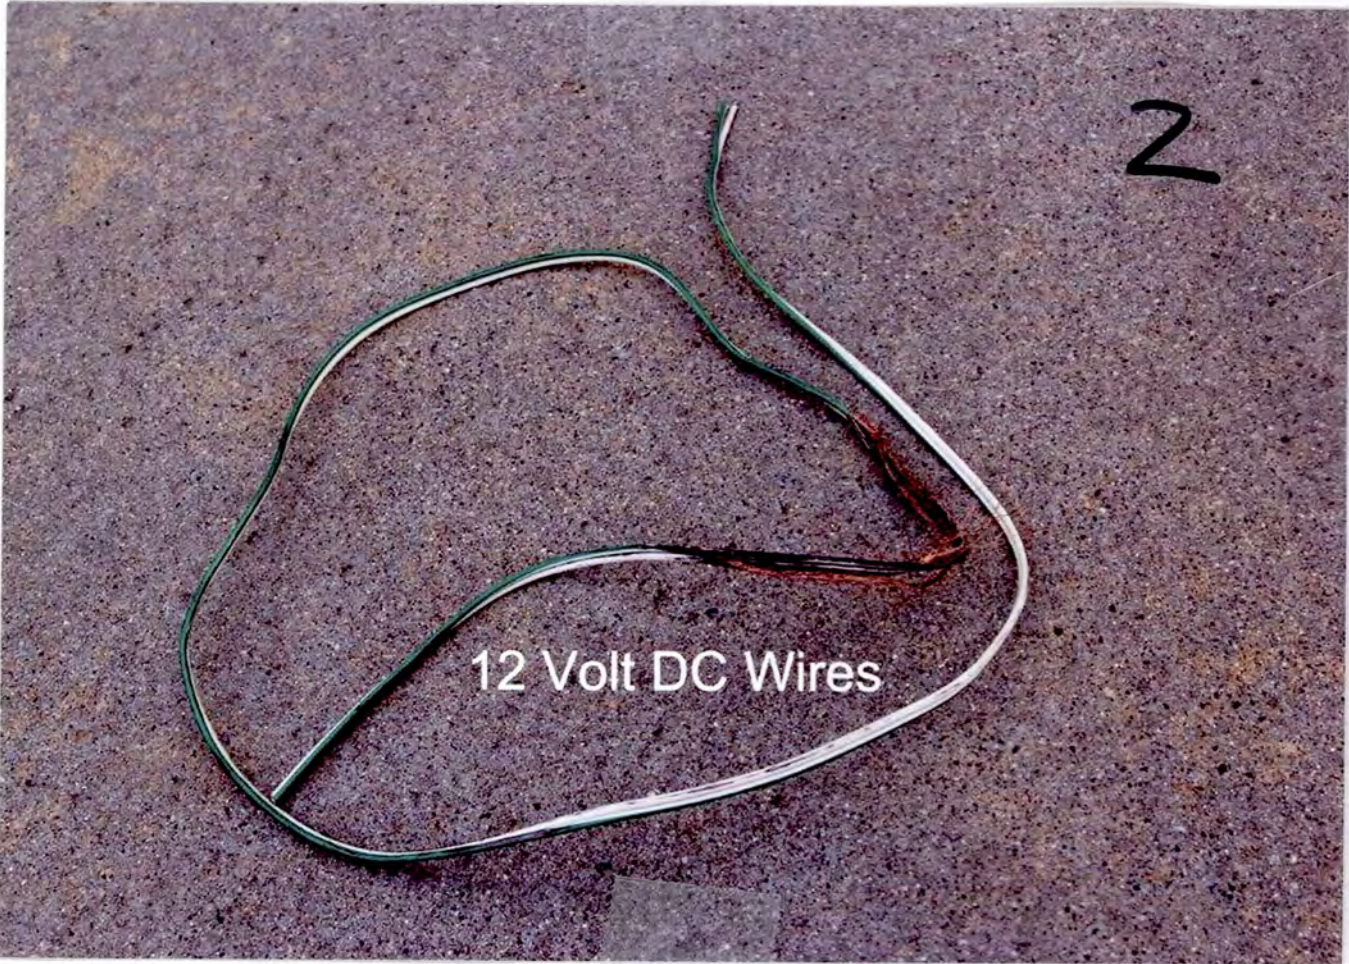
2

Once I had neutralized the threat of fire, I performed a visual assessment and saw that the wires and propane hose were in shreds (see photo 5) after being dragged on the pavement for quite some distance. (Note: The live 12 volt wires were in shreds (see photo 2). I later discovered that the 12 volt line fuse had blown cutting off the 12 volts preventing sparks that may have ignited the propane gas!) Having only the use of my right arm and no help in sight, I tried but could not tie up the dangling hose and wires so I had to cut them short enough to continue driving the 60 miles to my sister's house in Grants Pass Oregon. The following day, with the aid of some heavy duty Motrin, I drove 350 miles with one hand to return home. A day later, July 17, my family doctor told me that I tore my rotator cuff and will probably require surgery. On July 23, 2014 I saw an orthopedic surgeon and he confirmed my family doctor's diagnosis. He told me, "Without surgery your shoulder will never heal properly".

12 Volt DC Wires

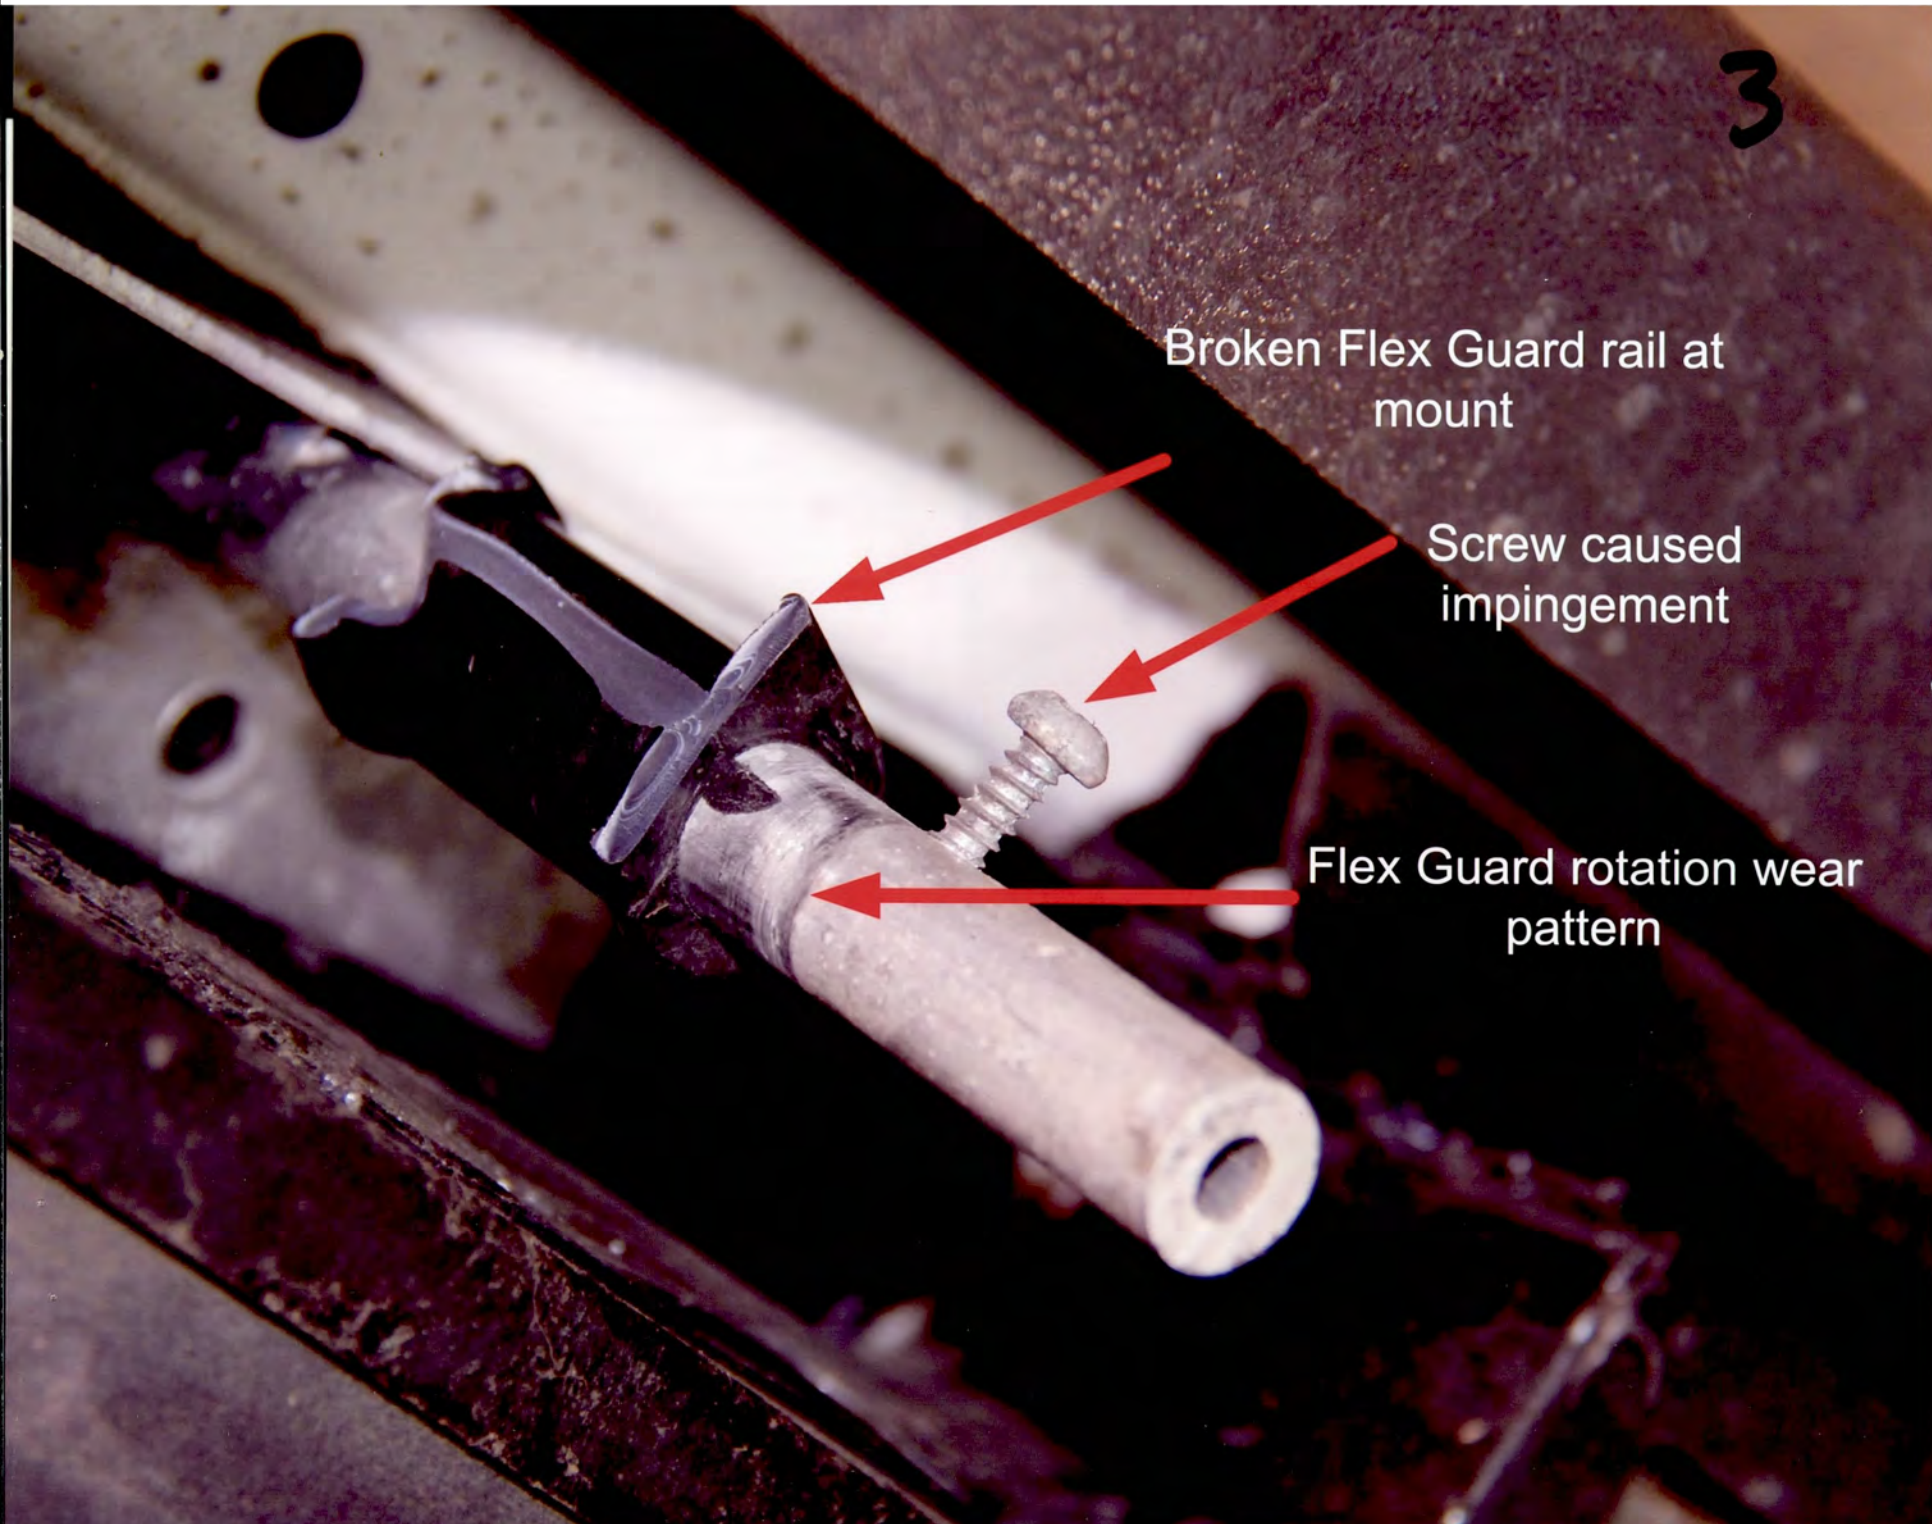
3

After inspecting the underside of the trailer I observed that the Flex Guard rail was totally gone with only a piece of plastic remaining on the ½' mounting rod. (See photo 3) After doing much research this is what I believed happened; the Flex Guard failed and broke off at the mounting rod and then fell off or abraded off during travel. Without the support of the Flex Guard rail the LP hose and wires (12 volt hot and 110 volt cold) fell down and came into contact with the spinning trailer wheel abrading them in two. The hose and/or wires then got caught between the trailer wheel and pavement and were violently ripped out even further. This theory can be confirmed by examining the damaged LP hose and wires.

I am convinced that the Flex Guard is made of inappropriate and/or inexpensive materials and is of poor mechanical design. That said, I also believe that Cruiser RV's installation of my trailer's Flex Guard rail was also flawed. Cruiser RV installed a round head screw into the ½" aluminum rod to keep the Flex Guard in position. The screw that Cruiser used is a round head screw with a head diameter of 0.314". The distance measured from the underside of the screw head to the rod is 0.339" (see drawing 1 and 1A). I believe it is reasonably plausible that the screw head may have impinged the Flex Guard's rotational ability resulting in undue stress on the Flex Guard joint thus exacerbating premature failure of an already flawed component. This impingement risk could have been totally eliminated by inserting a bushing spacer between the screw and the Flex Guard (see drawing 2 and 2-A). With an appropriately sized bushing, the Flex Guard could freely rotate above the screw head without the possibility of impingement. *I have enclosed a photo (see photo 4) of a brand new Flex Guard with the same size screw as the one used on my trailer. Note the impingement probability. Cruiser, I hope you are listening and start installing bushings as I have described.*

Broken Flex Guard rail at
mount

Screw caused
impingement

Flex Guard rotation wear
pattern

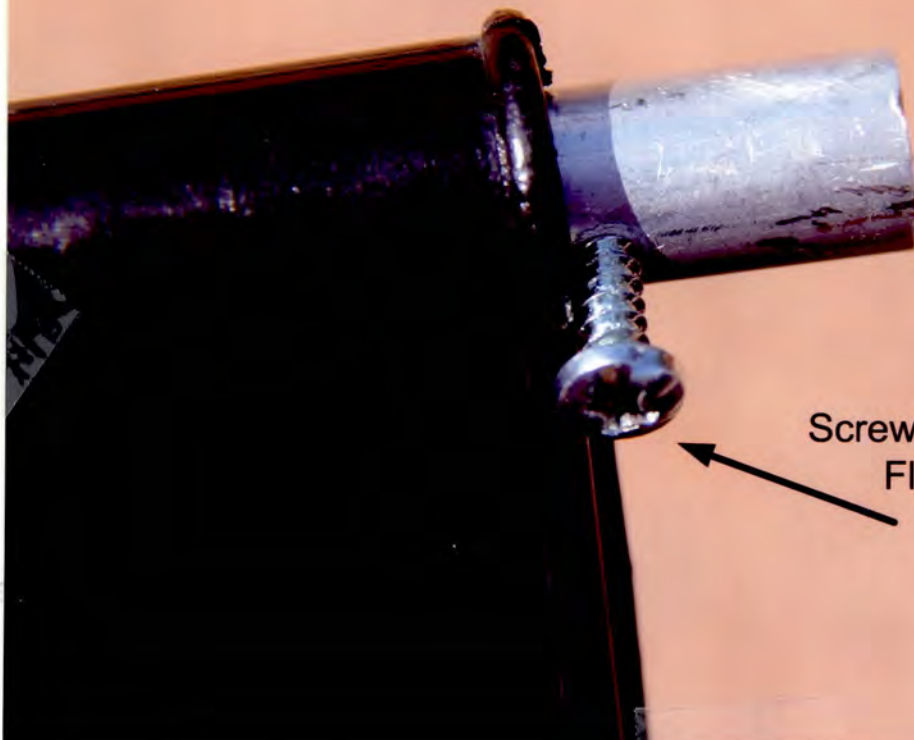
4

Screw head impingement of
Flex Guard rotation
