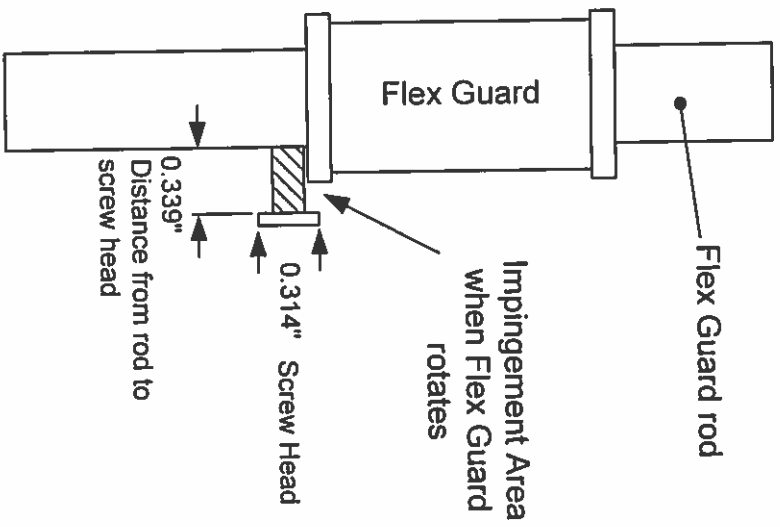
Drawing 1

I am convinced that the Flex Guard is made of inappropriate and/or inexpensive materials and is of poor mechanical design. That said, I also believe that Cruiser RV's installation of my trailer's Flex Guard rail was also flawed. Cruiser RV installed a round head screw into the ½" aluminum rod to keep the Flex Guard in position. The screw that Cruiser used is a round head screw with a head diameter of 0.314". The distance measured from the underside of the screw head to the rod is 0.339" (see drawing 1 and 1A). I believe it is reasonably plausible that the screw head may have impinged the Flex Guard's rotational ability resulting in undue stress on the Flex Guard joint thus exacerbating premature failure of an already flawed component. This impingement risk could have been totally eliminated by inserting a bushing spacer between the screw and the Flex Guard (see drawing 2 and 2-A). With an appropriately sized bushing, the Flex Guard could freely rotate above the screw head without the possibility of impingement. *I have enclosed a photo (see photo 4) of a brand new Flex Guard with the same size screw as the one used on my trailer. Note the impingement probability. Cruiser, I hope you are listening and start installing bushings as I have described.*
