**Vehicle Owner's Questionnaire**  
To Report Vehicle Safety Defects  
1-888-DASH-2-DOT  
(1-888-327-4236)  
INTERNET: www.nhtsa.dot.gov/hotline

Reference No.  
10655404

Vehicle Component Code: 162000 STRUCTURE: BODY

2004 Lexus RX330

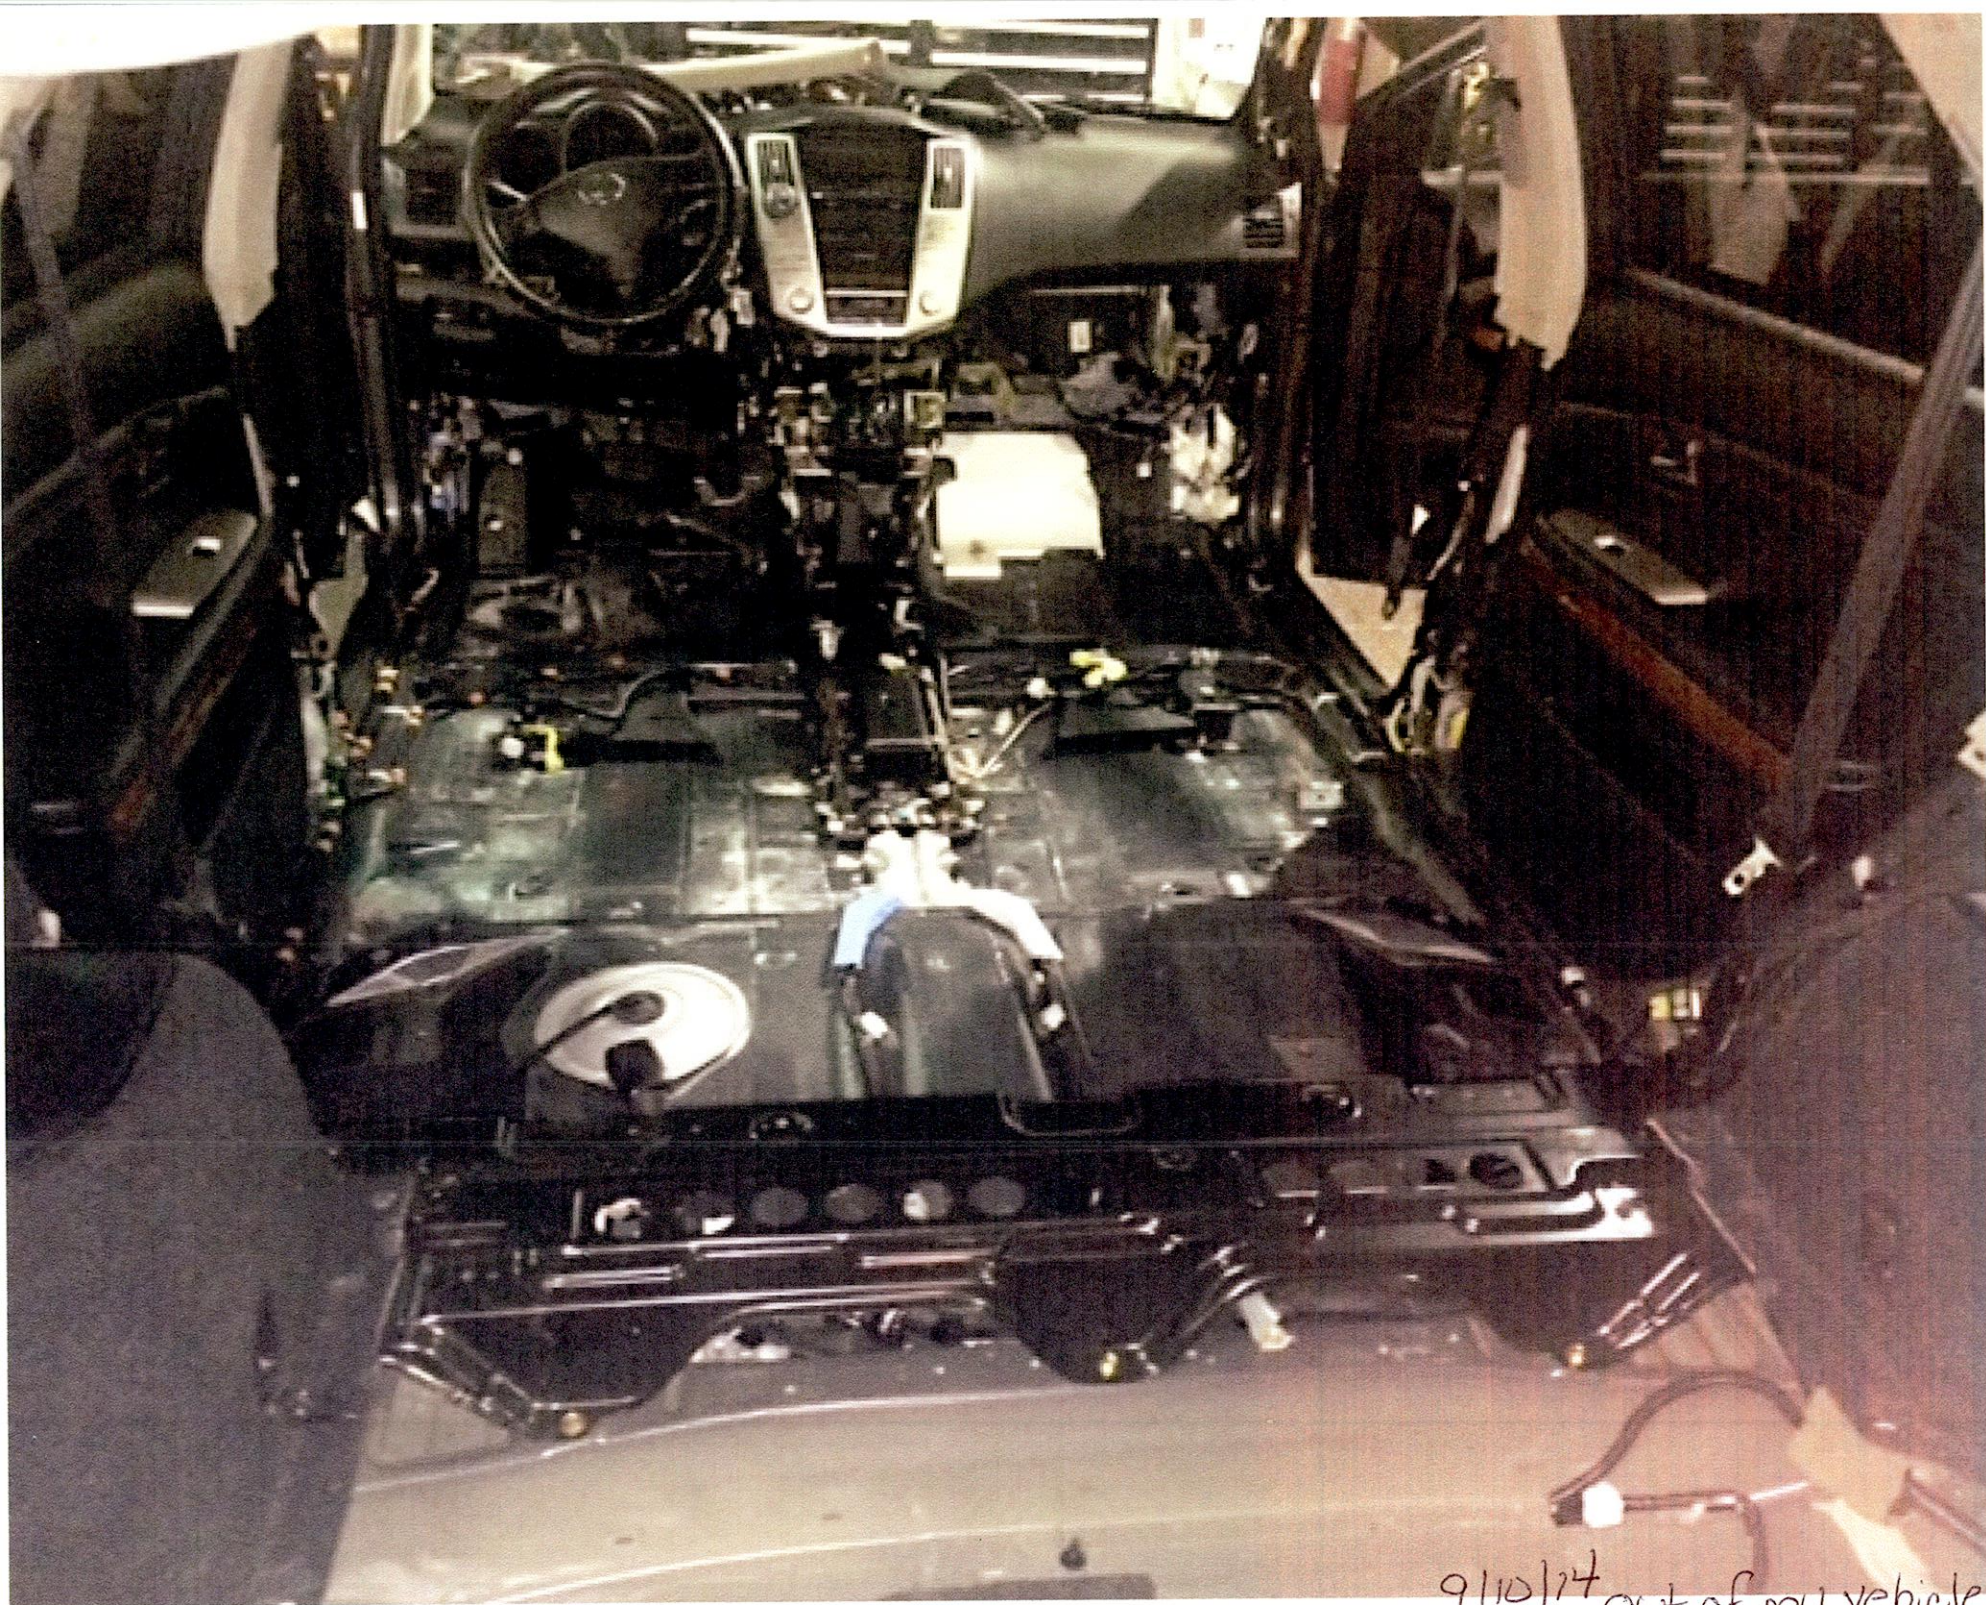
9/10/14 out of my vehicle

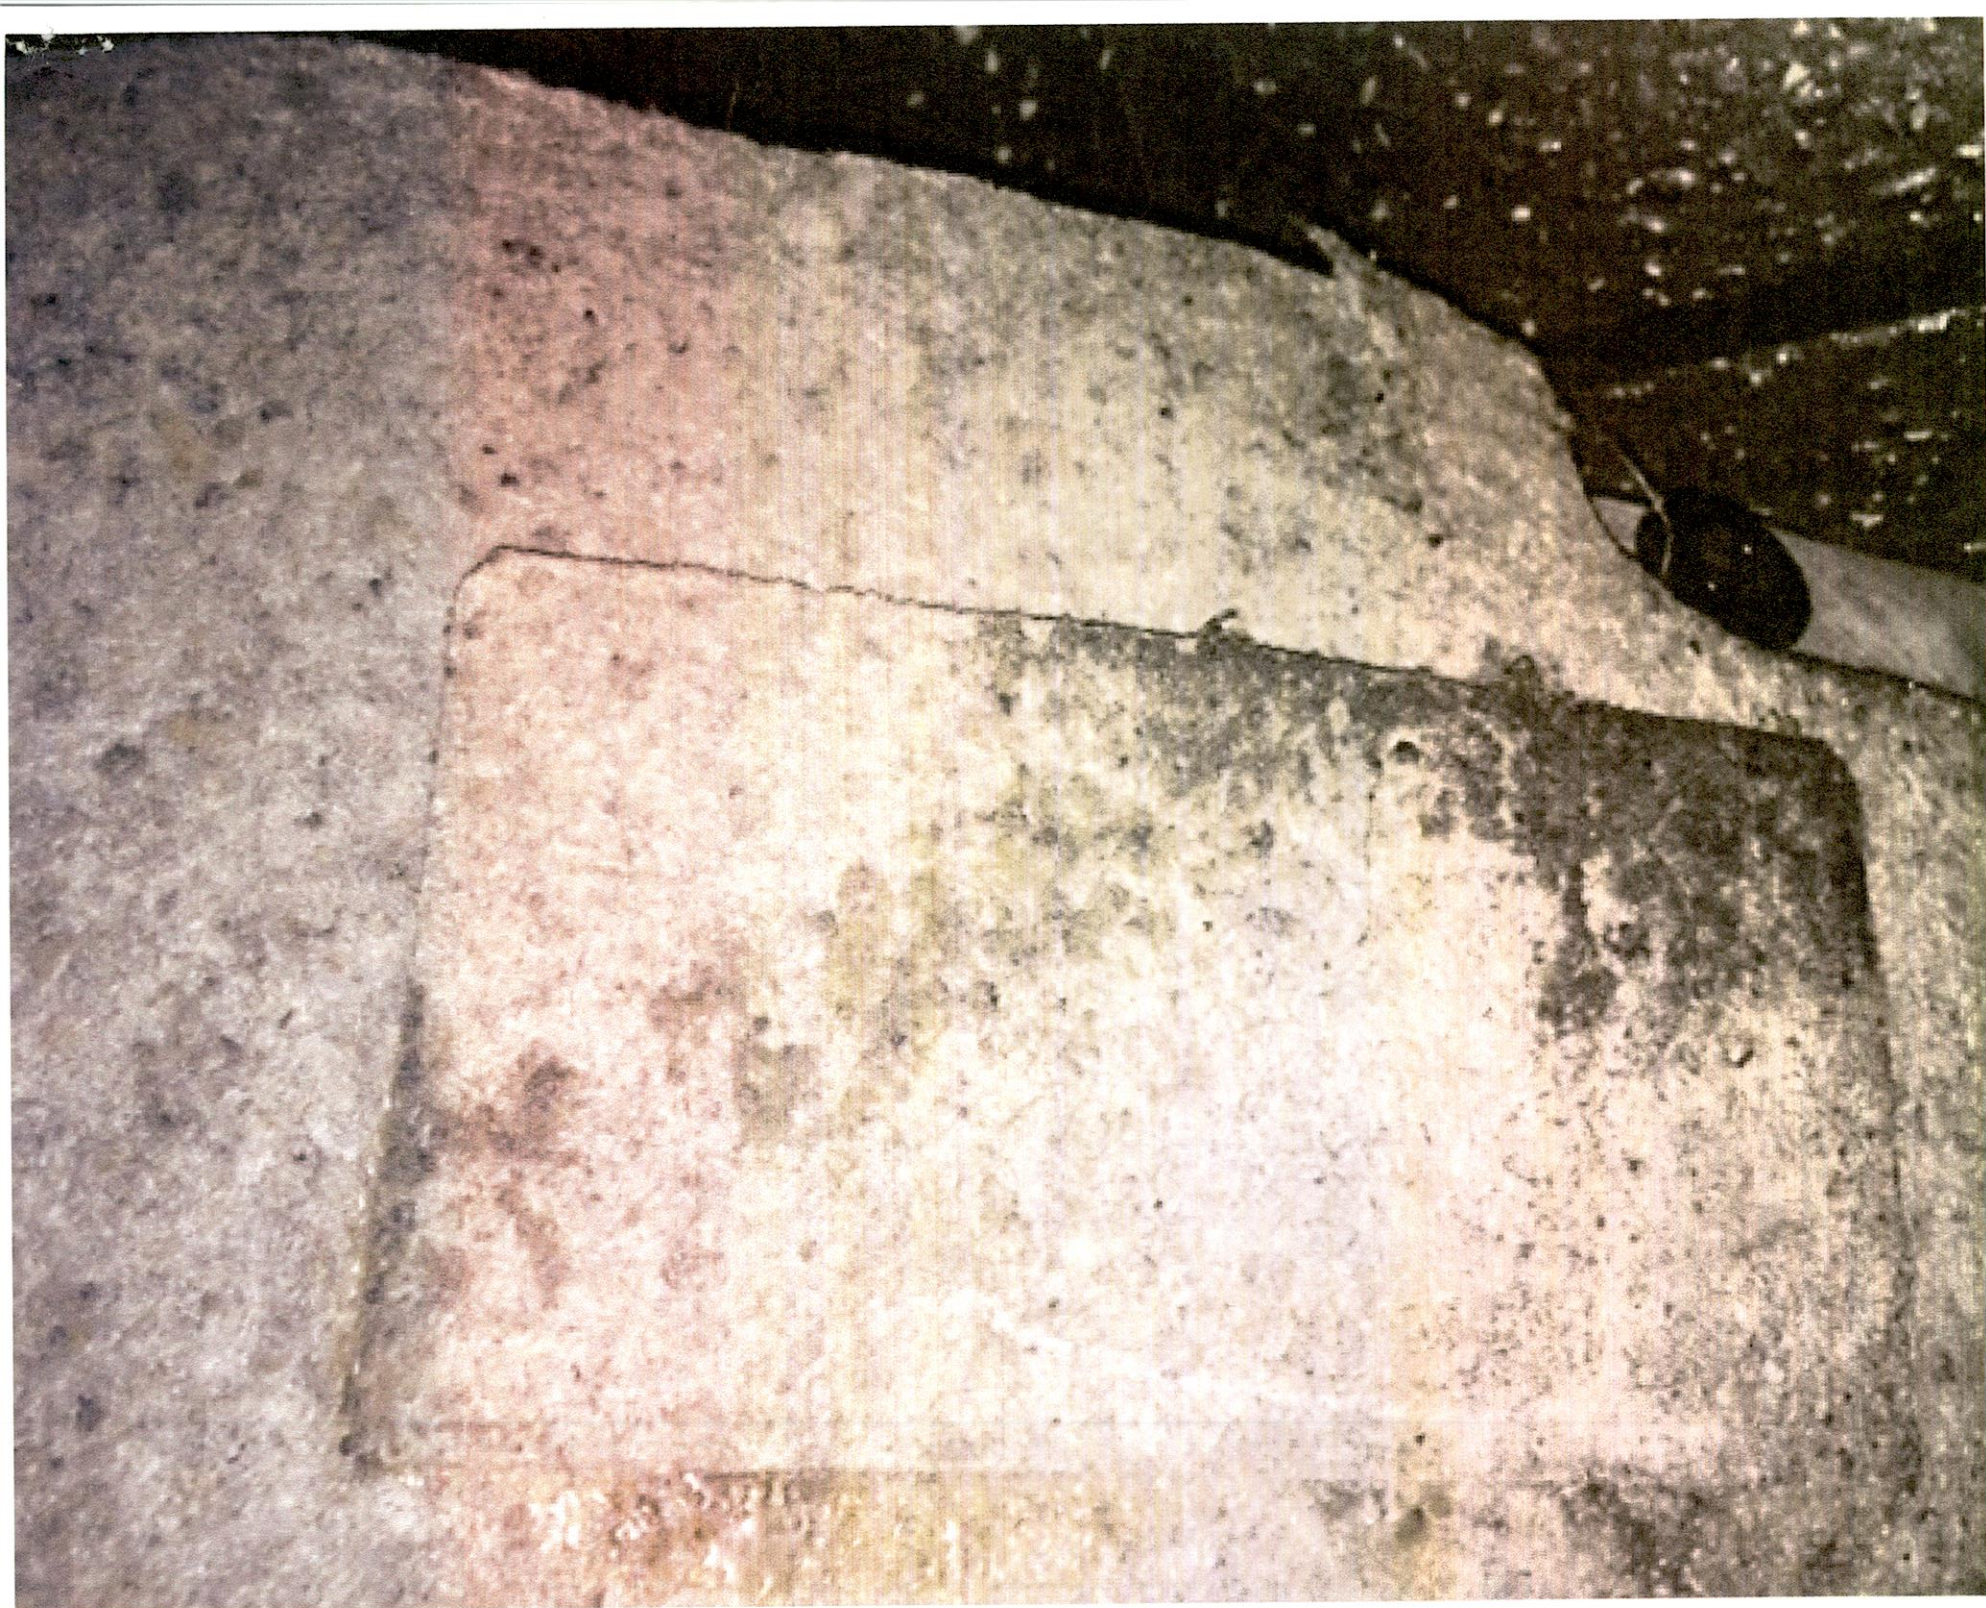
M  
O  
-  
O  
N  
+  
h  
e  
C  
A  
R  
P  
E  
+

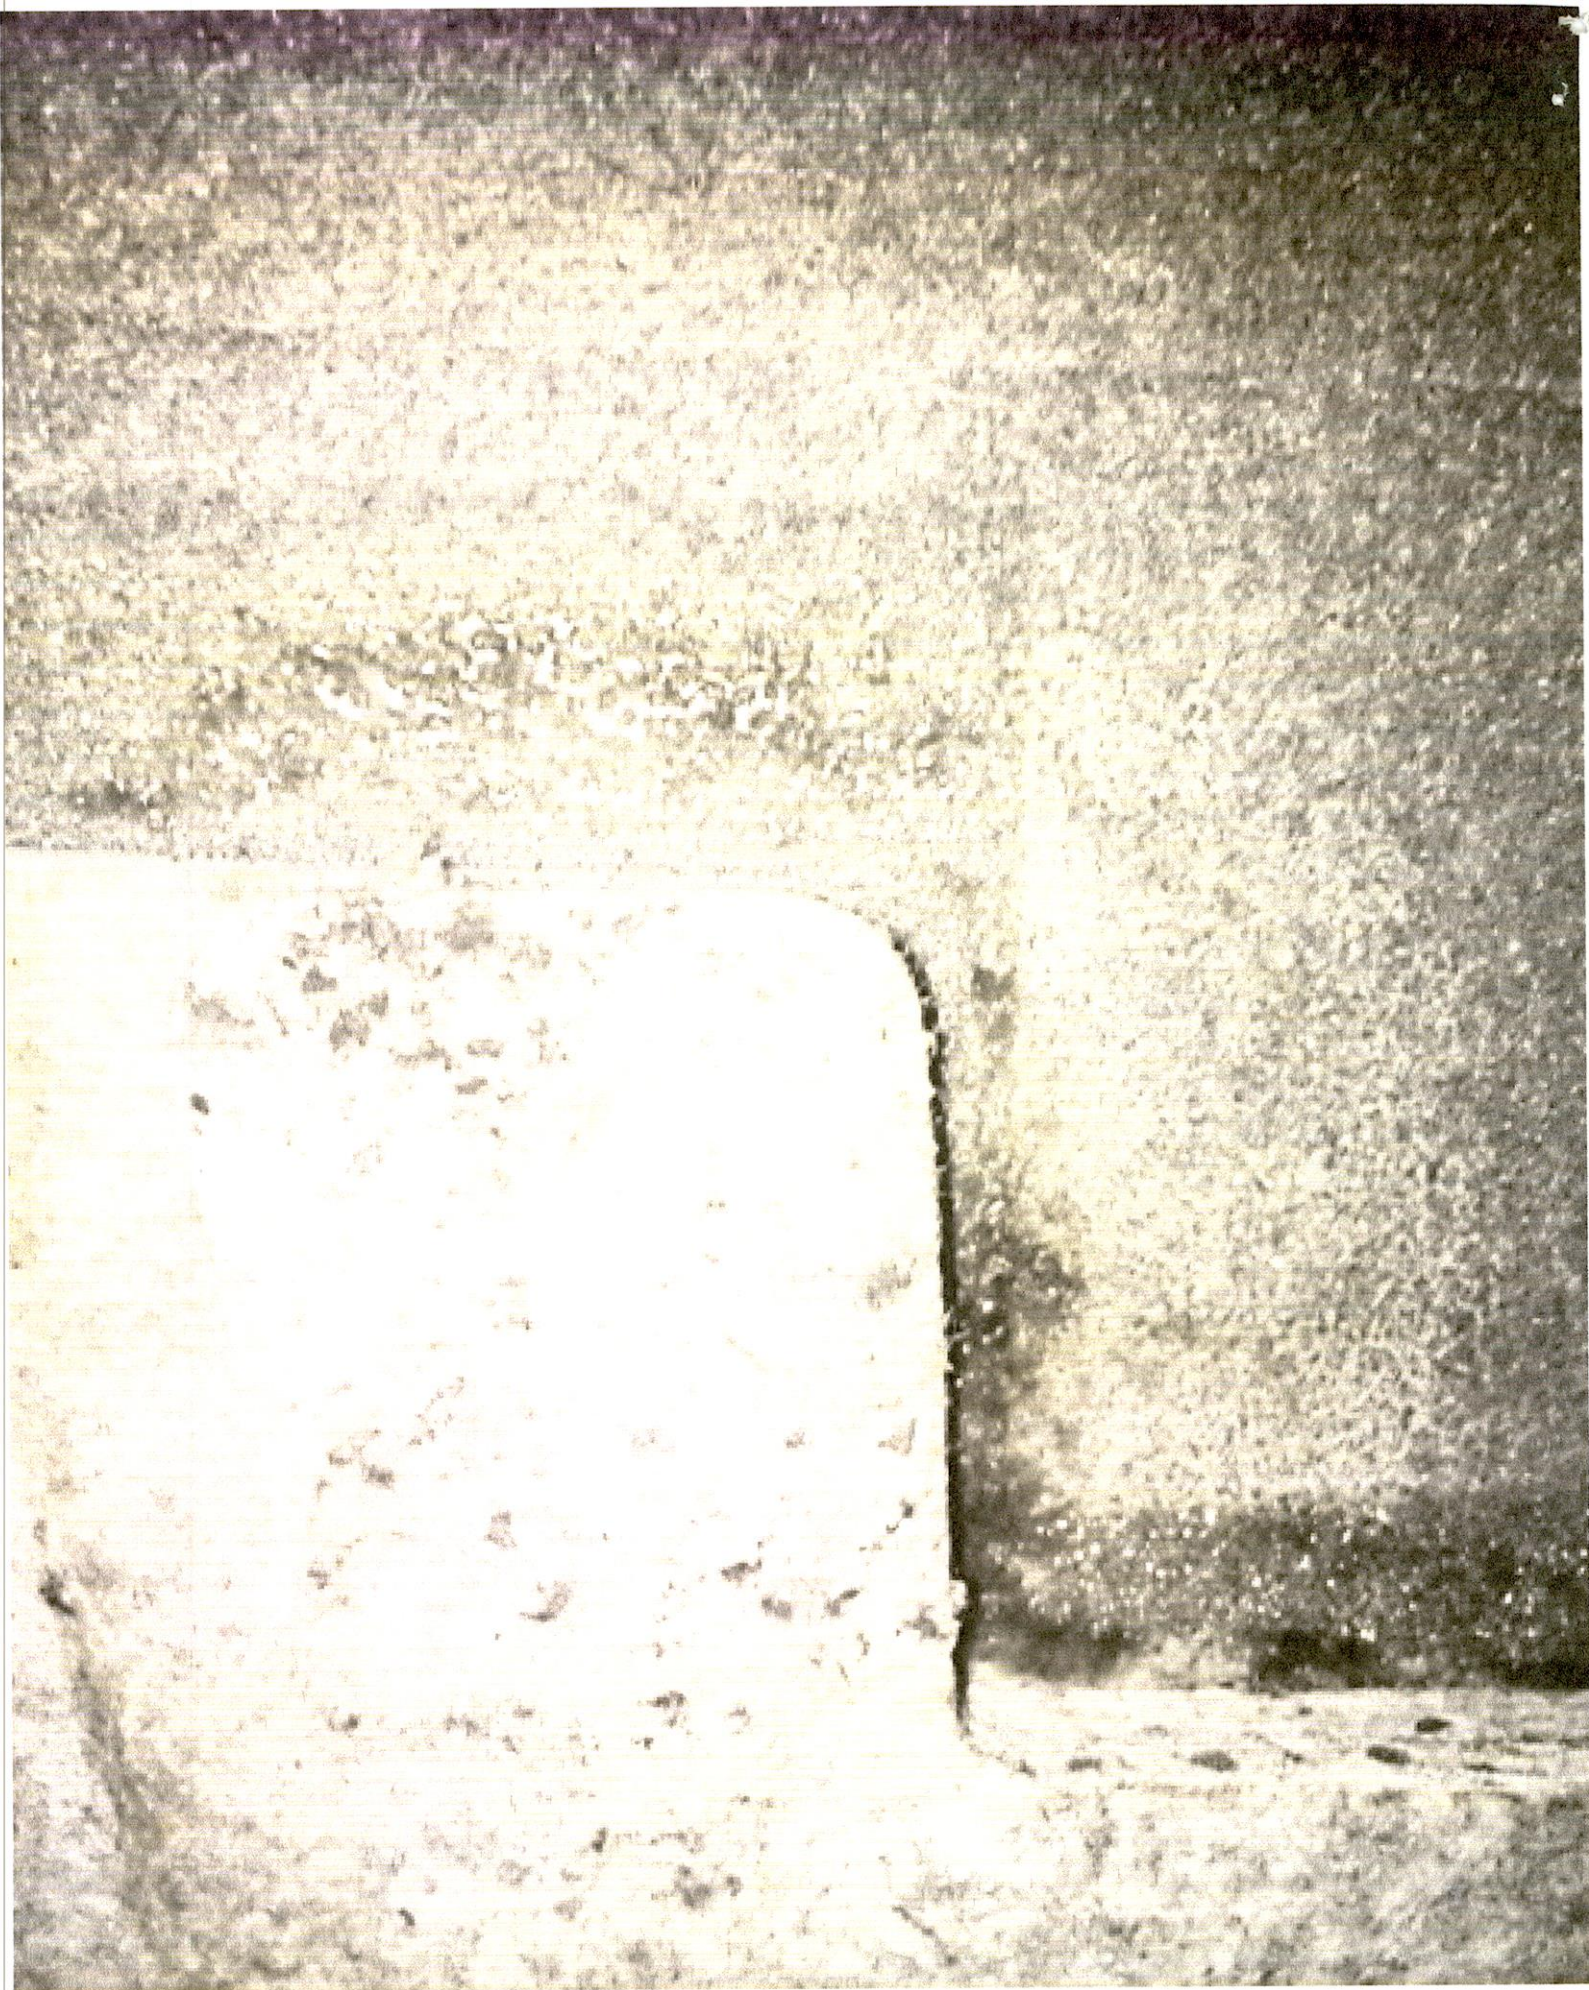
Mold on front passenger side

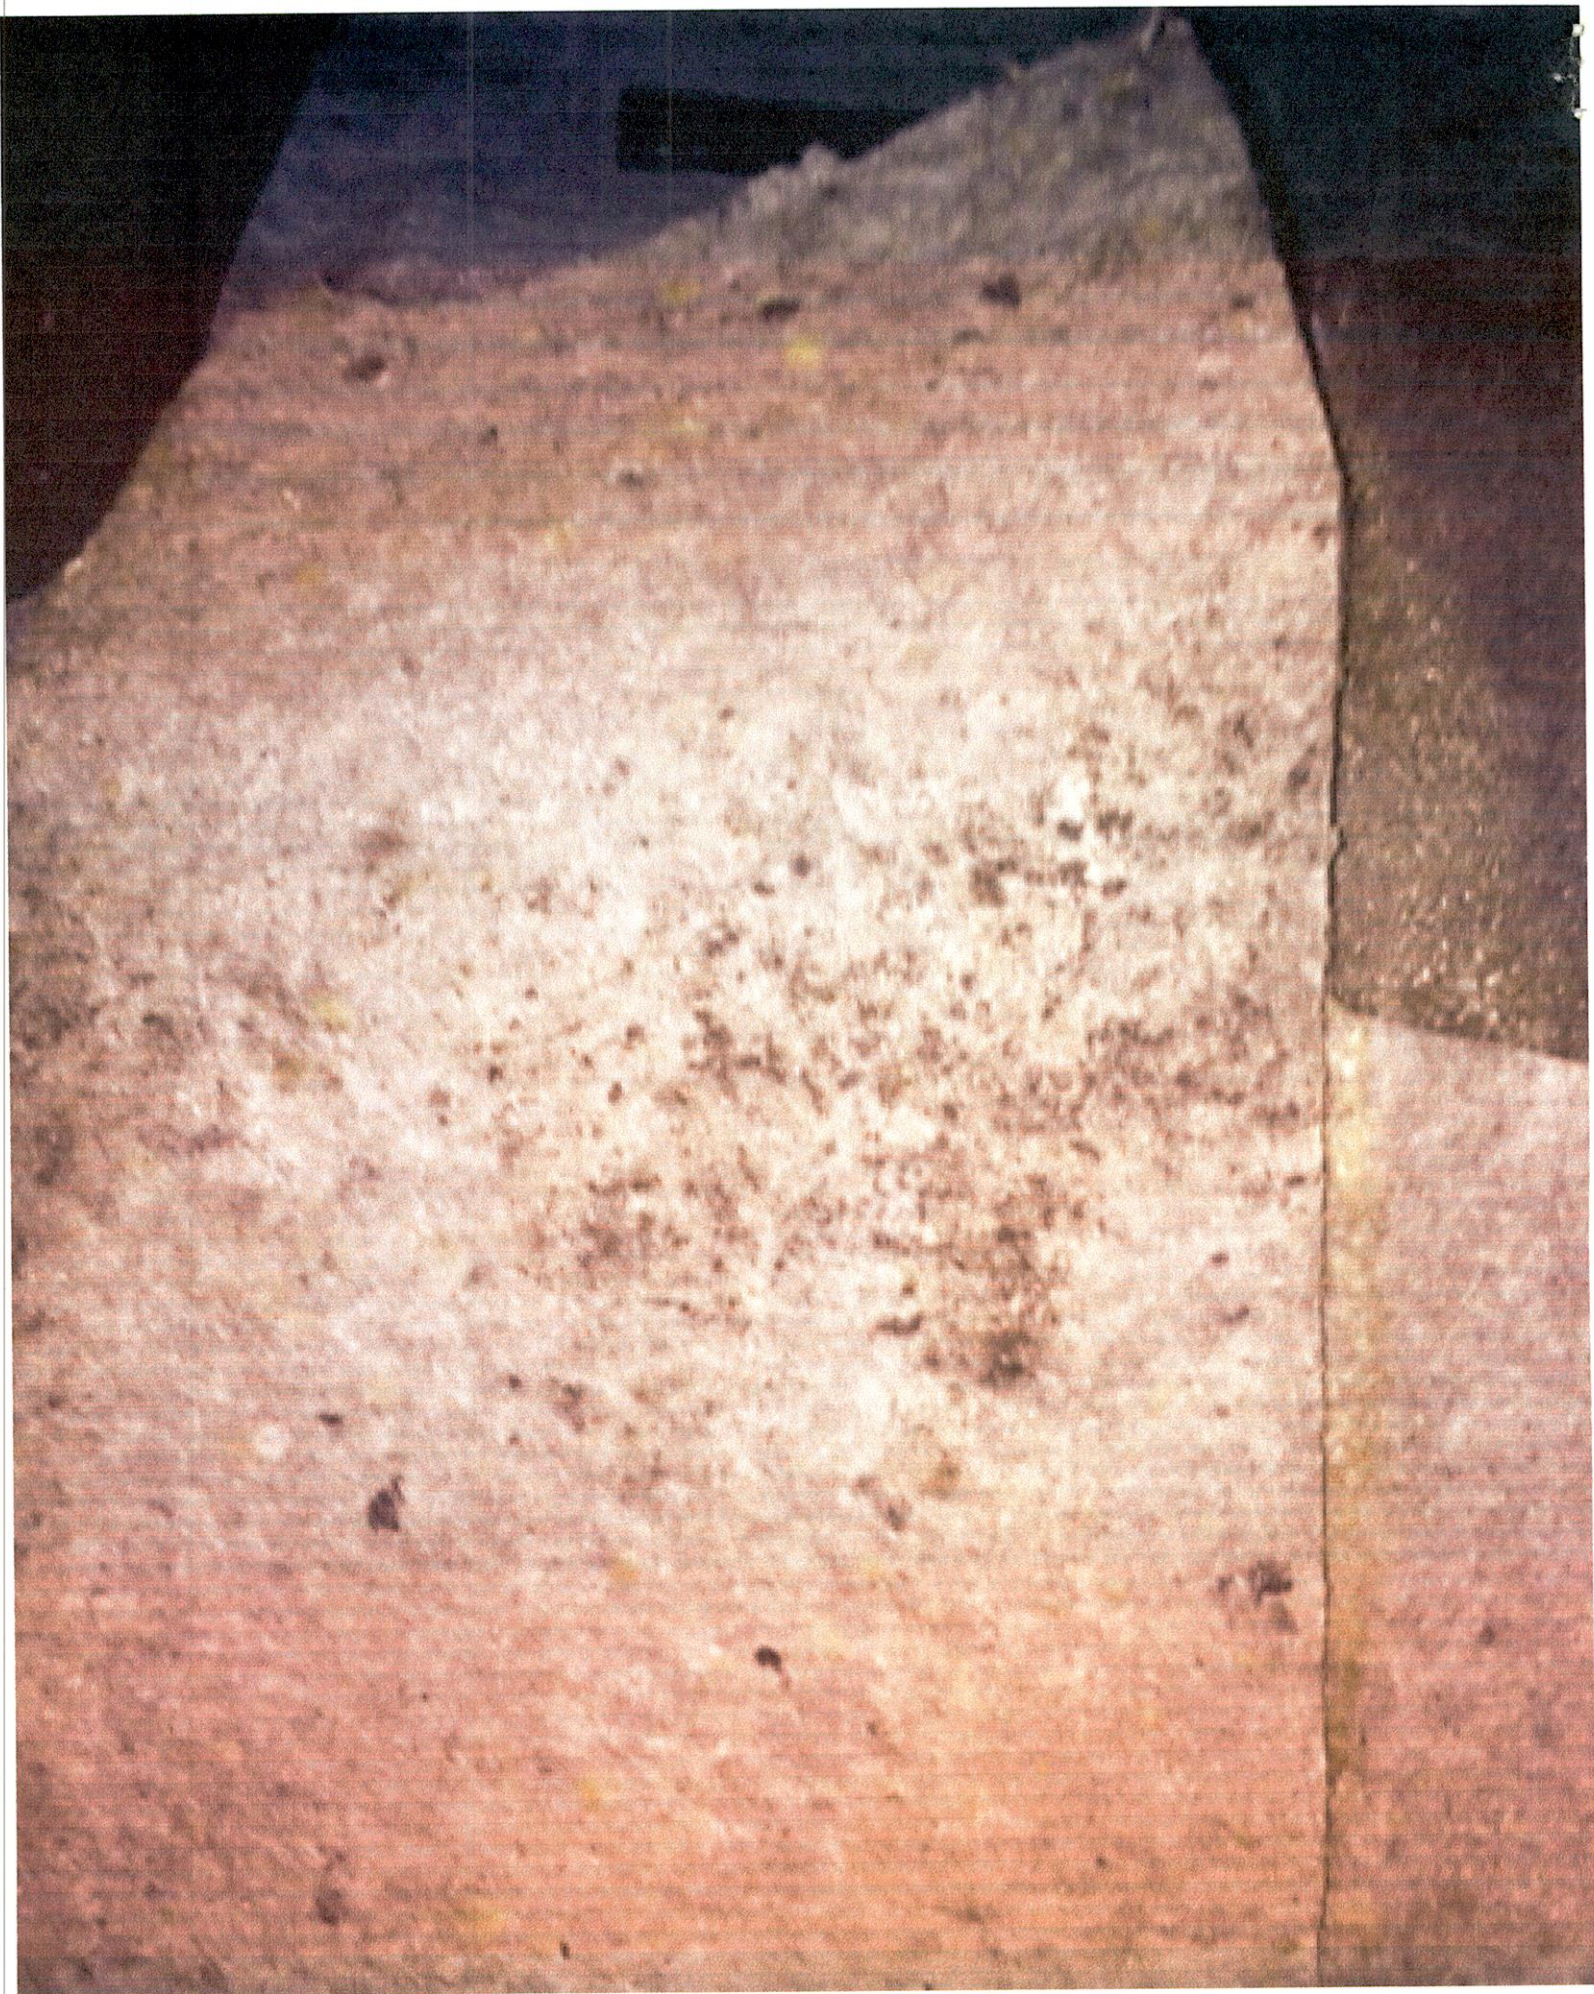
Wire & tube to sunroof  
9/10/14
