Subject: FW: Complaint 10668373
Date: Tuesday, January 13, 2015 11:05:58 AM
Attachments: [Catastrophic Failures of Interior Door Handle on 1998.pptx](#)

Catastrophic Failures of Interior Door Handle on 1998 GMC Sierra

Situation History

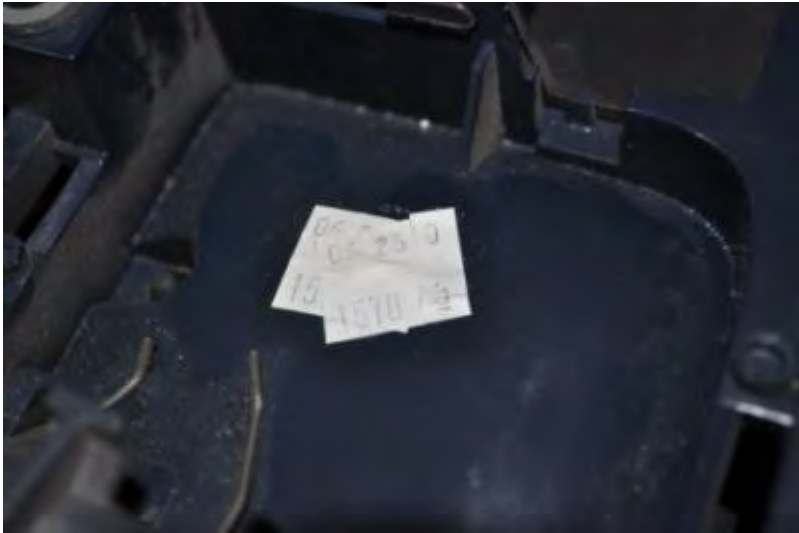
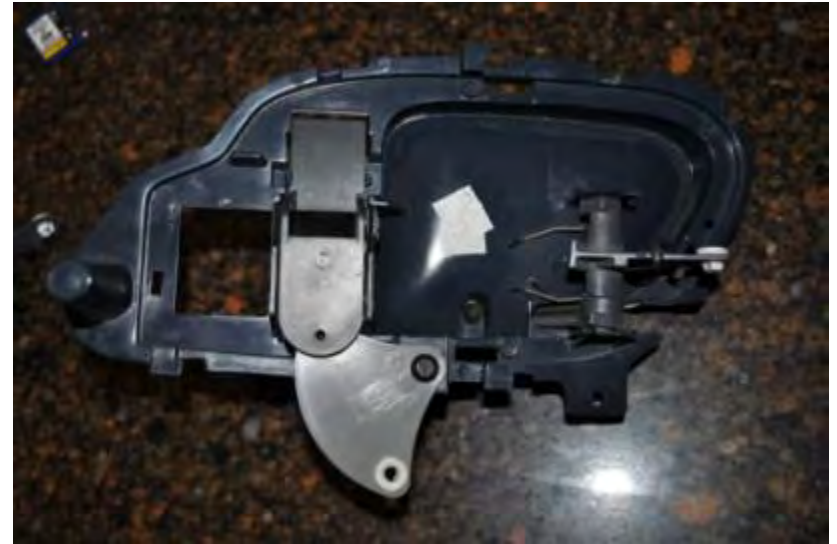
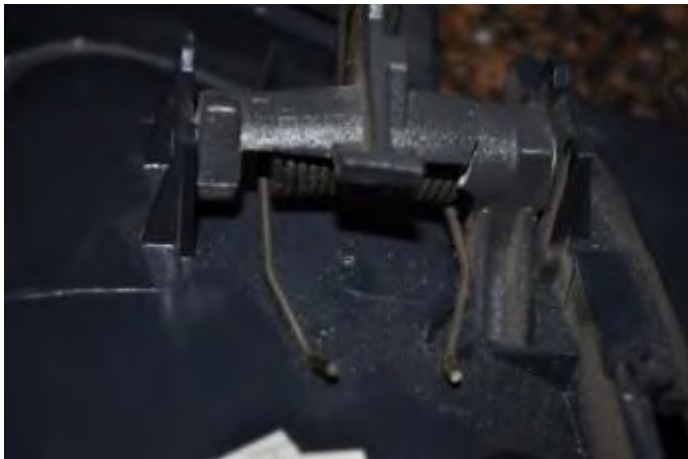
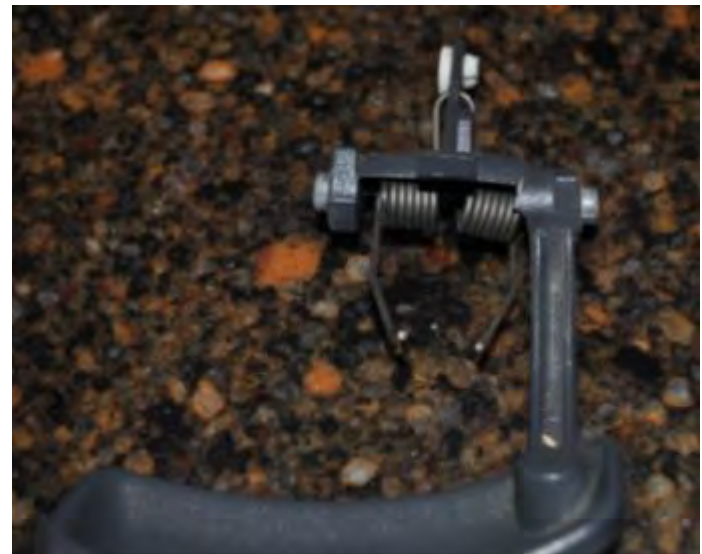
Exhibit 06.25.10 Failure

- Single owner of 1998 GMC Sierra, purchased in September 1998.
- Have experienced 7 failures of the interior left (driver) side door handle.
- All replacements have been purchased through GM dealerships.
- Last two failures were saved for analysis.
- Exhibit 06.25.10 was purchased on August 25, 2010 and failed on October 28, 2013.
- Exhibit 09.03.2013 was purchased on October 29, 2013 and failed on December 24, 2014.
- Previous five door handle failure points occurred exactly as the two failures reported in this document.
- These failures have all occurred without any indication of deterioration prior to total failure.

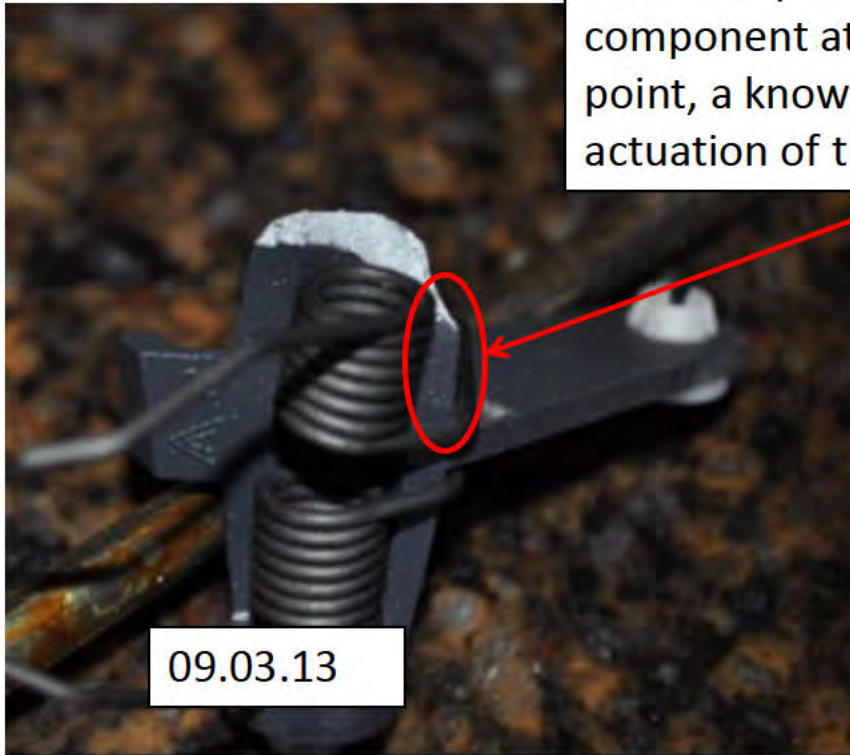
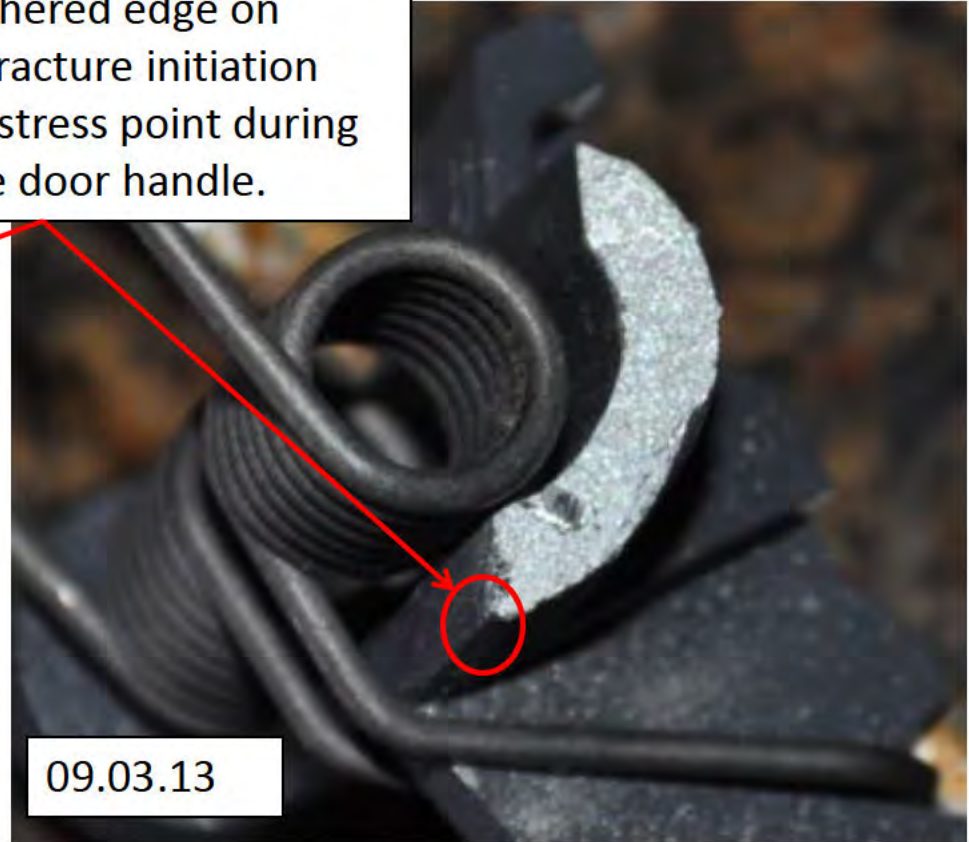
Note sharp feathered edge on component at fracture initiation point, a known stress point during actuation of the door handle.

- The inherent defect in the door handle design is a result of disregard to Powder Metallurgy design best practices.
- There is evidence supporting the failure of the interior door handle from other GM pick-up truck owners.
- Other owners have had repeated failures on a single vehicle with the interior door handle.

- Request FMEA results for the powder metallurgy (PM) design from General Motors.
- Request cycles-to-failure analysis report for the PM design from General Motors.
- Request critical-to-quality design parameters for the PM part from General Motors.
- Request sampling plan for PM product testing for validation that product meets critical-to-quality design parameters from General Motors.
- Request manufacturing quality control reports be produced for PM manufacturers from General Motors for this design.
- Request quantity of interior door handle replacements, of this design, which were performed at General Motors dealerships from General Motors.
- Request quantity of interior door handle replacements, of this design, which were sold as over the counter part sales from General Motors.

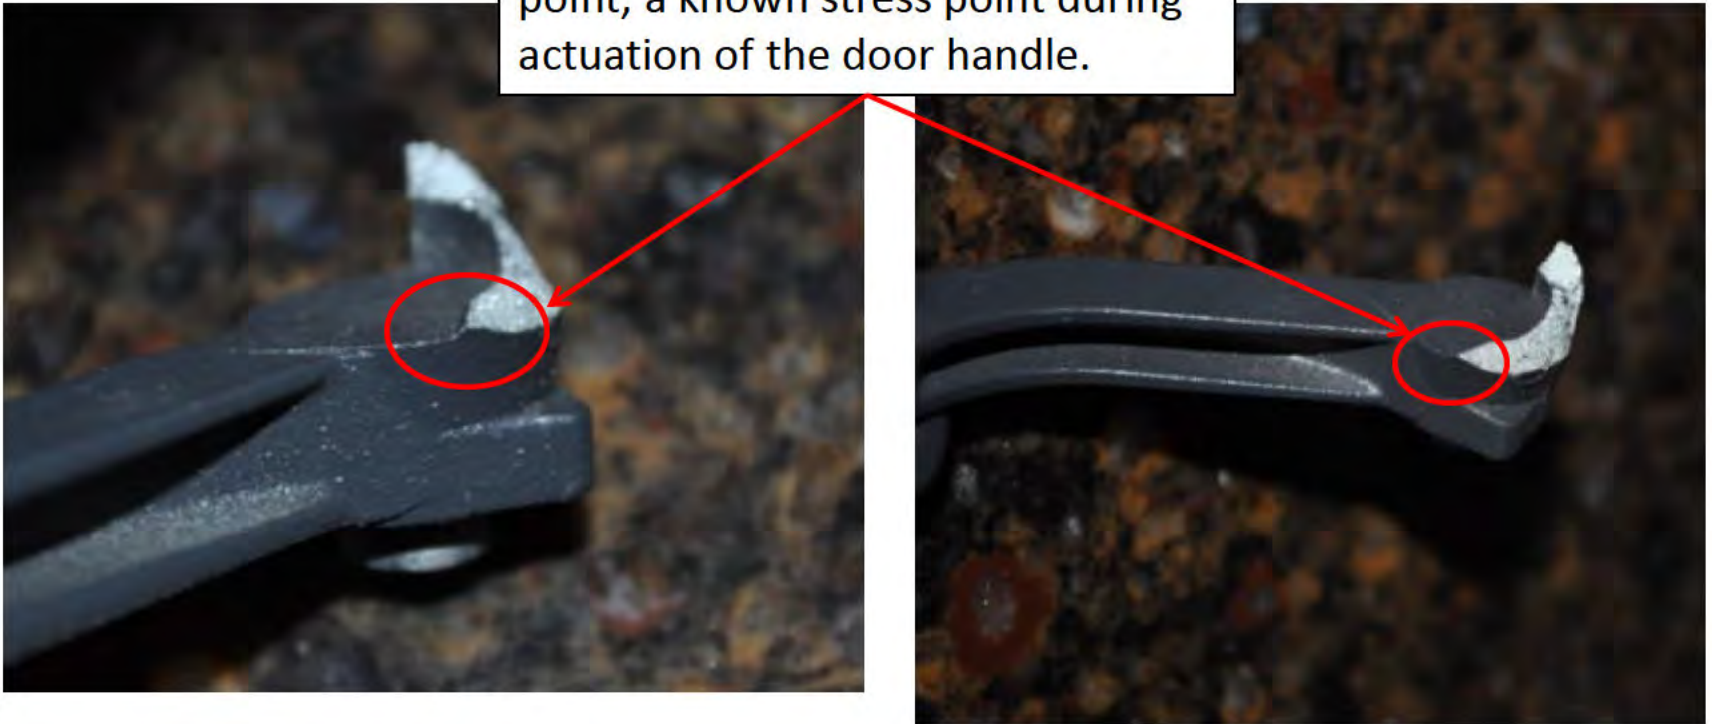
Note feathered edge on component at fracture initiation point, a known stress point during actuation of the door handle.

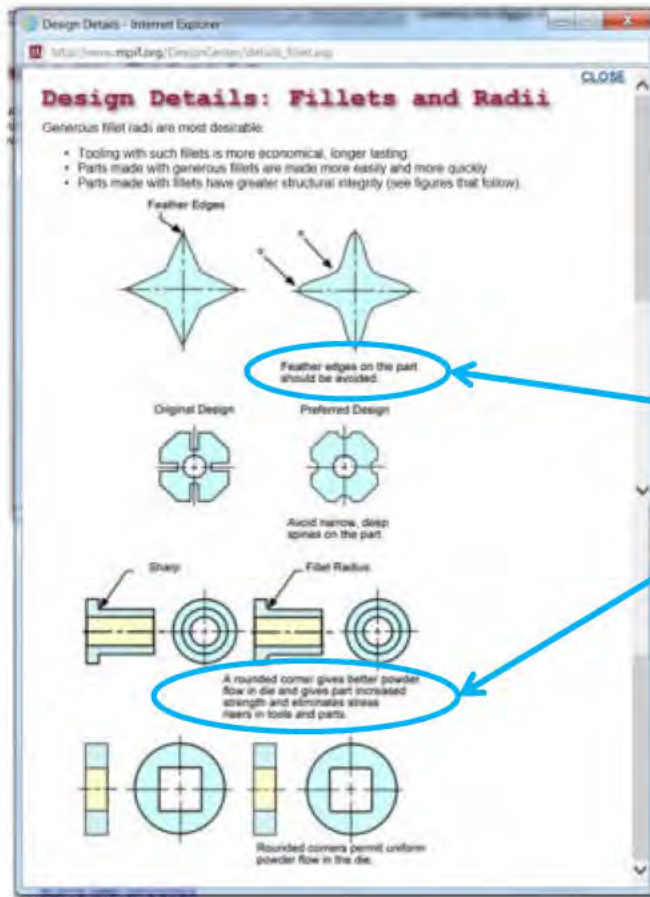
Note that sharp corners are undesirable and should be designed with a fillet radius.
