Decatur GA  
1G2NF52T7YC

## IMPORTANT SAFETY RECALL

GM Recall Number: 14350

14350 UNINTENDED IGNITION KEY ROTATION

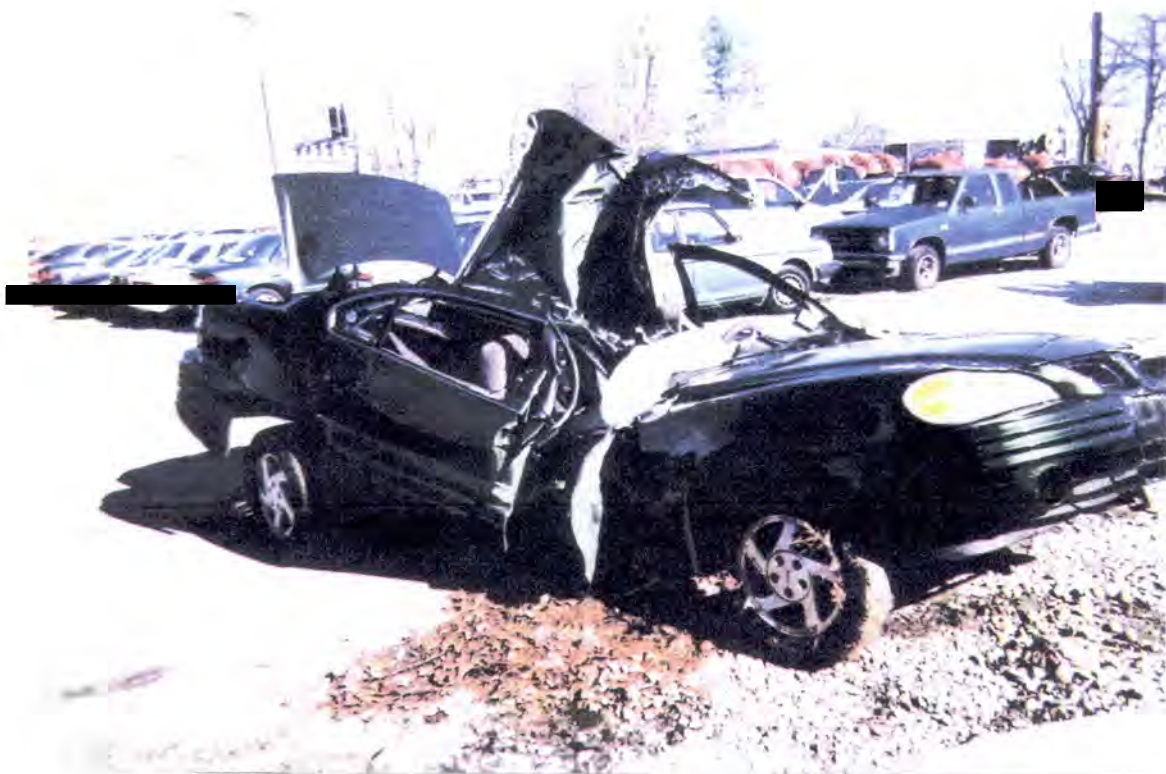
According to the information sent from this company to me about a car I did own 2000 model year Pontiac Grand Am (General Motors) concerning Safety and more. However, I was in a survived car accident in 2008. See the car below and included is the letter sent to me.
