TO: U.S. DEPARTMENT OF TRANSPORTATION  
NATIONAL HIGHWAY TRAFFIC SAFETY  
ADMINISTRATION

RE 2007 BX TOYOTA PRIUS  
VIN; JTDKB20U573 [REDACTED]

MY QUESTION FOR THE MOST RECENT NON-RECALL EVENT, THE NEED FOR A NEW SPIRAL CASING FOR THE STEERING WHEEL IS THIS ;

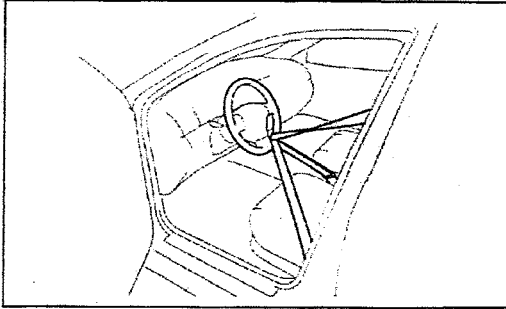
2A

14. CONFIRM THE STEERING WHEEL AND THE WHEELS ARE POINTED STRAIGHT AHEAD

15. SECURE THE STEERING WHEEL IN THE STRAIGHT AHEAD POSITION

a) Use the seat belt to secure the steering wheel.

- **DO NOT** damage the steering wheel.
- If the steering wheel is not secured, the spiral cable may be damaged.

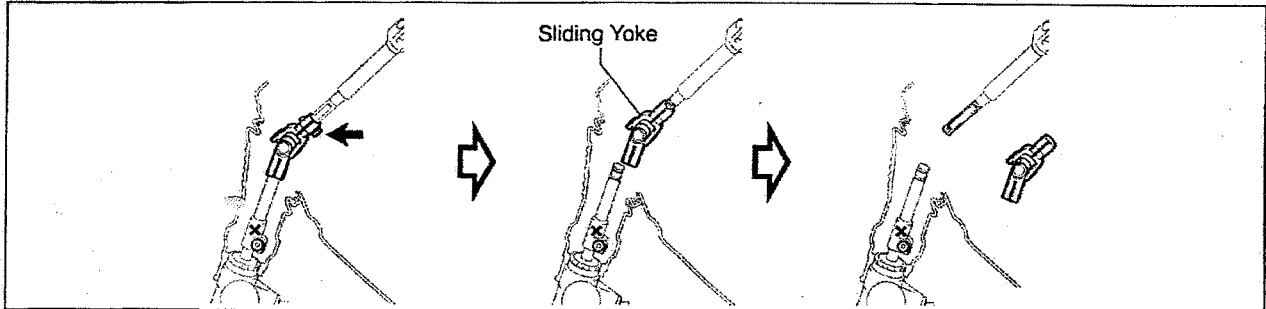
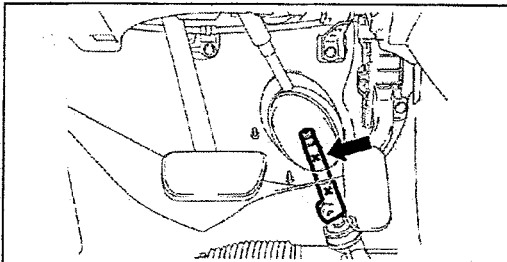
17. REMOVE THE STEERING SLIDING YOKE SUB-ASSEMBLY

- a) Remove the upper yoke bolt and the sliding yoke.  
b) Mark the bolt so it is not reused.

**STOP** After removing the shaft and yoke, **DO NOT** do anything that will cause the wheels to move, this may change the alignment of the steering wheel.

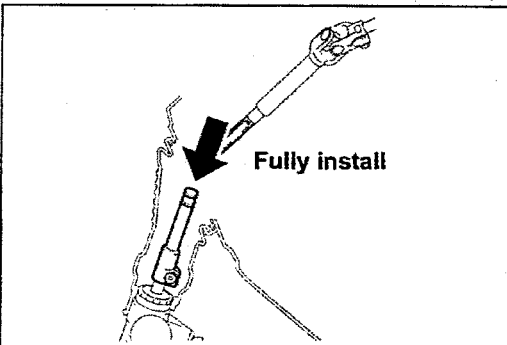
18. REMOVE THE EXTENSION SHAFT

- a) Remove the extension shaft.  
b) Mark the shaft so it is not reused.

The new shaft in the kit (04001-41212) is manufactured with a countersink, mark the NG shaft to confirm it is not reused.
