DOT Auto Safety Hotline  
INFORMATION ACT (FOIA), 5 U.S.C. 552(B)(6)  
**Vehicle Owner's Questionnaire**  
To Report Vehicle Safety Defects  
1-888-DASH-2-DOT  
(1-888-327-4236)  
INTERNET: www.nhtsa.dot.gov/hotline

Reference No.  
10730644

TOYOTA

VENZA

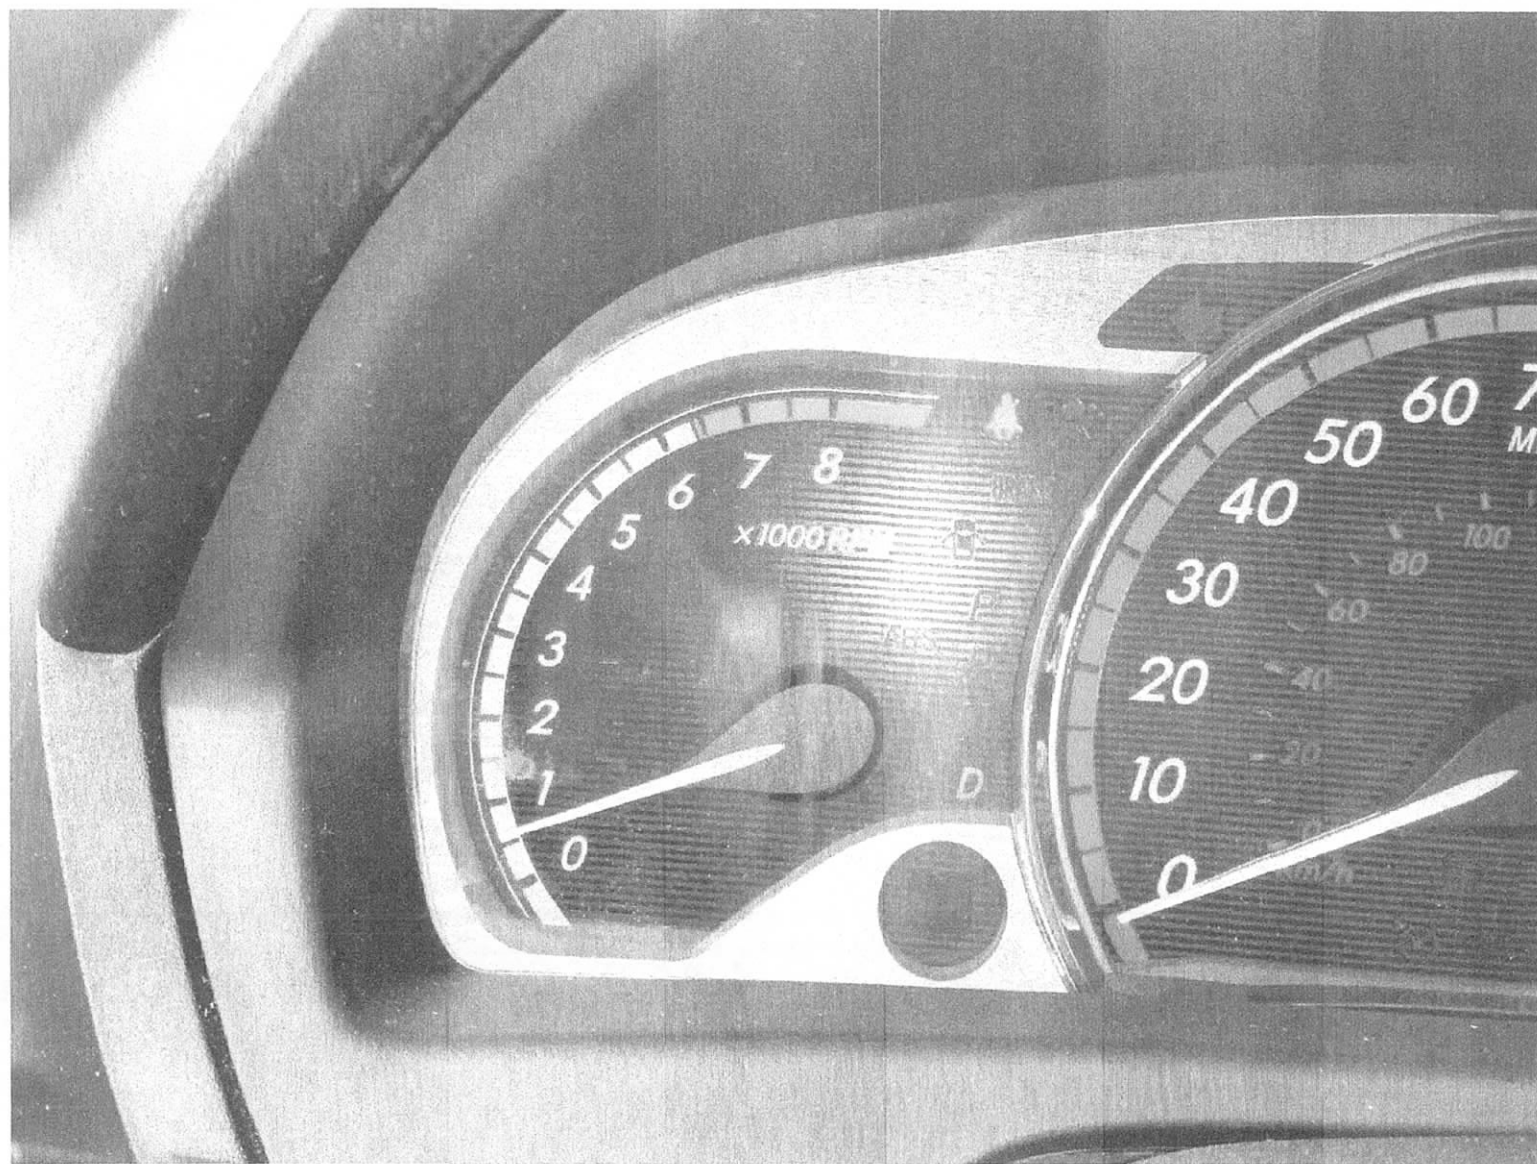
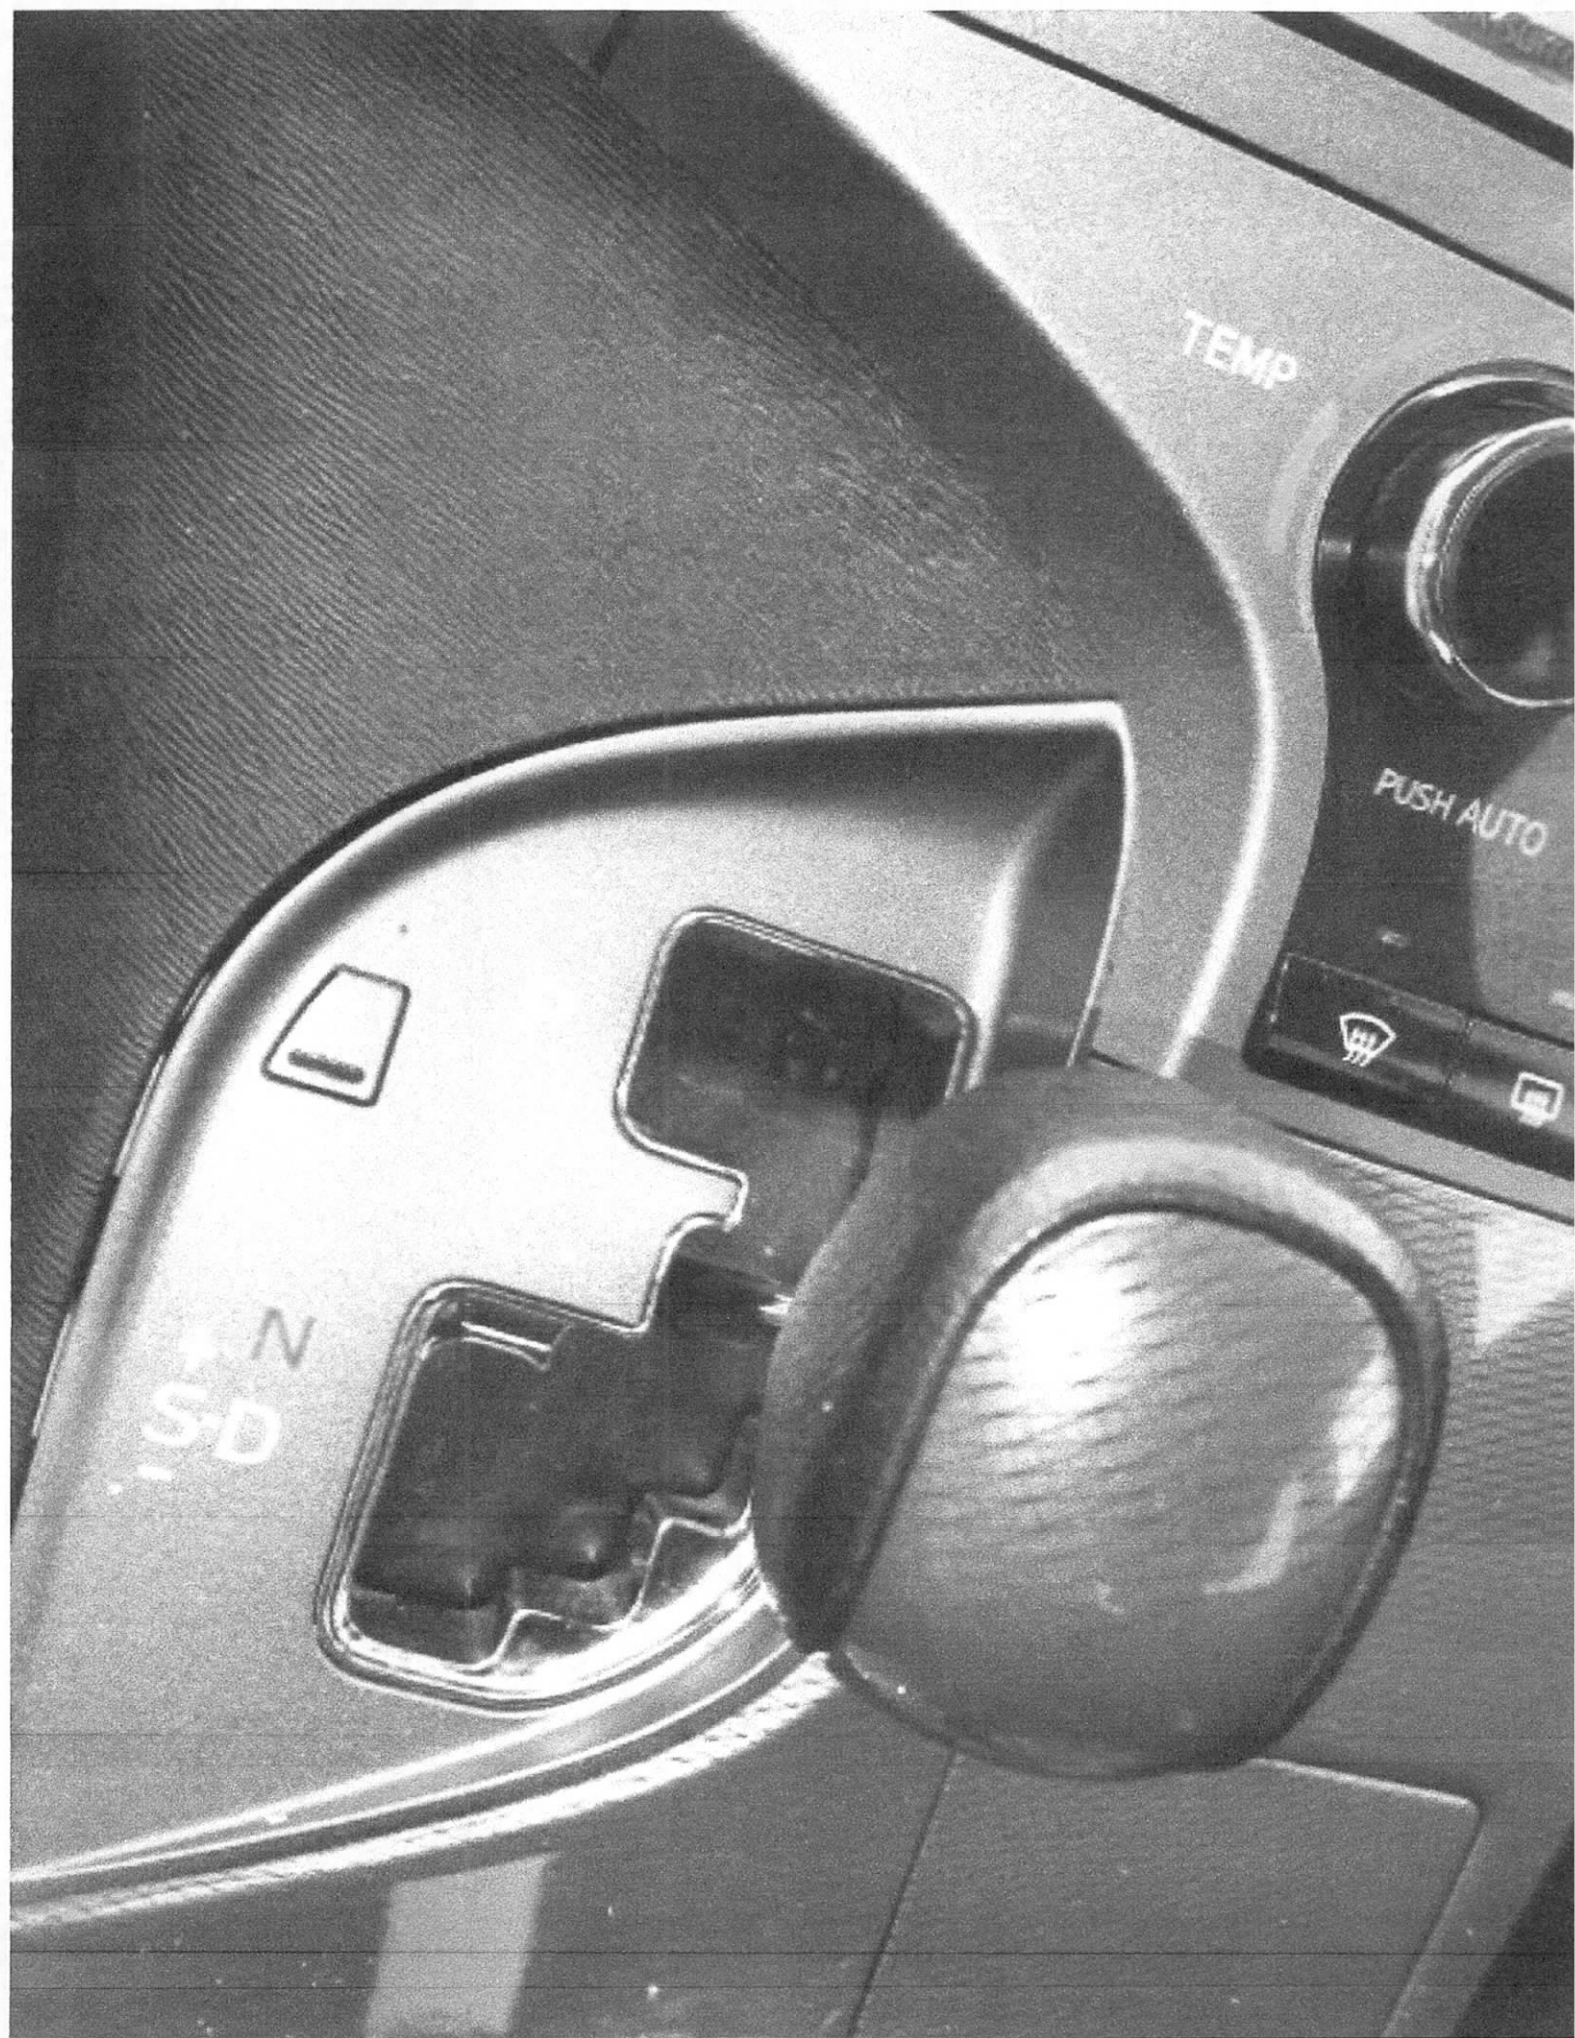
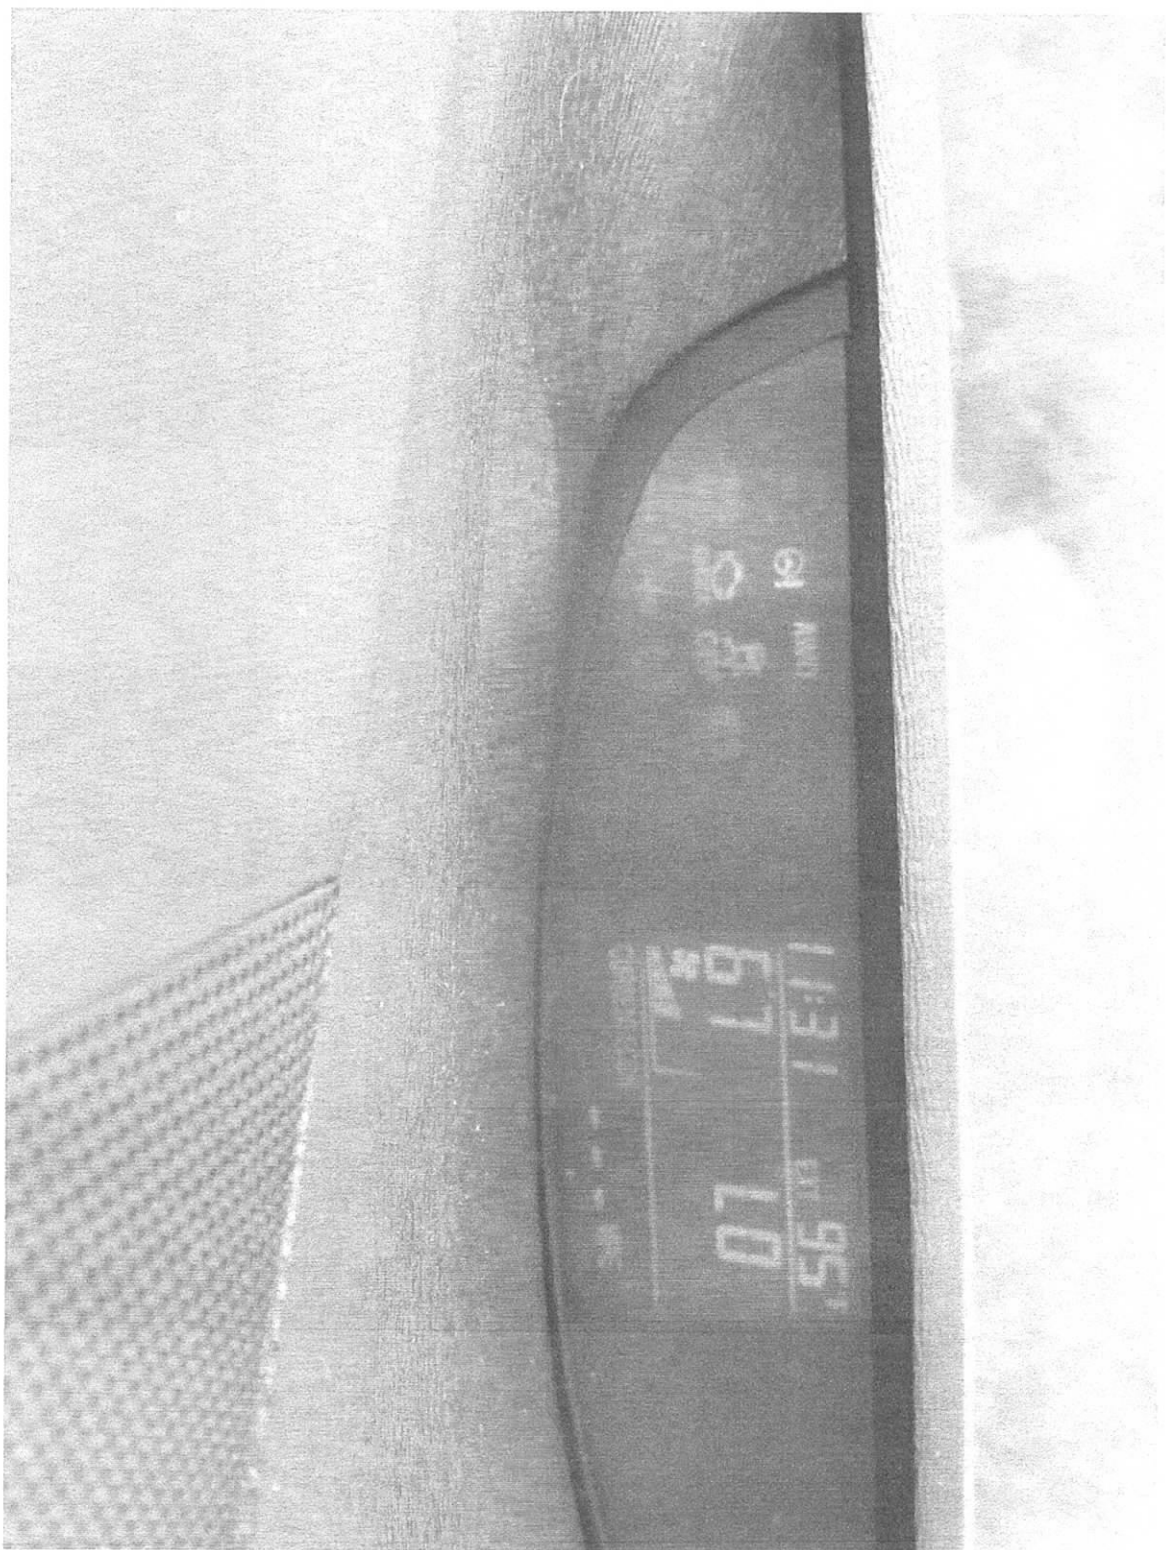
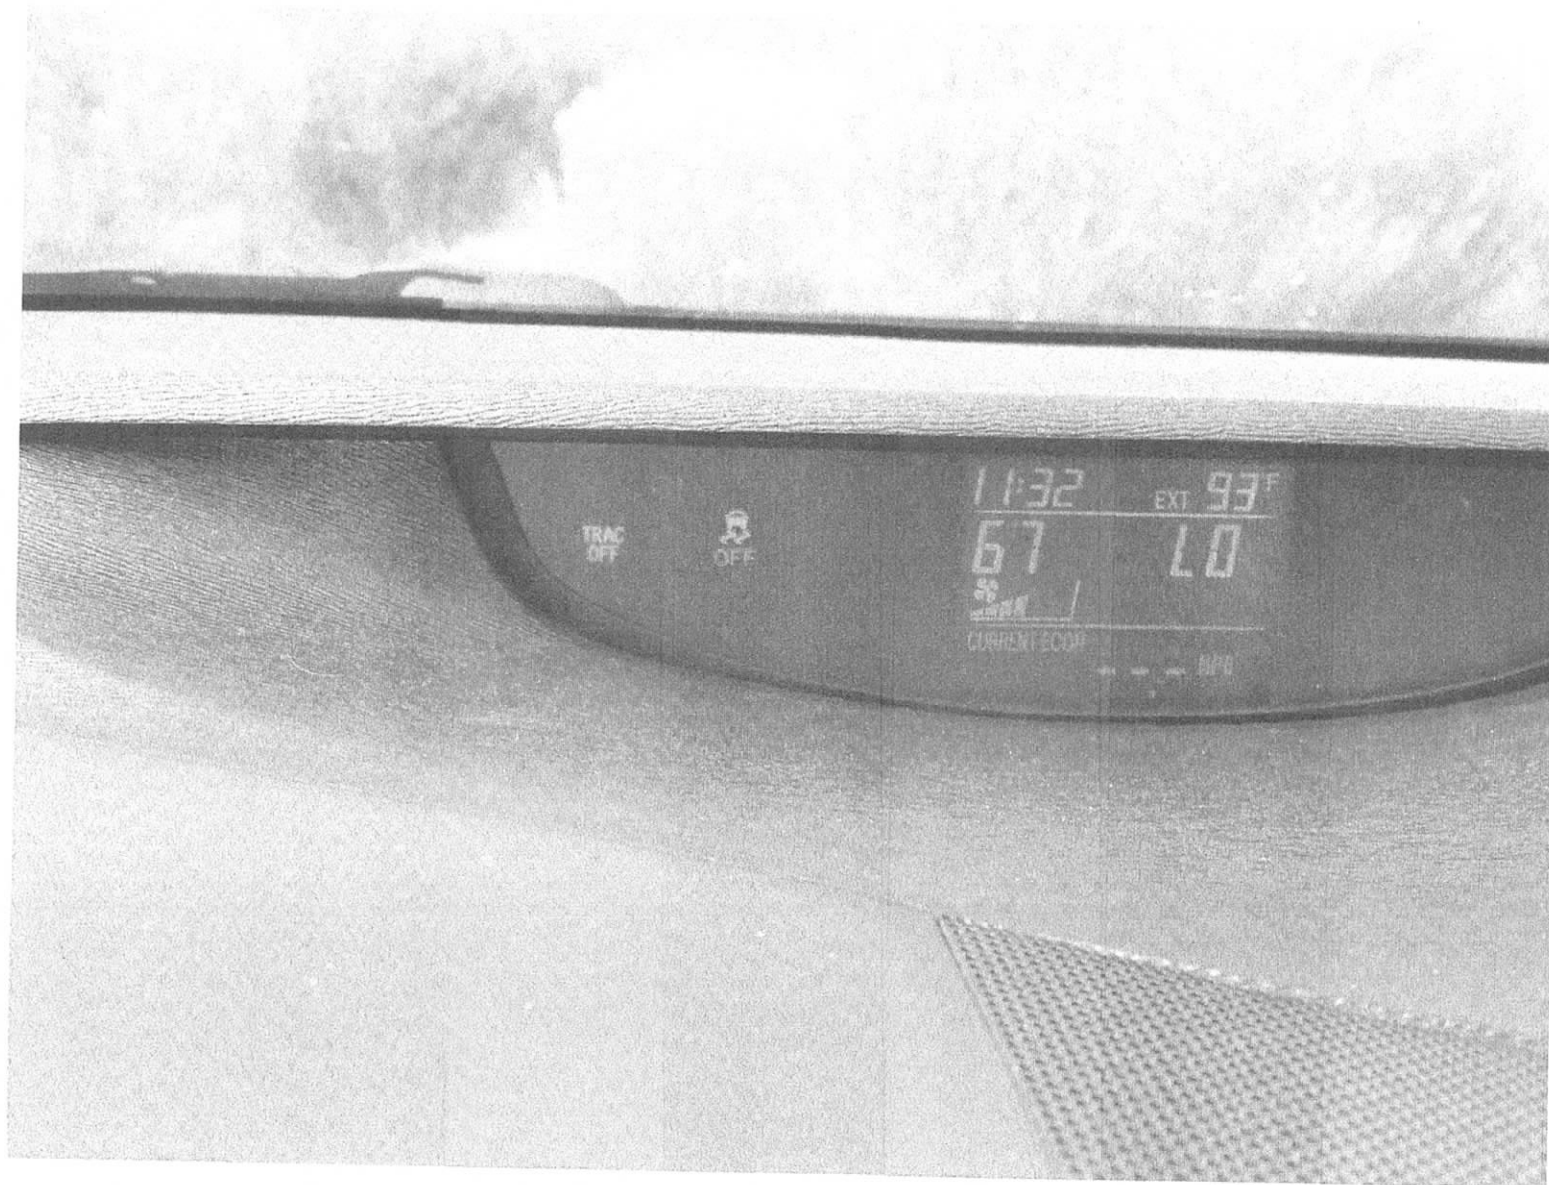
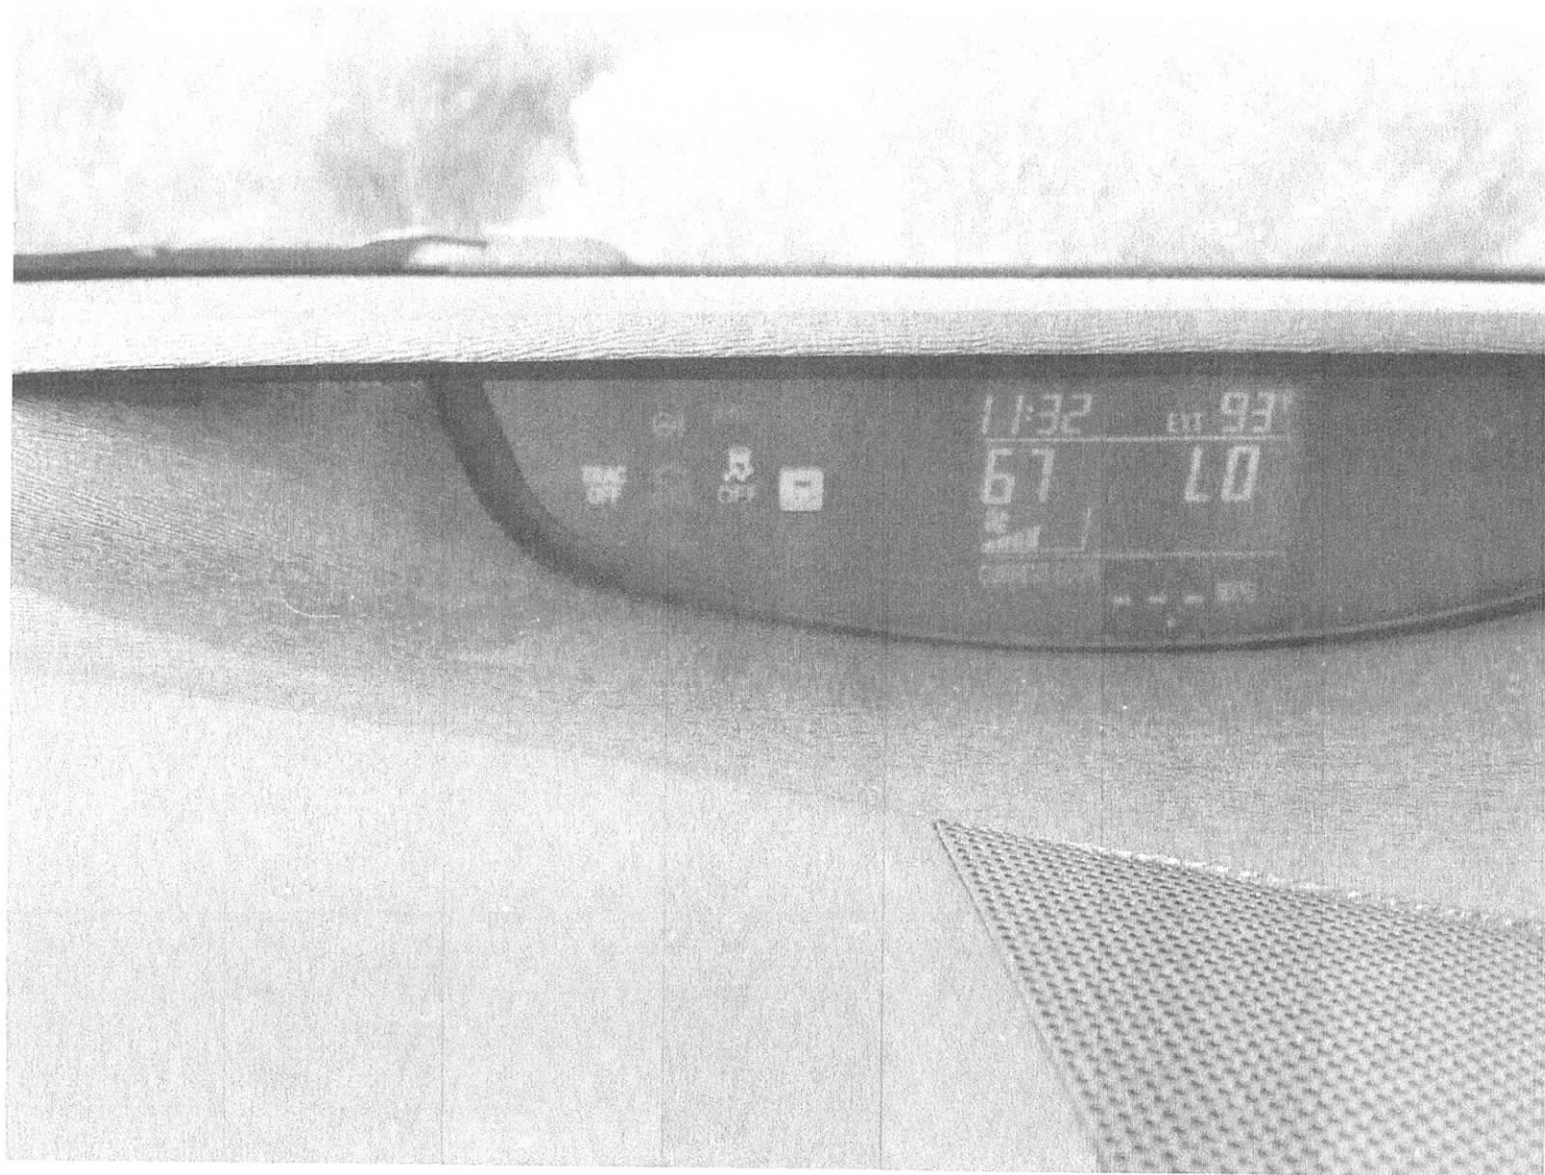
Dear Mr Reid attached are all of the information and photos of the incident, - accident that occurred with my 2013 Toyota Venza. As you will see the complete front end, damage tore off the front assembly where the Air Bag sensors are located.

These are pictures of the accident  
caused by the recall.
