1999 Buick Park Avenue 3.8L Eng Ultra

## ENGINE COOLANT CONSUMPTION OR COOLANT LEAK (INSPECT FOR MATERIAL DEGRADATION/REPLACE INTAKE MANIFOLDS)

### TECHNICAL SERVICE BULLETIN

Reference Number(s): 01-06-01-007C, Date of Issue: September 20, 2007

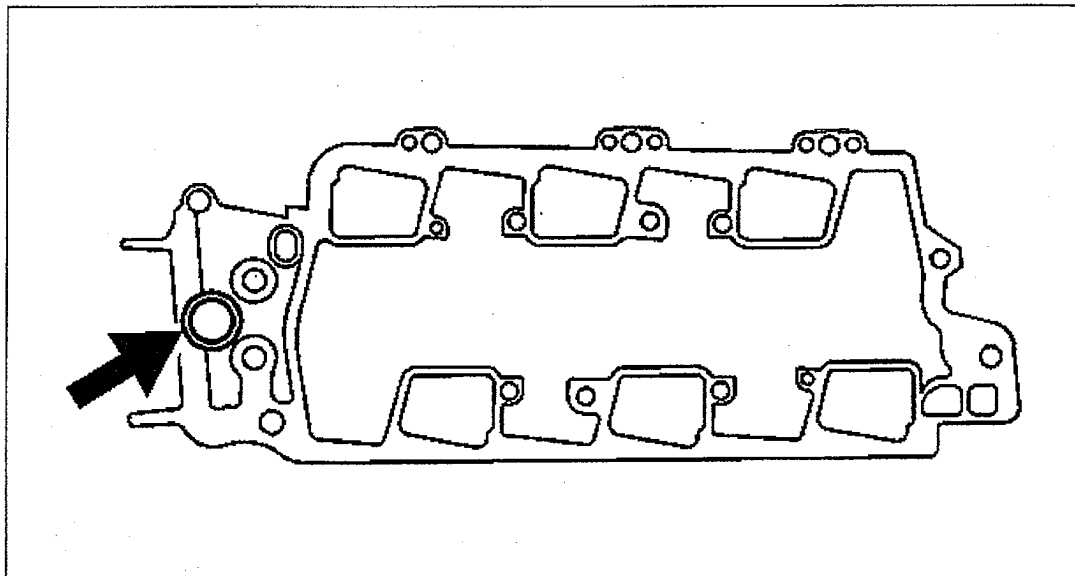
Fig. 1: Locating EGR Passage

Upper intake manifold composite material may degrade around the EGR stove pipe and could result in an internal or external coolant leak.

2. Refer to the arrow in the illustration of the upper intake manifold above. Inspect the inner diameter of the EGR passage for signs of material degradation. Degradation will appear as "pitting" of the composite material in the EGR port passage.

3. If degradation of upper intake manifold composite material is found, replace the lower and upper intake manifolds with the following part numbers:
  1. Gasket Kit, Upper Intake Manifold - 89017554

2. Manifold Kit, Upper Intake - 89017272
  3. Gasket, Lower Intake Manifold - 89017400
  4. Manifold, Lower Intake - 24508923
4. Follow the lower and upper intake manifold installation instructions found in the Engine Unit Repair Section of the appropriate Service Manual.

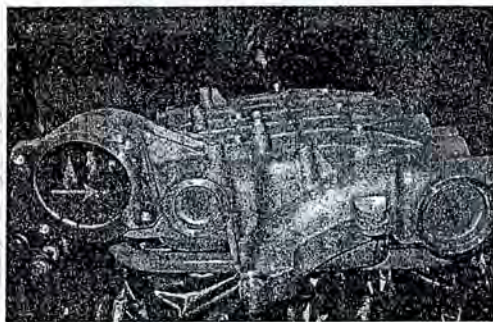
**View of Debris in Aluminum Intake Manifold - Throttle Body Opening**

- If **ANY** of the above were to occur, the intake manifold **MUST** be replaced or subsequent severe engine damage will occur. This replacement is required due to the complex inlet runner and plenum configuration of most of the intake manifolds, making thorough and complete component cleaning difficult and impossible to verify the complete removal of all debris.

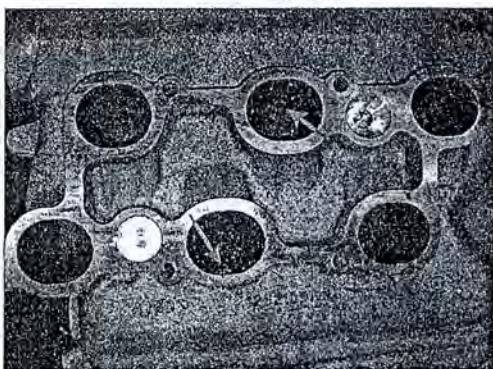
**View of Debris in Aluminum Intake Manifold - Ports to Cylinder Heads**

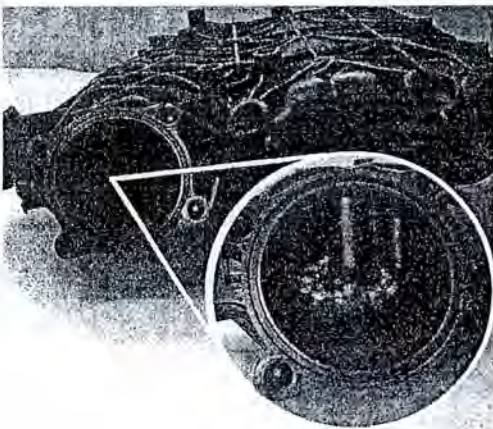
**View of Debris in Plastic Intake Manifold - Throttle Body Opening**
