DOT Auto Safety Hotline  
**Vehicle Owner's Questionnaire**  
To Report Vehicle Safety Defects  
1-888-DASH-2-DOT  
(1-888-327-4236)  
INTERNET: www.nhtsa.dot.gov/hotline

Reference No.  
10732460

17 digit Vehicle Identification Number Located at bottom of windshield on driver's side: 5TBJN321X1S [REDACTED]  
Make TOYOTA Model TUNDRA Model Year 2001  
Date Purchased June 2002 Dealer's Name and Telephone Number O'Fallon Toyota Engine: No: Cylinders V Six Fuel Type: 945  
Original Owner  Dealer's City State Zip Code  
Transmission Type manual  Antilock Brakes  Cruise Control Powertrain 2wd Multiple Failure: Incident Date(s) 28-JUN-2015

Vehicle Component Codes: 162000 STRUCTURE: BODY, 162810 STRUCTURE: BODY: HOOD: HINGE AND ATTACHMENTS due to premature rusting of attaching bolts which expanded, cracking hinge handle of hood Failure Mileage 102000 Failure Speed

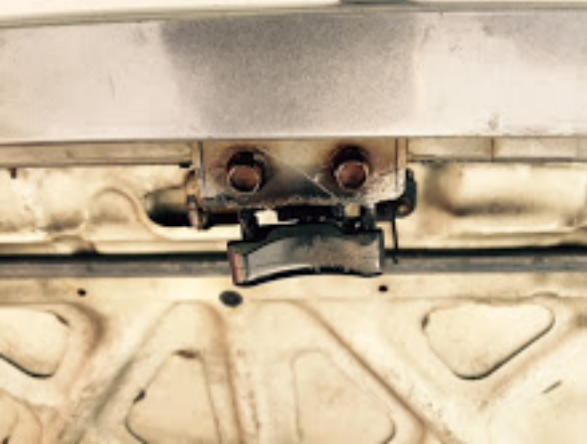
TL\* THE CONTACT OWNS A 2001 TOYOTA TUNDRA. THE CONTACT STATED THAT THE SECONDARY HOOD RELEASE-LEVER FRACTURED DUE TO CORROSION, WHICH MADE IT DIFFICULT TO OPEN THE HOOD. THE MANUFACTURER WAS NOTIFIED OF THE FAILURE. THE CONTACT WAS ADVISED THAT THE PART NEEDED WAS DISCONTINUED. THE VEHICLE WAS NOT REPAIRED. THE FAILURE MILEAGE WAS 102,000.

Since the hood release (secondary) is broken and no parts are available to replace it. It is very difficult to open hood. In the event of a fire in the engine compartment there would be no way to access engine bay to extinguish fire

Attached please find my up[dated vehicle owners questionnaire and attached photo of failed part # 53540-0C010 (Toyota part number) secondary hopod release along with all correspondence with Toyota North America Executive Offices Customer Service Representative Danica Sorenson.

According to Toyota this defective part is simply "no longer available" and they suggesxt searching junkyards. Unfortunately all the hoods in junkyards have the same problem where if you were to attempt to remove the secondary hood release the part would crumble due to the expansion of the rusty bolts used to secure the cheap plastic part.

Toyota should be required to make replacement parts available for this defect or compensate owners for loss of use of vehicle.

Due to these safety concerns, Toyota Motor Corporation should be required to provide replacement parts for defective secondary hood release part number 53540-0C10 s on all Toyota Tundra Trucks manufactured and sold in the US, or compensate owners for the loss of use of an otherwise functional vehicle.
